Failure Analysis of Low-Pressure Evaporator in Heat Recovery Steam Generator with 200 ton/h of Capacity

Tri Sigit Purwanto · Diki Ismail Permana · Meilinda Nurbanasari · Abdurrachim · Muhammad Pramuda Nugraha Sirodz

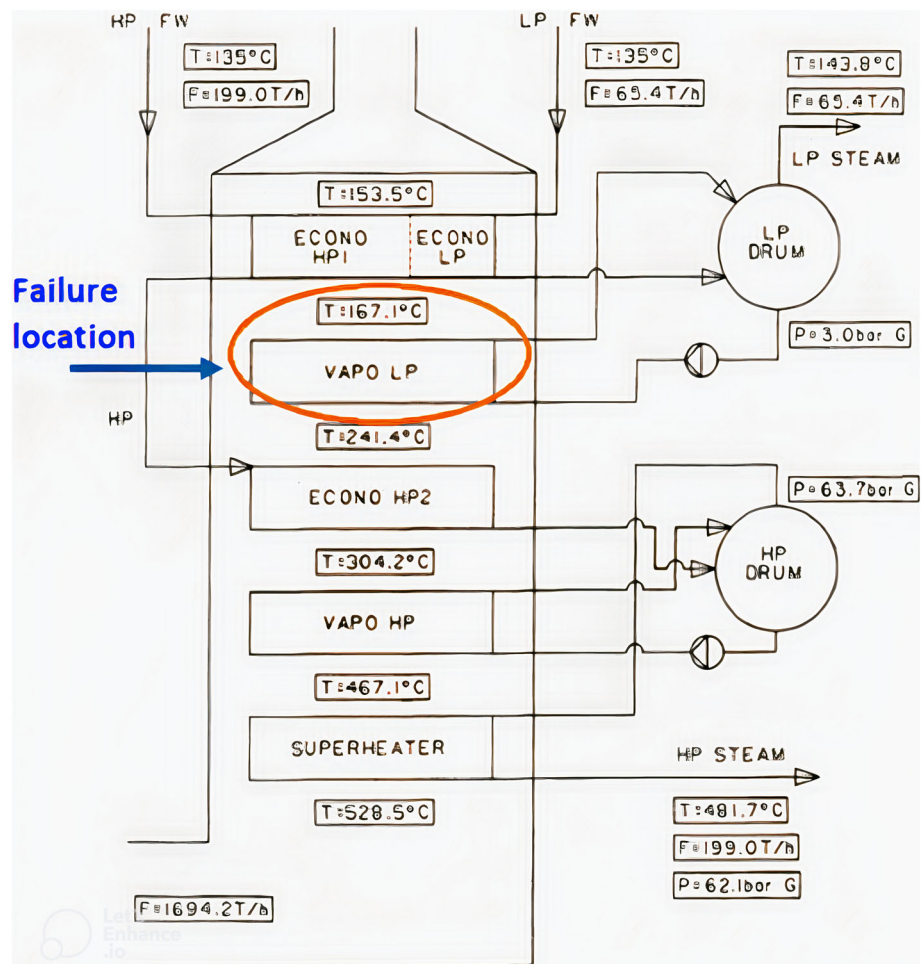
Fig. 1 The HRSG schematic with temperature and pressure distributions

average temperatures of around 218.1 and 208.6 °C, respectively. Additionally, the average temperatures of the LP evaporator on the west and east sides showed a significant difference from the design temperature, as shown in Fig. 1. The largest difference was found on the west-side, with a 100 °C variance between the actual and design temperatures. This temperature difference caused non-uniform expansion of the evaporator pipes, resulting in the east side pipe being longer than the west-side pipe and causing thermal stress in the LP evaporator pipe system (Table 8).
