CASE HISTORY—PEER-REVIEWED

# Multiple-site Fatigue Cracking of Fuselage Structure Due to Improper Rivet Installation

Frank Zakar

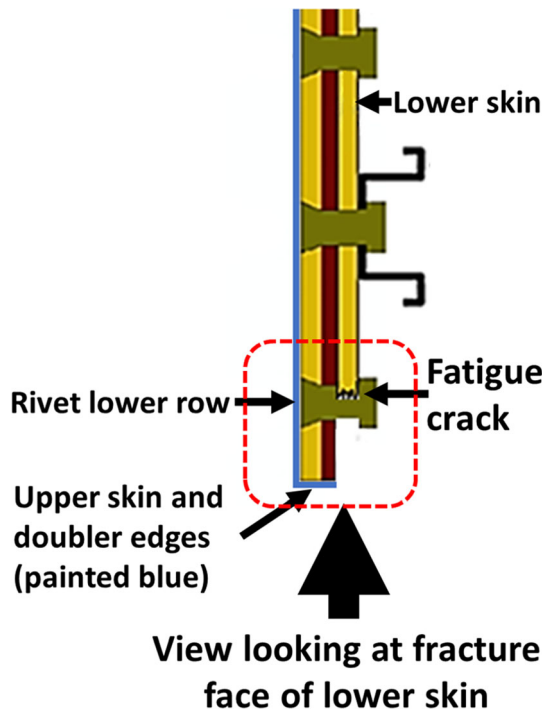
Stereo microscope examination of the lower skin fracture face (viewing the fracture face head on as shown in Fig. 4) revealed thumbnail fracture features typical of fatigue cracking emanating from 54 rivet holes. Fatigue cracking started on the forward and aft sides of each rivet hole. Figure 5 shows an example of one of the smaller fatigue cracks that did not intersect fatigue cracks from adjacent holes. Specifically, fatigue cracking started at the area where the rivet hole intersected the outer surface of the lower skin. The fatigue cracks in Fig. 5 emanated from diametrically opposite sides of the rivet hole, propagated forward and aft, and terminated in the areas indicated by a dashed line.

Fig. 4 Viewing the lower fracture face (line of sight)
