## Weathering phenomena, rock physical properties and long-term restoration intervention: a case study from the St. Johannis Chapel of Lütgenrode (Lower Saxony, Germany)

Siegfried Siegesmund<sup>1</sup> · Frank Wiese<sup>1,2</sup> · Calvin Klein<sup>1</sup> · Ulrich Huster<sup>3</sup> · Christopher Pötzl<sup>1</sup>

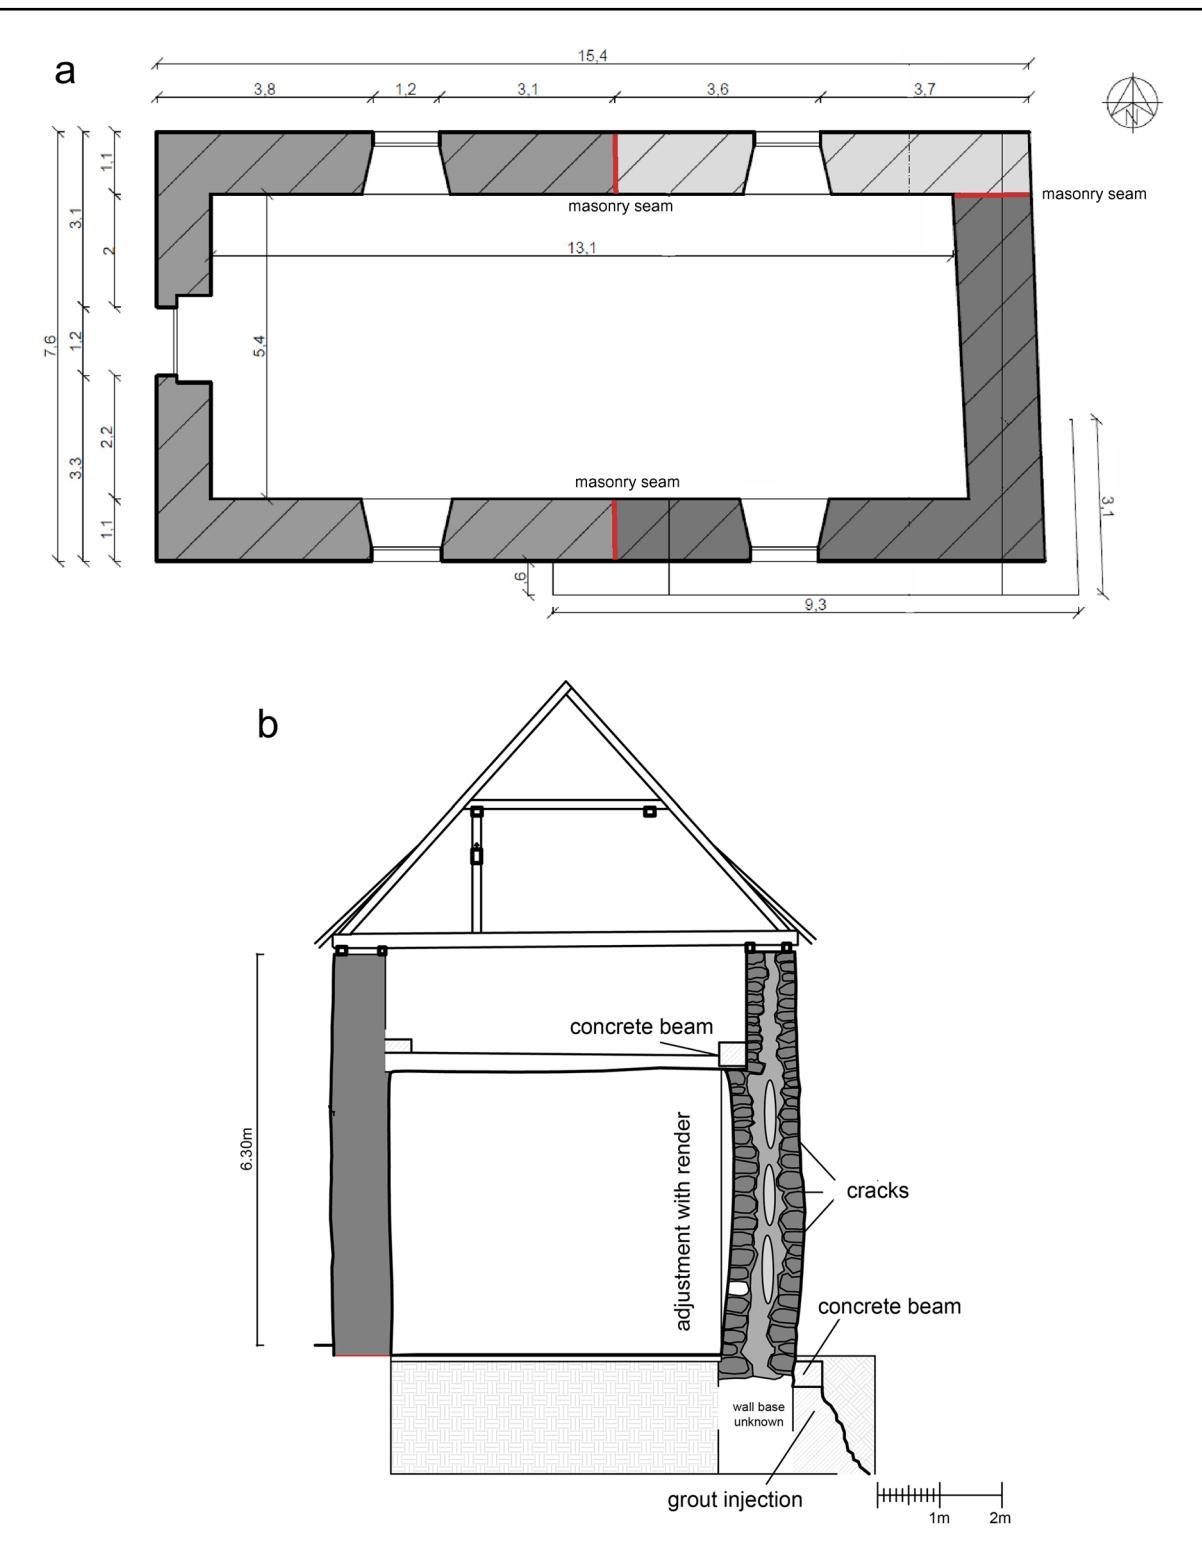
Fig. 2 a Layout of the Lütgenrode Chapel with masonry seams marked in red and  $\mathbf{b}$  section through the nave and roof structure, multi-layered natural stone masonry made of different dimensional stones

of factors. Because the loam mortar is sensitive to moisture, the wall lost its stiffness, where in contact with the soil and affected by splash water. This resulted in the eye-catching bulge in the southern wall of the former tower, and, to a lesser extent, in the southern wall of the nave. Resulting wall cracks increased humidity in the wall, accelerating the process of destabilization. Cracks and joints were repeatedly repaired/filled with various unsuitable lime and gypsum

mortars. Where the mortar was too hard, joints formed between mortar and the rubble, resulting in deep, funnel-like gates, where rain and splash water could enter the wall. A recent (1954?) injection of cement suspension further introduced humidity into the walls, causing the development of ettringite and thaumasite in the gypsum mortar and further decreasing the stiffness of the wall. Another problem results from the poor weathering resistance of Keuper siltstones, its strong back-weathering and development of large joints. The process of progressive wall destabilization is further amplified by heavy truck traffic on the nearby national road and the poor quality of the subsoil (Liassic claystone), causing settlement and settlement cracks. The latter problem was solved by the stabilization of the foundation by banquet concrete at the southern side (65 cm wide, 90 cm deep), and, in a second step (1972), the mounting of a reinforced concrete beam, needled to the foundation masonry, a tension rod and injection of concrete suspension into the foundation masonry (see Fig. 2b). Damages by humidity and sagging at the south-eastern corner resulted from a defect main conduit. A general sectional view of the southern wall is given in Fig. 2b.

Renovating the outer masonry requires uncovering the base of the wall at a depth up to approximately 1.0 m and up to 1 m in width. Renewal of the jointing with moisture resistant and compatible mortar is essential. Plastering in the area in contact with the ground to reduce moisture penetration, clay sealing close to the surface at least on the south and west sides, renewal of the main conduit are in question.

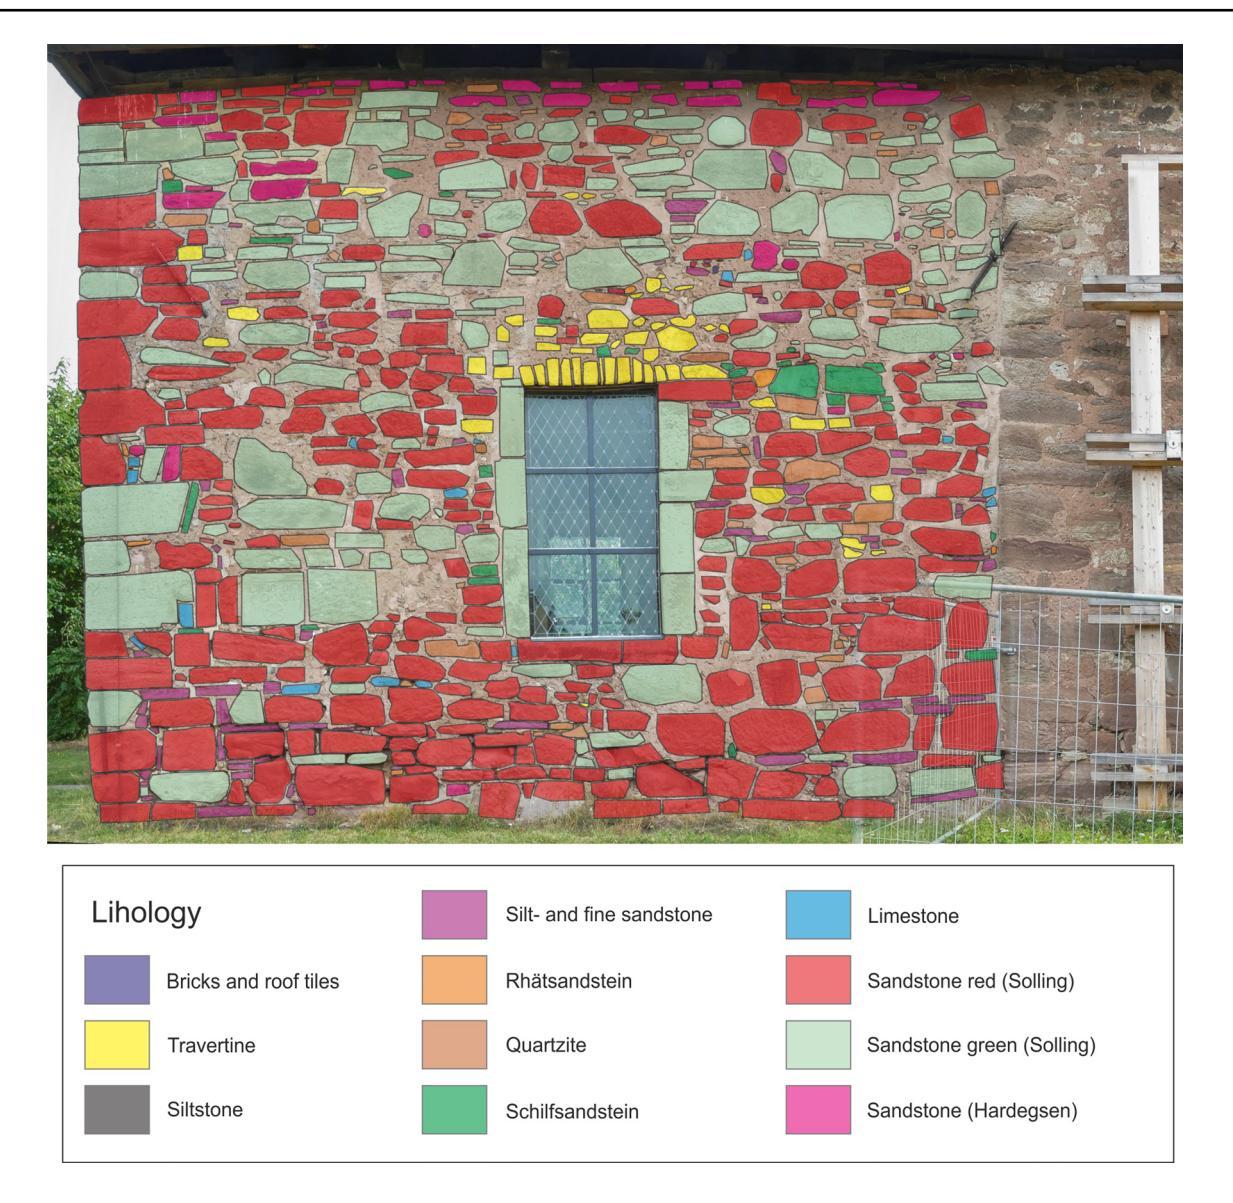
Fig. 9 Lithological mapping of the western part of the south side of the St. Johannis Chapel in Lütgenrode (width of the mapped wall ca. 8.10 m; comp. Fig. 2)

The red and grey-green sandstone of the Solling Formation dominates the visual appearance of the south side not only because of their sheer quantity, but also because the ashlars are significantly larger than the ones of the other lithologies (Figs. 9, 10, 11, 12). While 36% of the masonry is made of the red variety, about 20% consists of ashlars of the greygreenish variety. The lower and side window areas as well as the corner stones are built exclusively from sandstone blocks of the Solling Formation. Subsequently, the quartzites and silt and fine sandstone of the Exter Formation are most represented with 16% and 12%, respectively. These two lithotypes were used particularly often in the eastern part of the south wall. Please note that the percentages refer to the absolute quantity of ashlars and do not represent the proportion of the areal utilization of the individual lithologies, since the size of the ashlars may vary significantly.

only the western part could be reliably mapped (Fig. 18). The most common damage is minor chipping and spalling (35%), pollution and black crusts (30%) as well as smaller cavities through back-weathering (26%). These three damage groups are distributed over the entire side of the build-ing. However, the intensity of damage that the rocks have

suffered from the three phenomena is quite low. Black crusts are quite rare. Most of the stones are soiled. All other weathering phenomena are significantly less present (< 10%).

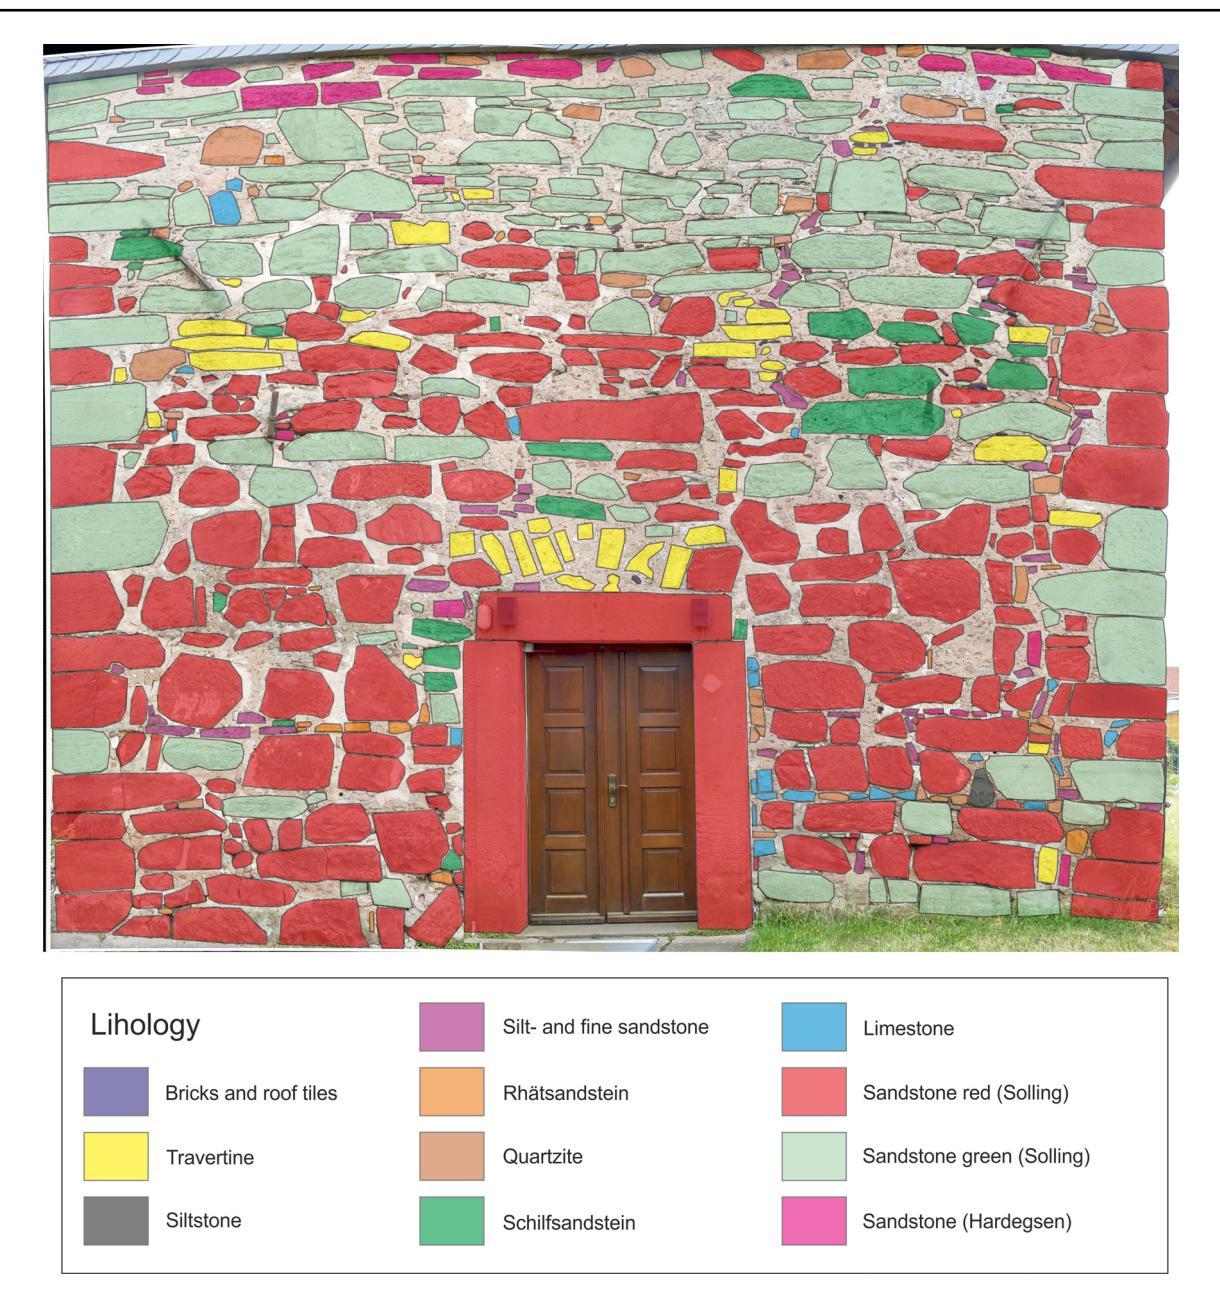
Fig. 11 Lithological mapping of the west side of the St. Johannis Chapel in Lütgenrode (width of the mapped wall ca. 7.60 m; comp. Fig. 2)

The damage mapping on the western facade is shown in Fig. 19. As on the south side, the highest damage intensity occurs in the lower area of the masonry, where rounded and sanding sandstone dominates. However, also in the higher parts of the facade, some ashlars show the same weathering phenomena. Salt crusts, biological colonization and sometimes very intensive scaling and flaking can be observed near the ground. Cracks and deformations also occur preferentially in the lower area and affect almost 10% of the masonry. Smaller chipping and spalling are the most common weathering phenomena (48%), but do not result in high damage intensities. They are followed by soiling and few

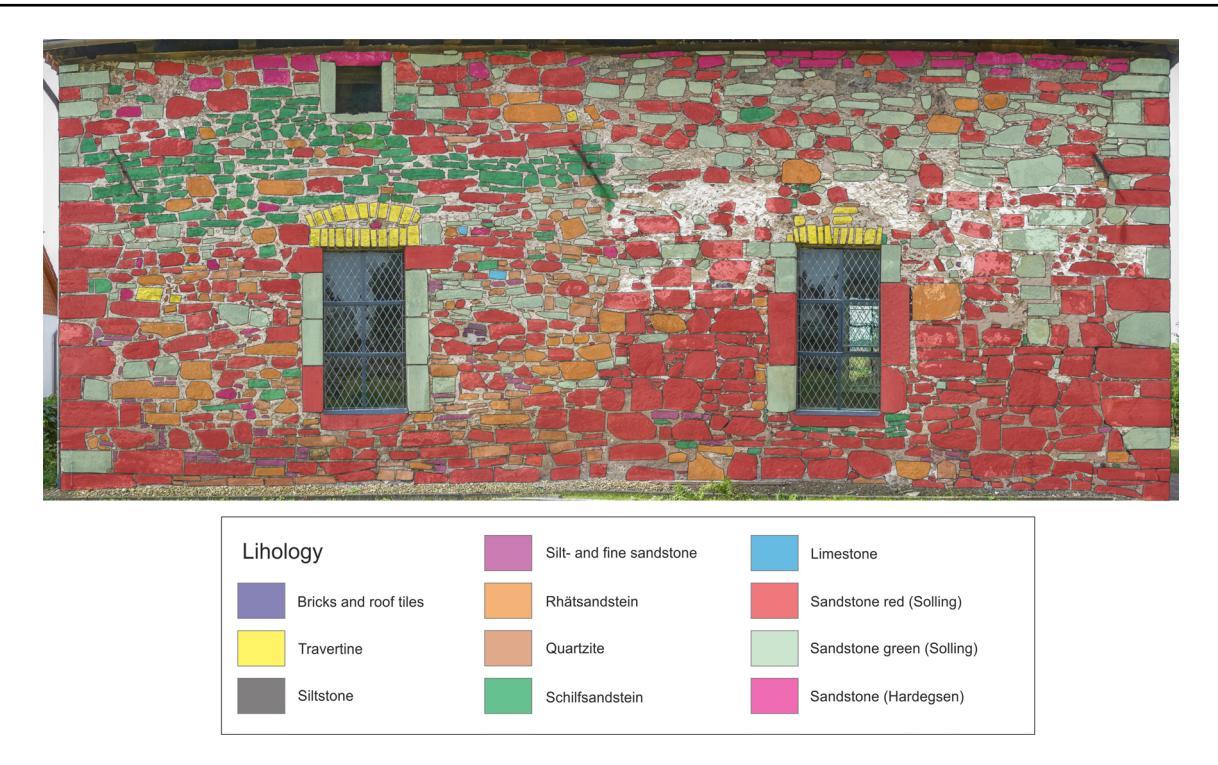
Fig. 12 Lithological mapping of the north side of the St. Johannis Chapel in Lütgenrode (width of the mapped wall ca. 15.40 m; comp. Fig. 2)

The St. Johannis Chapel suffers from numerous hairline cracks and fractures in the masonry (Fig. 12). Hairline cracks are narrow cracks less than a millimeter wide and can be found in almost all types of rock (Vergès-Belmin 2010). Fractures are cracks that completely cross the rock. These are partly due to larger crack systems in the masonry.

Soiling and black crusts (63%) as well as smaller spalling and chipping (46%) determine the damage pattern on the north side (Fig. 20). The presence of high amounts of black crusts could originate from the north-facing position. As the wind predominantly comes from the west or south all year round, the resulting lower exposure to precipitation leads to an undisturbed adhesion of atmospheric particles that form these crusts.

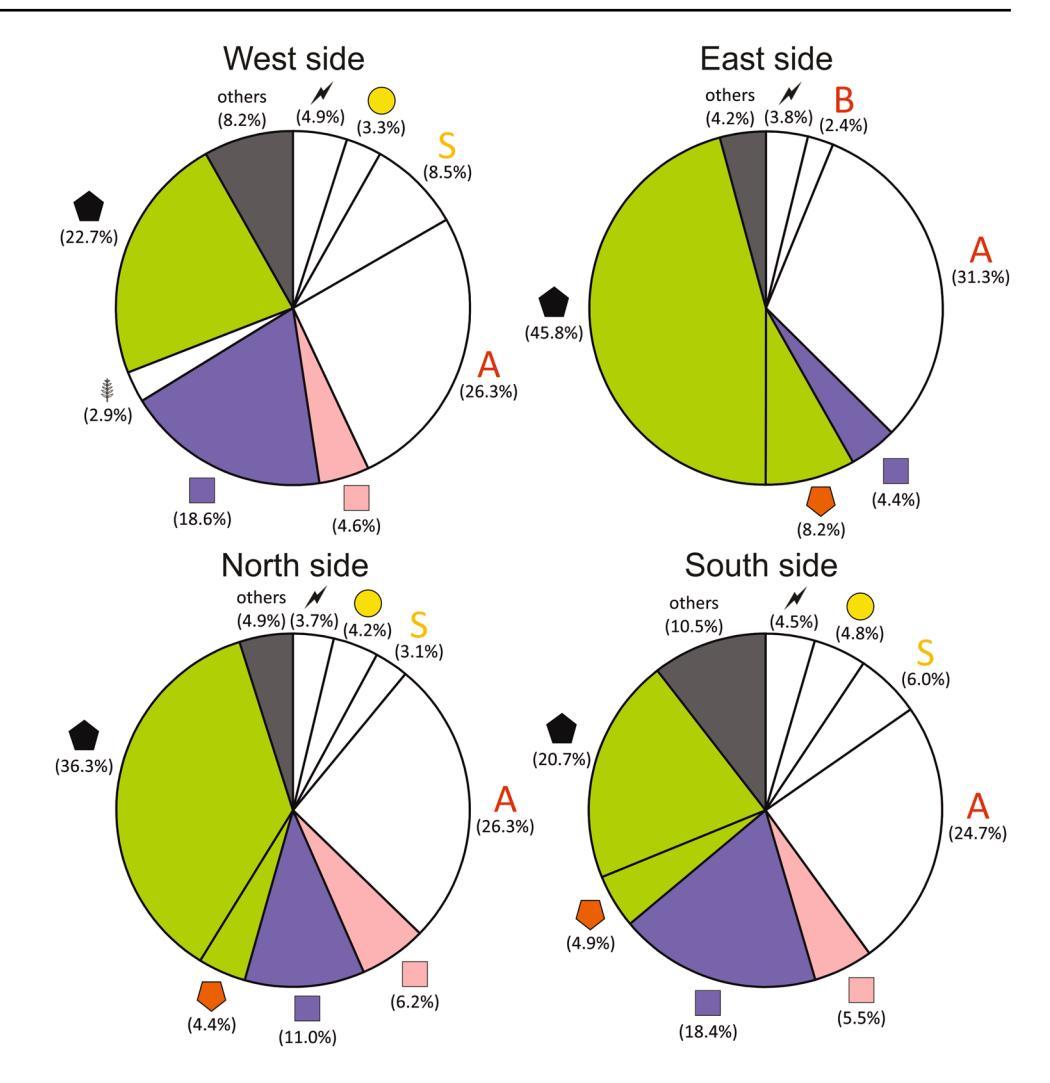
Table 2 shows all mapped damage and weathering phenomena with their respective frequencies on the four sides of the chapel. Figure 22 compares the incidence of damage phenomena on the respective sides of the building. Ashlars that showed no damage were not taken into account.

**Fig. 22** Comparison of the frequencies of damage phenomena on the four sides of the building (for details see Table 2)

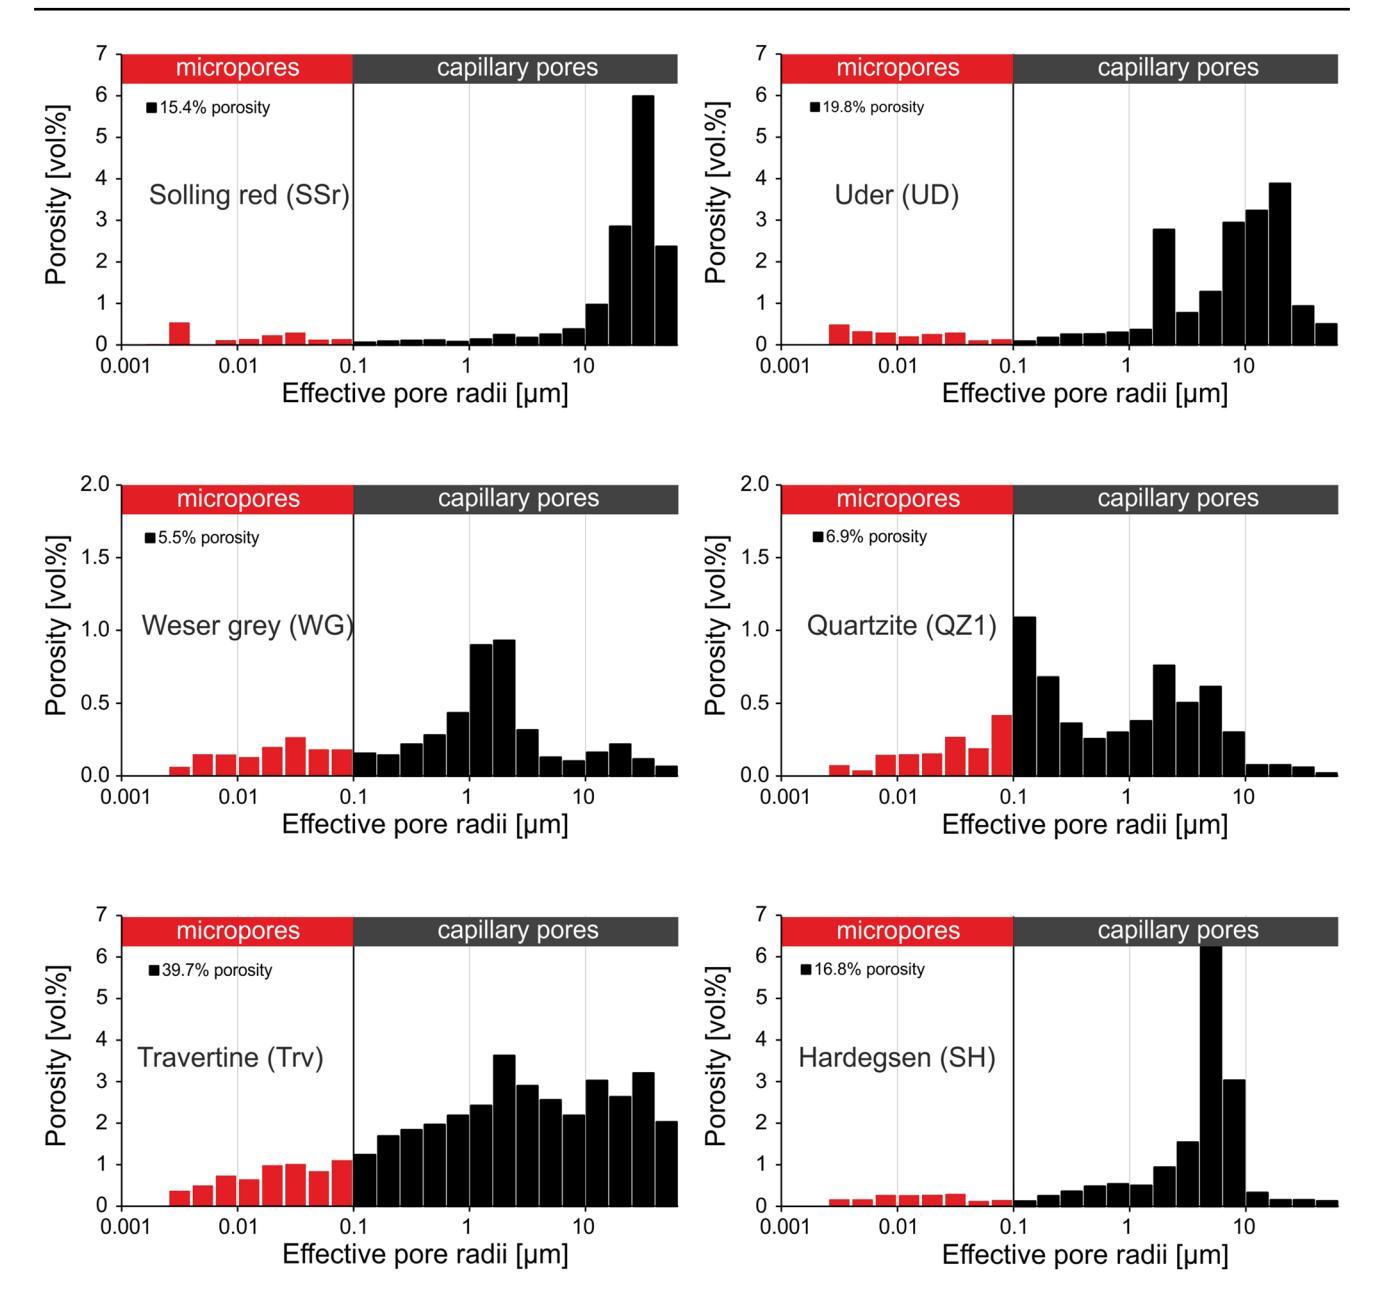
Extraordinary high porosity is shown by the Duckstein (Trv), with 39.7 vol% and an accordingly low bulk density of 1.58 g/cm<sup>3</sup> (Table 3). The rest can be divided into two groups according to their porosity: (1) very porous rocks with porosities between 10 and 20 vol% (RSc < SSr < SF < SH < SSt < UD in ascending order) and (2) intermediate to less porous rocks with porosities between 2 and 10 vol% (MK < MK–TK < WG < QZ1 < WR < RSf < TK < QZ2 < QZ4 < QZ3 in ascending order). With the exception of RSf, the less porous rocks of group 2 are characterized by mean pore radii < 1 µm. The highly porous rocks show mean pore radii up to 9.69  $\mu$ m (SSr), but not exclusively, as smaller radii are also observed (QZ3, SSt). In most of the investigated rocks the fraction of capillary pores clearly dominates (up to 90%) (Fig. 23). Only the less porous MK, MK–TK and WR exhibit higher fractions of micropores.

Fig. 23 Pore radii distributions of selected building stones of the Lütgenrode Chapel, as well as the potential replacement material

From the three potential replacement sandstones, the Uder Sandstone (UD) may come closest to the petrophysical properties and weathering behavior of the Solling Sandstone. Uder is likewise a relatively porous sandstone with a similar pore structure that enables water absorption to the degree of the Solling Sandstone. The Weser Sandstone
