Structural performance of impact damaged and repaired concrete bridge girder using GFRP rebars

Nur Yazdani¹ · Maria A. D. L. F. Montero²

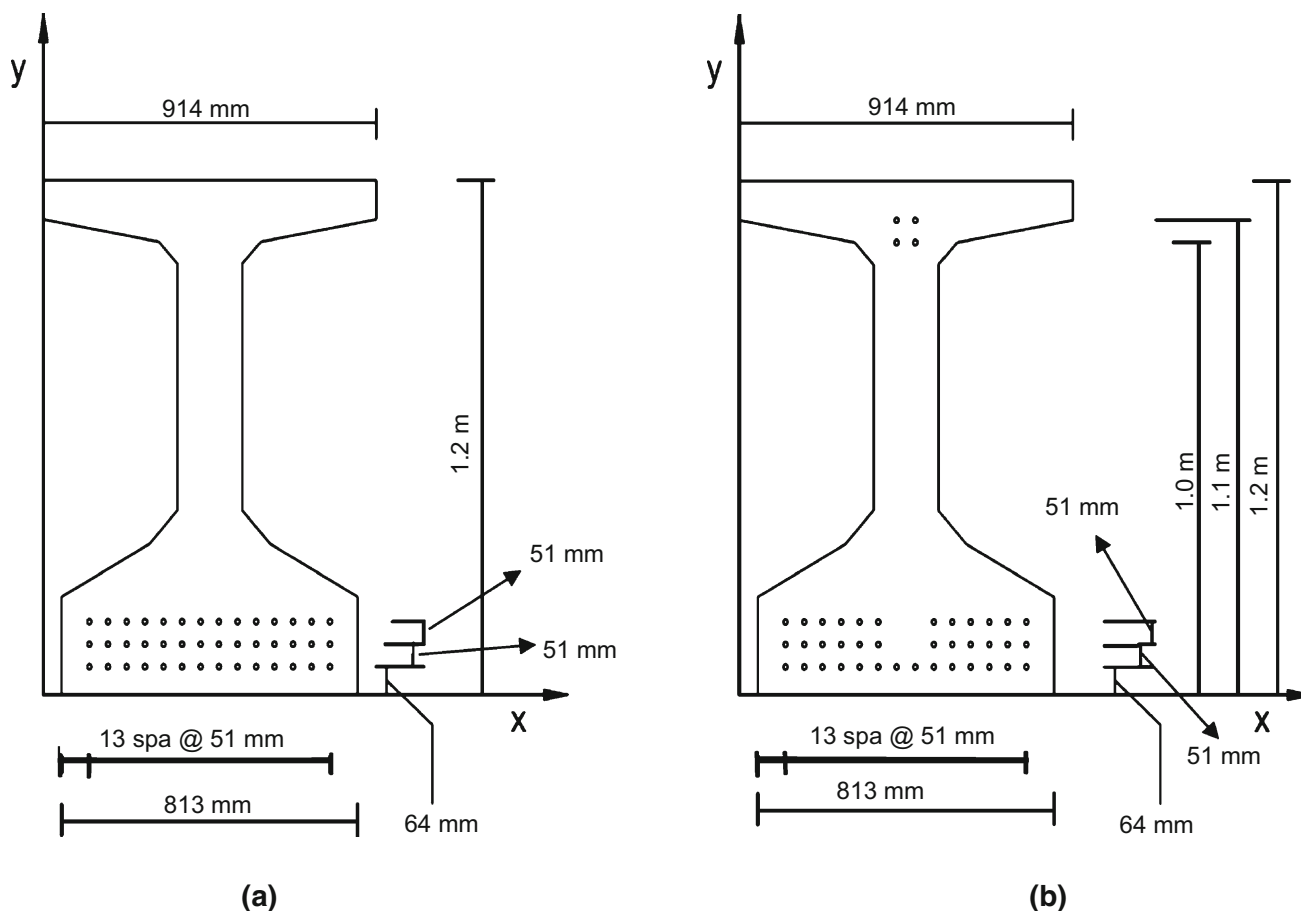
Fig. 2 Prestressing strand patterns. a Mid-span, b end

The damaged girder had 42 low-lax prestressing strands (with 12.7 mm diameter each and 1861 MPa ultimate strength) placed according to the patterns shown in Fig. 2, with no debonding and four harped strands. The corresponding eccentricities were 396 mm at mid-span and 309 mm at the end. The girder concrete compressive strength in service was 58.6 MPa. The non-prestressed mild steel had a yield strength of 414 MPa.

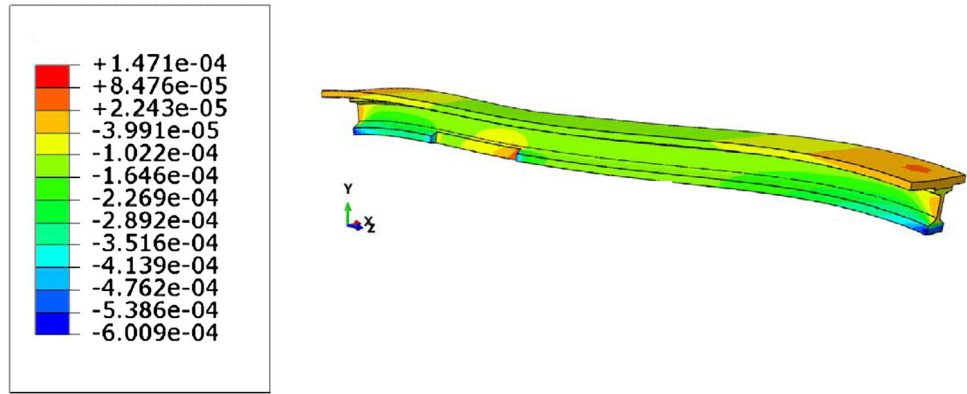
Fig. 16 Truck position 1 strain measurements

To compare the FEM strains to the average strains measured from load testing, the FEM strains from the closest nodes to each strain gage were used herein. Figure 15 presents the FEM strains for Phase 1 loading and truck position 1. The deformed shape of the girder and the stress concentration around the damaged area are evident. The time variation of the measured strains for Phase 1 truck position 1 is shown in Fig. 16. The strains for each gage remained about constant with time with minor fluctuations. This trend was demonstrated in results from other gages and truck positions.

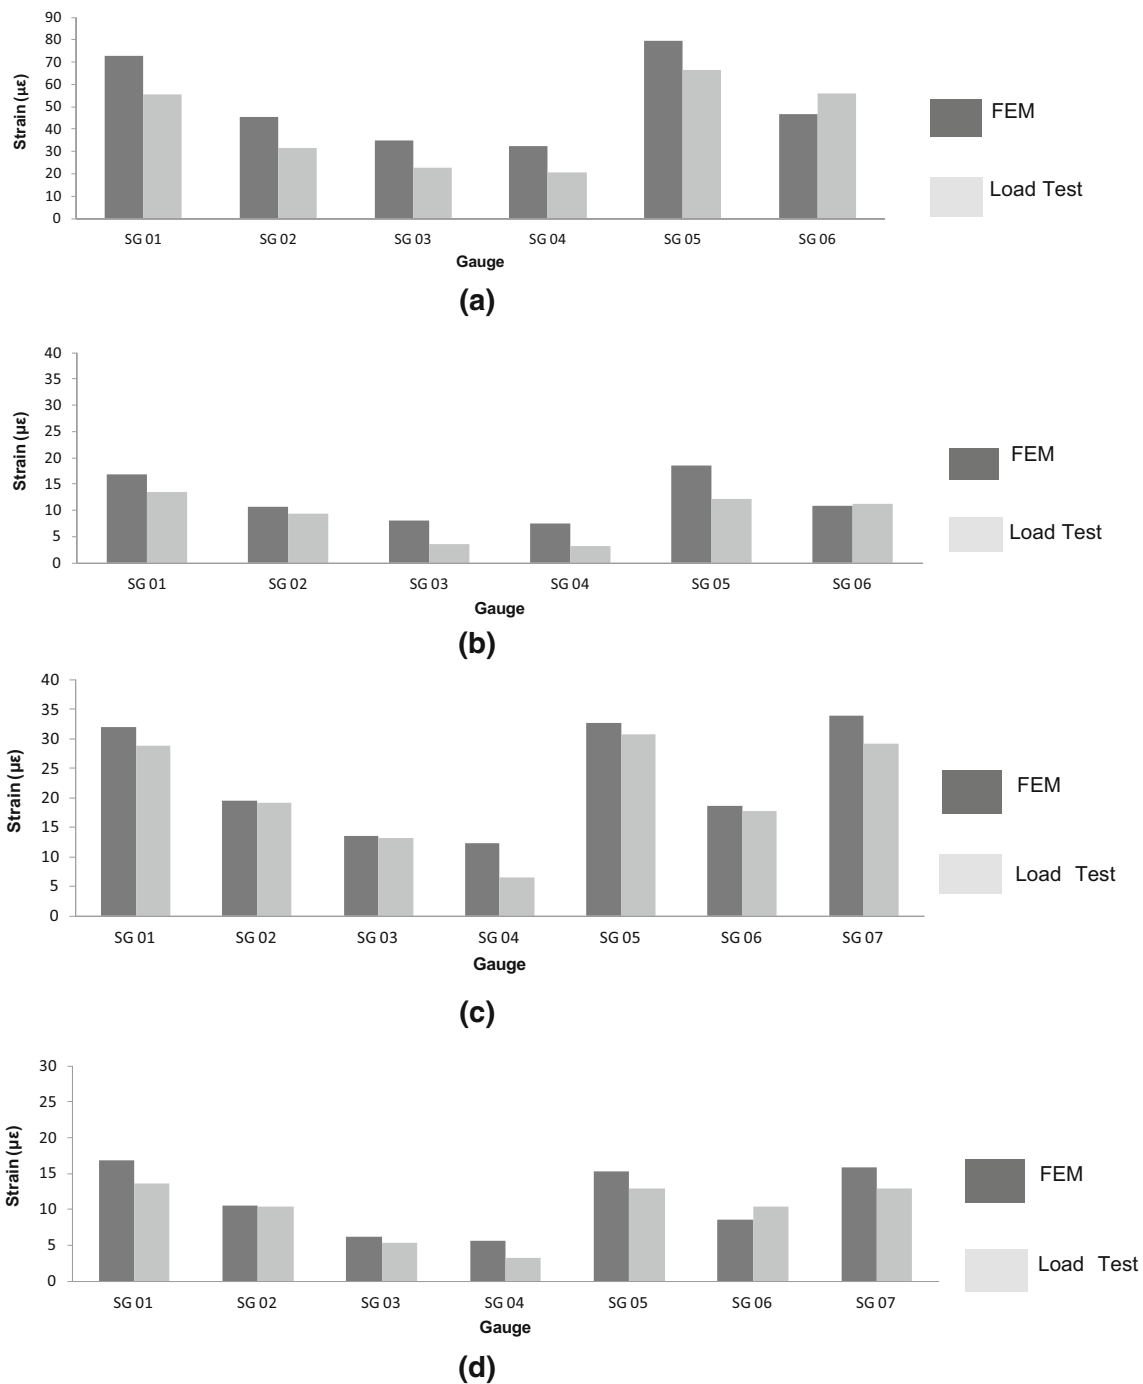
Fig. 17 Theoretical and measured strains. **a** Truck position 1, **b** truck position 2, **c** truck position 3, **d** truck position 4

The strains from the model and the load testing are presented in Fig. 17. Most of the FEM strains were slightly higher than those from the load testing for truck position 1. For position 2, the live loads applied on the girder were lower than those from position 1, resulting in decreased strains (Fig. 17b). The model prediction was more accurate for truck position 2 than position 1. The difference between the strains from the model and the testing is small; the greatest difference was about 6.3 µm. This validates the Phase 1 FEM model. In Phase 2 repaired girder, truck

position 3, the strains (Fig. 17c) decreased from those for truck position 1 by about 50 %. The greatest difference between the FEM and actual strains was for gage number 4. Gages 3 and 4 were located at the same height in the girder cross section and separated 0.61 m longitudinally. Therefore, the measured strains in the gages should have been similar. The FEM strains for these two gages were close. It may be inferred that gage 4 was not placed appropriately or did not work properly during load testing.

Because the loads applied to the girder for truck position 4 were lower than those for position 3, the strains values were relatively lower as well, with a maximum strain of about 17 micron. Figure 17d shows that the differences between the theoretical and actual strains were small.

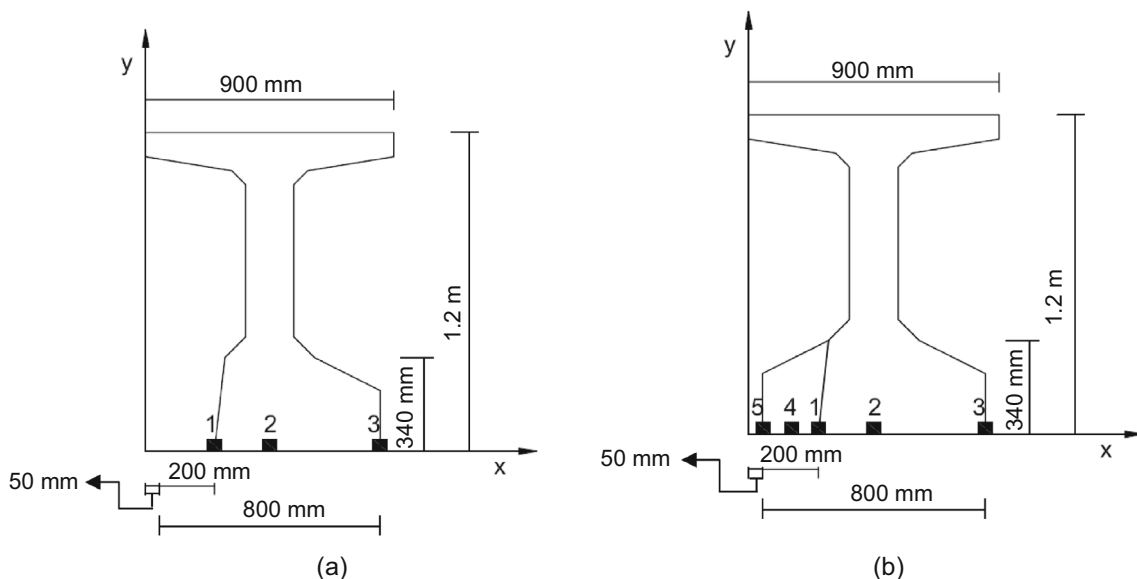
Fig. 18 Analyzed stress points. **a** Phase 1, **b** phase 2

The repair procedure was expected to recover the damaged section capacity by primarily increasing its moment of inertia, through which the gravity tensile stresses would be reduced. This should result in increased compressive stresses at the bottom fiber of the repaired girder. To demonstrate this, FEM stresses at the girder

bottom fiber at the center of the damage (located at 6.7 m from the left support) were reviewed herein. For Phase 1, stresses from FEM nodes closest to points 1, 2 and 3, shown in Fig. 18a, were considered. For Phase 2, in addition to the three points, two additional points 4 and 5 were considered (Fig. 18b). The corresponding FEM stresses are presented in Table 4. For the damaged girder, the maximum compression occurred at point 3 for both truck
