Failure analysis of ring die of a feed pellet machine

Abstract: The severely worn position and failure mechanisms of the ring die of a feed pellet machine were investigated. The macroscopic and microscopic morphologies of the failed surface, the chemical composition and mechanical properties of the collected samples were analyzed using scanning electron microscopy, energy disperse spectroscopy, optical emission spectrometry, and a universal testing machine. Results show that the dip angle at the entrance of the ring die hole between the roller and ring die was severely worn. The feed powder could not be fully extruded through the dip angle at the entrance of the ring die holes, thus the density of the feed particles produced could not meet the requirements. Therefore, abrasive wear under high stress is the main reason of failure at the entrance of the ring die holes under the action of feeding powder; and cutting and fatigue spalling lead to substantial material loss. In addition, a high damp-heat environment aggravates abrasive wear on the die hole internal surface.

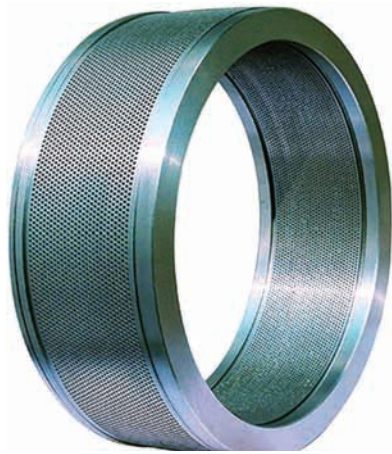
Fig. 1: Ring die of feed pellet machine

Figure 1 shows a ring die which is the key and most vulnerable component of the feed pellet machine. The ring die is made of high-quality steel and weighs up to several tons or even tens of tons. The steel for the ring die is usually 4Cr13 stainless steel, which has a high hardenability, good polishing properties, and excellent resistance to corrosion and hot oxidation. Due to its excellent properties, 4Cr13 stainless steel can be applied in several important fields, such as structural automotive applications and the petrochemical industry. During the manufacturing process, heat treatment has a significant effect on the mechanical properties of 4Cr13 components^[2]. The designed service life of a ring die is 800–1000 h, and the frequent replacement and maintenance are of high cost^[3]. As shown in Fig. 2, the feed pellet machine is mainly composed of a ring die and two to four grooved free-rotating or driven rotation rollers. The ring die is rotated by the driving of the rollers, and the machine works as follows^[4]: (1) The feed powder and water vapor are simultaneously introduced into the working area and squeezed into the ring die holes through the entrance of the rotating rollers. (2) As the subsequent feed powder and water vapor are continuously added, the feed pellets form on the outer wall of the ring die hole, and are cut into a suitable length by the scraper. According to market investigations, the briquetting rate of feed pellets is required to be greater than 75%. Otherwise, the ring die needs to be replaced. Therefore, the durability of the ring die hole becomes the key factor for decreasing the production cost of the feed pellet.
