# Tool wear analysis in milling of locomotives wheels

P. A. P. Pacheco<sup>1</sup>

Received: 3 August 2020 / Accepted: 21 December 2020 / Published online: 6 January 2021

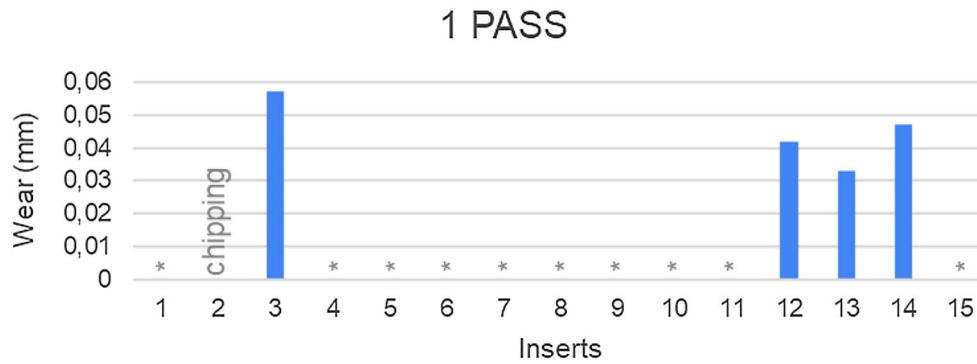
Fig. 8 Graph of wear with one pass (for \* no wear values)

The first observation of the inserts, right after the first pass, revealed that not all the inserts touched the wheel, showing no wear values (Fig. 8). The wheel had high and

thick frieze characteristics. Due to these characteristics, it was not possible for the entire wheel profile to have contact with the tool.

The other inserts that came into contact with the part showed flank wear. The measured values are shown in Fig. 8. The hypothesis of increased hardness due to hardening is reinforced due to the more prominent wear perceived in position 3, next to the one that showed chipping. Inserts 12, 13 and 14, which had contact with the frieze, also showed wear. Due to chipping, it was not necessary to measure wear of insert 2, although it certainly occurred.

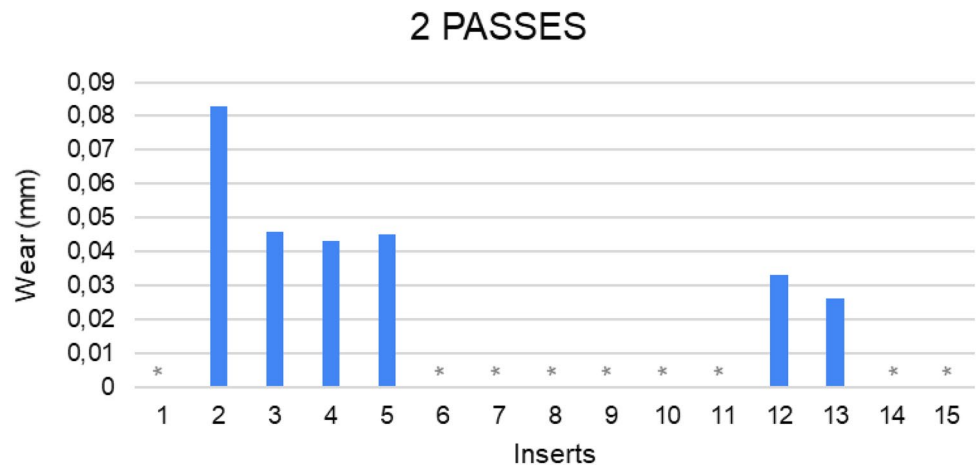
Fig. 10 Wear graph with two passes (for \* no wear values)

The second observation collected inserts that worked two passes. The wheel had a high frieze characteristic. Not all inserts have had contact with the wheel yet, but, compared to the first observation, more inserts came into contact with this part, given the vast amount of material removed. Wear values were recorded (Fig. 10). The inserts that came into contact with the part showed flank wear.

The measurement results (Fig. 10) show wear in the crimp region (positions 12 and 13) and at the beginning of the raceway (positions 2, 3, 4 and 5). Due to the practice of lubricating the rails, friezes wear is reduced, especially in curves. Therefore, many wheels will have high friezes when recovered. This region ends up having more contact

with the tool. Due to the complex geometry of the milling head, not all regions touch the wheel equally from the beginning of milling. Point 2, also on the wheel's raceway presented a high wear too. It is the same one that showed chipping in the previous observation. Due to the characteristics of the railroad where this locomotive travels, this region of the wheel has little wear. MRS manages 1,674 km of railways and its route has a large extension in curves of medium or small radius. Centro Line, for example, has 58% of its length formed by curves up to 300 m in radius [14]. Again, it is clear that the region at the beginning of the raceway caused more wear on the tools, even with insert 2 showing more accentuated wear. According to Chaves [3] by comparing the hardness profile of the raceway with the friezes, it is possible to observe that in the raceway a greater hardening occurred when compared to the flange.

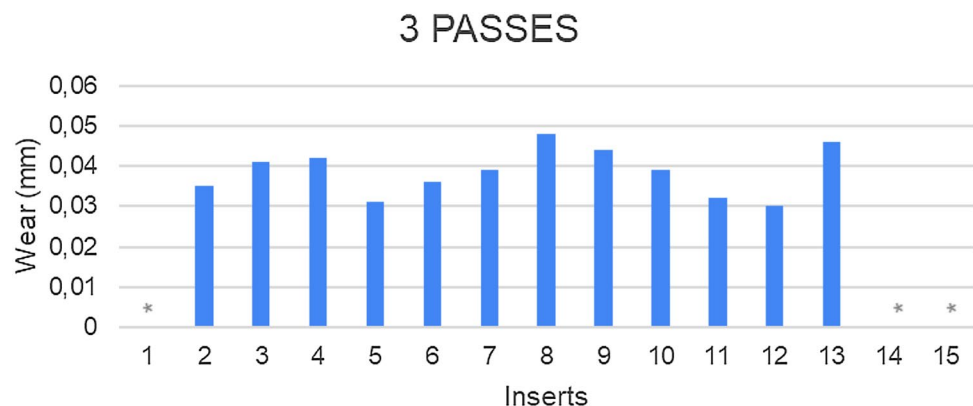
**Fig. 12** Wear chart with three passes (for \* no wear values)

In the third observation, after three passes, the wheel also had high and thick frieze characteristics. Once again, the number of inserts that came into contact with the piece was greater than in previous passes, as shown in Fig. 12.

The inserts that came into contact with the part showed flank wear. At this point, it is possible to observe in Fig. 12 that most of the inserts came into contact with the wheel. The inserts have very close flank wear values, given that the difference in measurements between the tools with the highest and lowest wear is less than 0,02 mm. It happened because at the beginning of the cut the efforts are bigger, so that wear grows quickly. Afterward, wear tends to an almost constant value before it grows again and fails [16].

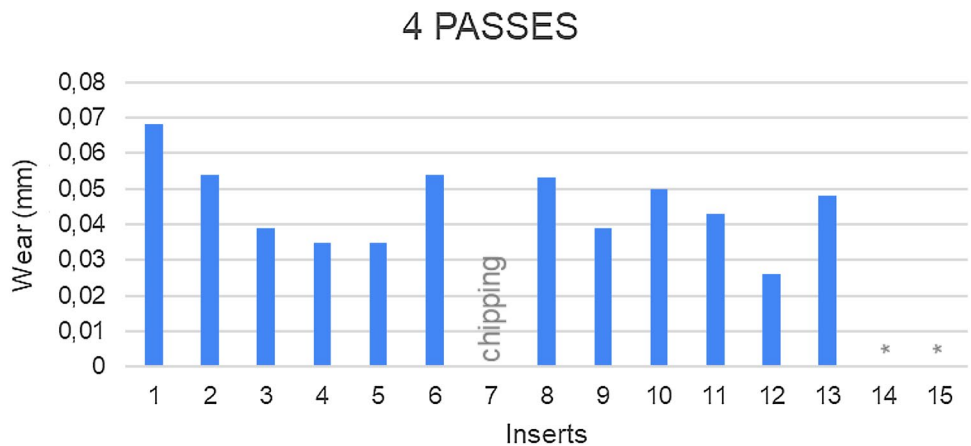
**Fig. 14** Wear chart with four passes (for \* no wear values)

It was not possible to measure the wear of insert 7. According to Fig. 14, the number 1 insert suffered the greatest wear, in addition to, possibly, that of position 7, where the chipping occurred.

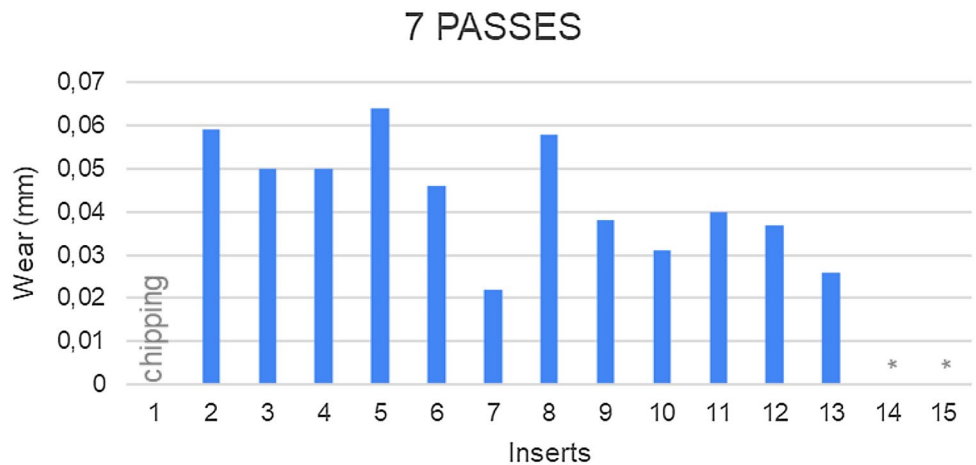
**Fig. 15** Wear chart with seven passes (for \* no wear values)

In the fifth analysis, the inserts that machined for 7 consecutive passes were observed. It can be seen in wear measurement, represented by Fig. 15, that tools wear that machine the raceway was greater than the others. Comparing with the samples from the previous observation, it is noted that the average wear, considering only the tools that cut in both cases, was 0,0389 mm for 4 passes and 0,0454 mm for 7 passes, an increase of 16,7%, that is, tool degradation due to friction is occurring. Although the region formed by tools 11, 12, 13, 14 and 15 are those that remove the largest amount of material, it is not the one that presents the greatest wear.

Inserts 14 and 15, due to the geometry of the wheels machined in this stage, did not cut, so they did not show wear. Insert 1 showed chipping, Fig. 16, so wear measurement was not possible.

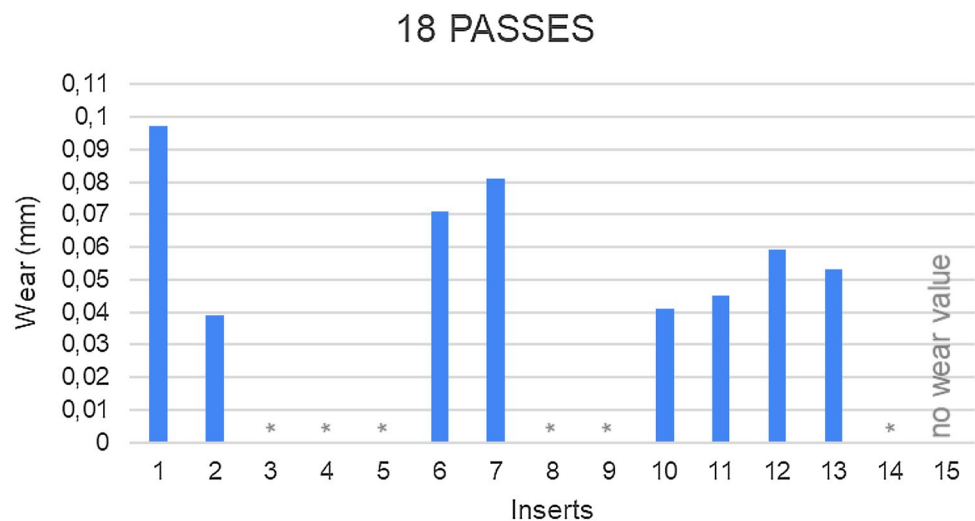
**Fig. 18** Wear chart with eighteen passes (for \* chipping or fracture)

With 18 passes, in the sixth observation, six inserts showed chipping. Thus, as shown in Fig. 18, it was not possible to measure these tools wear, along with number 14 and 15 (which did not touch the wheel). Wear continues to evolve on the other inserts, reaching

approximately 0,1 mm for insert 1 and above 0,05 mm for other 4 inserts.

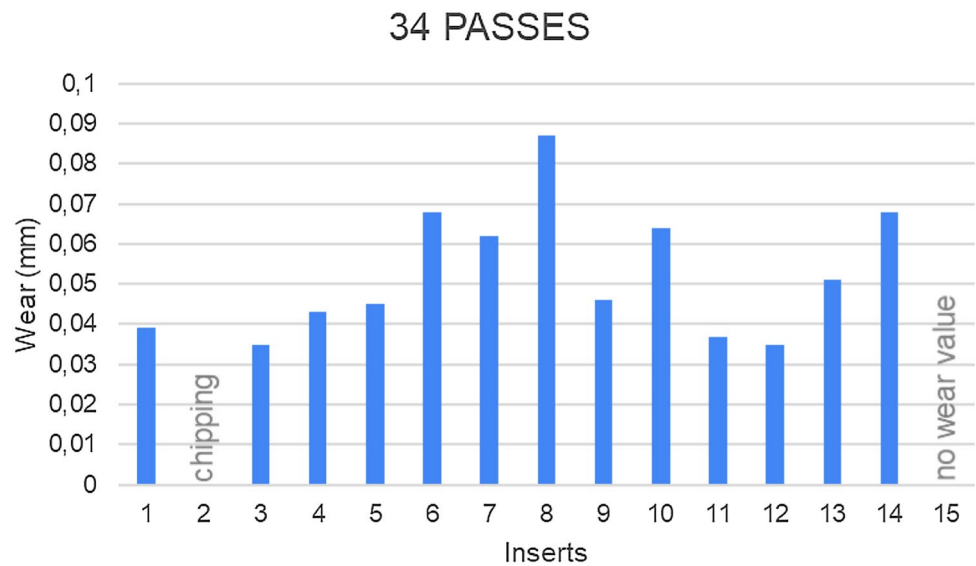
**Fig. 24** Wear chart with thirty four passes

After 34 passes, with the seventh analysis, wear measurement shown in Fig. 24 was obtained. Despite the high number of consecutive passes, only the address tool 2 showed chipping. Insert 15 did not perform machining.

The average wear of the inserts that performed machining with 34 passes was 0,049 mm, almost the same identified after 18 passes. According to Machado [9], the evolution of tool wear goes through three stages: the first shows rapid wear evolution, as well as the last, while in the intermediate period there is a less accentuated wear rate. This theory was confirmed experimentally by Mesquita and Barbosa [11], who present Fig. 25, which shows a more central region of each of wear curves for tools when milling two types of steel. Between 18 and 34 passes some of the inserts may have reached this region of wear stability.

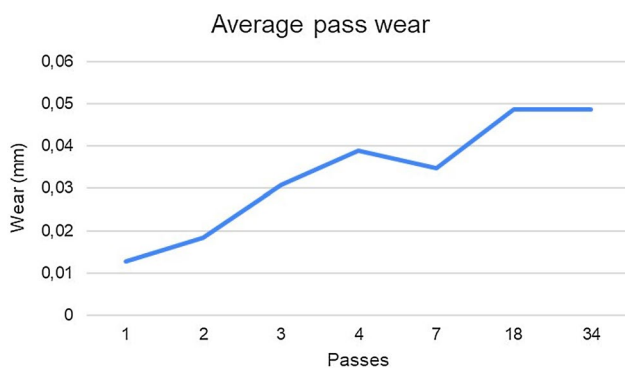
**Fig. 27** Average wear per pass

Figure 27 represents the average of wear measurements found in each analysis. As it was expected, the average value of the expenditure increased in almost all observations. In addition, when using coated carbide tools, wear grows slowly, firstly due to coating resistance, but after

reaching high wear values (VB), the coating layers are almost completely consumed and the substrate is less resistant, it is exposed to the process, considerably increasing wear and tear, which can lead to breakage [16].
