# Modelling and analysis of the stability of a harbour wharf's embankment with regards to its failure

## Abstract

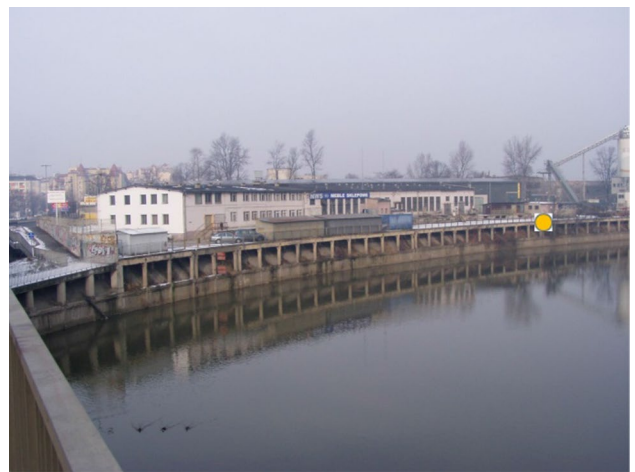
**Fig. 6** General view of the considered RC river wharf

The numerically modelled case of the loss of the stability of the slope, and the state of the structure's failure (analysed from the construction point of view), concern the transshipment wharf of the Odra River from the beginning of the twentieth century [25, 26] (Figs. 6, 7).

The considered reinforced embankment, which underwent failure at the same time as the quay, was a structural element of an old harbour wharf situated on the left bank of the southern branch of the Odra River in Wrocław—directly below the left abutment of the Roman Dmowski Bridge (Fig. 6).

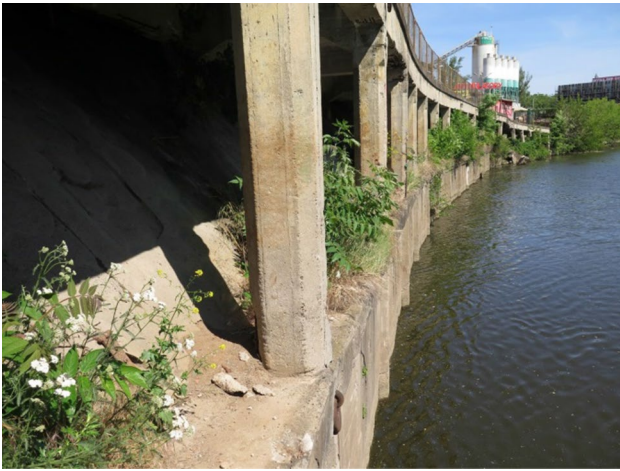
In recent years, due to the very diversified and deteriorating technical condition of these quays [1, 2], the risk of flooding, and the current trends of including river quays in the life of a city [3–7], a number of renovation and revitalization works have been carried out. They aimed to ensure the safe operation of these quays within the city's tissue. However, some quays, especially those with an industrial and harbour function (Fig. 6), remained for a long time without any repairs (Fig. 7). This was an indirect cause of the serious failure of one of these quays (Figs. 6, 10).

**Fig. 7** View of part of the RC river wharf

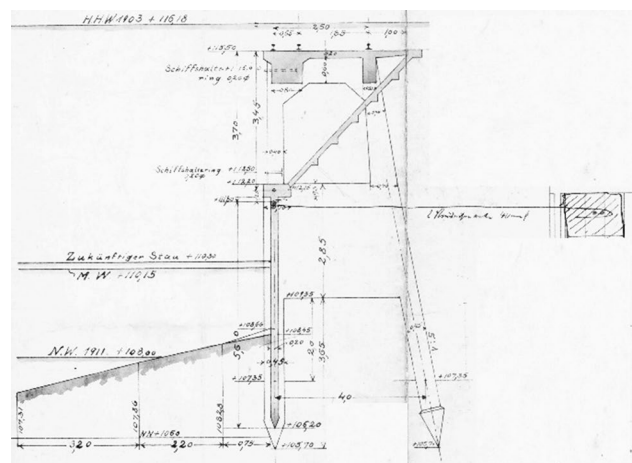
**Fig. 9** Archival design of the considered RC wharf and river slope [27]

A 45° slope was made under the wharf slab, which connected the lowest reinforced concrete beam with the edge of the slab (Fig. 9). At the edge of the slab, the slope became a horizontal embankment, which was a continuation of the wharf. From the side of the river bed, the slope was supported by the reinforced concrete beam of the retaining wall made of reinforced concrete planks. The slope was reinforced with octagonal concrete cubes, and a paved surface was made on the horizontal part of the embankment.

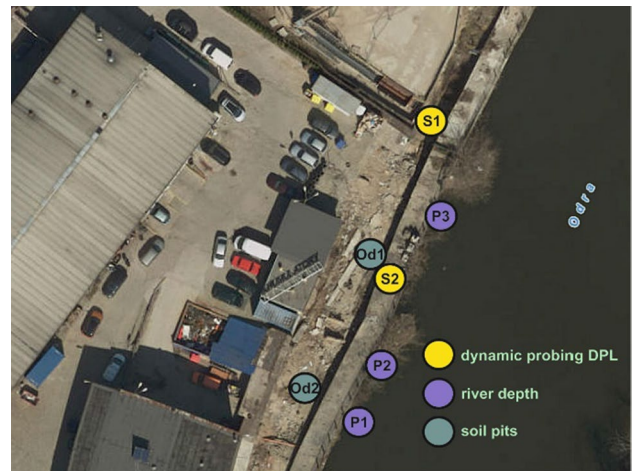
condition tests were carried out in the two available places (Fig. 14). The conducted tests (Fig. 15) showed that under the layer of the loose embankment (approximately 2 m) there are fine medium-compacted sands, the degree of compaction of which ranges from 0.46 to 0.59 (Table 1). During the geotechnical investigations, the depth of the riverbed was also probed in three places located near the reinforced concrete planks. As a result of the research, it was found that the bottom of the river bed is located at a level of approx. 4.5 m below the embankment's reinforced concrete beam, which connects the reinforced concrete planks.

**Fig. 14** Location of geotechnical survey points [photo: <https://geoportal.wroclaw.pl/>; 15.03.2021]

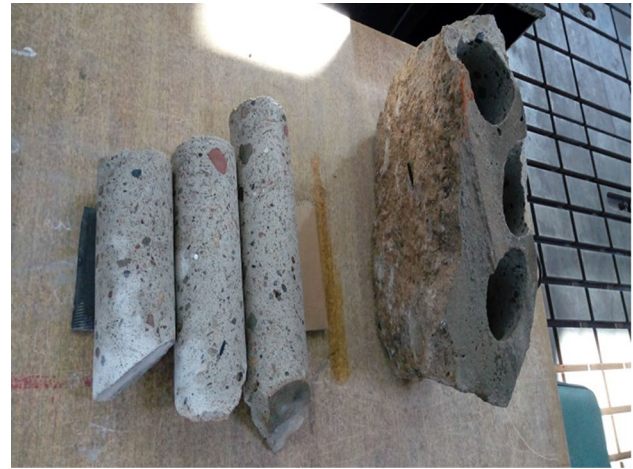
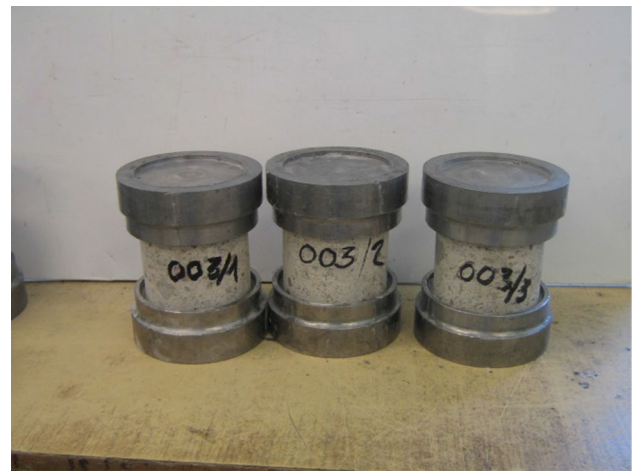
**Fig. 16** Concrete probes taken

**Fig. 17** Concrete probes prepared for testing

Concrete blocks and 8 reinforcing bars were taken from the quay structure (Figs. 16, 17). Cylindrical samples were cut from the blocks, and were then destroyed in a testing machine, while the bars were cleaned and torn off.

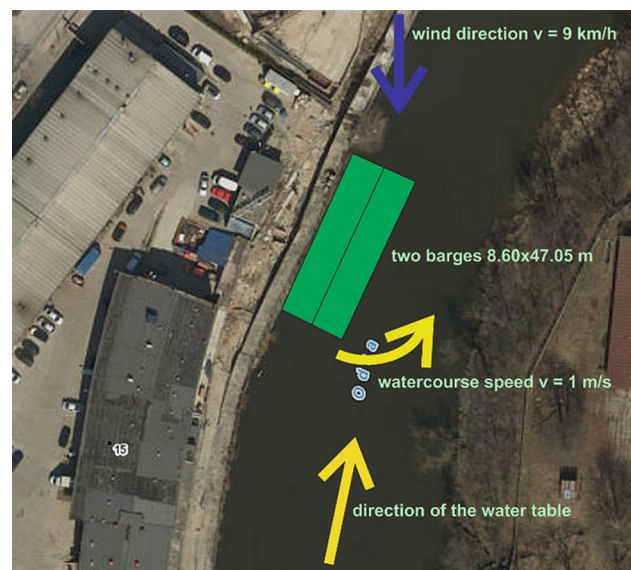
On the basis of monitoring, the speed of the river at the accident site on the day of the incident was determined to be about 1 m/s, and on the basis of meteorological data, the wind speed was about 9 m/s (Fig. 20). Data concerning the technical parameters of the barges' mooring at the wharf were obtained from the Polish Register of Shipping S.A. Based on the assumed initial parameters, the forces that could occur in the mooring lines of the barges at the wharf were calculated. In the calculations, a case concerning the hydrodynamic pressure of the pressing river water was analysed.

Fig. 20 Location of the barges anchored at the wharf [photo: <https://geoportal.wroclaw.pl/>; 15.03.2021]

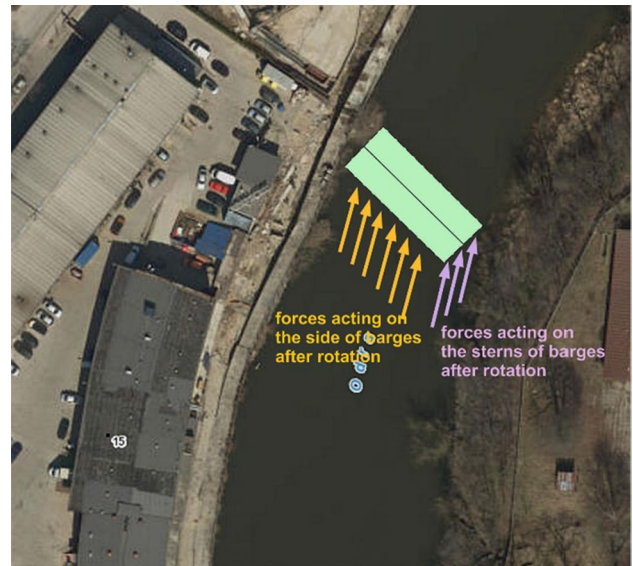
The immersion depth of the hull was assumed to be 1.0 m, while the width of one barge was 8.6 m. The wetted area of the hull was different depending on the location of the barges in relation to the watercourse (Figs. 21, 22, 23). It is a functional variable that depends on the angle of rotation of the barges in relation to the main stream of the river. The shape of the body on which the pressure is generated determines the size of the drag coefficient  $c_F$ . In the case of a plate-shaped body, which is formed by the stern walls of barges, the drag coefficient  $c_F$  during the flow of the liquid around it is 1.0 [31].

Fig. 22 Forces acting on the sterns and sides of the barges after rotation [photo: <https://geoportal.wroclaw.pl/>; 15.03.2021]

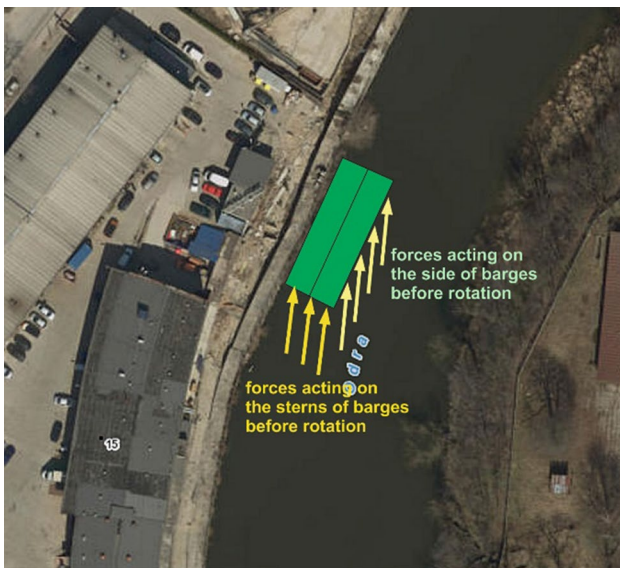
In the analysis of determining the forces acting on the barges, it was assumed that before and during the rotation of the barges, a force from the watercourse current also occurred on the side walls of the barges’ hulls (Figs. 21, 22, 23). In the case of the transverse position of the barges in

Fig. 21 Forces acting on the sterns and sides of the barges before rotation [photo: <https://geoportal.wroclaw.pl/>; 15.03.2021]

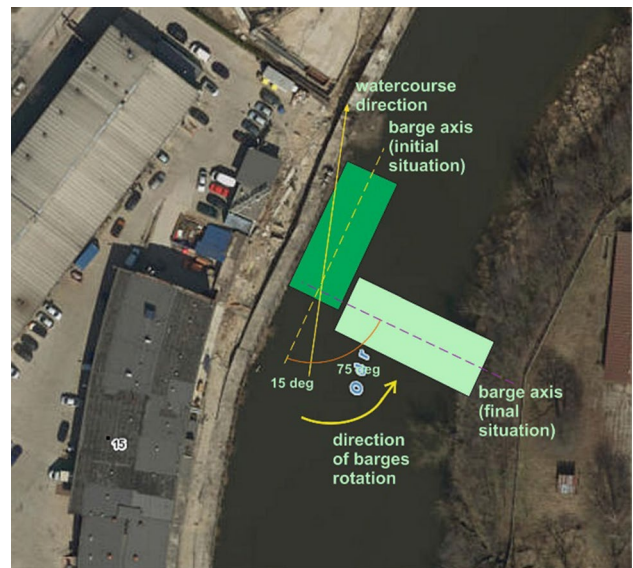
Fig. 23 Definition of the angles of rotation for the barges [photo: <https://geoportal.wroclaw.pl/>; 15.03.2021]

The total forces acting on the moored barges were determined using a functional relationship, in which the constants are the geometric parameters and the hydrodynamic conditions listed above, and the variable value is the angle between the main longitudinal axis of the barges and the axis of the watercourse's mainstream (Fig. 23) [28–30]. This angle determines the total area (transverse and longitudinal) of the barges' hulls, which is subjected to the force of the watercourse in the open channel. Due to the lack of precise information, the range of the defined angle was assumed from  $-15^\circ$  to  $75^\circ$ .

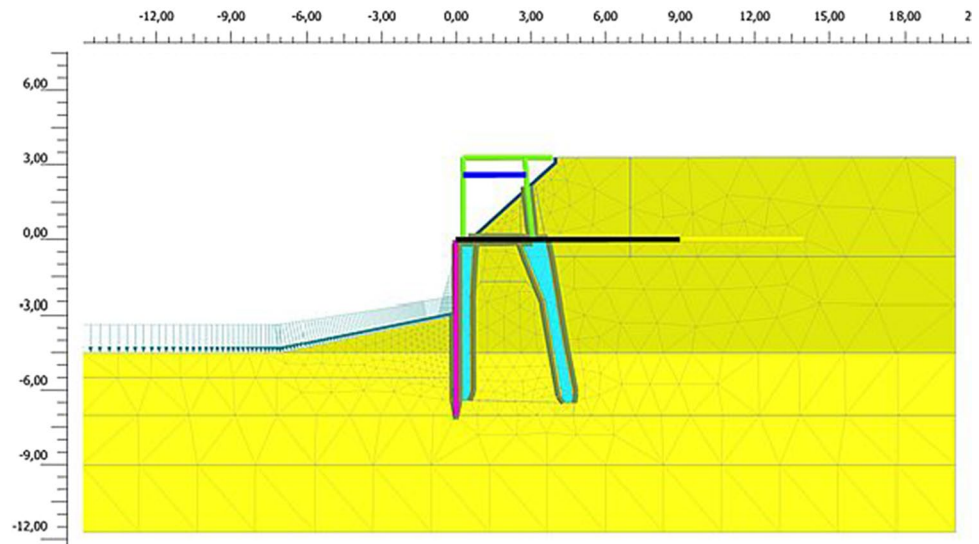
**Fig. 26** Numerical model for scheme I

- **Scheme I** The original condition, after constructing the load-bearing structure and the sheet piling – with the assumption of the original level of the river's bottom (Fig. 26).
- **Scheme II** The condition after lowering the river's bottom to the ordinate of 107.70 m above sea level (Fig. 27).
- **Scheme III** The condition after loosening of the soil behind the sheet piling, which was caused by fluctuations (in the annual cycle) in the ground-water level behind the wall (Fig. 27).
- **Scheme IV** The condition at the moment of losing the load-bearing capacity of the anchor rods (stresses exceeded due to the corrosion of the steel) (Fig. 28).
- **Scheme V** The condition after the application of an external load from the mooring forces of the barges (Fig. 28).

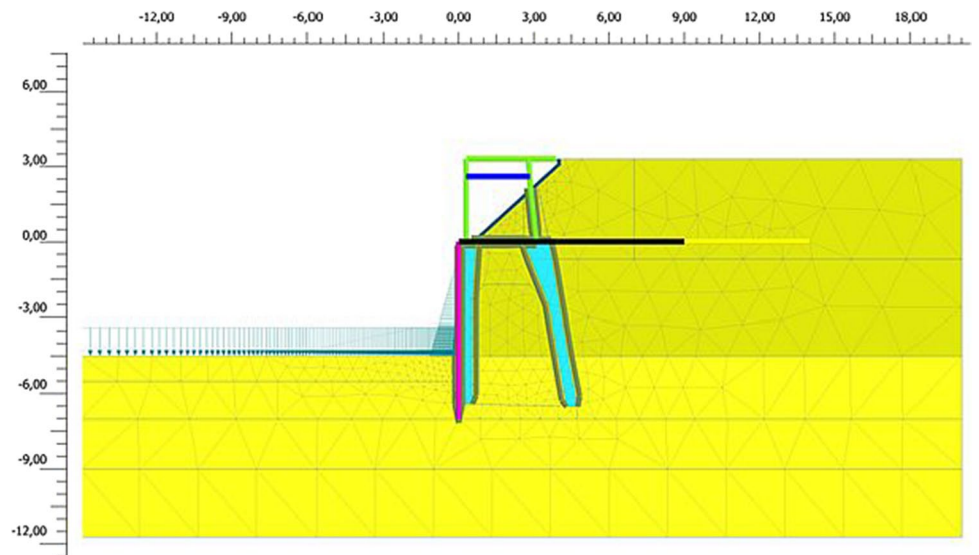
**Fig. 27** Numerical model for schemes II and III

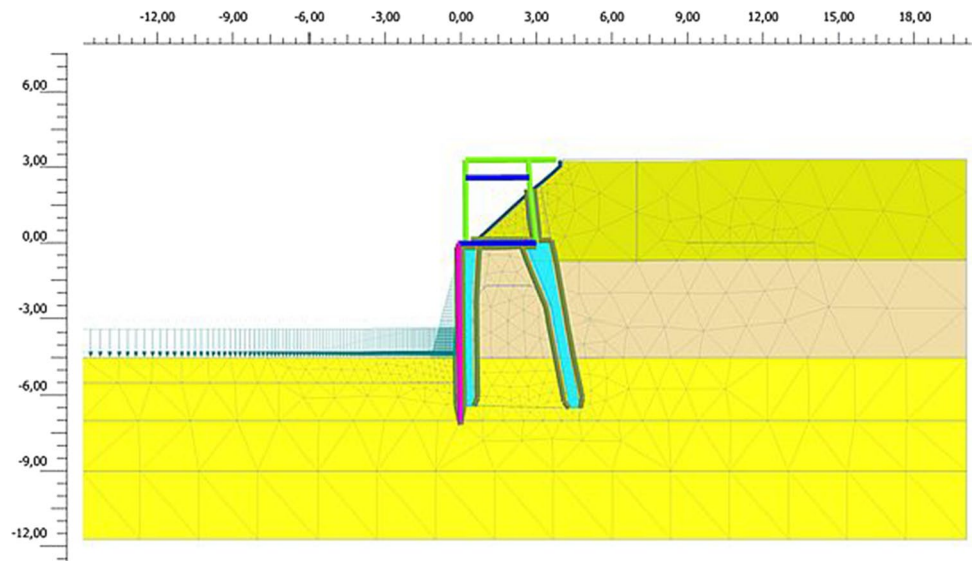
**Fig. 28** Numerical model for schemes IV and V
