Inglesinhos convent: Compatible renders and other measures to mitigate water capillary rising problems

Journal of Building Appraisal (2009) 5, 171–185. doi:10.1057/jba.2009.28

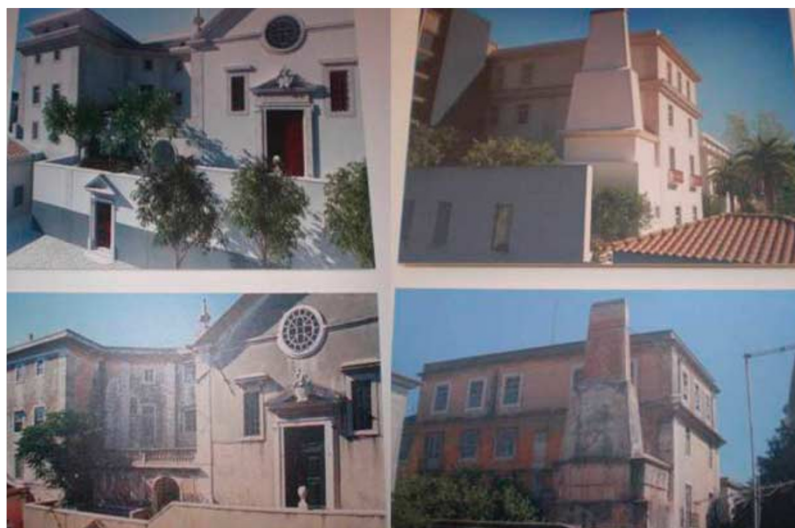
The English College, or ‘Inglesinhos Convent’, as it is referred to by the people of Lisbon, is located in the middle of Bairro Alto, in the historical center of Lisbon. It is considered a reference because of its localization, architectural beauty and decorative elements. The beginning of the construction dates back to the seventeenth century, in 1622. It was built as a school for the English secular priests, named ‘St Peter’s and St Paul’s College’ but known as Inglesinhos Convent (Figure 1).

Figure 1: Inglesinhos convent: views before and after the intervention.

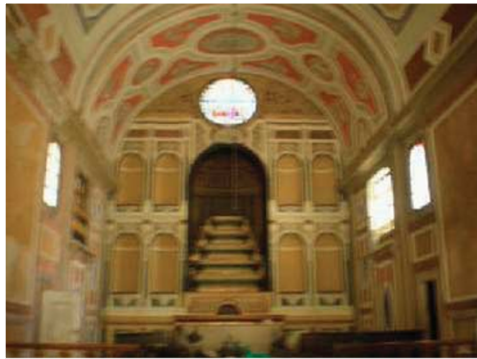
Later, in 1644, a church adjacent to the main building was built, with interior walls covered with plaster simulating stones of different colors, creating a space full of beauty and technic and aesthetic singularity (Figure 2).

Figure 2: Church with lime plaster simulating marble.

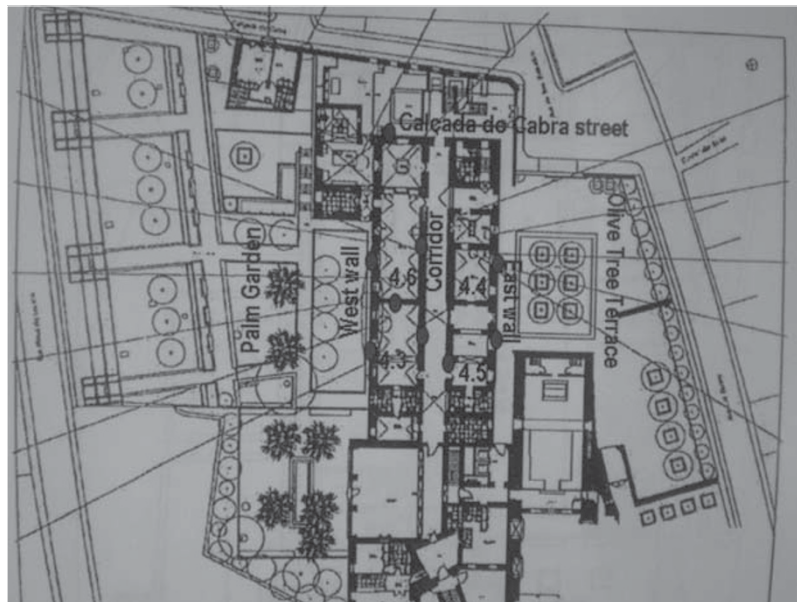
Figure 7: Plan of the ground floor with the tests localization.

The tests were carried out in several internal and external walls, whose localization is illustrated in Figures 7 and 8, for the ground floor and the first floor, respectively.

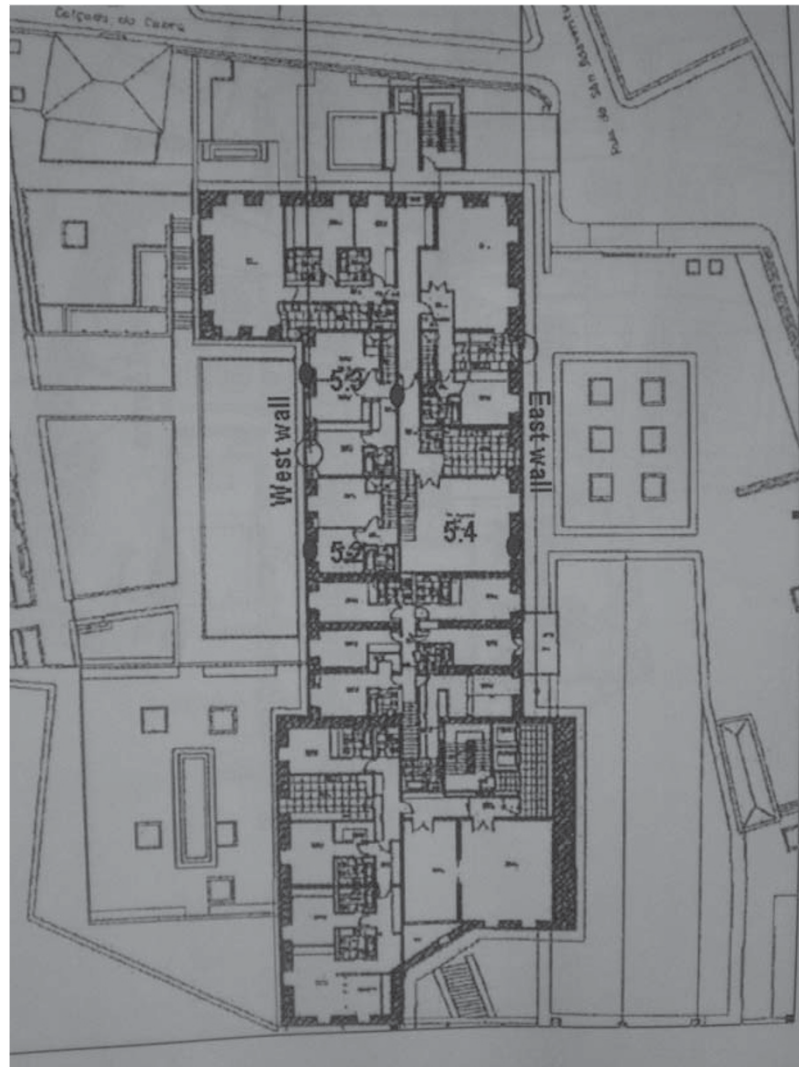
Figure 8: Plan of the first floor with the tests localization.

The comparative analyses of the results reported that the walls of the ground floor experienced higher humidity than those of the higher floors. The interior walls were found to have high moisture contents, almost as high as those of the external walls. This moisture increased after rainy periods. In the interior walls and some exterior walls, the humidity content was higher at the base, decreasing towards the top of the walls. High moisture contents were concentrated at the base of the vaults and in other places, especially near the windows and under the cornice. These results showed that the main water source is not infiltration by exterior walls, and that there is capillary rising water

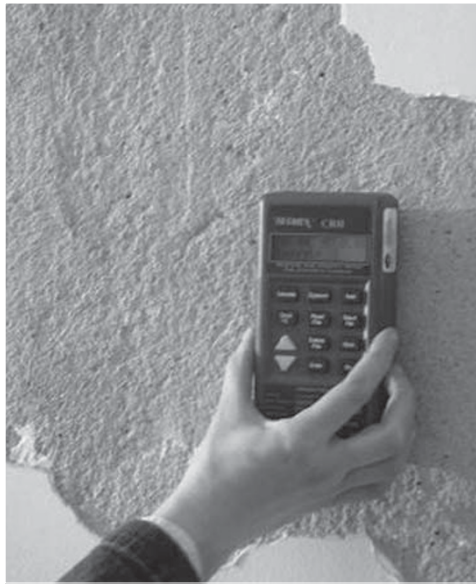
The portable humidimeter (Figure 9) – Tramex CRH – is a device used to evaluate water content in walls (Henriques, 2001; Massari and Massari, 1993; and Veiga *et al*, 2009). This test was performed in several internal and external walls, at different heights – 0.30 m and 1.80 m from the pavement – and in two different conditions – dry weather and after a rainy week – in order to determine the possible origin of the water. The results of these measurements are summarized in Tables 1 and 2.

Figure 9: Evaluation of the moisture content with portable humidimeter.

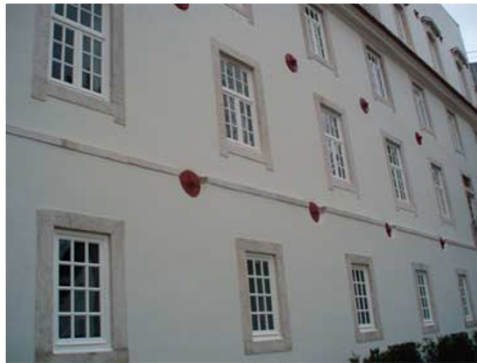
Figure 20: General view of the final appearance of the East Façade finishing.

coat, consisting of a thin air lime mortar, executed with siliceous sand and calcium carbonate, with volumetric dosage 1:3 (lime:aggregate), was carefully applied, with a soft squeeze with a mason trowel and periodic sprinkling of water (Figures 17 and 18). It was left to dry for 1 month before the application of the final paint.

In the internal space, ventilation during the works was achieved by opening the windows and installing portable fans. The cement and lime plaster of the walls and ceilings were removed and replaced with air lime and sand mortars, with a volumetric dosage of 1:3 (lime:aggregate), and were covered with a traditional plaster composed of gypsum and air lime (Figure 19). This traditional gypsum plaster should not to

be painted for at least 2 years to improve the evaporation of the water retained inside the vaults and walls. A gap between the floor footers and the walls was created for ventilation of the interior walls, to allow for continuous drying of masonry over time.

The construction company, Edifer Construções, cooperated in the various stages of the study and implemented the recommended measures, despite the difficulties involved. The final aesthetic appearance of the building was close to that of the original, preserving the identity of the historic building (Figure 20). The collaboration of all intervenients in the process was crucial in achieving the elimination of anomalies with the minimum cost and delay of the works, and in promoting the success of the intervention at aesthetic and functional levels, according to the ethical principles of conservation.
