Structural damage to houses and buildings induced by liquefaction in the 2016 Kumamoto Earthquake, Japan

Hendra Setiawan^{1,2*}

, Yuko Serikawa¹, Mitsuru Nakamura¹, Masakatsu Miyajima¹ and Masaho Yoshida³

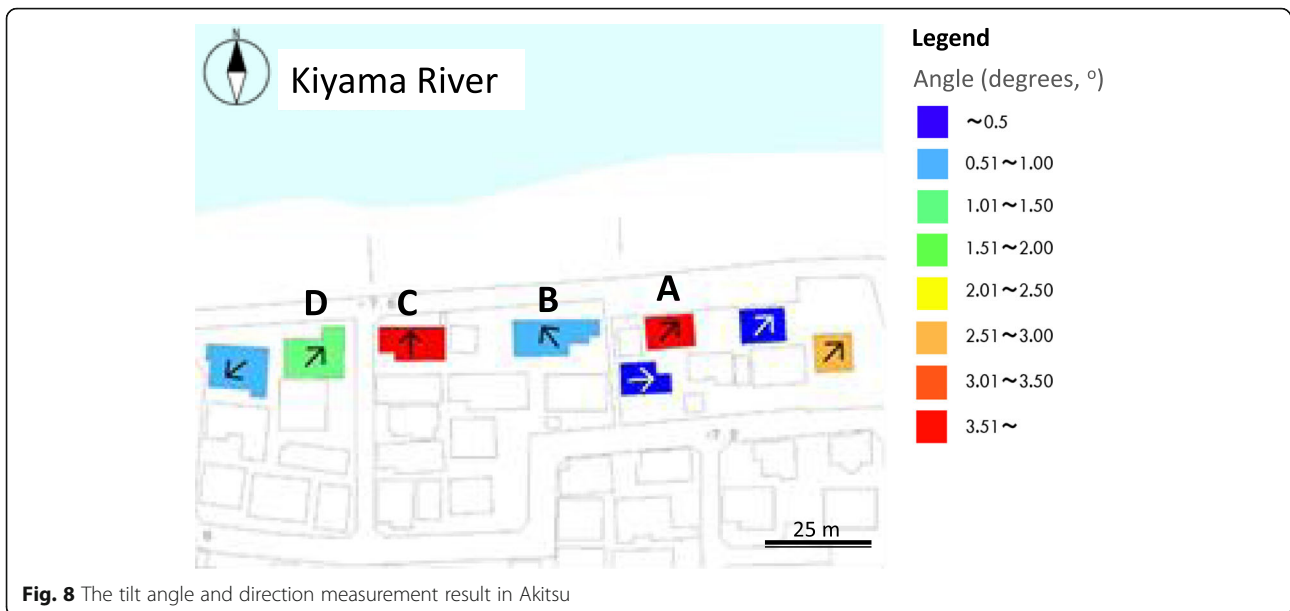
Eight houses were measured in this area. Figure 8 shows the measurement results of their tilt angle and tilt direction. In this figure, the tilt angle is indicated by a color difference for every 0.5° and the direction of inclination is marked by an arrow. The tilt angle used is the largest angle of all points measured in each house. Interestingly, a few houses assessed in this area were inclined in the same direction, which was the location of the river. This implies that the damage was caused not only

by the subsided soils under the structure but also by the liquefaction occurrence at the riverside area located in front of the houses.

Figure 9 shows the state of the house after the earthquake struck and shows that the house became tilted toward the river. Furthermore, as can be seen in Fig. 10, the lateral movement also occurred toward the river side at this site. As a result, adjacent houses tend to be tilted in the same direction with a lateral spreading direction. Figure 11 presents the summary of the structure types and the damage in this area. As for building A, it was inclined 3.6° to the north and 3.7° to the east as there was substantial ground subsidence on the north side and different settlement of the foundation occurred. Ground subsidence at the north side also occurred in buildings C and D and similarly to building A, these buildings tilted to the north. Although
