# Permeability of a fault zone crosscutting a sequence of sandstones and shales and its influence on hydraulic head distribution in the Chatsworth Formation, California, USA

Antonino Cilona · Atilla Aydin · Nicholas M. Johnson

**Abstract** Faults influence groundwater flow paths. The transport of groundwater contaminants within the faulted sandstones and shales of Chatsworth Formation exposed in southern California, USA, have been investigated. Structural and hydrogeological data are combined to interpret the hydraulic-head drop measured across a fault with tens of meters of oblique-slip. The fault zone architecture was delineated at two locations: an outcrop and a borehole intersecting the fault at depth. At the first station, the fault juxtaposes sandstones against shales with a fault core mostly consisting of deformed shale. A series of shale beds striking parallel to the fault zone and dipping  $\sim 50^\circ$  toward the fault zone provides evidence that the shale was incorporated into the fault zone. At the second station, borehole images show a plane juxtaposing fractured sandstone against shale-rich fault rock. Hydraulic heads measured at 30 wells show a drop of 75 m acro

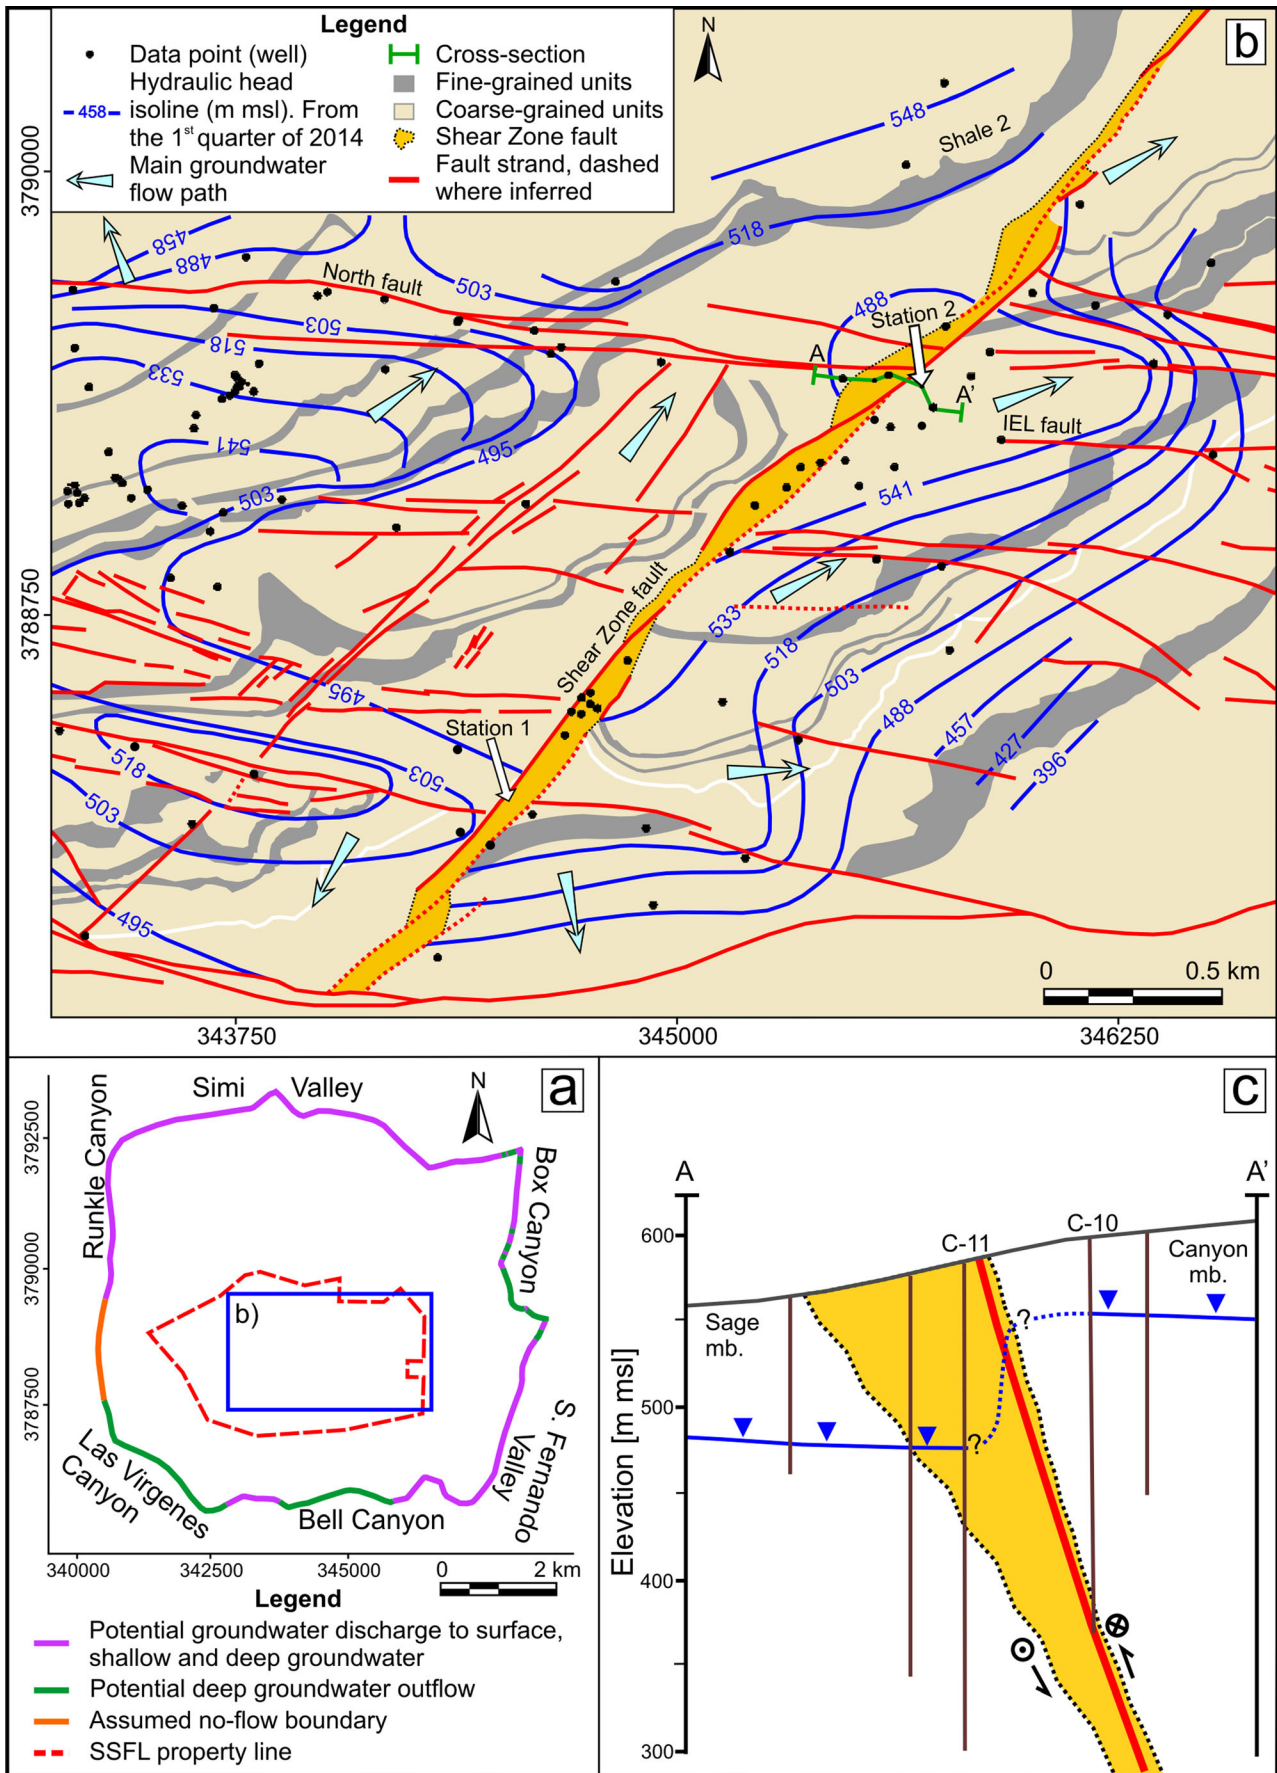
**Fig. 2** a The large-scale hydraulic system and the detailed study area location (modified from MWH 2009). b Hydrogeological map of the Santa Susana Field Laboratory (modified from MWH 2014). The Shear Zone fault is highlighted by yellow infill. The hydraulic head elevation (blue lines) and well locations (solid circles) are shown. c Schematic cross-section A–A' in part b, showing the hydraulic head drop recorded in five wells located along an approximately E–W direction on either side of the Shear Zone fault (modified from MWH 2009). The inferred kinematics of the fault zone (west side down and toward viewer) also are shown

The groundwater system underlying the study area is a part of the Simi Hills bounded by Simi Valley to the north, Box Canyon to the northeast, San Fernando Valley to the east, Bell and Las Virgenes Canyons to the south, and Runkle Canyon to the west (Fig. 2a). Previous investigators discussed the potential for subsurface groundwater outflow (i.e., deep and/or shallow) along the entire boundary of the groundwater system of the area (Fig. 2a), except for the western portion of the boundary (orange color in Fig. 2a) that is sub-parallel to the inferred direction of groundwater flow (MWH 2009). One of these studies (Cherry et al. 2009) integrated available literature data from direct measurements performed in the field area (MWH 2009; Williams and Knutson 2009) and set the bottom of fresh groundwater at approximately sea level. The upper boundary of the groundwater flow system is represented by the regional water table and localized perched water tables. At the scale of the mountain, the

surface beneath the topographic highs and some areas with residual drawdown from past pumping (Fig. 2b).

members (MWH 2009). The coarse-grained members (sandstones) store and transmit locally significant quantities of groundwater, and thus may be considered aquifer units (Fig. 2b). Conversely, the fine-grained members (i.e., mudstones, siltstones, and shales) tend to impede groundwater flow, and thus are considered aquitards (Fig. 2b). The other formations exposed near and beyond SSFL boundaries comprise hydrogeologic units that are more relevant toward the margins of the mountain groundwater system.

Two different sets of hydraulic head distribution data have been analyzed for this report: one was collected during the third quarter of 2008 (MWH 2009), and the other during the first quarter of 2014 (MWH 2014). Because these two datasets are very similar, Fig. 2(b) shows only the most recent one.

Groundwater occurrence and movement are also influenced by some of the tectonic structures (see arrows in Fig. 2b). As shown in Fig. 2b–c, groundwater levels differ by as much as 75 m across a major NE–SW striking fault zone called the “Shear Zone” (Sage 1971; MWH 2009), the subject of the present study. For consistency with former studies, this fault is referred to with its previously assigned name (Shear Zone fault or SZF), even though any well-developed fault is a shear zone in *sensu stricto*. The hydraulic heads on the southeast side of the fault are systematically higher than those on the northwest side. Despite this strong NW–SE (fault-perpendicular) groundwater hydraulic gradient, the migration of contaminant plumes is significantly restricted from east to west across SZF (Cherry et al. 2009).

A wide range of fault permeability structures have been observed at SSFL. For instance, evidence of enhanced hydraulic communication exists along the E–W striking North fault (northwestern portion of the map in Fig. 2b), which connects two zones of the aquifer that would be otherwise separated by Shale 2. Most of the other E–W striking faults, which generally occur within the thick sandstone units of the Chatsworth Formation, do not show significant evidence of reduced cross-fault conductivity (MWH 2009).

The Shear Zone fault (SZF) is one of the major NE–SW striking fault zones, and is located in a critical remediation area within SSFL because of its vicinity to several of the former sources of contaminants. As seen in Figs. 2 and 3, this fault has a significant compartmentalization effect on the groundwater system. In this section, the geometry, kinematics, and architecture of the SZF are characterized.

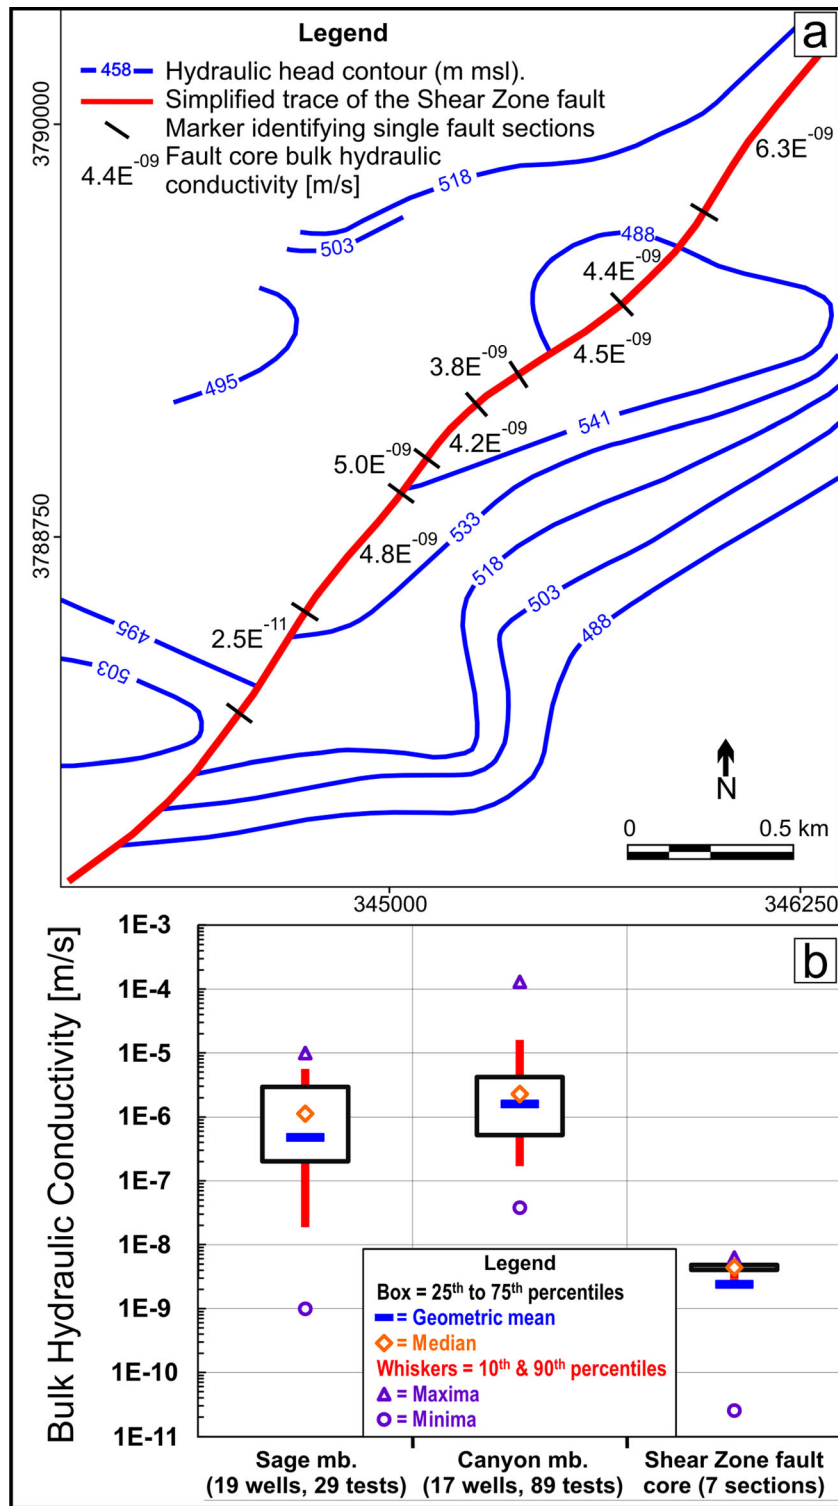
**Fig. 3** Hydraulic conductivity data. **a** The hydraulic head contours from the first quarter of 2014 (blue lines; from MWH 2014), the schematic representation of SZF as drawn in the groundwater flow model (red line; redrawn from AquaResource/MWH 2007); the values of the hydraulic conductivity of the 6-m-thick fault core are listed adjacent to each section of the fault (from AquaResource/MWH 2007). **b** Box-and-whisker diagram of the hydraulic conductivity of the Shear Zone fault and the two surrounding sandstones

conductivity values were then calibrated using a groundwater flow model (AquaResource/MWH 2007); the model calibrated values for different sections of SZF are potted in Fig. 3a. Figure 3b is box-and-whisker plot comparing the bulk hydraulic conductivities of the two sandstone units surrounding the studied fault zone (i.e., Sage and Canyon members) and the conductivity of the SZF core (Haley and Aldrich 2000; MWH 2004; AquaResource/MWH 2007). This report will focus on the faulting mechanism responsible for the architecture of the Shear Zone fault and its consequent permeability structure.

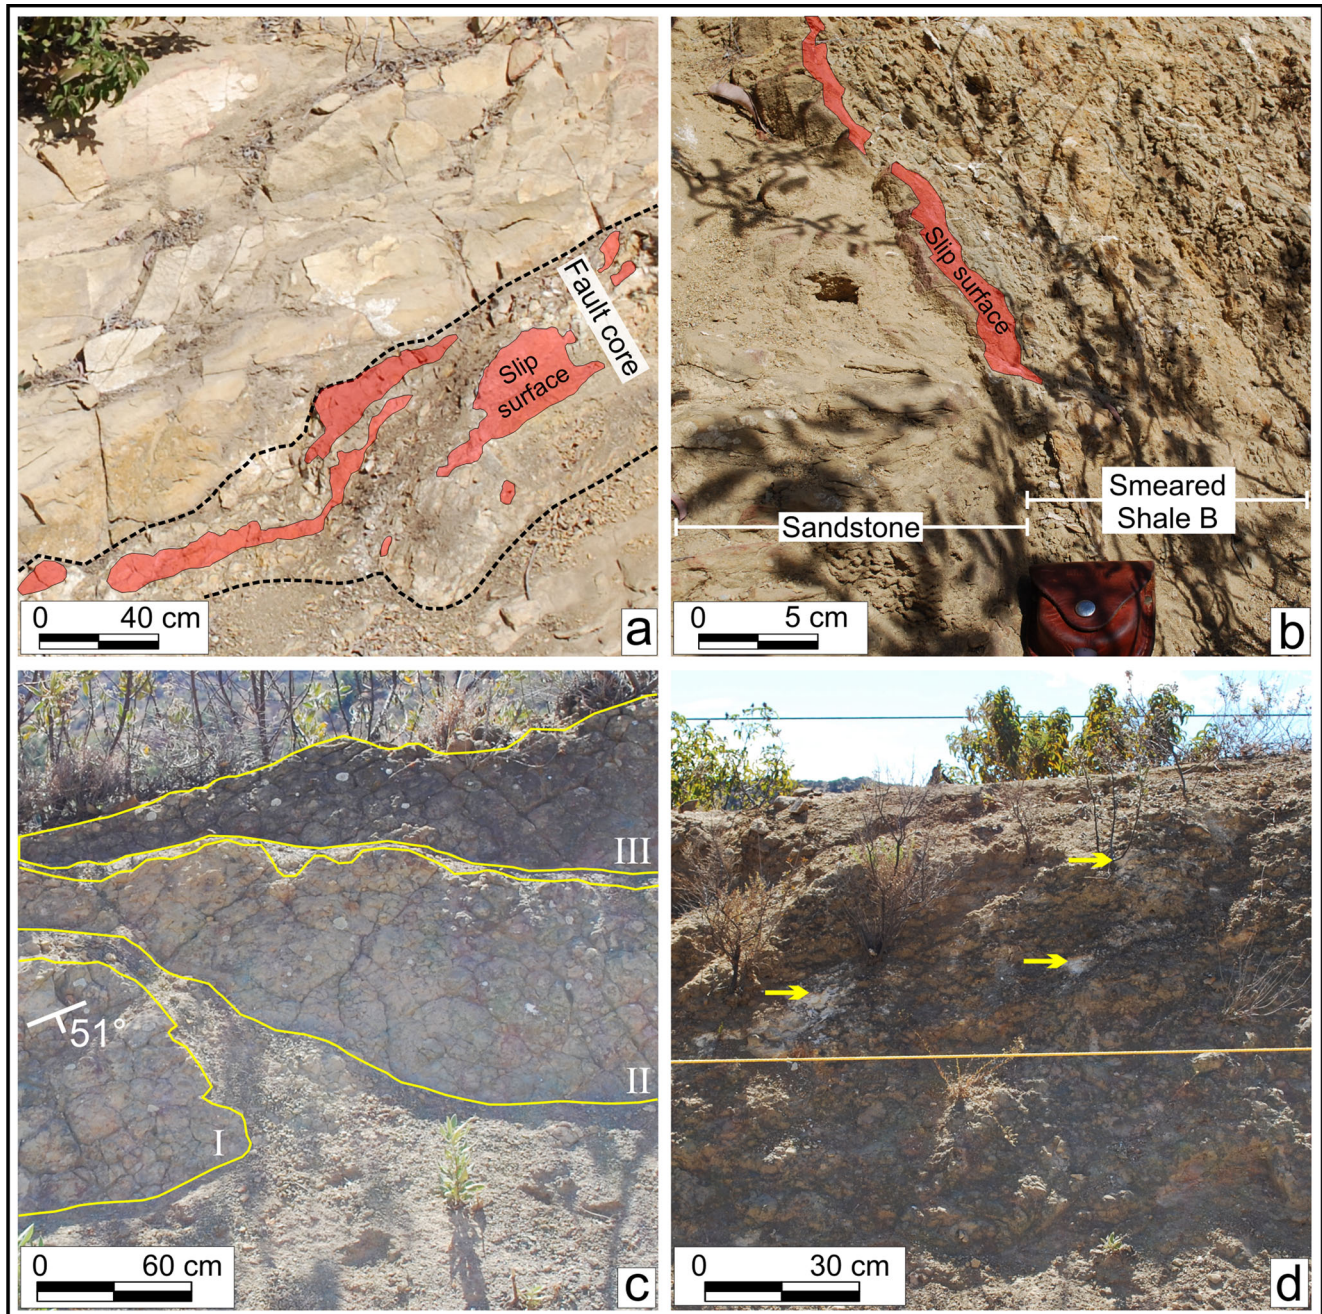
**Fig. 6** Photographs of different portions of the Shear Zone fault at Station 1. **a** Fault strand in sandstones; closely-spaced slip surfaces are highlighted in red (due NW); **b** Smearing of shale unit “B” along a secondary fault strand (due NE); **c** Shale unit “A” highly bent and dipping toward the fault zone (due SE). I, II, and III represent distinct beds dipping towards the viewer and their boundaries are highlighted in yellow; **d** Shale-rich fault core with carbonate veins pointed out by yellow arrows (due SE)

from each other (see Fig. 1 for the locations). Station 1 encompasses an outcrop along the southern portion of the fault (Figs. 5a and 6), while Station 2 includes a borehole interpreted as intersecting the central portion of the fault and one of the shale units offset at depth (Fig. 7c–d). The former has the advantage of showing a transversal section of the fault zone in a large surface, whereas the latter reveals an image of a portion of the fault zone at the subsurface thereby avoiding effects of weathering and the related cover.

At this location the fault zone trends about N50°E and is about 15 m-wide (Fig. 5a). It juxtaposes a highly deformed sandstone on the northwest side of the road and a shale-rich fault rock on the southeast side. Five major strands can be recognized within the fault zone (Fig. 5a). In the sandstone, the offsets were resolved along N42°E striking and steeply SE-dipping slip surfaces localized within a 40-cm wide sub-vertical strand of the fault (Fig. 6a). Further to the east, another SE-dipping

diffuse deformation with a foliated texture sub-parallel to the fault zone (Figs. 5a and 6d). The fault core is overprinted by a N30°E-striking array of carbonate veins; its clay content decreases westward closer to the juxtaposition of the footwall sandstone against the shale fault rock (Figs. 5a and 6d).

At the southeastern edge of the exposure, the shale unit “A” dips towards the fault zone with a northwesterly strike and 50° dip angle (Fig. 6c). This part of the outcrop provided the key piece of data to infer that the shale unit gradually changed its dip angle and merged into the fault zone in a

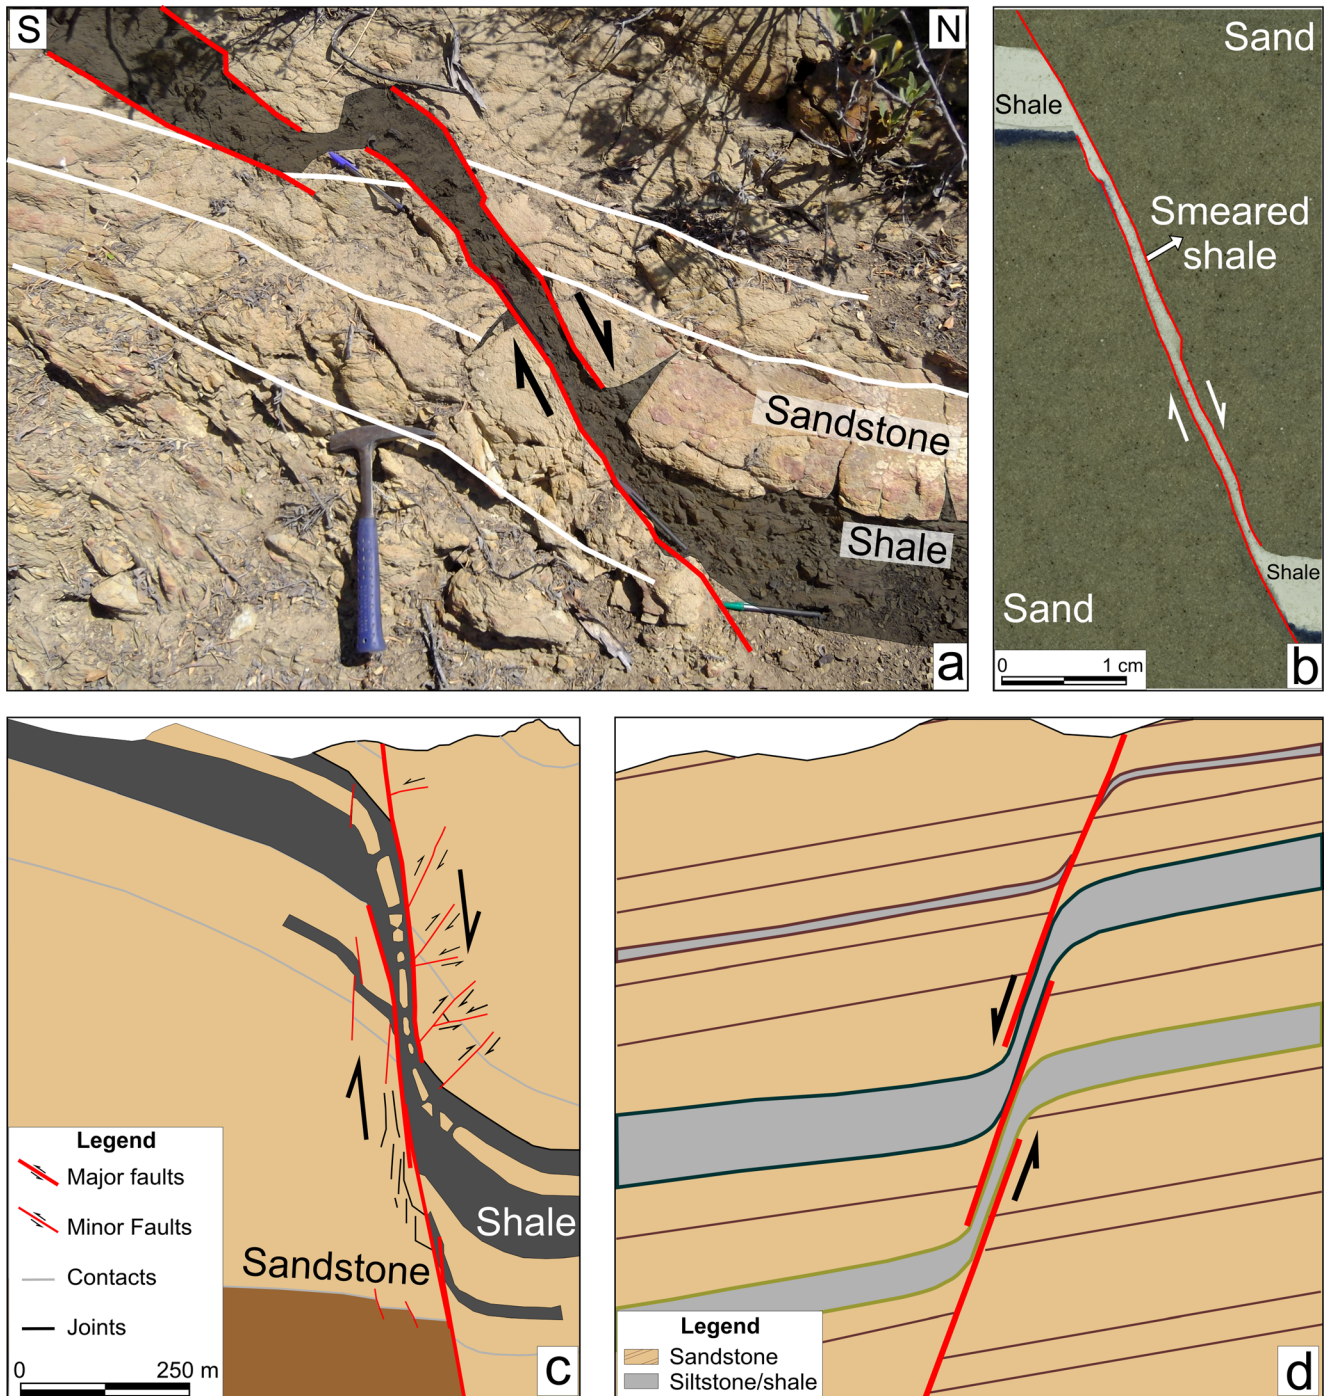
**Fig. 8** Examples of faults with shale smearing. **a** An outcrop scale dip-slip fault zone exposed along CTL IV Road within the study area; fault segments are represented in *red*, sandstone bedding in *white*, shale bed has been *shaded*; **b** sand box analog model showing a single shale layer smeared along an extensional step-over of two segments of a normal fault (simplified and re-drawn from Noorsalehi-Garakania et al. 2013); **c** field-based conceptual model of a normal fault cross-cutting a sequence of alternating sandstones and shales (slightly modified from Aydin and Eyal 2002); **d** conceptual model of shale smearing in an alternating sequence of sandstones and shales. A thin shale unit becomes discontinuous across the fault zone, whereas thick shale units are incorporated between fault stopovers and merge together

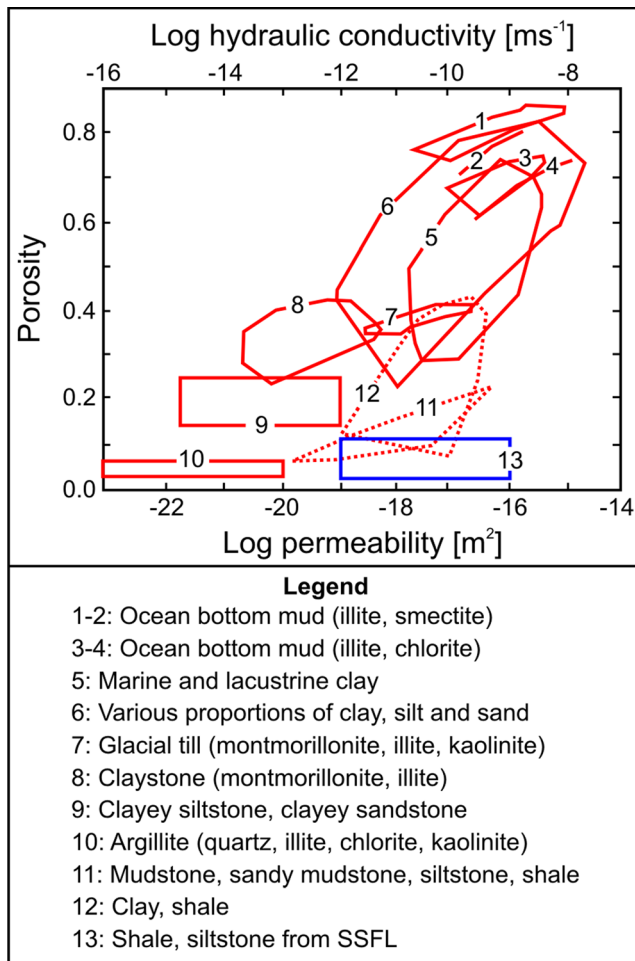
**Fig. 9** Plot of laboratory-derived permeability versus porosity for a variety of natural argillaceous rocks (Neuzil 1994). Fields (outlined in red) denote the range of result values determined for each clay-rich rock type listed in the legend. Permeability is shown along the lower horizontal scale: the corresponding hydraulic conductivity of water at room temperature is shown along the upper horizontal scale. Numbers for each field correspond to lithologies stated in the legend (Neuzil 1994 and references therein). Fields 1–4: bottom deposits from North Pacific; 5 Pleistocene to recent from Quebec (Canada), Mississippi Delta (USA) and Sweden; 6 from Gulf of Mexico; 7 Southerland Group from Saskatchewan (Canada); 8 Pierre Shale from South Dakota (USA); 9 from western Canada; 10 Elena Formation from Nevada (USA); 11 from Japan and Alberta (Canada); 12 Upper Triassic, mid-Miocene, lower Pleistocene from Italy; 13 Shale and siltstone members from the Upper Cretaceous Chatsworth Formation, nominally unfractured rock cores (Hurley et al. 2007)
