# Chapter 2

## Characterization of Pre-bond Contamination and Aging Effects for CFRP Bonded Joints Using Reference Laboratory Methods, Mechanical Tests, and Numerical Simulation

**Abstract** In this chapter, the pre-bond contamination and ageing effects on carbon fiber reinforced plastic (CFRP) adherends and CFRP bonded joints are characterized by means of reference laboratory non-destructive testing (NDT) methods, mechanical tests, and numerical simulation. Contaminations from two fields of application are considered, namely in aircraft manufacturing (i.e. production) and for in-service bonded repair. The production-related scenarios comprise release agent, moisture, and fingerprint, while the repair-related scenarios comprise fingerprint, thermal degradation, de-icing fluid, and a faulty curing of the adhesive. For each scenario, three different levels of contamination were pre-set and applied, namely low, medium and high level. Furthermore, two types of samples were tested, namely coupons and pilot samples (a stiffened panel and scarf repairs). The CFRP adherends were contaminated prior to bonding and the obtained surfaces were characterized using X-ray photoelectron spectrosc

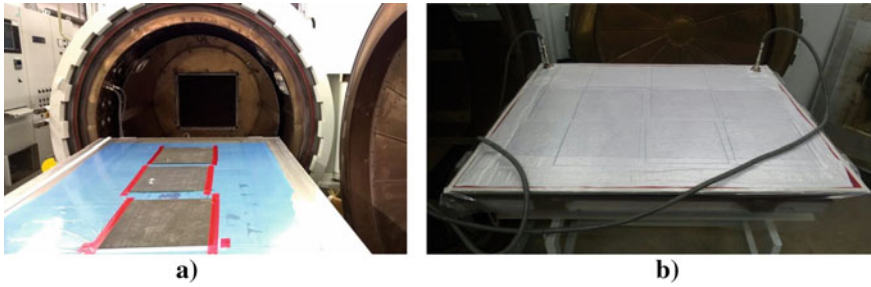
**Fig. 2.12** Photographs showing the preparation of samples for bonding **a** in the autoclave and **b** using a vacuum bag

Plates with the dimensions 30 cm × 30 cm and 30 cm × 15 cm were bonded and afterwards cut into the desired sizes for measurements with the respective measuring techniques as well as for mechanical testing in the specified geometries. The cutting was performed dry (diamond cutting) to prevent any contamination of the cleaned surfaces as might be the case when using cooling liquids. After cutting, the surfaces were cleaned again with isopropanol (IPA) soaked tissues. Figure 2.12 shows the preparation of the samples for bonding in the autoclave (at Fraunhofer IFAM facilities).

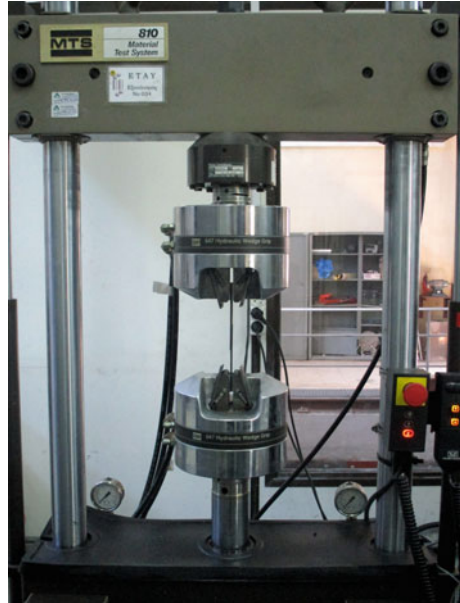
**Fig. 2.22** Photograph showing a scarfed specimen under tensile loading

Scarfed samples were loaded under ambient conditions (25 °C/48%RH) by tensile stress using an MTS universal testing machine with a load capacity of 100 kN under a constant crosshead speed of 0.5 mm/min (Fig. 2.22) until a final failure (separation) of the two scarfed adherends occurred. Aluminum end tabs (30 mm × 25 mm × 2 mm) were bonded to the ends of the specimens using a two-part adhesive (PM Mega Cryl) in order to achieve a successful and smooth introduction of the load into

the specimen. Moreover, the end tabs prevented gripping damage to the adherends or premature failure as a result of a significant discontinuity. The load and crosshead displacement were recorded using a computerized data logging system. A total of four tests were performed for each contamination scenario and the failure load was the mechanical feature used for comparing the tested specimens.

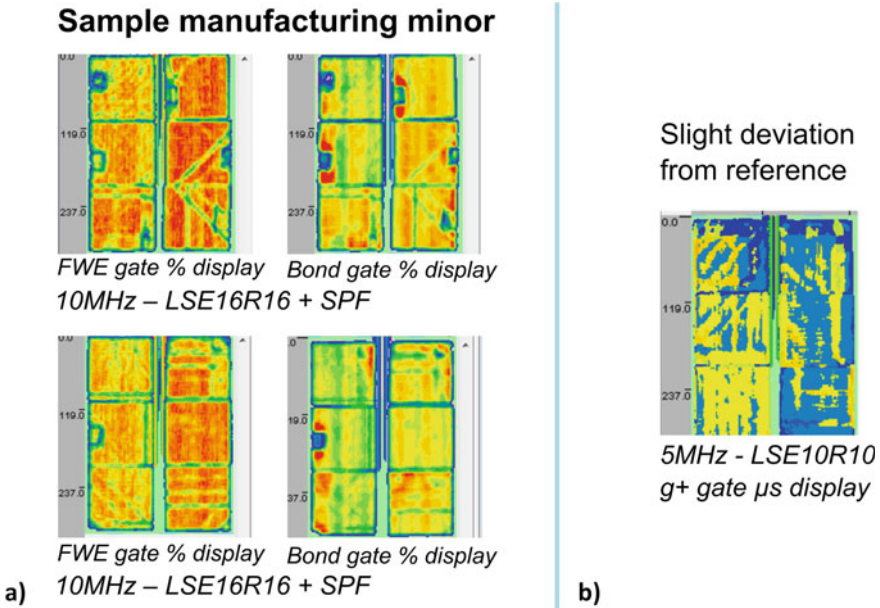
**Fig. 2.29** Overview of the defects observed by ultrasound investigations of CFRP samples from the combined contamination scenarios, especially the scenario “release agent+finger print”; **a** minor manufacturing defect and **b** minor deviation from reference

Multi-contaminated samples were also investigated using the same methodology and the same instrument settings as described above. Essentially, the same kinds of defects were observed for these samples, which is as expected since their manufacturing and contamination procedures were the same. Some examples are given in Fig. 2.29, and are these are further detailed below.

Minor defects were also observed; in this case, they are attributed to clamp marks, as shown in Fig. 2.29a. These are located on the edges and occur during the sample manufacture (probably while stabilizing the plate for bonding). On the ultrasound data acquisitions, they are visible on the bond amplitude C-scan as well as on the
