# Weldability of wrought Haynes<sup>®</sup> 282<sup>®</sup> repair welded using manual gas tungsten arc welding

**Abstract** The ability of the precipitation hardening superalloy Haynes<sup>®</sup> 282<sup>®</sup> to be repaired by multi-pass gas tungsten arc welding is investigated in this study. The repair welding has been carried out on forged discs having four pre weld heat treatments, resulting in different grain sizes and precipitate structures of the base material. Another set of discs has additionally been put through a post weld heat treatment. The tendency to form cracks in the heat-affected zone and the fusion zone has been investigated metallographically. No cracks in the base metal heat-affected zone were found, whereas solidification cracks were present in the weld fusion zone of all tested conditions. While high heat input during welding increased cracking by a factor of 1.5, none of the heat treatments had a measurable influence on the cracking behaviour. Voids with solid state crack-like appearance turned out to be aluminium-rich oxides being present from the deposition of previous weld deposit layers.

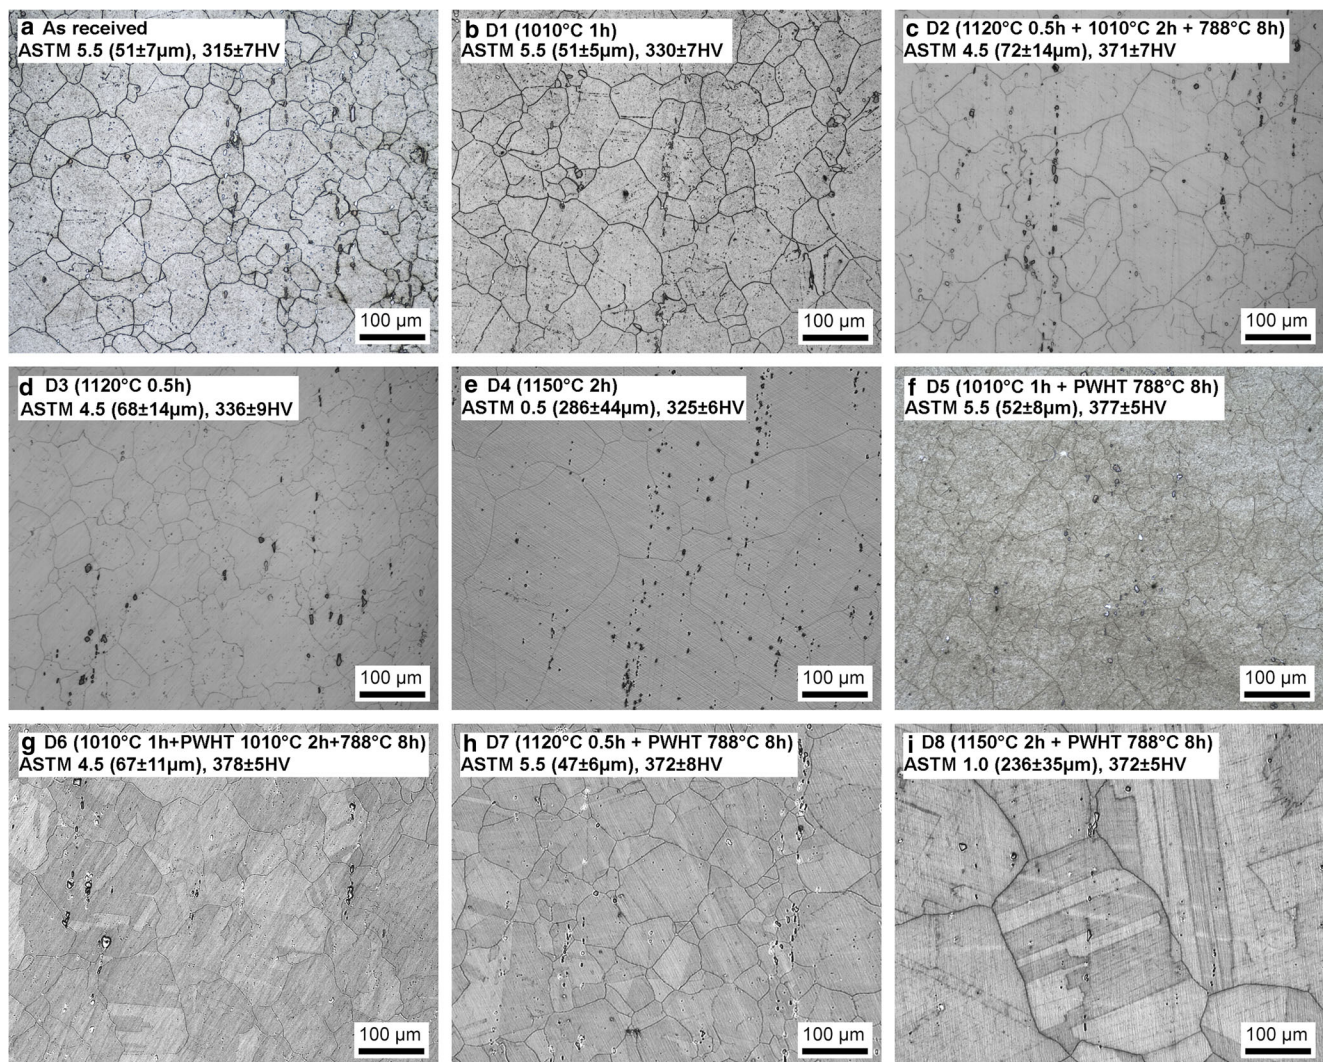
**Fig. 1** Microstructure of the base material after different heat treatments, including respective grain size and hardness values

Wrought Haynes® 282® in the form of a 100-mm-diameter forged bar has been used for this study, with the nominal chemical composition given in Table 1. The as-received, solutionised condition had a grain size of ASTM 5.5 ( $51 \pm 7 \mu\text{m}$ ) and a hardness of  $315 \pm 7 \text{HV}$  with the microstructure showing strings of primary carbides typical for the thermomechanical history of the material (cf. Fig. 1a). Grain boundary carbides were not present in this material condition.

The microstructures obtained with the different heat treatments are shown in Fig. 1b–i together with the respective grain size

and hardness values. Grain size varied within one ASTM number for the different heat treatments, except for the discs heated to 1150 °C, which is above the secondary carbide solvus temperature. This led to significant grain growth, as indicated in Fig. 1e, i. The larger grain size did not have a measurable effect on the hardness. All age-hardened samples show hardness values between 370 and 380 HV. As expected, neither heat treatment was able to change the string-like carbide alignment present from the forging process (cf. Fig. 1). Based on the microstructural evaluation, the heat treatments of disc 1 (1010 °C 1 h) and disc 3 (1120 °C 0.5 h) show no striking difference, with the amount and distribution of carbides, while not quantified, appearing to be the same. The hardness values of the base material of discs 1 and 3 however were exceeding those being expected for precipitate-free material.

the as-received condition (cf. Fig. 1) and the finding that γ' precipitation is rather fast in Haynes® 282® [13] led to the conclusion that the forced convection cooling as used in this study still leads to significant hardening reactions in the material. The unexpected hardness difference between weld and base metal after post weld heat treatment could be related to a difference in size and volume fraction of the γ' phase, caused by the different thermal history. While present in the material, this difference did not affect the cracking response since both the solidification cracks and oxide inclusions remain from the welding process and were not caused by the post weld heat treatment.

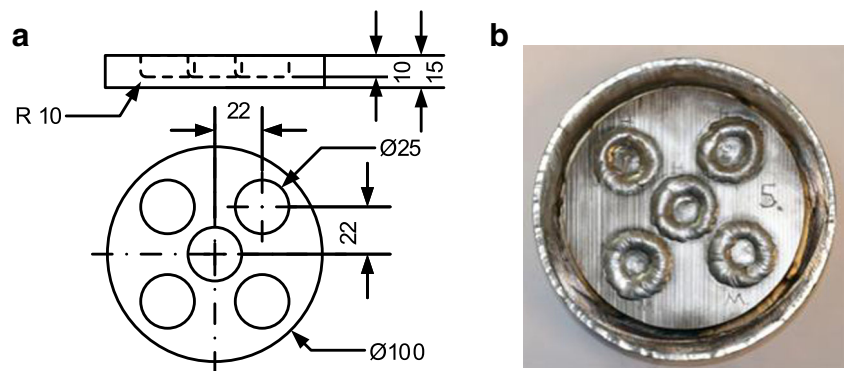
**Fig. 2** **a** Sample design. **b** Disc with filled grooves. Note the restraint maximising stainless steel disc welded onto the bottom of the Haynes® 282® disc

Five circular repair welding grooves with a diameter of 25 mm, a depth of 10 mm, and a bottom radius of 5 mm have been machined into the discs after the pre weld heat treatments, as indicated in Fig. 2a. To maximise welding restraint, the discs were fixed to 25-mm-thick stainless steel discs by a circumferential weld (cf. Fig. 2b). Repair welding has been carried out by experienced welders using manual gas tungsten arc welding (GTAW) with a tungsten-2% thorium (WT-20) electrode. Argon was used as shielding gas, with a nozzle gas flow of 8–15 l/min. Filler material in the form of 1.14-mm wire with matching chemistry has been used to fill the grooves. Two out of the five grooves have been filled using negative polarity and a welding current of 120 A, while 140 A have been used for the remaining ones. The former is typical for such a repair operation, whereas the higher weld current represents tougher conditions due to the higher heat input. The grooves have been filled with 7 to 8 layers, while the material was quenched by argon after the deposition of each layer to an inter-pass temperature of approximately 50 °C. The grooves have been filled one by one, but without specific sequence and no brushing between layer deposition.

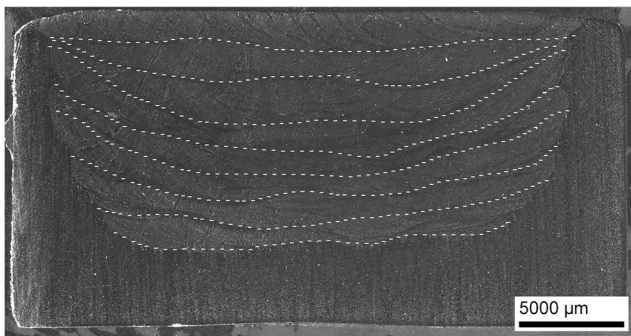
**Fig. 3** Macro image of an etched cross section with several weld deposits visible in the fusion zone (as indicated by dashed lines)

The general appearance of the repair-welded grooves is shown in Fig. 3, with the weld deposit layers being indicated by dashed lines. The groove's depth of 10 mm has been filled with seven to eight welding deposit layers, leading to an average layer thickness of  $1.5 \pm 0.3$  mm. It has to be noted that the apparent layer thickness is lower than right after depositing, since some re-melting occurs during subsequent layer deposition. The welding deposits are further referred to as fusion zone, while the term heat-affected zone describes the

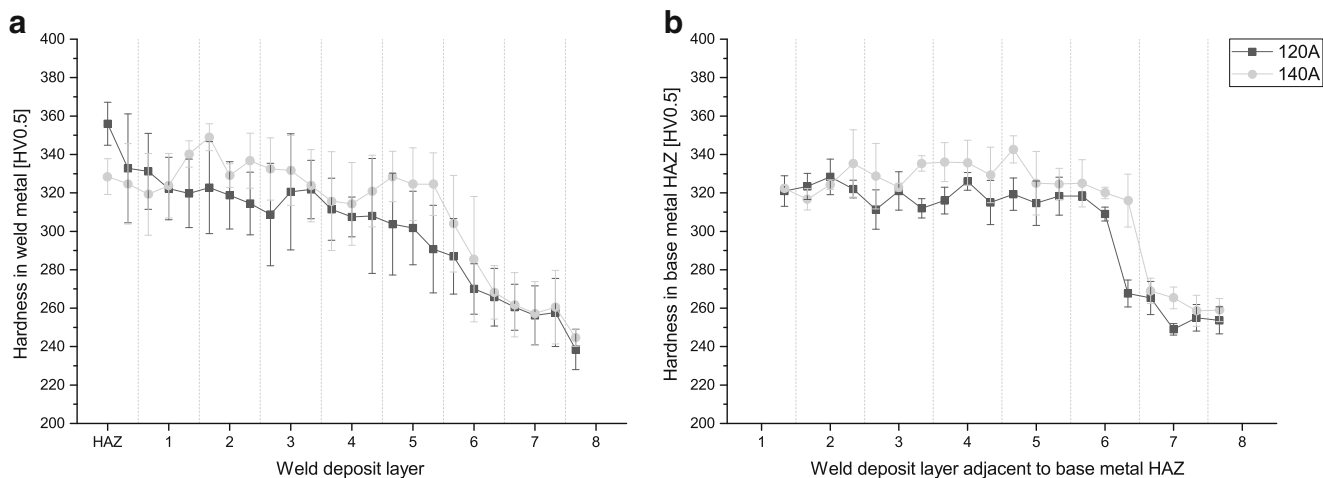
**Fig. 4** Hardness evolution as a function of weld deposit layer for 120-A and 140-A welding current. **a** Weld metal. **b** Hardness in the base metal HAZ and adjacent to the fusion zone. Indent spacing 0.5 mm

heat-affected zone of the base material. The post weld heat-treated discs show a uniform hardness distribution over the whole weld area (120 A  $402 \pm 13$  HV, 140 A  $393 \pm 15$  HV), whereas a hardness drop below 300 HV is visible for the top fusion zone layers in the discs without PWHT, as visible in Fig. 4a. While this drop in hardness occurs in both welding conditions, the higher heat input of the samples welded with 140 A welding current led to a somewhat delayed but sharper reduction in hardness. The same hardness drop also occurs in the base metal HAZ, measurable on the side walls of the grooves, cf. Fig. 4b. The hardening response is however somewhat more rapid, since values below 300 HV were only measured adjacent to the 2 to 2.5 topmost layers.

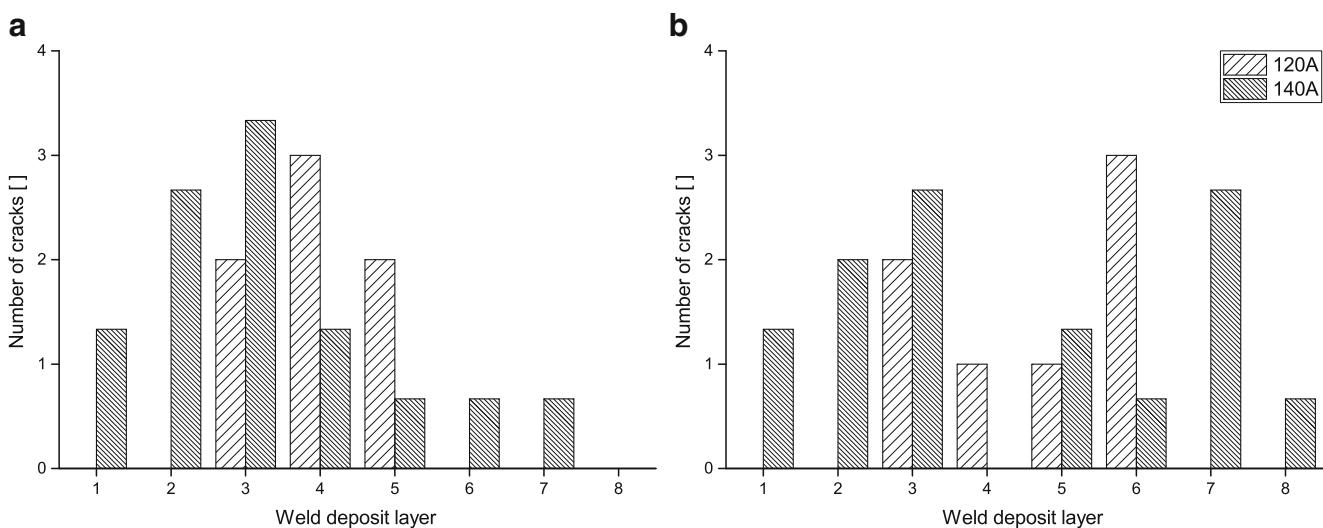
**Fig. 5** Total number of cracks per weld deposit layer. **a** Pre weld heat-treated discs (1–4). **b** Pre + post weld heat-treated discs (5–8). Results for 140-A welding condition are normalised to account for the difference in sample size between the two conditions

further. Lack of fusion has been observed in all samples, but was not further investigated. Solidification cracks had an average crack length of 375 μm, while LoF typically ranges from 500 to 1500 μm and the small voids around 100–200 μm. Figure 5 shows the total number of cracks per welding deposit layer for all pre and post weld heat-treated samples. Note that only solidification cracks are shown here, since these were the only cracks present in the material. While those cracks do not form during post weld heat treatment, the grouping of samples has been kept to point out that PWHT did not lead to more cracks in the material.

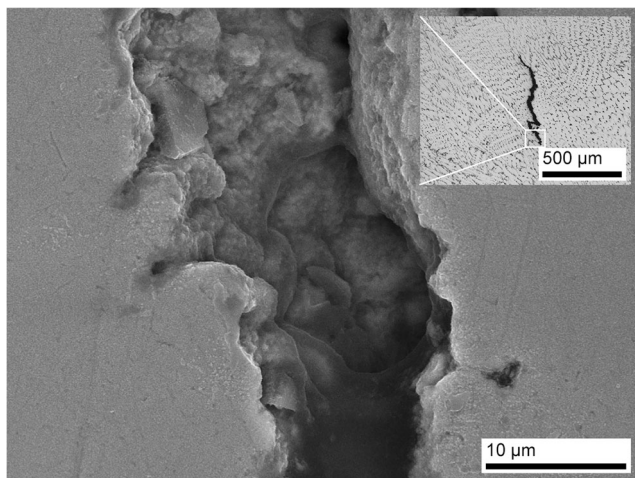
**Fig. 6** Solidification crack in disc 8, 120-A welding condition. Clear indication of a dendrite structure in the crack opening. Crack length 706 µm

cracks in the base metal HAZ would indicate that, irrespective of the material condition, wrought Haynes<sup>®</sup> 282<sup>®</sup> exhibits a generally good response to repair welding operations. This is however different for the fusion zone, where in total 47 cracks have been observed in the 40 investigated grooves. Welding with higher heat input increased cracking by a factor of 1.5, with no clear pattern being evident regarding overall crack distribution over the welding deposit layers. While stress levels have not been quantified within this study, it can be reasonably assumed that higher thermal stresses were present during welding with 140-A welding current and hence facilitating crack formation. SEM investigations of found cracks revealed the dendritic structure formed during the solidification process without signs of decohesion, as shown in Fig. 6. This further supports the assumption that those cracks are indeed solidification cracks.

The voids found in bottom regions of weld deposits appear to be cracks when viewed under an optical microscope, lying horizontally, i.e. parallel to the fusion boundary. Most of them are located at the interface between columnar grains on the bottom and equiaxed grains on top (cf. Fig. 7). No signs of liquation could be found during SEM investigation. EDS scans however revealed the presence of aluminium-rich oxide films in the voids, as indicated in Fig. 7. This finding makes it very unlikely that those voids are stain age cracks and instead support the hypothesis that these voids are caused by oxide films present during the deposition process. The large number in comparison to the amount of solidification cracks is related to the manual welding process, where more thorough surface cleaning between layer depositions would have been necessary. It should be noted though that voids caused by oxide layers are about half the size of solidification cracks and LoF (cf. Figs. 6 and 7).

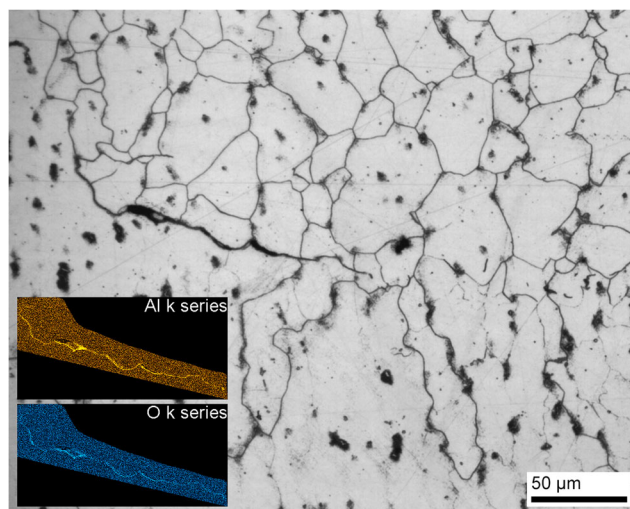
**Fig. 7** Aluminium-rich oxide layer at a presumed layer start location in disc 6, 140-A welding condition. Note the equiaxed grain structure above the oxide layer. Void size 184 µm
