## Chapter 3

# Defect Types

**Abstract** This chapter provides an overview of the common types of defects found in various structural materials and joints in aircraft. Materials manufacturing methods (including large-scale production) have been established in the aircraft industry. However, as will be seen in this chapter, manufacturing defects and defects during in-service conditions are very common across all material types. The structural material types include metals, composites, coatings, adhesively bonded and stir-welded joints. This chapter describes the defect types as a baseline for the description of their detection with the methods of Chap. 5 to 8. Based on the understanding of the defect types, there is great expectation for a technical breakthrough for the application of structural health monitoring (SHM) damage detection systems, where continuous monitoring and assessment with high throughput and yield will produce the desired structural integrity.

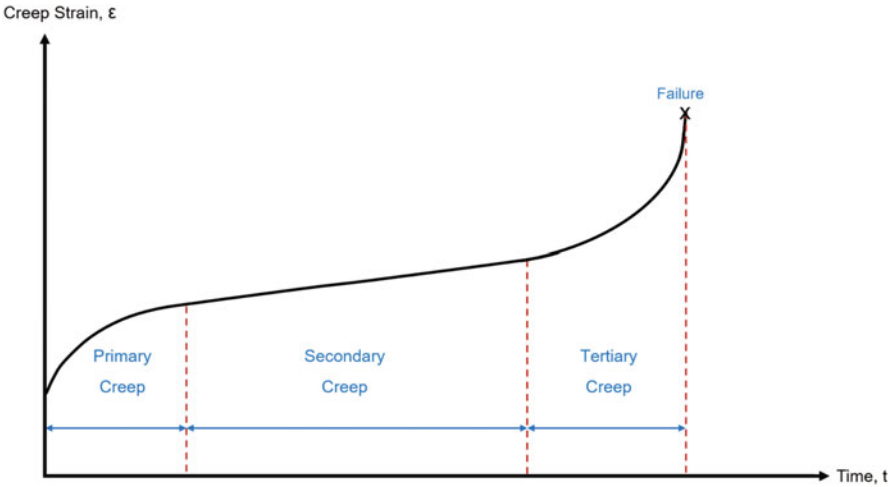
**Fig. 3.11** A typical creep curve and its progress

These stages have distinct behaviours with the function of the time and are illustrated in Fig. 3.11.

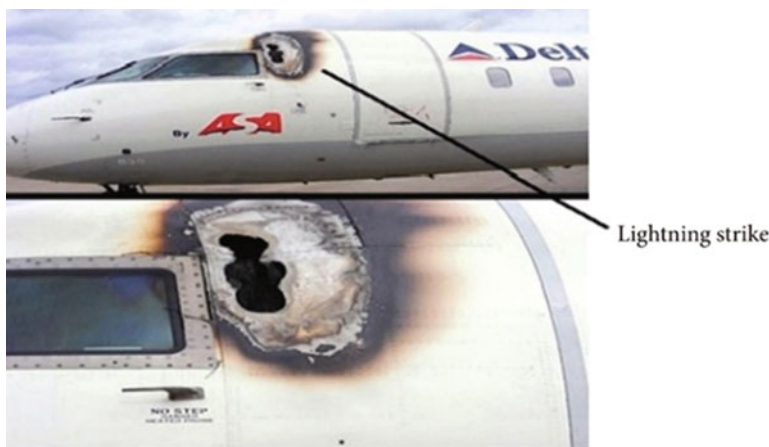
**Fig. 3.21** Lightning strikes damage to a regional jet (Alemour et al. 2019)

In 1967, Pan American Airlines Flight 214 was a Boeing 707 flying from San Juan in Puerto Rico to Philadelphia with a stop in Baltimore. The aircraft suffered a lightning strike upon taking off from Baltimore heading to Philadelphia, in which lightning-ignited vapours in the fuel tank led to an inflight explosion, totally destroying the aircraft and killing all aboard. Since then, lightning protection techniques have been improved tremendously. Nowadays, airplanes should be certified to verify the safety of their designs against lightning. As aircraft materials vary, their response to lightning differ. For example, Aluminium is a highly conductive material and, even in the worst-case scenario, the 200,000 A jolt can be quickly conducted away. However, for less-conductive materials such as carbon fibre composites or non-conductive fibreglass, lightning strike protection becomes more critical (Sweers et al. [2014](#); Black [2013](#); Rupke [2006](#)). Figure [3.21](#) shows a lightning damage to a regional jet fuselage.

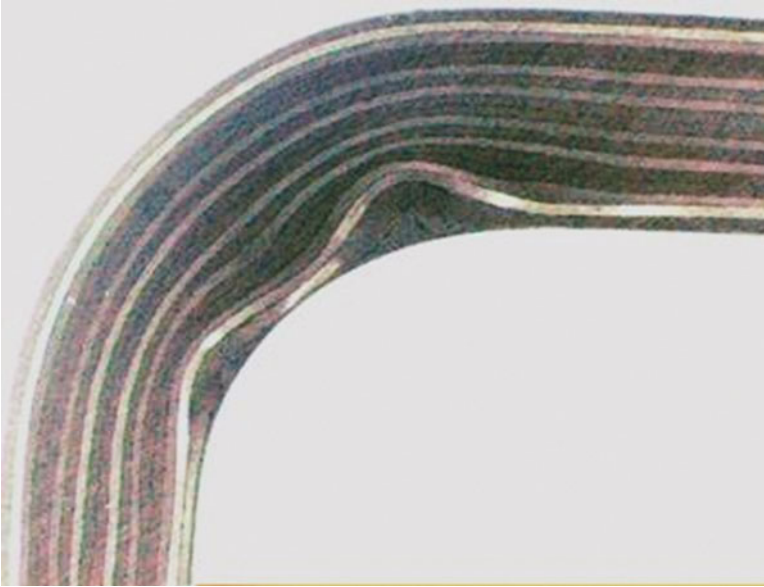
**Fig. 3.38** Laminate wrinkles in composite radius

Apart from the defects mentioned above, composite laminate may have other defects such as non-uniform laminate thickness and wrinkles or waviness. Non-uniform laminate thickness is a typical manufacturing defect generally related to non-uniform pressure or moulding tool misplacement during fabrication. An example of non-uniform laminate thickness in radius is shown in Fig. 3.37. Wrinkles (waviness) is also a typical manufacturing defect generally related to uncontrolled layer displacement during processing. Wrinkles can significantly affect the mechanical properties of composite laminates. A typical laminate wrinkle in a radius is shown in Fig. 3.38. Waviness can be formed during the cool-down phase of composite

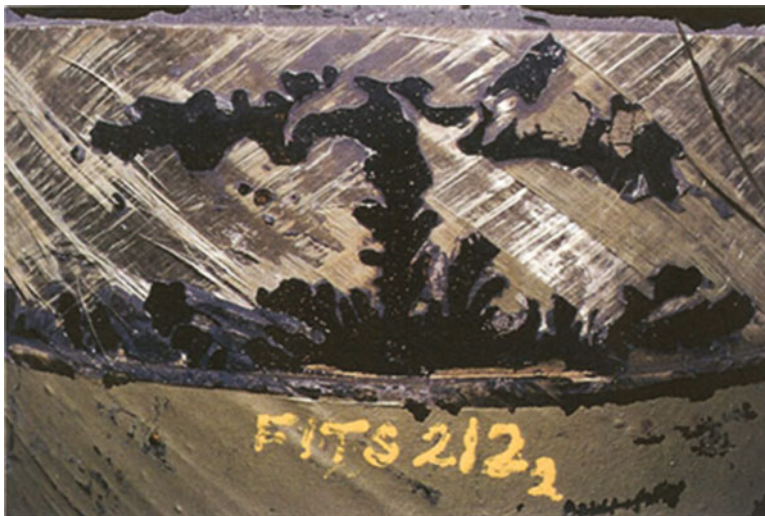
**Fig. 3.55** Void in the adhesive caused by premature handling of the joint before the adhesive cured (da Silva et al. 2018)

Manufacturing defects in adhesive bonds are classified into three main types: (a) complete voids, disbonds, porosity. This type of defect occurs because of air trapped within the adhesive during the fabrication stage (e.g. Fig. 3.55), the presence of volatiles, defects in the application of the adhesive or insufficient quantity of adhesive. The mixing of the adhesive and hardener during fabrication can sometimes introduce air trapped within the mixture (b) poor adhesion, the improper bond between the adherends and the adhesives. This kind of defects occurs due to improper surface preparation and impurities being present on the surfaces of the adherends before fabrication and (c) kissing defects caused by the local disbonding of the adhesives and adherends. These are also called zero volume disbonds due to the very small dimensions along with the thickness. The wider category of surface disbonds into which kissing bonds fall into that created by the application of adhesive only on one of the adherends in the fabrication stage. Kissing bonds are the worst case of this.
