# Automated monitoring of delamination factor during up (conventional) and down (climb) milling of melamine-faced MDF using image processing methods

## Abstract

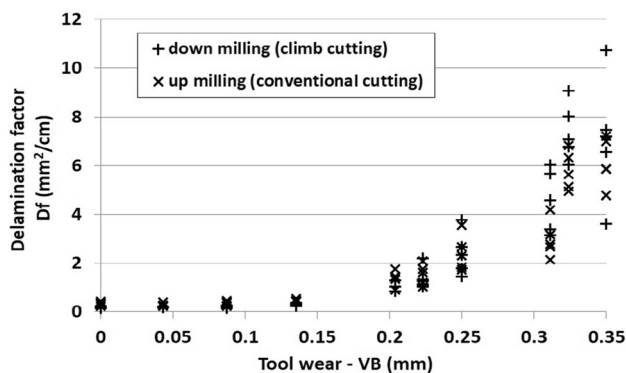
**Fig. 1** Effect of tool wear on delamination factor observed for knife no. 5

Exemplary results of delamination factor monitoring are shown in Fig. 1. Each marker (in this case, a plus sign and x) in these graphs represents the average delamination factor value calculated for one groove edge. The delamination factor increased significantly with increasing tool wear. However, the increase was not very regular.

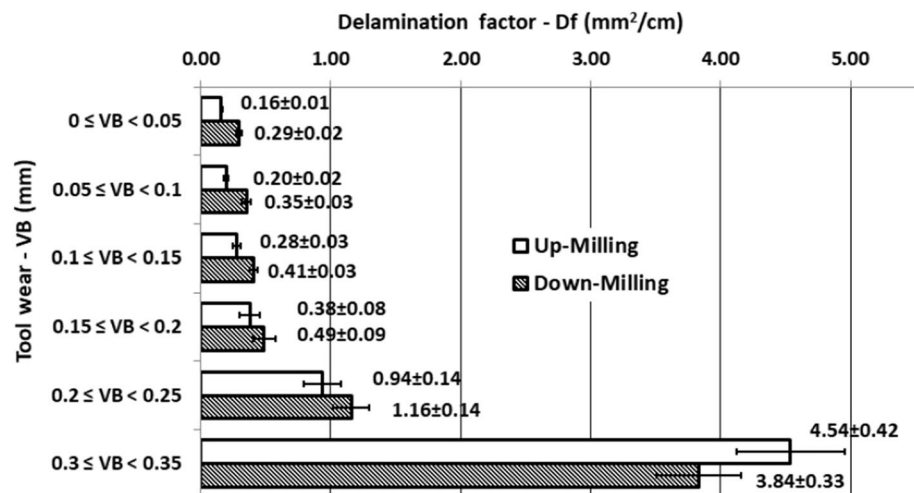
**Fig. 2** Effect of cutting mode (conventional vs. climb) on the mean values of delamination factor for different tool wear ranges (the range  $0.25 \leq VB < 0.3$  has been skipped due to the accidental gap in experimental data)

Initially, the general correlation between delamination factor observed for the up and down milling was tested. The strong positive correlation ( $R^2=0.88$ ) suggests that the cutting mode did not have a statistically significant impact on the machining quality. On the other hand, though, it turned out that for small ( $0 \leq VB < 0.1$  mm) and moderate ( $0.1 \leq VB < 0.15$  mm) tool wear the conventional cutting was much more favorable than climb cutting (Fig. 2).

It was a statistically significant effect ( $p$ -value  $< 0.01$ ). This fact confirms the conclusion by Lemaster et al. (2000) for melamine-coated particleboard routing. On the other hand, the climb cutting (instead of conventional cutting) was definitely recommended by Davim (2013) and Darmawan et al. (2018), who analyzed raw MDF and pine wood (respectively) machining quality.
