# Initiation and growth of edge cracks after shear cutting of dual-phase steel

Dual-phase steels suffer from low edge ductility, which limits their formability. In this study, an in-plane bending test is used to investigate the initiation and evolution of edge cracks. The edges of samples were prepared by shear cutting and afterwards further deformed by the in-plane bending test. Void distribution and non-uniform plastic deformation were explored with the help of scanning electron microscope (SEM) and electron backscatter diffraction (EBSD) analysis and microhardness measurement in different regions of the material edge. The extent of micro-cracks was revealed by microcomputed tomography ( $\mu$ CT) scan. The result shows that the blanking process creates inhomogeneous void distribution in the thickness direction. As the deformation increases during the subsequent in-plane bending test, the micro-cracks initiate at the burr region and grow towards the rollover region. Once they entirely pass the thickness of the material, they grow further, away from the edge. High roughness, plastic deformation, and void volume fraction were observed at the burr region, triggering crack initiatio

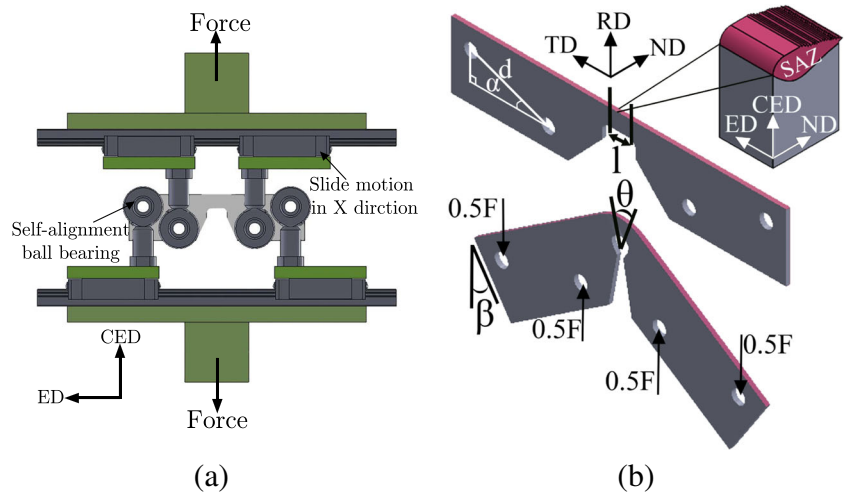
**Fig. 2** The in-plane bending test; a) Fixture and b) Sample geometry with angles for calculating the moment-curvature diagram

The in-plane bending test, schematically shown in Fig. 2(a), was used to investigate the edge ductility. The setup was installed on a Zwick tensile machine of 5.0 kN capacity, run at  $10 \text{ mm min}^{-1}$  cross head speed. To ensure repeatability, each test was repeated at least 4 times.

composition (wt%) and mechanical properties in the rolling direction of the steel are presented in Tables 1 and 2, respectively. The top edge of the samples was made by shear cutting for edge ductility investigation. A cutting clearance of 15% with cutting angle of 1.5° was chosen. The rest of the geometry was created by laser cutting as shown in Fig. 2.

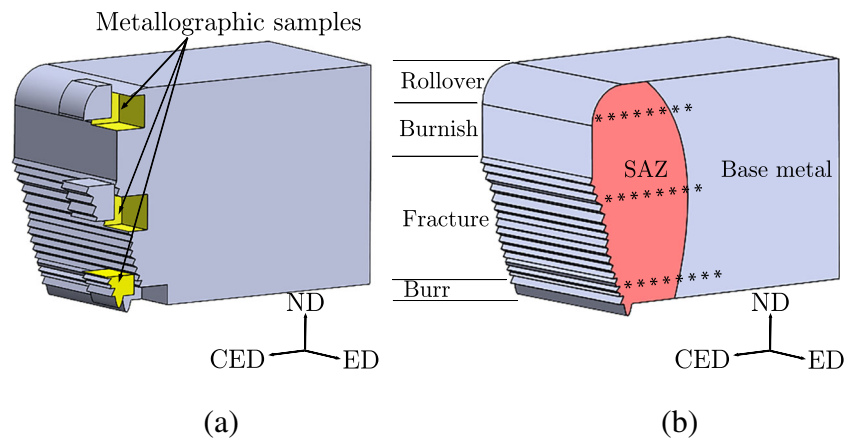
**Fig. 3** The edge microscopy investigation; **a** Locations for void analysis, and **b** Spots, indicated by a star sign, selected for EBSD analysis

The as-cut and as-bent samples were cut by an abrasive cutting machine, model Struers Secotom 60, for microscopy investigation. Subsequently, Bakelite was used for embedding. Then, metallographic samples were ground down with 500 to 2000 grit SiC paper, followed by polishing with 3 to 1 μm diamond suspensions. Finally, ultrasonic cleaning for 5 min removed the residue from the surface. The samples were etched with 4% Nital solution for 7 s to get sufficient contrast between ferrite and martensite. Three different locations near the edge at the top, middle, and bottom of the sheet in thickness direction were selected for void analysis, as shown in Fig. 3a.

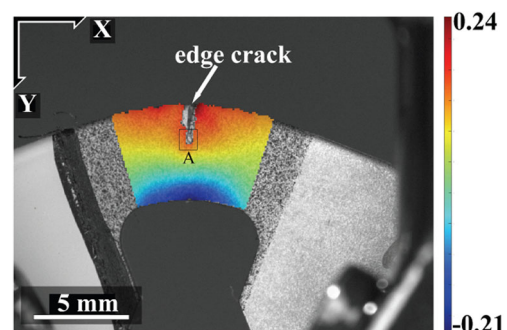
**Fig. 4** Maximum principal strain distribution during the in-plane bending test at the CED-ED plane (sheet surface). The top edge is under tension

The in-plane bending test creates a moment at the rectangular beam at the center of the sample. Therefore, the shear cut edge, located at the top of the beam, is loaded under tension. Figure 4 shows the strain distribution during the in-plane bending test, recorded by DIC. An edge crack always appears at the top edge due to tensile stress. An advantage of the in-

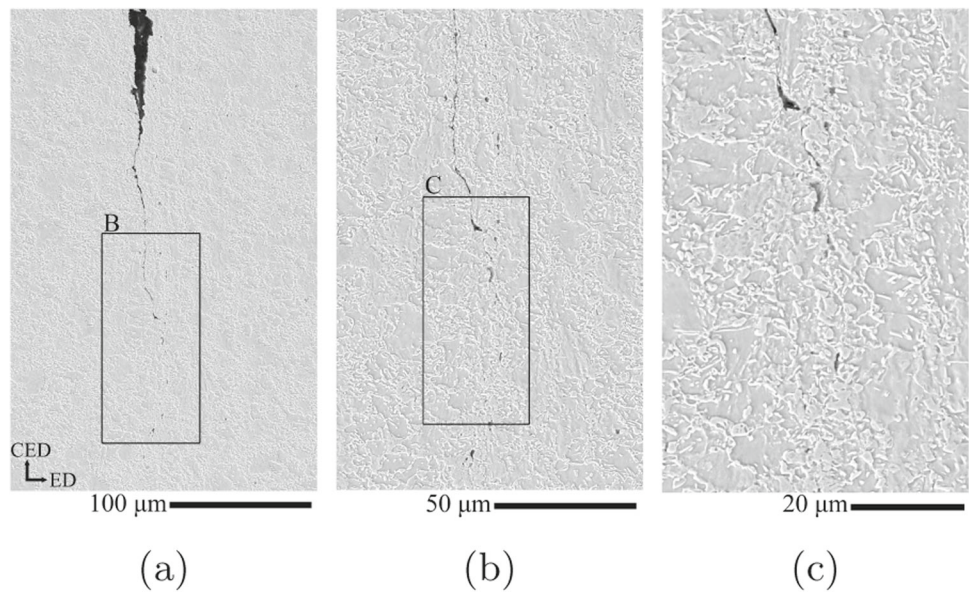
**Fig. 5** Edge crack at ED-CED plane; a) Higher magnification of rectangle A in Fig. 4, b) Higher magnification of rectangle B, and c) Higher magnification of rectangle C. The images are in the CED-ED plane

plane bending test is that an edge crack propagates slowly, making tracking of the edge crack easier. Figure 5 shows the

high magnification of the edge crack tip in the propagation stage. The void nucleation and coalesced voids are visible

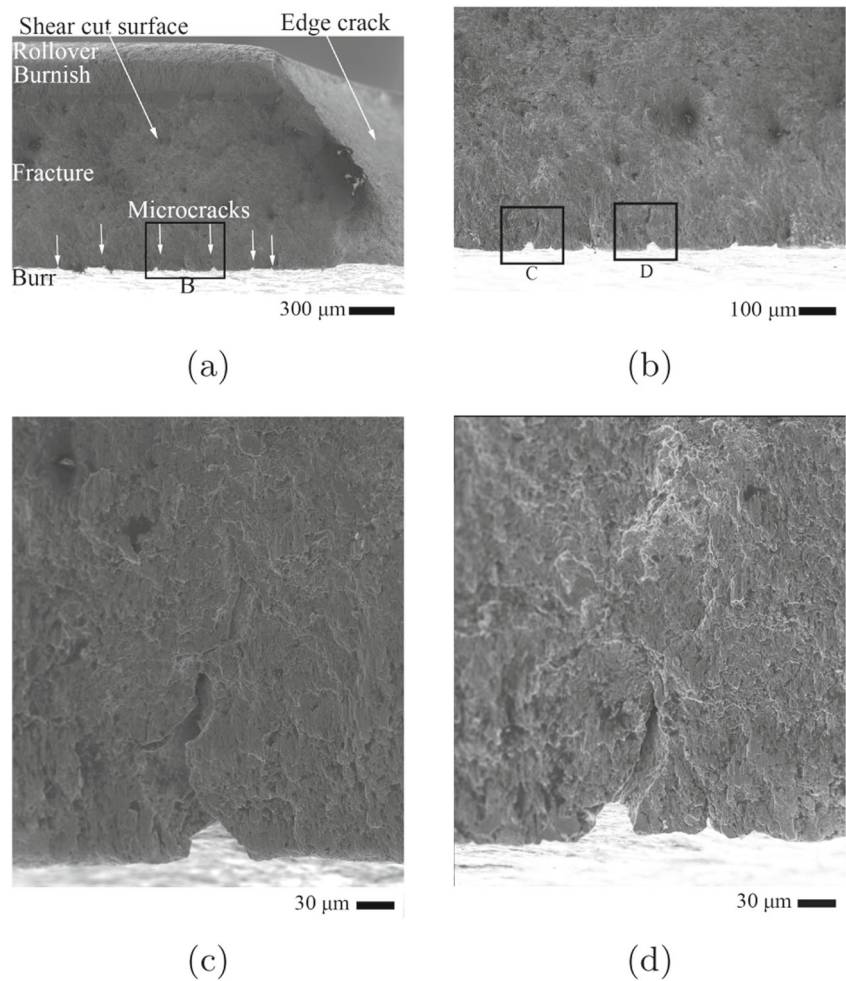
**Fig. 6** Edge appearance after in-plane bending test; a) Both fracture surfaces due to the shear cutting and edge cracking are visible, b) Higher magnification of the rectangle B on shear cut fracture surface, c) Higher magnification of rectangle C, d) Higher magnification of rectangle D

Both fracture surfaces created by the shear cutting and edge crack are visible in the picture of the as-bent sample in Fig. 6(a). Multiple micro-cracks are visible close to the burr region, while the rollover region is free of micro-cracks, as shown in higher magnification in Fig. 6(b) to (d). Note that based on ISO16630 standard, a crack is defined as an edge crack if it passes the entire thickness of the sample. There-

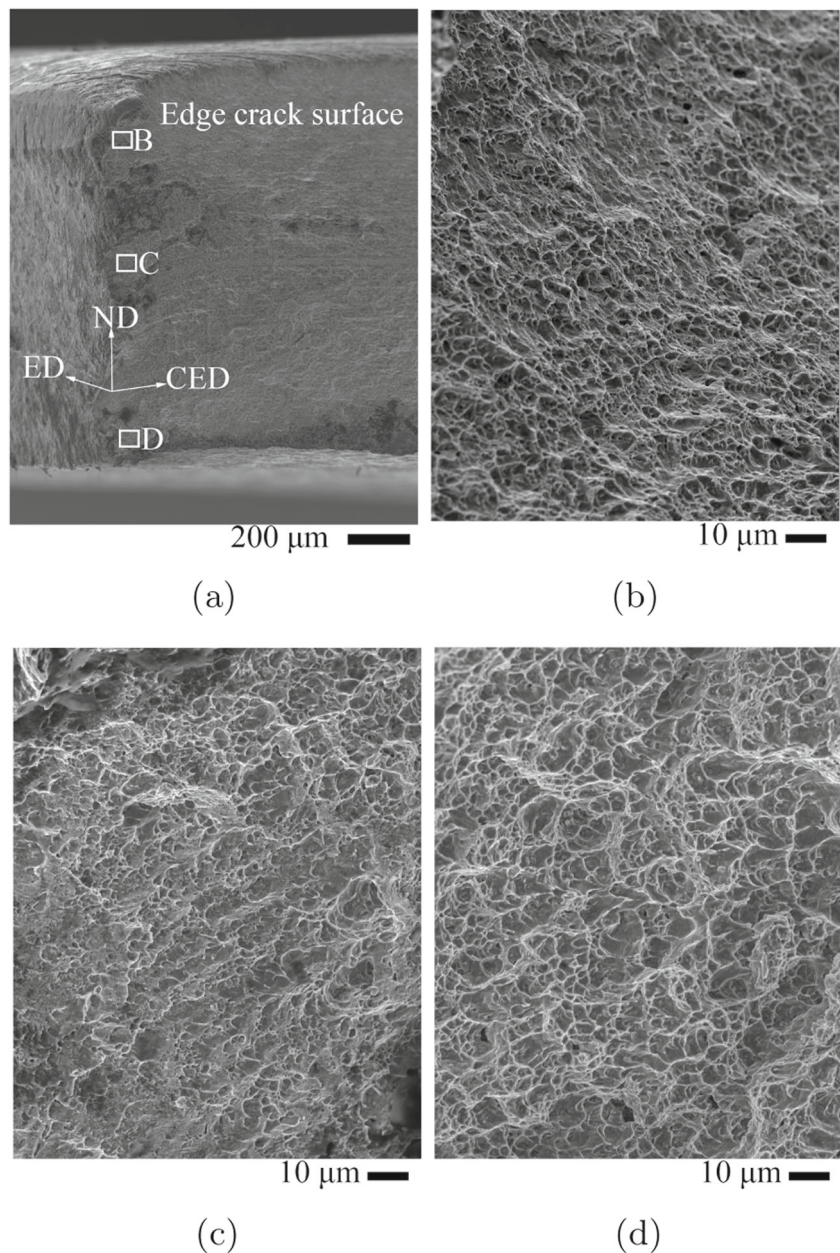
**Fig. 7** Edge crack appearance after the in-plane bending test; a) Both fracture surfaces due to the shear cutting and edge cracking are visible, b) Higher magnification of the rectangles B, c) Higher magnification of the rectangles C, and d) Higher magnification of the rectangles D

fore, none of these micro-cracks can be considered as an edge crack. The edge crack fracture surface is presented in Fig. 7(a). Higher magnification from different surface regions in Fig. 7b to d show a ductile fracture as indicated by the presence of dimples.

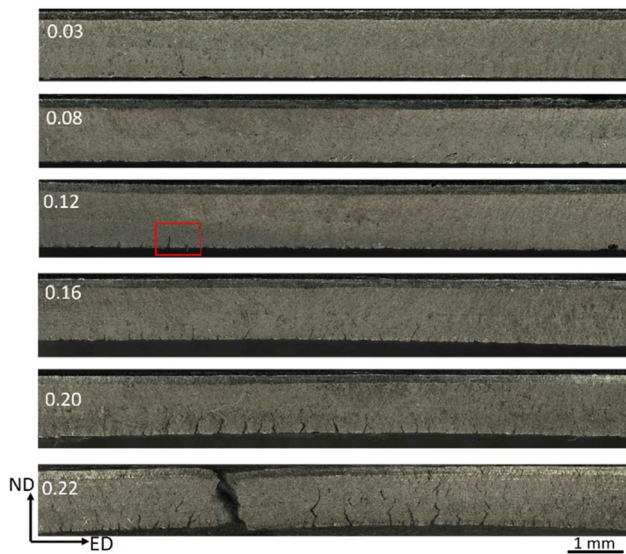
**Fig. 8** Edge appearance of DP800 in ED-ND plane during interrupted bending tests at edge strain of 0.03, 0.08, 0.12, 0.16, 0.2 and 0.22

Interrupted bending tests at different strain levels were performed to determine how the micro-cracks evolve into an edge crack during deformation. The interrupted bending tests as presented in Fig. 8 show that the micro-cracks are visible at around 12% of elongation of the edge (major strain). A  $\mu$ CT

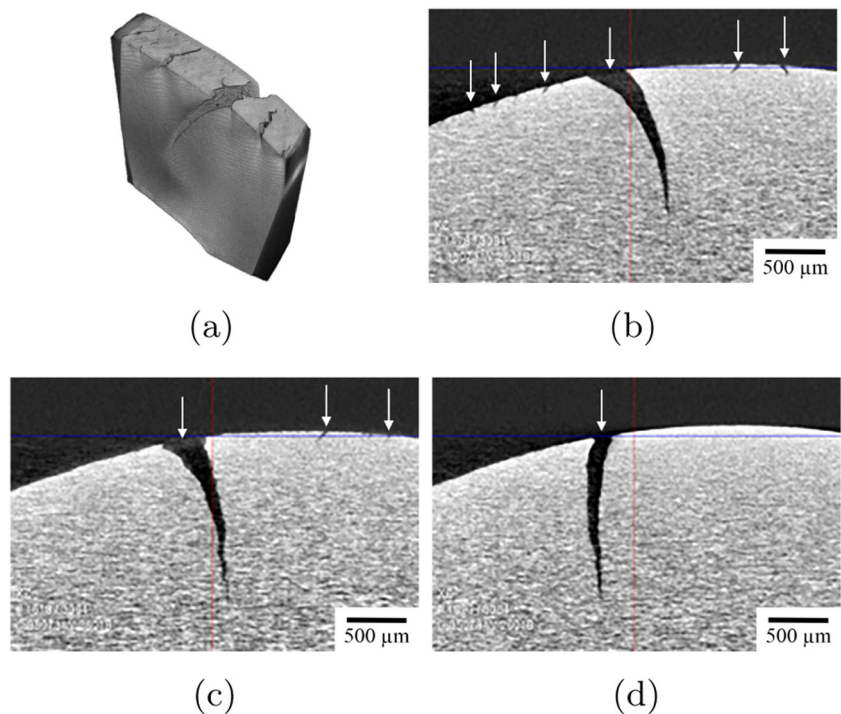
**Fig. 9** CT scan of DP800 after bending test; a) 3D CT scan, CED-ED plane in b) Burr region c) Mid-thickness. d) Rollover region. Arrows indicate the cracks

scan as presented in Fig. 9 shows that these micro-cracks are shallow and do not grow in depth, i.e. cross edge direction (CED), before passing the material thickness completely. The micro-cracks increase in number and grow during the in-plane bending test towards the rollover side as the deformation continues. Once they entirely pass the thickness of the material (fracture strain  $\approx 0.22$ ), they are identified as edge cracks and start to grow in depth. In summary, the burr region shows more susceptibility to crack initiation than the rollover

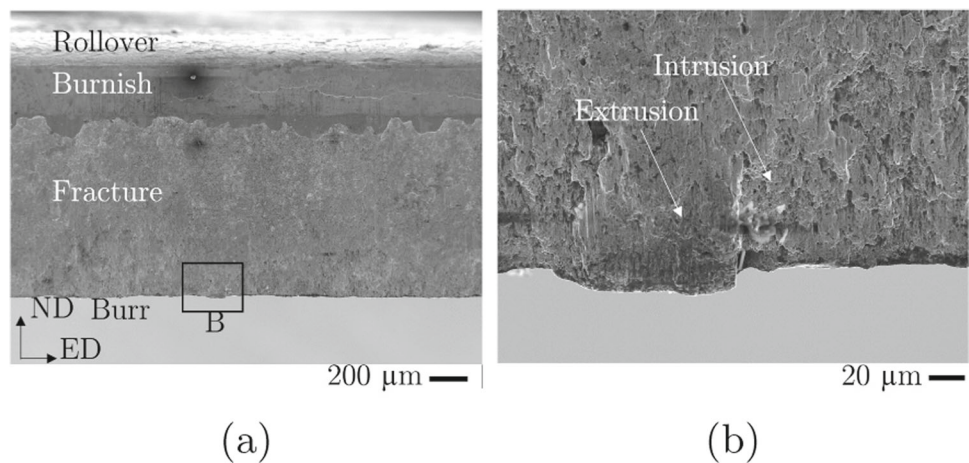
**Fig. 10** Fracture appearance in as-cut condition; a) Material surface at ED-ND plane and, b) Higher magnification from rectangle B. Multiple intrusions and extrusions in the burr region are visible

The rollover, burnish, and fracture regions are apparent in Fig. 10A. The rollover and burnish regions are smooth and shiny. The fracture and burr regions are relatively rough. Some extrusions and intrusions on the surface at the burr region are visible with the help of higher magnification in Fig. 10(b). These extrusions and intrusions caused the highest roughness in this location, as shown in Fig. 10b. These irregularities can be a preferred location for edge crack initiation.

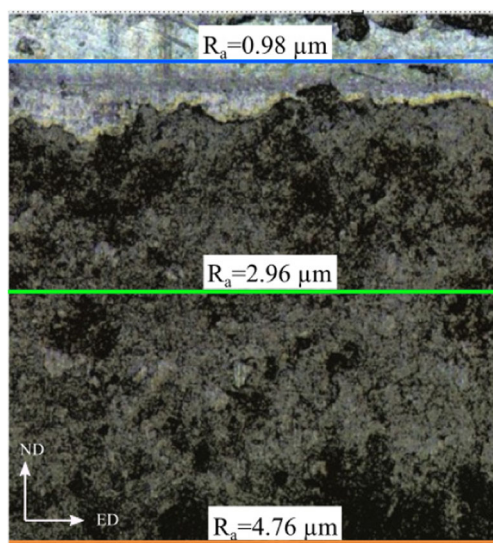
**Fig. 11** Roughness measurement at the top, middle, and bottom of thickness in ED-ND plane of the as-cut sample

Roughness is formed due to geometrical irregularities in the extent of less than 10 μm of the as-cut surface (Fig. 11). Further away from the edge, the first 40 μm of the edge contains the maximum void density (Fig. 13). Finally, the complete SAZ extends to less than 500 μm, as shown in Fig. 16. Since, polishing removes material, it can be used to distinguish the effect of roughness, voids, and plastic deformation on edge ductility. Therefore, samples with varying extend of polishing 10, 40, and 500 μm in the cross edge direction (CED), were compared in the bending test vs. non-polished (as-cut) samples.

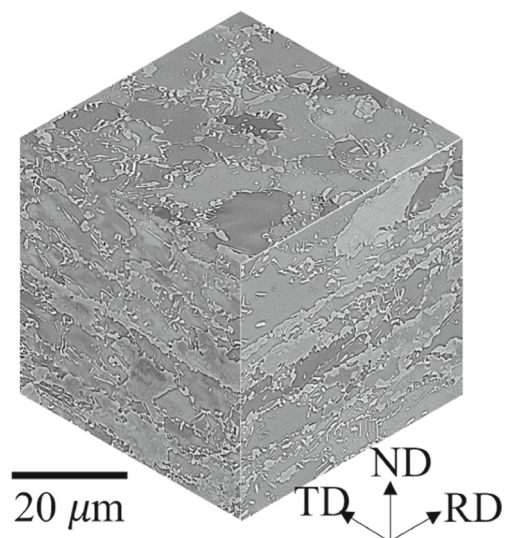
**Fig. 12** Microstructure of DP800 at the mid-thickness. Martensitic bands are evident in the transverse and rolling directions

The microstructure of the undeformed material before cutting in the mid-thickness can be seen in Fig. 12. The constructed

3D image is made from three separate cross-sections in different material orientations. The martensite phase is lighter, while the ferrite is darker. It can be observed that banded martensite is formed in TD and RD due to microsegregation, originating from the casting process [40].

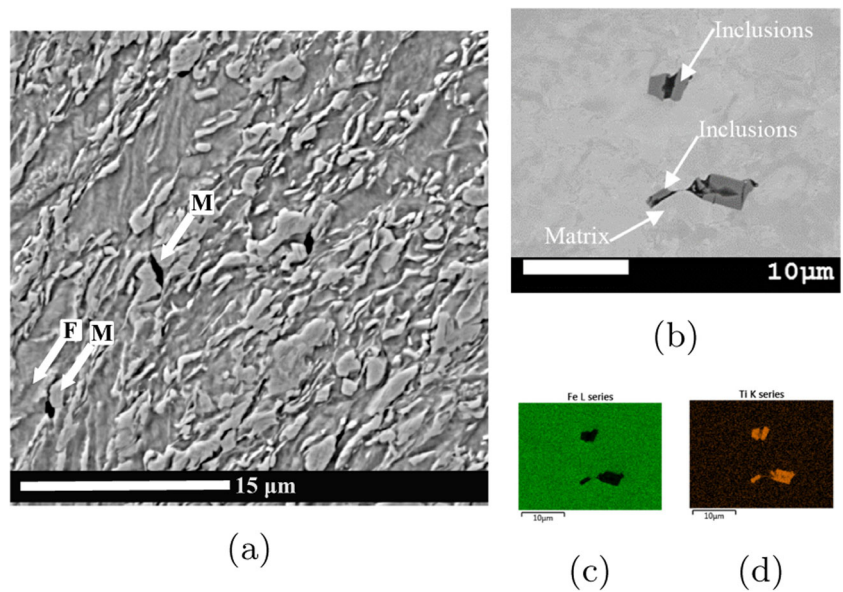
**Fig. 14** Damage mechanism of DP800; a) Separation of ferrite/martensite boundaries and fracture of martensite, b) Fracture and separation of inclusions boundary from the matrix, c) EDS maps for Fe and, d) EDS maps for Ti

The cutting process deforms the banded microstructure with the material flow. Elongated grains are evident in the ND-CED plane of the as-cut sample in Fig. 13. A critical observation is that no voids are present in rolover and burnish regions (Fig. 13(a)). However, the material edge in fracture and burr regions contains many voids (Fig. 13(b) and (c)), especially in the first 40 μm of the edge. Different mechanisms for void nucleation were observed. The majority of voids are a result of martensite cracking and separation of ferrite–martensite interfaces (Fig. 14(a)). The minority of voids are due to fracture of inclusions and their boundary separation from the matrix (Fig. 14(b) to (c)).

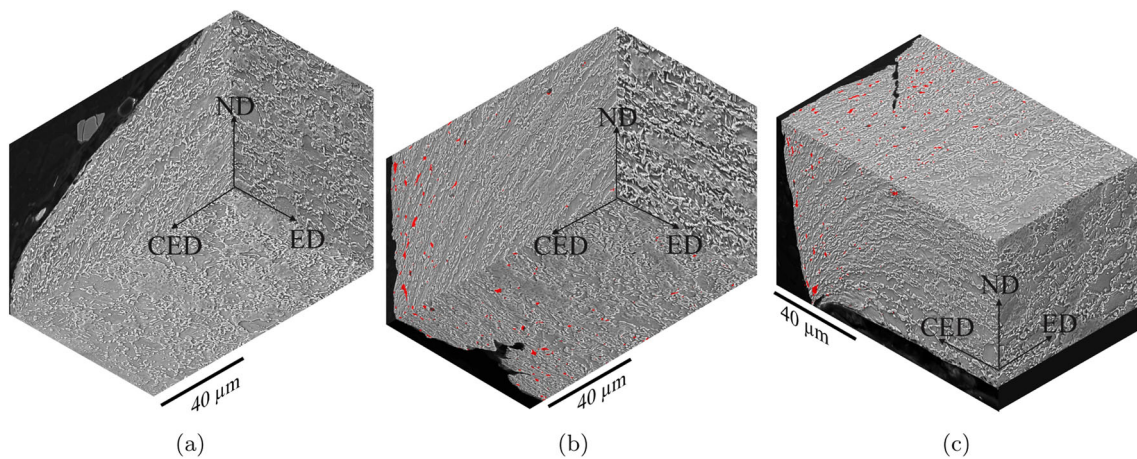
**Fig. 15** As-bent sample; a) Rollover and burnish regions; b) Fracture region c) Burr and fracture regions

The shear cut edge creates an inhomogeneous distribution of voids over the thickness. Then, the in-plane bending test deforms further the shear cut edge. Figure 15 shows the as-bent micrograph in different areas of the material edge. Further deformation during the in-plane bending test did not activate the void nucleation mechanism in rolover and burnish regions (Fig. 15(a)). However, many voids are present in Fig. 15(b) and (c) close to the material edge in the fracture and burr regions. Furthermore, micro-cracks that did not pass the entire thickness of the sheet can be seen in the fracture and burr regions.

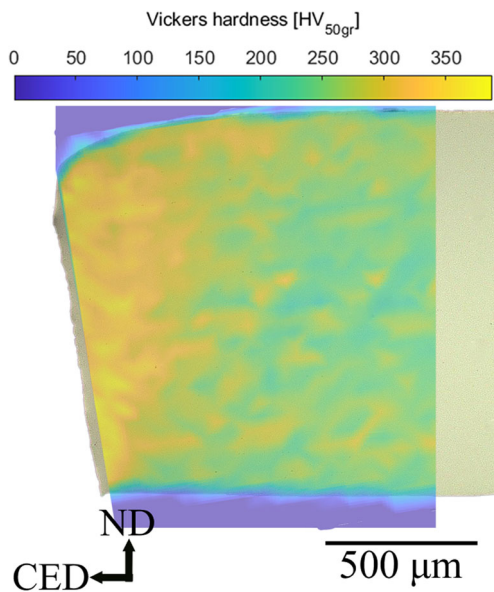
**Fig. 16** Overlay of the hardness map onto the edge macrograph in the ND-CED plane for the as-cut sample

section (ND-CED plane), is reported in Fig. 16. Hardness at the edge is maximum, as expected. Performing microhardness tests in a relatively big area provided the global shape of SAZ, and it shows that the maximum size of the affected area is less than 500  $\mu\text{m}$ . EBSD technique is employed in the following sections to reveal the plastic deformation locally at the material edge, which is not feasible with microhardness test due to required safe distance from the edge.

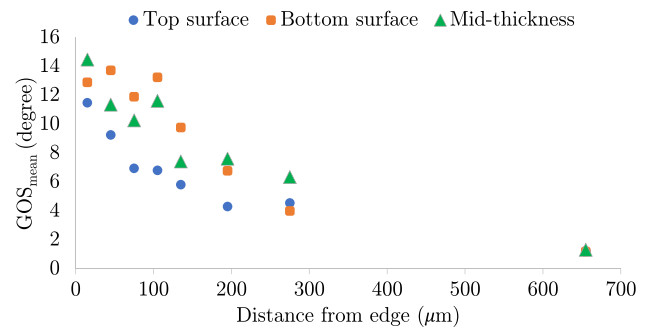
**Fig. 18**  $GOS_{mean}$  vs. distance from the edge after shear cutting as indicator for plastic deformation

The GOS values increase close to the edge of the material. The SAZ is smaller on the top side, close to the rollover and burnish regions. The rotation of grains toward material flow is also evident, while the grains remain more equiaxed far from the material edge. The calculated  $GOS_{mean}$ , based on Sect. 3.3 on a  $22\ \mu\text{m} \times 29\ \mu\text{m}$  square region, is reported in Fig. 18.  $GOS_{mean}$  magnitudes in mid-thickness and at the bottom are higher than the top edge. In summary, the EBSD result indicates that the top surface (rollover and burnish regions) is less plastically deformed than the rest of the edge; which is in agreement with the volume fraction of voids observed in section 4.2.2.

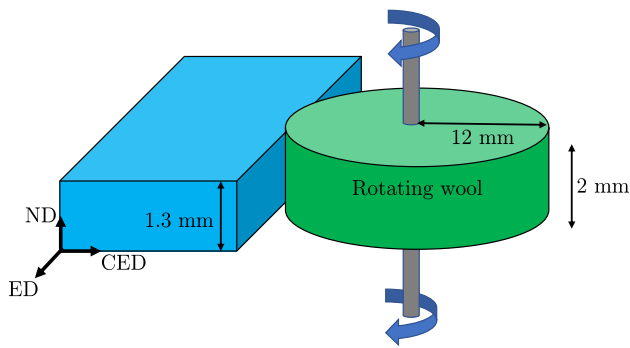
Fig. 19 Schematic of the edge polishing process

It is essential to have a controlled process that uniformly removes material from the edges, considering that the edge surface is not flat. Figure 19 illustrates the use of a Dremel tool equipped with a rotating wool wheel (12 mm radius and 2 mm thickness) to apply an abrasive paste starting from 6 μm particle size and subsequently decreasing it to 0.25 μm. The rotating wool was chosen to be thicker than the material to ensure it covers the entire thickness and uniformly removes material from the edge. The amount of material removal was controlled under a light microscope at 200× magnification with respect to the distance between the material edge and a reference point far from the edge. The polishing process provided a uniform roughness ( $R_a=0.2 \mu\text{m}$ ) while preserving the shape of the edge, as shown in Fig. 20. It can be seen that the burnish region is the highest in both samples.

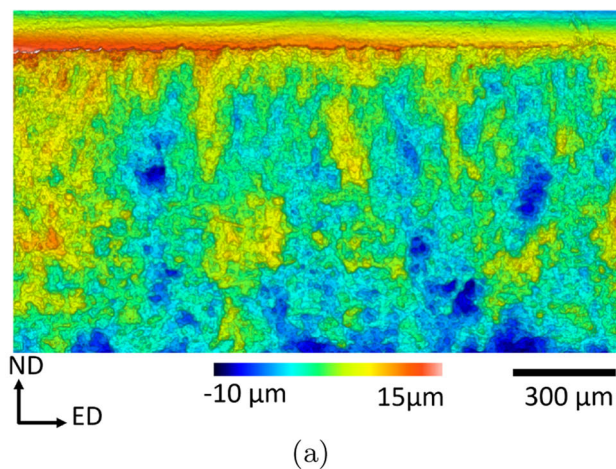
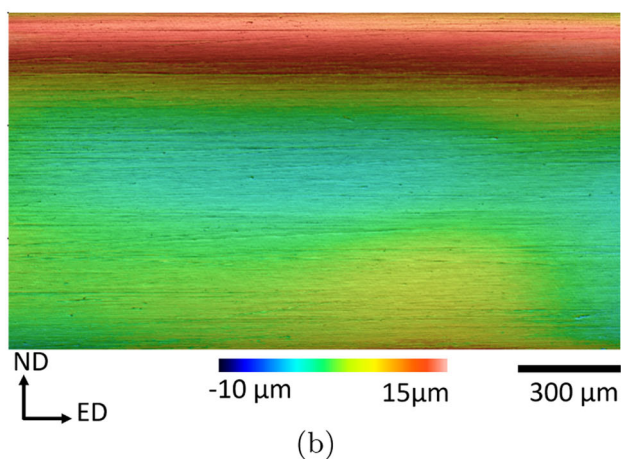
Fig. 20 Height profile of the edge surface in ED-ND; **a** As-cut sample and **b** As-polished sample

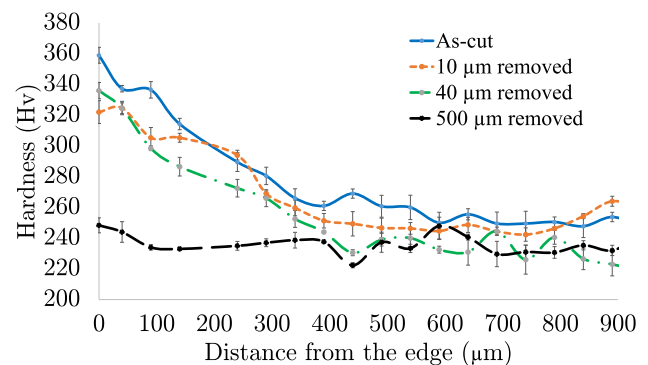
Fig. 21 Microhardness in CED from the edge of as-cut and polished samples

The microhardness test at the CED was performed to verify that the polishing process was completed as intended in Section 4.3.1. Figure 21 confirms that the SAZ is fully removed

in the 500  $\mu\text{m}$  polished samples, while SAZ is present in the rest of the samples. Microscopy investigation shows that removing 10  $\mu\text{m}$  of the as-cut sample (Fig. 22(a)) smoothed the rough edge (Fig. 22(b)), while the layer of voids and the rotated grains are still present. Further material removal to 40  $\mu\text{m}$  in Fig. 22(c) only eliminated the voids and roughness while keeping the deformed grains and SAZ at the edge of the material. It confirms that the polishing process was performed as intended.

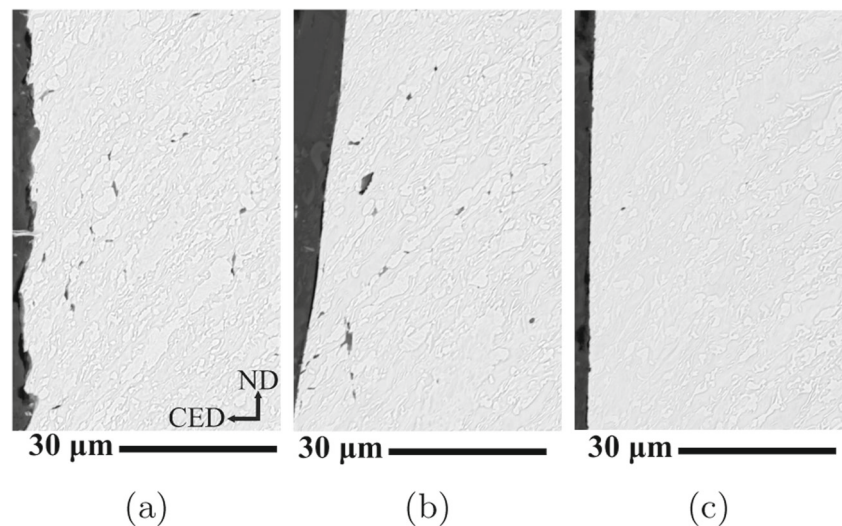
**Fig. 22** SEM image in the CED-ND plane of a) as-cut, b) 10  $\mu\text{m}$  polished, and c) 40  $\mu\text{m}$  polished samples. The images were taken from the middle of the thickness at the edge

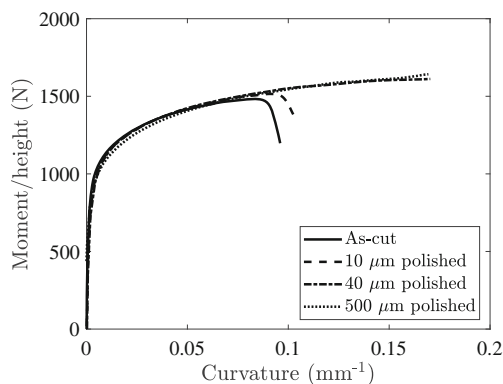
**Fig. 23** The moment-curvature diagram during the in-plane bending test for the as-cut sample with and without polishing

The bending test on polished and as-cut (non-polished samples) was used to determine the dominant mechanism behind edge cracking. The as-cut sample broke in the early deformation stage during the subsequent in-plane bending test at fracture strain of  $0.22 \pm 0.02$ . The smoothed samples (10  $\mu\text{m}$  polished) also failed, but at a slightly higher strain ( $0.25 \pm 0.02$ ) than the as-cut samples, as shown in the

moment-curvature diagram of Fig. 23. It can be concluded that the roughness has a very small effect on edge ductility.

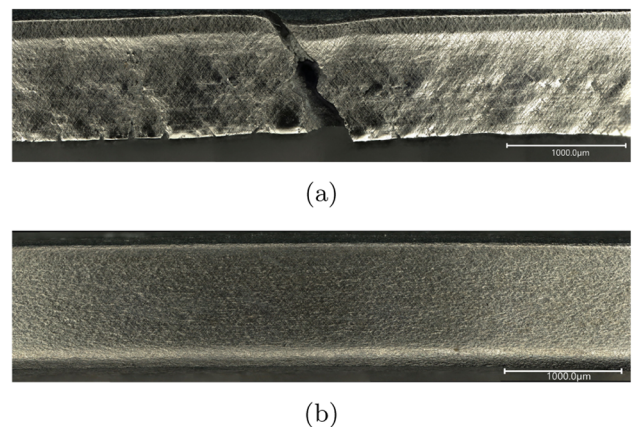
**Fig. 24** Edge appearance of 10  $\mu\text{m}$  and 40  $\mu\text{m}$  polished samples in ED-ND plane after bending test

The samples without initial voids (40  $\mu\text{m}$  polished) did not fail until the maximum achieved deformation of the test. The edge experienced around twice more stretch (true strain =  $0.42 \pm 0.02$ ) than the as-cut sample. The edge is still free of any microcrack, even in the burr region as shown in Fig. 24, and this is a significant improvement. Therefore, the first 40  $\mu\text{m}$  of the cut edge has the most critical influence on edge ductility. This region has voids and the highest values of hardness. These results give a strong indication that voids play the most important role in edge cracking. Combined with high hardness around them, they promote crack nucleation. Hardness, however by itself does not seem to form cracks. This can be justified by the huge jump in fracture strain from 10  $\mu\text{m}$  to 40  $\mu\text{m}$  polishing. If hardness was the main factor, a more gradual change would be expected; since there is still hard material in the remaining portion of the edge.

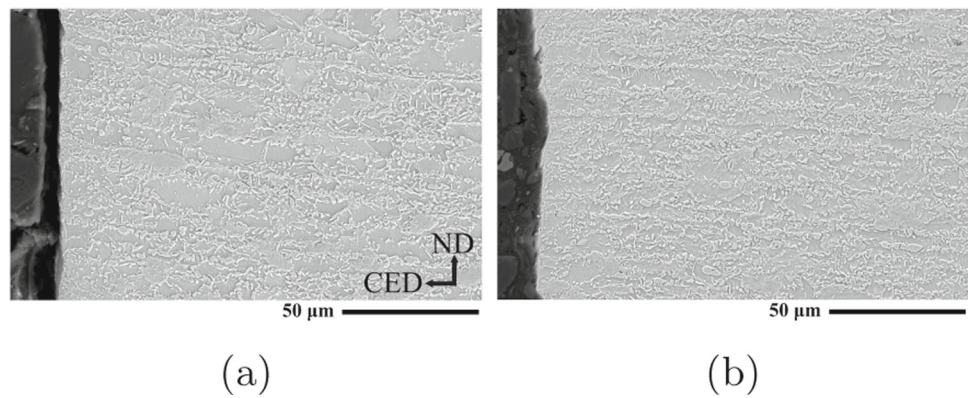
**Fig. 25** The cross-section of 500  $\mu\text{m}$  polished sample in CED-ND; a) Before bending test and b) After bending test

By removing 500  $\mu\text{m}$  from the edge all effects from shear cutting are eliminated, leaving only the base metal, as shown in Fig. 25(a). Therefore, it can be considered a reference edge. The 500  $\mu\text{m}$  polished sample did not fail during the in-plane bending test. The edge of the reference sample after the bending test is presented in Fig. 25(b). It demonstrates that the plastic deformation during the in-plane bending test is insufficient for the void nucleation mechanism in a uniaxial stress state close to the edge. At the same time, this plastic deformation is more than enough to grow and coalesce the initial voids produced by cutting in the shear stress state, causing the micro-cracks on the edge of the sample.
