Measuring instantaneous angular speed using a gear wheel as material measure to detect pitting damage during an endurance test

Yanik Koch¹ · Julian Hirschmann² · Eckhard Kirchner¹

Received: 20 March 2023 / Accepted: 20 May 2023 / Published online: 15 June 2023
© The Author(s) 2023

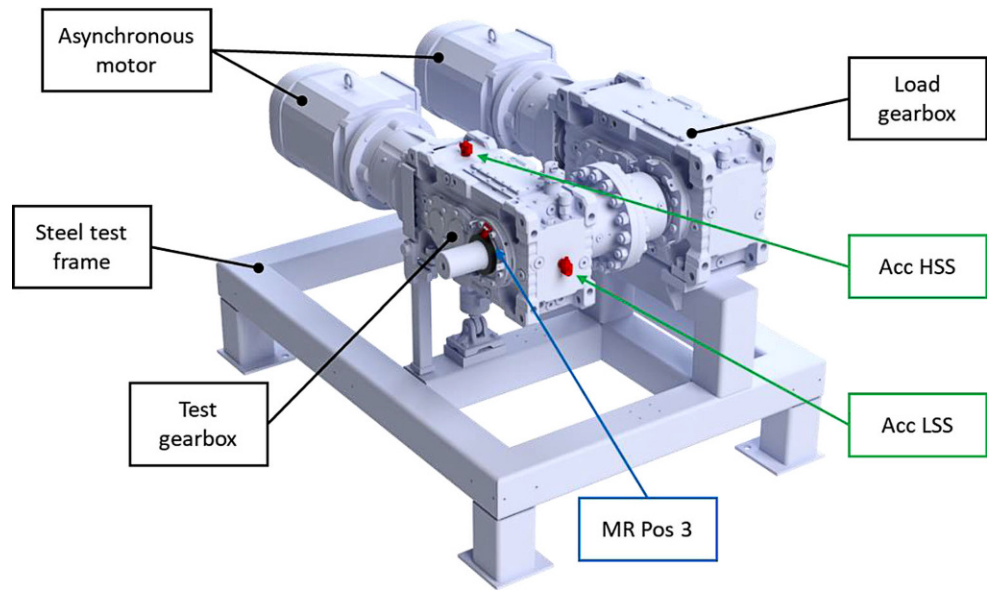
Fig. 1 Back-to-back test stand

A 3-stage gearbox of the X series (X3KR100, SEW-Eurodrive), size 100, is being tested, see Fig. 1. The test gearbox has one bevel gear stage and two helical gear stages. The test gearbox is mounted to the steel test bench via a torque arm. A force-measuring sensor is integrated into this torque arm to monitor the torque during operation. The output shaft of the test gearbox is connected to the output shaft of the load gearbox (X series of SEW-Eurodrive, size 120) via a flange coupling. The load gearbox is bolted to the steel test bench frame. Both gearboxes are driven by asynchronous motors of the DRN series (SEW-Eurodrive)

and controlled by frequency inverters of the MOVIDRIVE® B series (SEW-Eurodrive). During the test, the test gearbox is regulated to a constant speed of 1500rpm with a high overload to create fatigue pitting damage within 2000 operating hours.

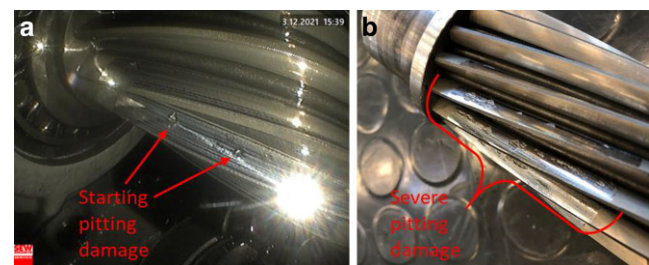
Fig. 2 Fatigue pitting damage of pinion Z4; a endoscopy during the endurance test; b after the endurance test

The MR sensors used are provided by Sensitec. During the endurance test, the analogue sine and cosine signals of the MR sensors (MR Pos 3, MR Pos 4, MR Z1, MR Z3, MR B) are time-synchronous recorded with an imc CRONOSflex measuring system. The signals are sampled every 8h for a duration of 60s at 50kHz and stored locally. In addition, the HS150 IEPE acceleration sensors from Hansford are sampled with the DriveRadar® IG Edge Processing Unit from SEW-Eurodrive every 60min for a duration of 30s at 50kHz and transferred to a cloud system. An overview of the data acquisition equipment is shown in Table 1. During the endurance test, endoscopies are carried out several times to document the progress of the damage. First fatigue pitting damage is detected by an endoscopy, see Fig. 2a. After the

endurance test, the gearbox is decomposed and the damages are documented. Figure 2b shows significant fatigue pitting damage along the whole tooth flank of pinion Z4 at multiple teeth.

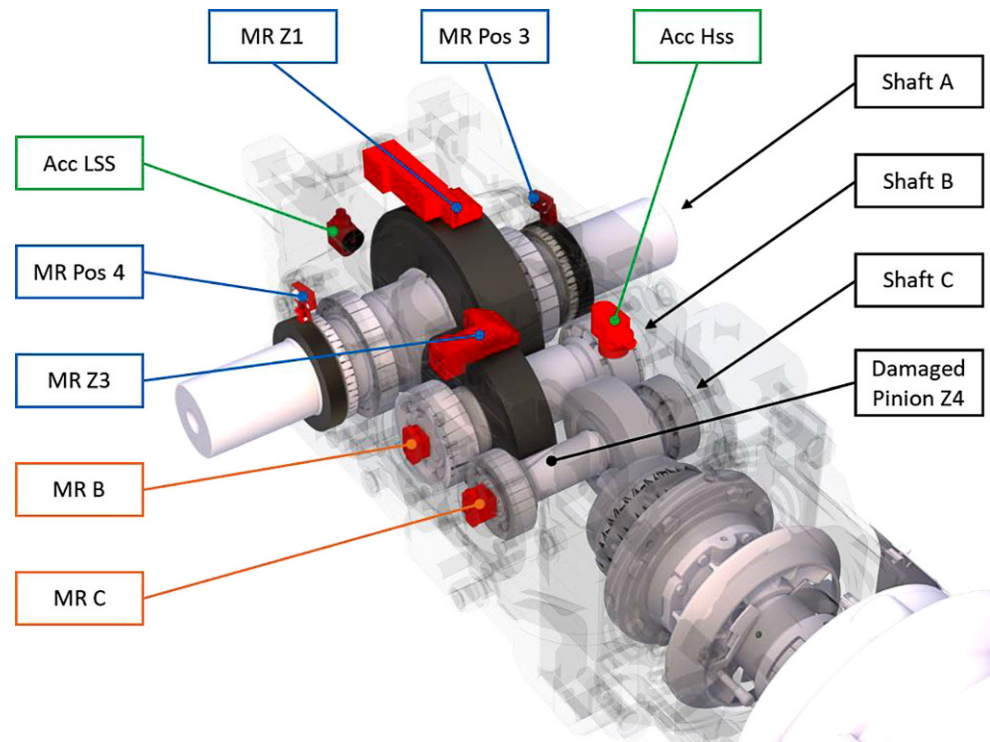
Fig. 3 Transparent test gearbox with integrated sensors

For the description of the integrated sensors the housing of the gearbox is shown transparently in Fig. 3. The helical gear wheels are consecutively named starting at shaft A with Z1 to the damaged pinion Z4. This naming convention is also used for the GMF for further evaluations GMF Z34 is relevant, which is the meshing of the damaged pinion Z4 with the gear wheel Z3. The integrated sensors are grouped into three classes:

1. Acceleration sensors mounted onto the housing (green frame in Fig. 3)
2. Magnetostrictive sensors using a gear wheel as a material measure (blue frame in Fig. 3)
3. Magnetostrictive sensors using an encoder magnet glued to the shaft end as a material measure (orange frame in Fig. 3)

Two acceleration sensors are glued to the gearbox housing. One at the high-speed shaft (HSS) near shaft C, which is named Acc HSS and one at the low-speed shaft (LSS) near shaft A, which is named Acc LSS.

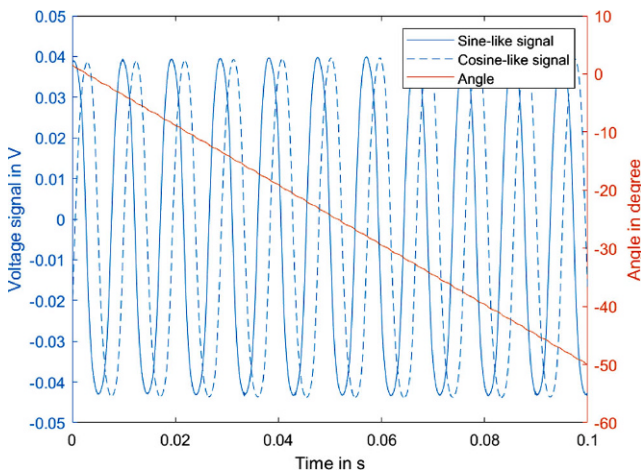
Fig. 4 Raw signal acquired with MR Z3 and calculated angle

Figure 4 shows the two sine-like raw signals of Sensor MR Z3. Due to the phase shift of 90° one signal is called sine and the other cosine. One signal period represents one tooth of the gear wheel. The raw signal is scaled to -1 and 1 to calculate the angle φ using the atan2-function, see Eq. 1 [6]. The angle is then derived by the time to calculate the instantaneous angular speed (IAS), see Eq. 2. To evaluate the speed fluctuations caused by fatigue pitting damage a spectrum analysis is carried out using the IAS.

When evaluating the angle signal in Fig. 4 oscillating deviations are visible. These deviations are nearly 2 degrees. These deviations can not be explained by mechanical fluctuations of the meshing gears. The signal differs from a real sine. It has an M-W-structure, which indicates mounting deviations of the signal caused by the tooth geometry. Tooth-specific influences are shown in the first tests by Koch et al. 2022 [1]. These deviations are equal to fluctuations in the revolution speed. Therefore, influence the frequency spectrum a phase and amplitude excitation similar to the GMF, which causes a rise in the corresponding amplitudes. For

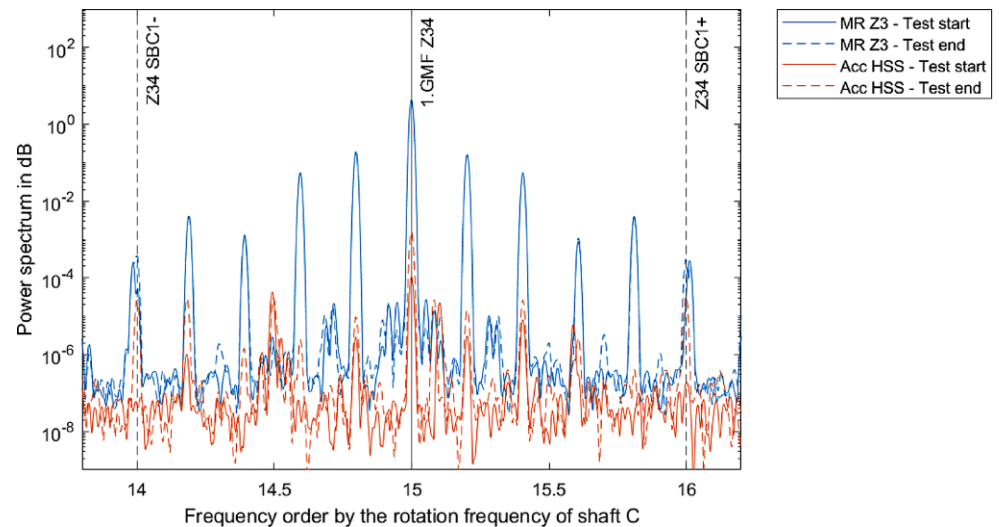
Fig. 5 Power spectrum of sensors MR Z3 and Acc HSS around the first order of GMF Z34 and the first sidebands

To evaluate the change resulting from the tooth flank fatigue damage, the GMF and first sidebands of sensors MR Z3 and Acc HSS are analysed in Fig. 5 at the start and end of the endurance test. First, the power spectrum of sensor MR Z3 is analysed. The GMF does not show an increase between the start and end of the endurance test. This is caused by the high excitation of the raw signal by mounting and per tooth deviations, which superimposes the damage-dependent rise of the GMF. The rise of the GMF amplitude of sensor Acc HSS is two orders of magnitude lower than the rise of sensor MR Z3, which shows that the amplitude rise due to the damage might not be detectable at the GMF at such a high rise. Furthermore, there are high amplitudes around the GMF modulated by shaft frequency B. The first damage-relevant sideband (modulated with shaft frequency C) is near to the 5th sideband modulated by shaft frequency B and so influenced by it. But still distinguishable as the rise between the start and the end of the endurance test show. At the first sidebands, a clear rise of the amplitude from sensor Acc HSS is visible. This shows that damage can be detected with sensor Acc HSS. As there is no clear rise of the GMF for sensor MR Z3, because of the high excitation due to the measurement concept, but a rise of the first sidebands, the capabilities to detect the damage is ambiguous, when evaluating the GMF. Therefore, in the following multiple sidebands are analysed.

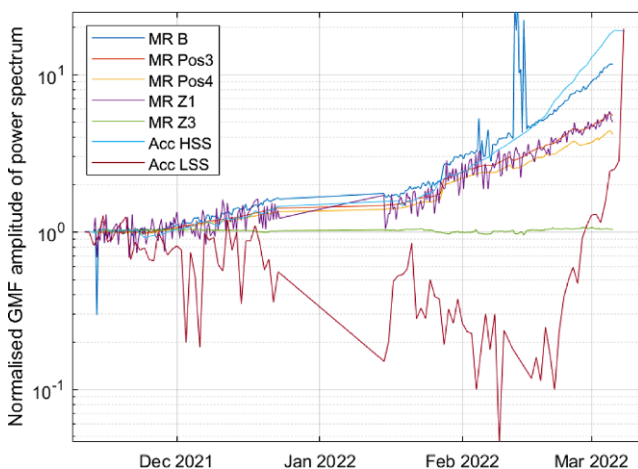
Fig. 6 Relative rise of GMF amplitude for all sensors during the endurance test

The next step is to the analysis the relative rise of the GMF over the endurance test for all sensors. The tests were paused between mid-December and mid-January, which is

visible in the horizontal progress for this period. The amplitudes are normalised to compare the relative rise of the amplitudes. Therefore, the first value of the test is set as a reference and all amplitude values of further measurements are divided by this reference value. These values are plotted against the endurance test time in Fig. 6. As discussed above the GMF of MR Z3 does not show a rise. But all the other sensor concepts show a significant rise of the GMF amplitude relative to the reference value, which indicates that tooth flank fatigue damage can be detected with all these sensors. When looking at the MR sensors it is visible that the amplitude of MR B rises the most and the rise of MR Pos 3, MR Pos 4 and MR Z1 are similar. The longer transfer path can cause this because the damage signal is transferred from the damage at gear wheel Z4 through the meshing of Z1 and Z2 to these sensors. Furthermore, these sensors are at a shaft with a lower revolution frequency and have fewer sine-like waves per revolution, which causes

a lower accuracy. When comparing the sensors MR Pos 3 and MR Pos 4 with MR Z1 it is also visible that MR Z1 has a higher noise during the test. This can be traced back to the lower amount of teeth and the reduced accuracy of the gear wheel as the gear wheels of MR Pos 3 and MR Pos 4 are manufactured as material measure and gear wheel Z1 to transmit torque and speed. Also, similar deviations due to mounting and per tooth deviations are visible at MR Z1 as at MR Z3.

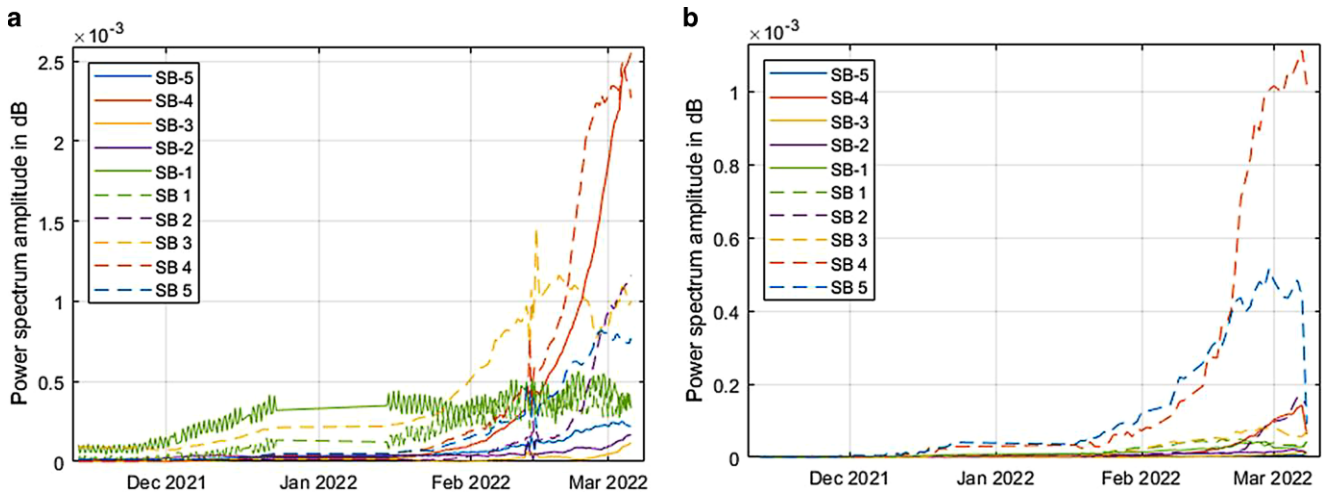
Fig. 7 Absolute rise of five sidebands below and above GMF Z34 modulated by shaft frequency C over the endurance test; **a** sensor MR Z3; **b** sensor Acc HSS

Figure 7 shows the plots of the five sidebands surrounding GMF Z34 modulated by the shaft frequency C. Starting at the first measurements in December 2021, it is visible that most of the amplitudes of MR Z3 are higher than the ones of Acc HSS. This is caused by the mounting and per tooth deviations described in Chapter “Data evaluation”. These effects are sensor-specific and have to be taken into account when analysing the damage dependency. The highest risen sideband amplitude is the one of SB 4 for both sensors, which shows that this effect is caused by the meshing of the gears and is not a sensor effect of MR Z3 nor Acc HSS. The amplitude values of MR Z3 are higher than for Acc HSS. This can be caused by the measuring position closer to the damage, but can also be a sensor immanent effect and has

to be further evaluated in future tests. Another difference is that for MR Z3 sideband SB –4 rises nearly equal to SB 4, but for Acc HSS the rise is not that high, which could be caused by interference due to the transfer path to Acc HSS. Nevertheless, all sidebands rise during the endurance test, which shows the influence of the damage on the sidebands. However, the difference in the rise is unclear and should be focused on by future tests, so that cause and effect of the rise can be explained, what is necessary for using the sidebands for monitoring of gears.

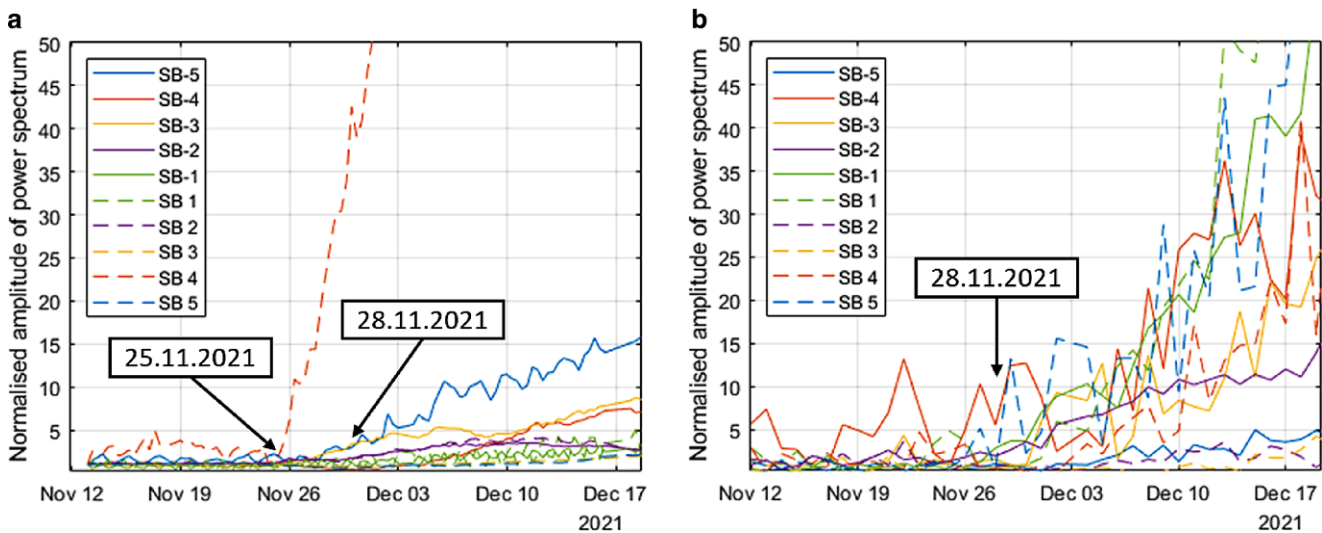
Fig. 8 Relative rise of five sidebands below and above GMF Z34 modulated by shaft frequency C at the beginning of the damage; **a** MR Z3; **b** Acc HSS

In the next step, the beginning of the damage is analysed. For a better comparison, the relative rise of the sidebands is used for the evaluation. Therefore, the first value is set as a reference and all future values are divided by this reference value. The first rise of Sensor Z3 is at 25. November

2021, which is 2 days earlier than the first rise of Acc HSS, Fig. 8. Only one sideband rises this early and it has to be further explored and understood why this sideband rises to interpret this rise as a beginning fault. Also, the relative rise varies highly between the sidebands for MR Z3, which is also influenced by the strong modulation effects due to mounting and per tooth deviations. For Acc HSS multiple sidebands start to rise with a similar amplitude at 28. November 2021, which is a clear indicator of damage.

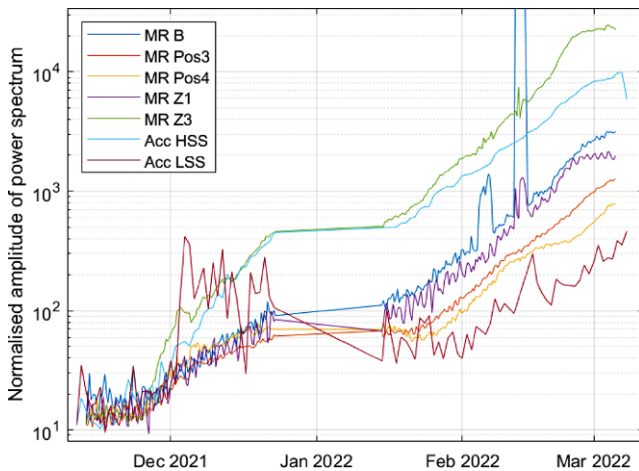
Fig. 9 Sum of normalised sideband amplitude of power spectrum for all sensors over endurance test

Nevertheless, a clear rise in these features is visible using the data of all sensors, see Fig. 9. When looking at the MR sensors it is visible, that MR Z3 has the highest rise, followed by MR B and MR Z1, which are almost equal. This can be caused by the higher resolution of MR Z1 of 73 teeth compared to one pole per revolution for MR B. In contrast, a higher rise of MR Pos 3 and MR Pos 4 compared to MR Z1 can be expected as they have 250 teeth and are mounted at the same shaft. The evaluation of the acceleration sensors shows clearly a higher rise of Acc HSS compared to Acc LSS, which shows the influence of the transfer path. Summarised, the influence of the transfer path is visible but still superimposed due to different sensor properties.

The reliability of the feature and the capability for condition monitoring is shown by the stability of the feature value after a long standstill of the test between the end of December and the middle of January.
