# HVOF and Laser-Cladded Fe–Cr–B Coating in Simulated Biomass Combustion: Microstructure and Fireside Corrosion

**Abstract** Biomass is often considered as a low carbon alternative to fossil fuels in the power industry. However, the heat exchangers in biomass plants can suffer from chloride-based aggressive fireside corrosion. A commercially available amorphous Fe–Cr–B alloy was deposited onto a stainless steel substrate by HVOF thermal spray and laser cladding. The controlled environment corrosion tests were conducted in a HCl-rich environment at 700 °C for 250 h with and without KCl deposits. The samples were examined with XRD, SEM and EDX mapping to understand the corrosion mechanisms. In the absence of any deposits, the amorphous HVOF coating performed very well with a thin oxide growth, whereas the crystalline laser cladding suffered from ~350 µm metal loss. The scales were composed of MnWO<sub>4</sub>, Fe<sub>2</sub>O<sub>3</sub>, Fe<sub>3</sub>O<sub>4</sub> and Cr<sub>2</sub>O<sub>3</sub>. When a KCl deposit was present, the HVOF-sprayed coating delaminated from the substrate and MnCl<sub>2</sub> was found in the scale.

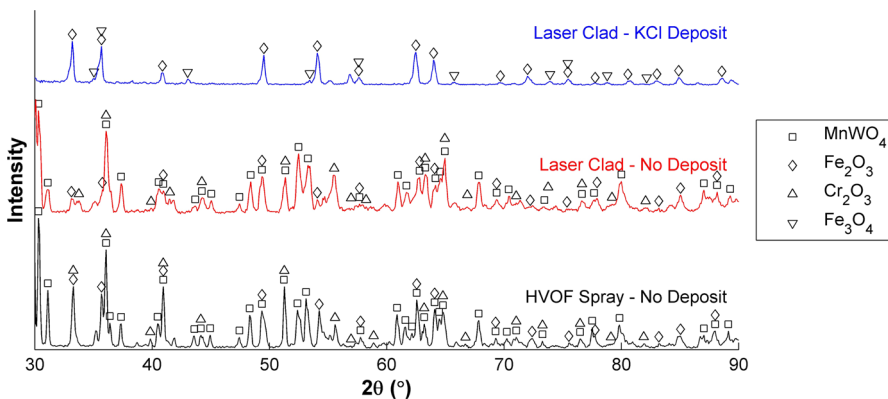
XRD analysis of the exposed coatings is shown in Fig. 4. The integrity of the HVOF-sprayed coating with KCl deposit was poor, and it was not possible to use XRD on that sample. Both the HVOF-sprayed and laser-clad samples showed strong reflections from  $\text{MnWO}_4$ , when no deposit was present. This oxide was not detected on the surface of the laser cladding with a KCl deposit.  $\text{MnWO}_4$  reacts with gaseous  $\text{Cl}_2$  to form  $\text{MnCl}_2$  and  $\text{WO}_2\text{Cl}_2$  [17]. No chlorides were detected on the surface of the samples without any deposit, suggesting that HCl from the gas did not react to form chlorides, and instead the KCl deposit was providing the gaseous  $\text{Cl}_2$  needed for the removal of  $\text{MnWO}_4$ .  $\text{Cr}_2\text{O}_3$  is another phase that was observed in both the HVOF-sprayed and laser-clad samples without any deposit, but not when KCl was present. The phase most dominant across all of the samples, however, was  $\text{Fe}_2\text{O}_3$ . On the laser-clad sample with the KCl deposit, the only other major phase identified other than  $\text{Fe}_2\text{O}_3$  was  $\text{Fe}_3\text{O}_4$ . It is well established that  $\text{Fe}_2\text{O}_3$  and  $\text{Fe}_3\text{O}_4$  are much less protective than  $\text{Cr}_2\text{O}_3$ . This suggests when KCl was involved the clad material, with 25 wt% Cr, failed to form a protective chromia layer.

**Fig. 4** XRD of HVOF and laser-clad samples after exposure
