# Behavior of Laterally Damaged Prestressed Concrete Bridge Girders Repaired with CFRP Laminates Under Static and Fatigue Loading

**Abstract:** Many bridges are subject to lateral damage for their girders due to impact by over-height vehicles collision. In this study, the optimum configurations of carbon fiber reinforced polymers (CFRP) laminates were investigated to repair the laterally damaged prestressed concrete (PS) bridge girders. Experimental and analytical investigations were conducted to study the flexural behavior of 13 half-scale AASHTO type II PS girders under both static and fatigue loading. Lateral impact damage due to vehicle collision was simulated by sawing through the concrete of the bottom flange and slicing through one of the prestressing strands. The damaged concrete was repaired and CFRP systems (longitudinal soffit laminates and evenly spaced transverse U-wraps) were applied to restore the original flexural capacity and mitigate debonding of soffit CFRP longitudinal laminates. In addition to the static load tests for ten girders, three more girders were tested under fatigue loading cycles to investigate the behavior under simulated traffic conditions. Measur

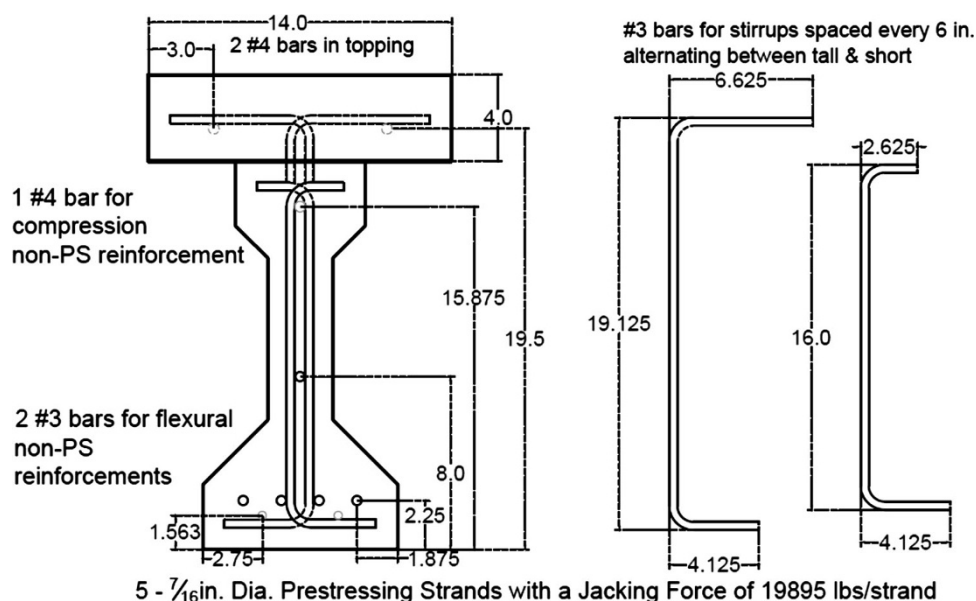
**Fig. 1** PS test girder cross-section and reinforcements (dimensions in inch; conversion: 1 in. = 25.4 mm).

6 in. (150 mm) alternating between the two height sizes, providing nearly the maximum amount of shear reinforcement for the cross-section. The girders were designed to be heavily reinforced in shear in order to avoid any premature shear failure that could jeopardize the test results and the investigations into the debonding issues. Figure 1 presents the details of the girder cross-section and the reinforcements.

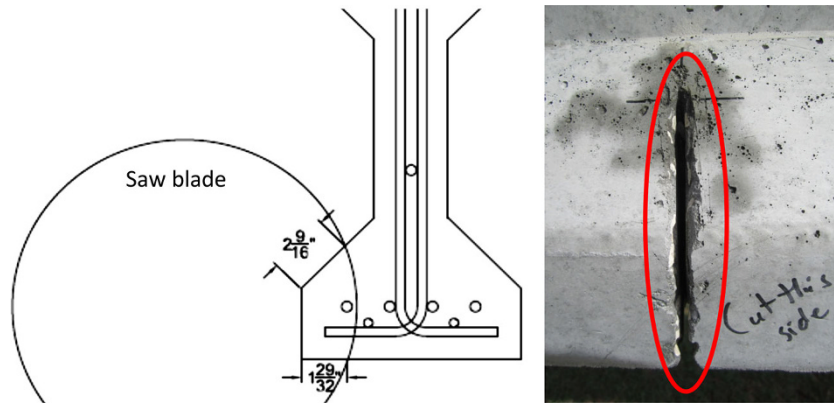
**Fig. 2** (left) Diagram of sawing used to simulate damage in the girders; (right) photo showing resulting cut in actual girder sample (conversion: 1 in. = 25.4 mm) .

The lateral damage simulation was achieved by sawing through the concrete of the bottom flange and slicing through one of the prestressing strands. A schematic of this procedure and a picture of the resulting cut are shown in Fig. 2.

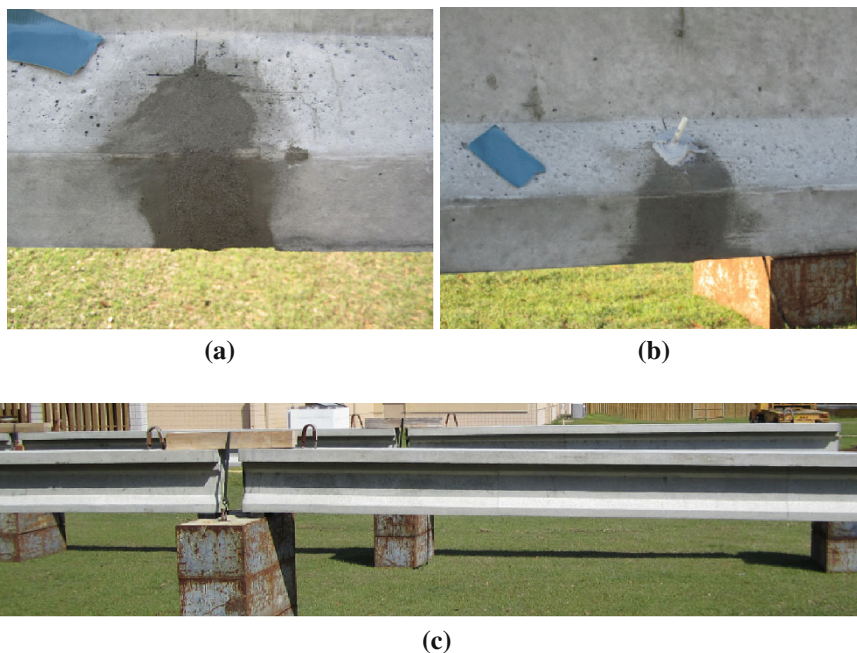
**Fig. 3** Concrete repair of girders with cut strands and damaged concrete. a Cementitious repair mortar. b Epoxy injection. c Repaired half-scale girders.

To repair the cut, the surfaces exposed by cutting were first roughened with chisels to improve bonding quality. These surfaces were then thoroughly cleaned with a water jet and pressurized air, as specified in both NCHRP 514 (NCHRP R-514) and ACI 440.2R-08. The cleaned cut was filled with a high-strength cementitious repair mortar (Fig. 3a), and a high-pressure epoxy injection procedure was performed after the mortar set (Fig. 3b). The procedure resulted in a perfect repair of the concrete cross-section, as shown in Fig. 3c.

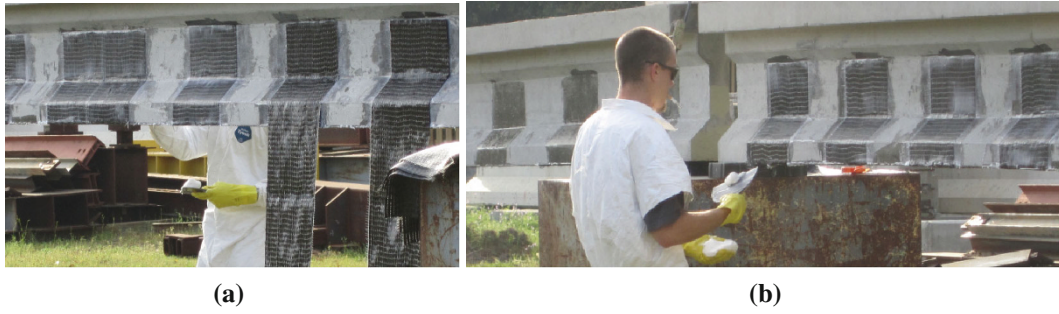
**Fig. 4** Wet layup application of CFRP fabric laminates on PS girder. **a** Wet layup application of CFRP. **b** Applying epoxy to CFRP.

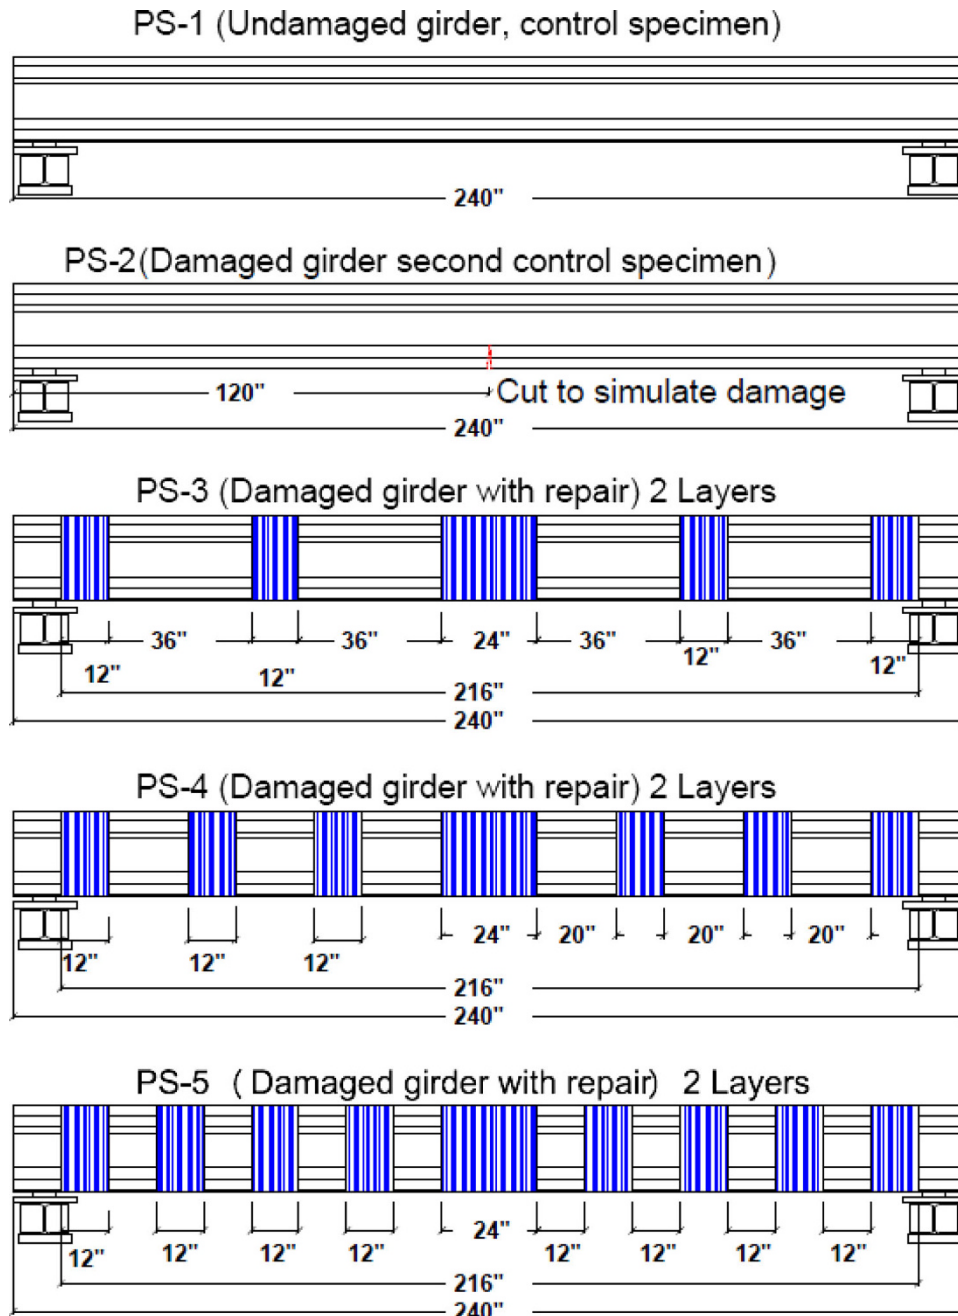
**Fig. 5** CFRP configurations used for tested girders PS-1 to PS-5 (dimensions in inch; conversion: 1 in. = 25.4 mm).

and 6 show the CFRP configurations for the half-scale AASHTO type II girders tested under static loading.

As shown in Fig. 5, girder (PS-1) is a control girder that represents an undamaged and unrepaired specimen. Also, girder (PS-2) is a damaged specimen with sawing through the concrete and slicing through one of the prestressing strands. The girder did not receive any CFRP repair and only had concrete repair, thus representing the lower bound of the tested girders. The remaining girders had both simulated impact damage imposed on them and two layers of CFRP at various spacing to constitute the repair. The spacing between U-wrappings was set at a distance of 12 in. (304.8 mm), 20 in. (508 mm), or 36 in. (914.4 mm). Similarly, Fig. 6 displays the CFRP configurations for the remaining girders tested. The girders (PS-6 through PS-8) were damaged and repaired with three layers of CFRP at the girder soffit and U-wrappings at spacings of 12 in. (304.8 mm), 20 in. (508 mm), or 36 in. (914.4 mm). The

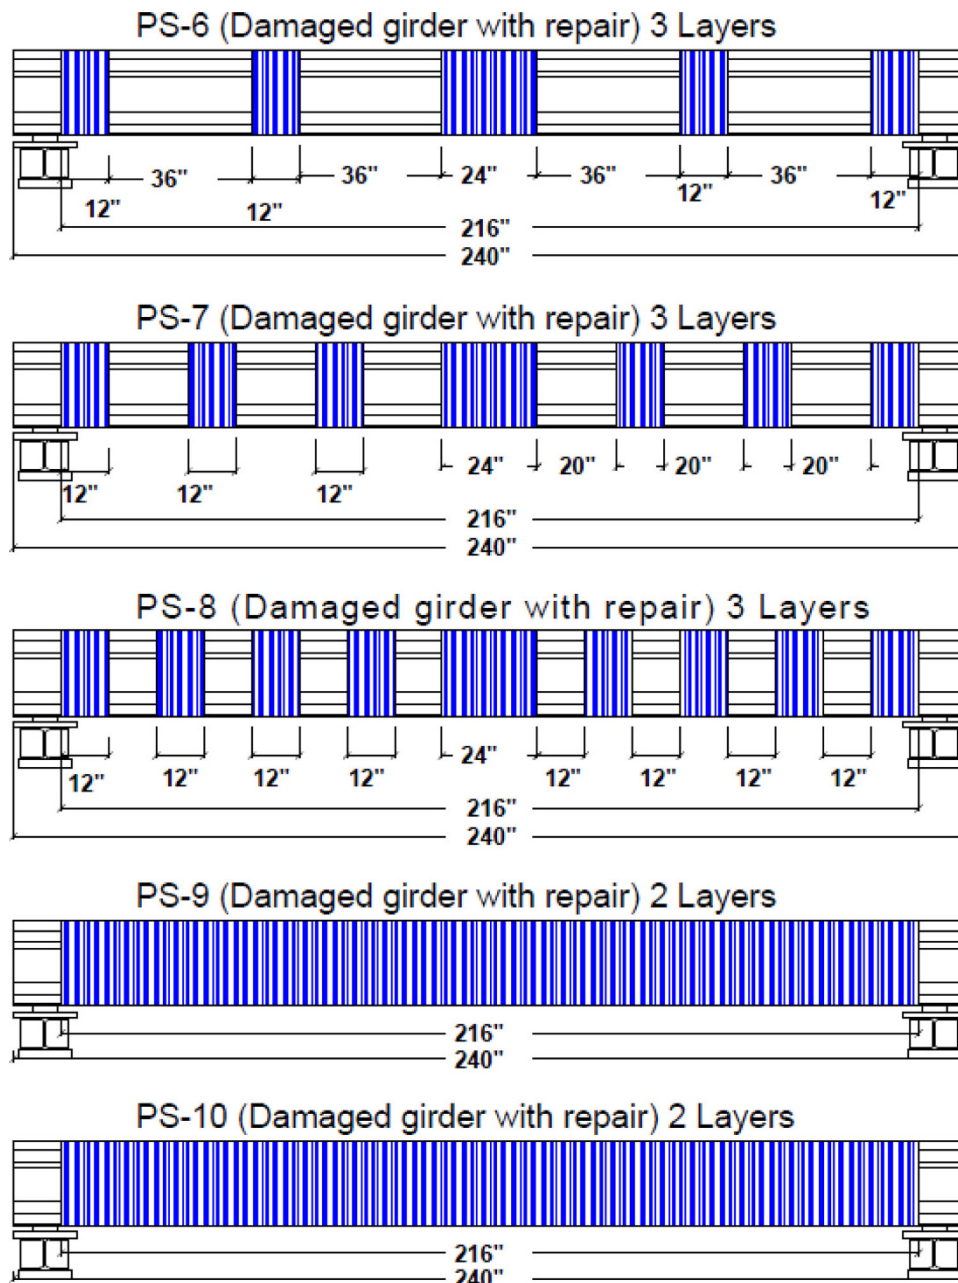
**Fig. 6** CFRP configurations used for tested girders PS-6 to PS-10 in static loading (dimensions in inch; conversion: 1 in. = 25.4 mm).

two girders (PS-9 and PS-10) were fully wrapped girders (U-wrappings covered entire girder) using two layers of CFRP for the repairs (soffit and U-wrapping). However, the

U-wrappings applied to PS-10 were overlapped by an inch (25.4 mm), whereas those applied to PS-9 were not overlapped.

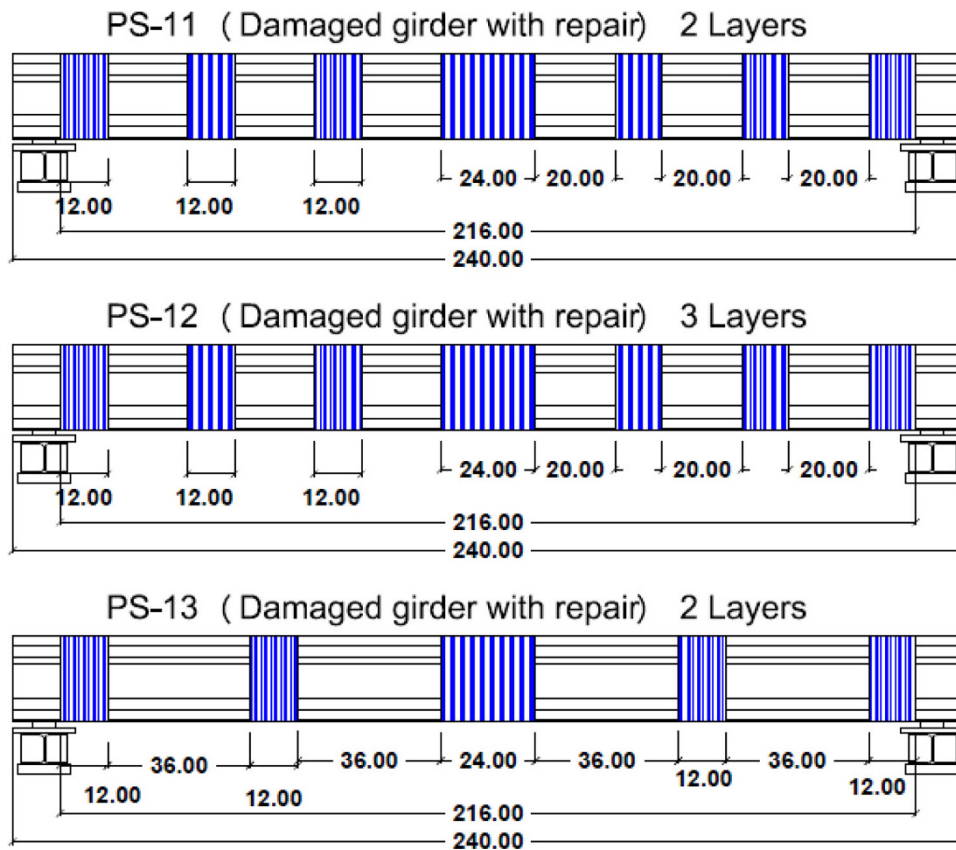
Fig. 7 CFRP repair configuration layout for half-scale PS girders tested in fatigue (dimensions in inch; conversion: 1 in. = 25.4 mm).

Figure 7 shows a sketch of the CFRP configurations used for the three half-scale AASHTO type II girders tested under fatigue loading conditions.

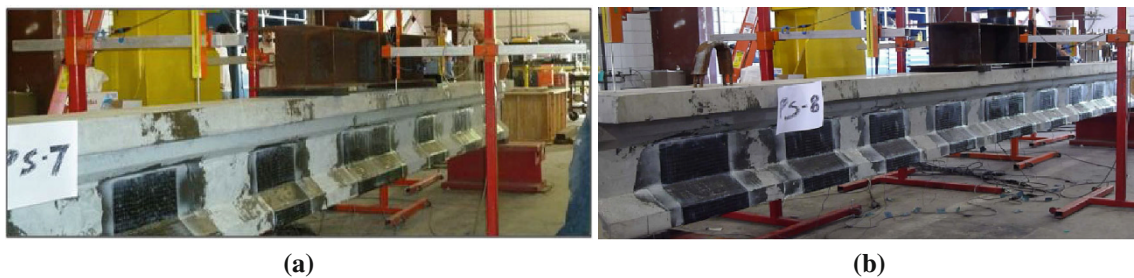
Fig. 8 Girder test setup diagram and photo of specimen during testing. a Static testing of PS-7. b Static testing of PS-8.

the bearing pads which rested on stationary supports. The girder static loading was applied using a steel spreader beam resting on another set of two pads with a center to center distance of 50 in. (1,270 mm). Figure 8a, b show two girders under loading. The four point static load was applied using a 110 kip (489.30 kN) actuator mounted on a steel frame. On the other hand, the fatigue testing was carried out under a three point loading arrangement using MTS dynamic load actuators. The fatigue testing of the AASHTO II girders was performed using a 55 kips (244.66 kN) and a 110 kip (489.30 kN) hydraulic actuators selected based on their large capacity servo valve which permitted testing of the girder using a frequency of 2–4 Hz. The loading contact area was specified by AASHTO (AASHTO 2004). Neoprene pads were used at girder supports to simulate field supporting conditions. Laser and Linear variable differential transformer

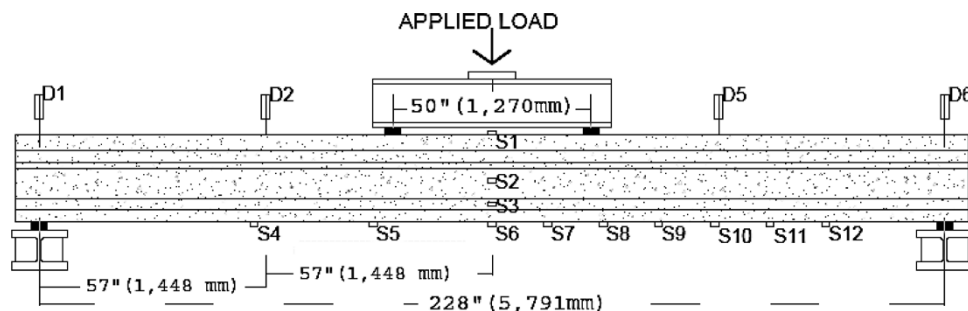
Fig. 9 Schematic of loading set-up and measurement device layouts.

Load measurements were recorded by the actuator. The girders were instrumented with six LVDT deflection gauges and up to twelve strain gauges (30 mm long-120  $\Omega$ ). Two

LVDT deflection gauges were positioned at center span on each side of the girder, two LVDTs were placed at girder top surface above the support areas, and the remaining two LVDTs were placed at quarter points of the girder span. On each girder, four of the strain gauges were placed along the height of the cross-section at mid-span and the remaining

strain gages were distributed along the flexural tension side at various locations depending on the CFRP configuration. The general placements of all measurement devices are shown in Fig. 9. The loading arrangement for the fatigue test setup for the half-scale girders is shown in Fig. 10.

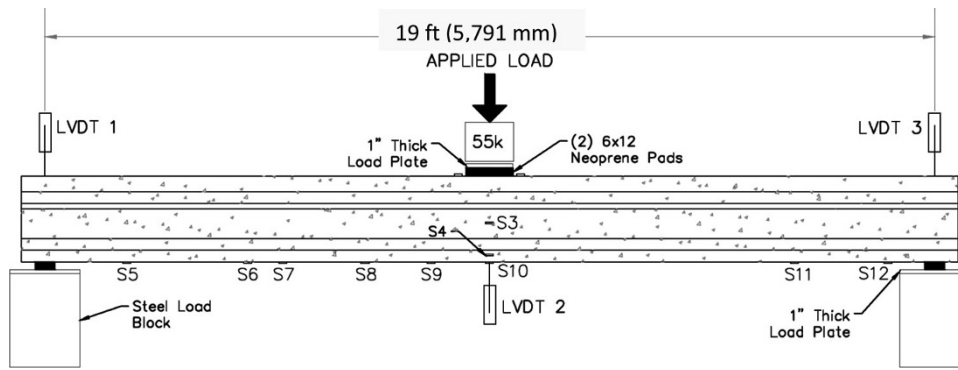
**Fig. 10** Fatigue loading setup arrangement for half-scale AASHTO PS girders.

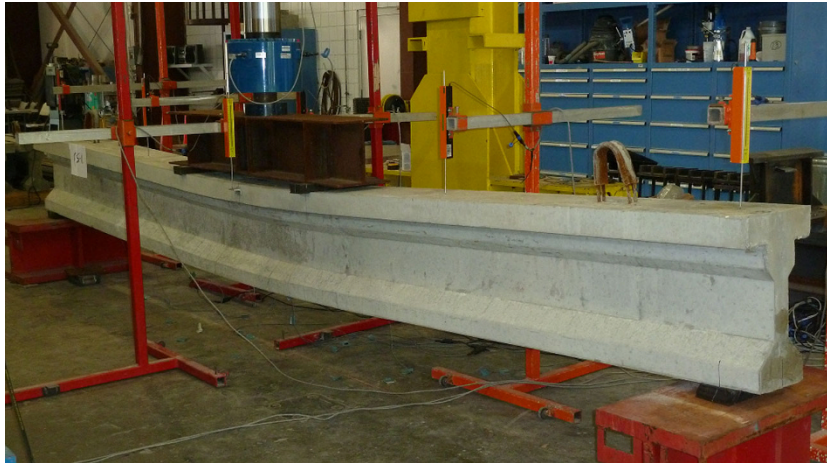
**Fig. 11** Half-scale control girder displaying excessive deflection under loading.

Figure 11 shows the control girder with significant deflection under loading. Table 3 shows the maximum loads, corresponding deflections, and increased capacity results from testing. It is shown that a comparison between the failure load of control girder PS-2 (un-strengthened with CFRP) and repaired girders with 2 layers of CFRP shows that CFRP repair enhanced the flexural capacity by a range of 27.53–45.66 % compared to control girder with one less strand. Also, for repaired girders with three layers of CFRP, increases in the flexural capacity were reported to range from 60.24 to 68.74 % compared to control girder PS-2. Increases of 24.85–41.69 % in the failure load were observed for the fully wrapped girders PS-9 and PS-10 compared to the un-strengthened control girder PS-2. The load–deflection behaviors for tested girders are presented in Figs. 12, 13, 14, 15, 16, and 17.

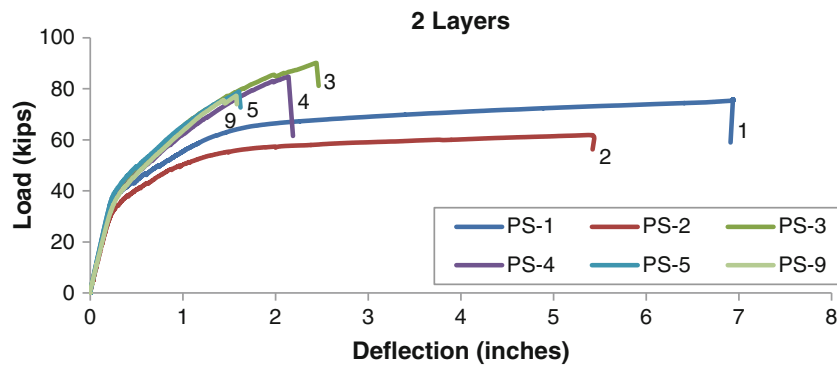
**Fig. 12** Load versus deflection for controls and girders with two layers of CFRP (conversion: 1 kip = 4.45 kN; 1 in. = 25.4 mm).

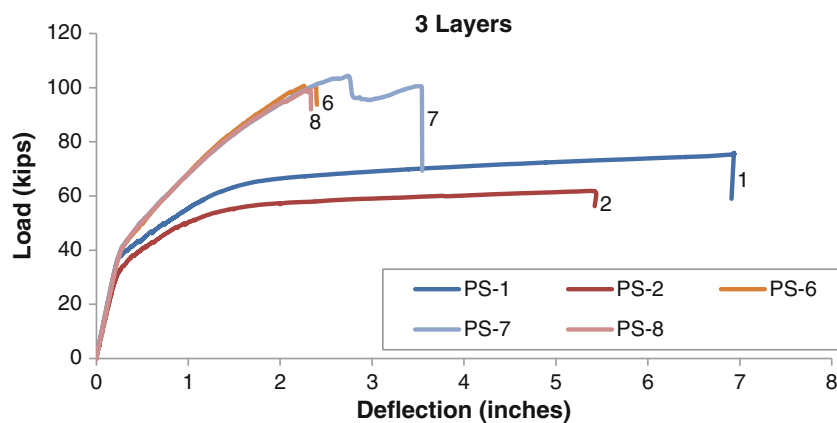
**Fig. 13** Load versus deflection for controls and girders with three layers of CFRP (conversion: 1 kip = 4.45 kN; 1 in. = 25.4 mm).

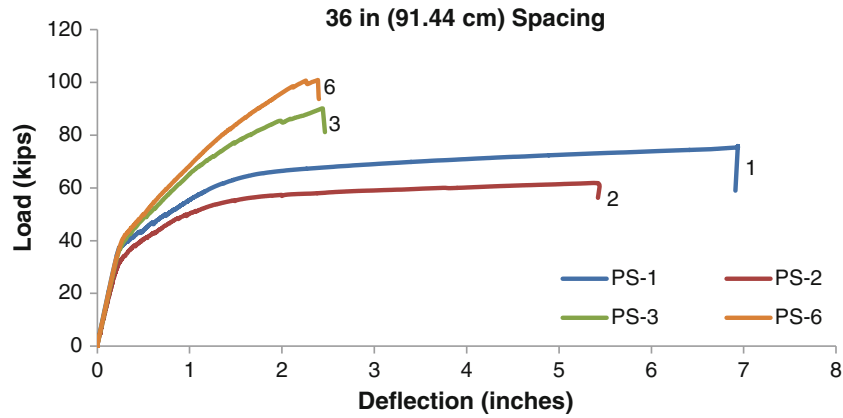
Fig. 14 Load versus deflection for controls and 36 in (91.44 cm) spacing configurations (conversion: 1 kip = 4.45 kN; 1 in. = 25.4 mm).

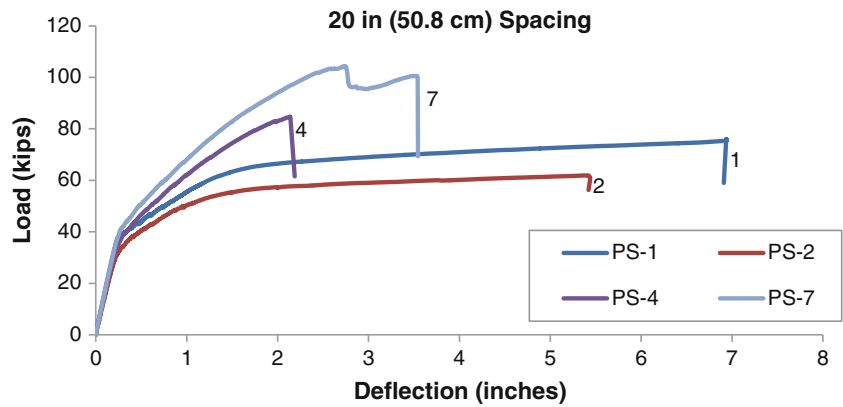
Fig. 15 Load versus deflection for controls and 20 in (50.8 cm) spacing configurations (conversion: 1 kip = 4.45 kN; 1 in. = 25.4 mm).

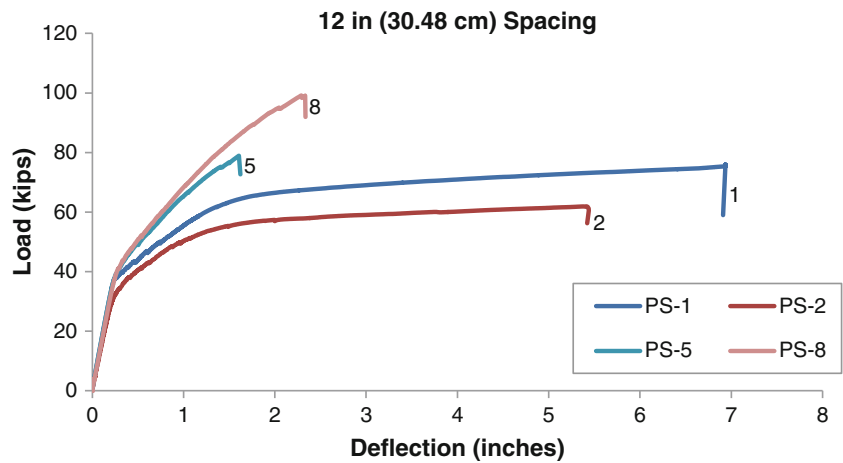
Fig. 16 Load versus deflection for controls and 12 in (30.48 cm) spacing configurations (conversion: 1 kip = 4.45 kN; 1 in. = 25.4 mm).

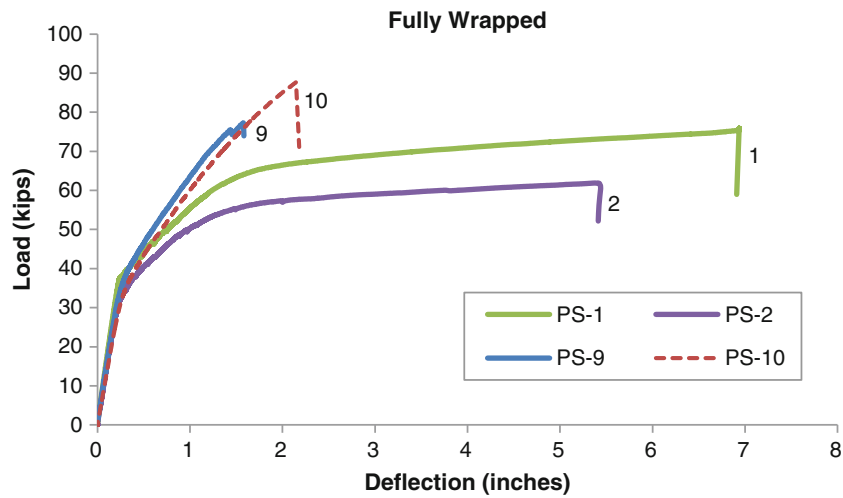
Fig. 17 Load versus deflection for controls and fully wrapped configurations (conversion: 1 kip = 4.45 kN; 1 in. = 25.4 mm).

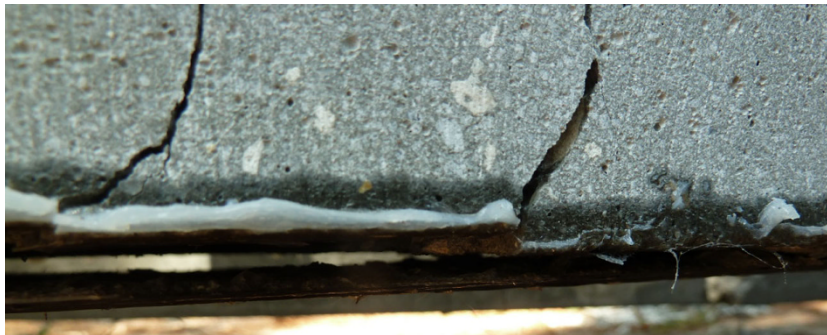
Fig. 18 Close-up of laminate debonding initiated by flexural crack development.

The control girders experienced a classic flexural failure initiated by excessive deflection and widening of flexural cracks. The repaired girders experienced either CFRP debonding, CFRP rupture without debonding, or localized debonding followed by rupture of CFRP, as shown in Figs. 18 and 19. Some repaired girders also experienced

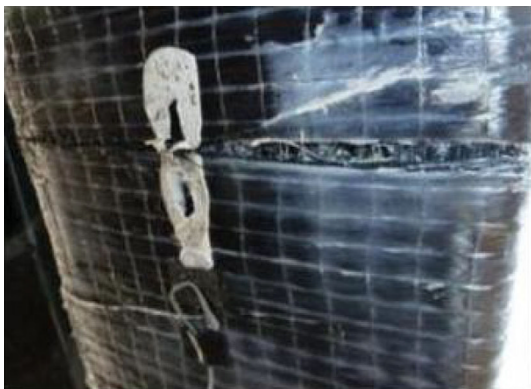
Fig. 19 Rupture of longitudinal CFRP.

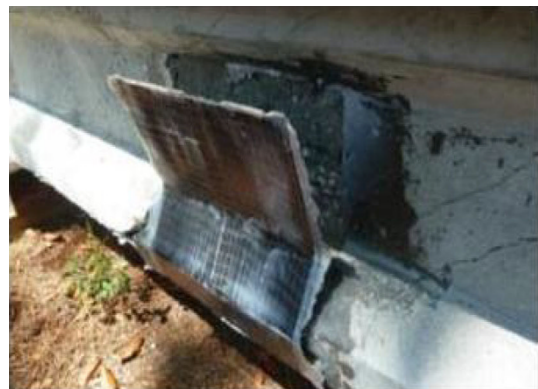
Fig. 20 Debonding of CFRP U-wrapping.

debonding of some of their U-wrappings, as shown in Fig. 20.

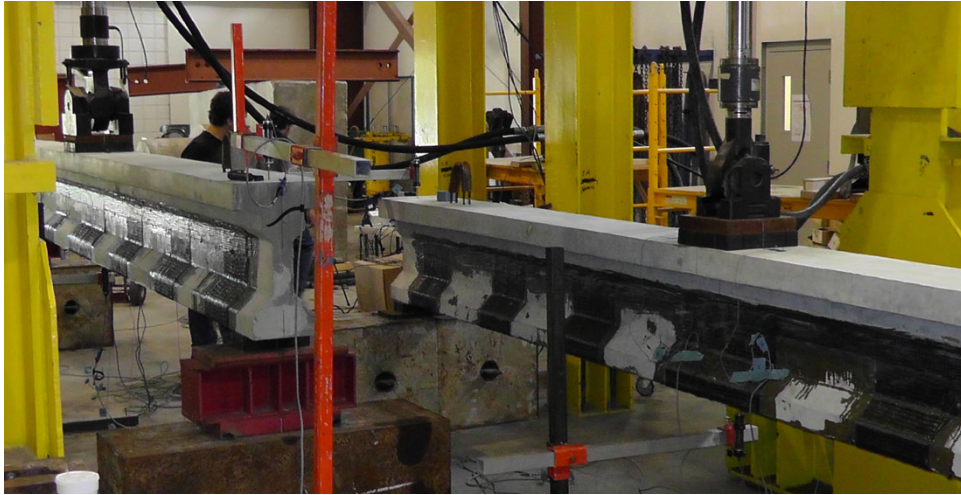
**Fig. 21** Fatigue loading setup arrangement for half-scale PS girders.

to the high fatigue load level that exceeded the specified fatigue load level in AASHTO. There were also some deficiencies in anchoring the end of the U-wraps and in covering the induced concrete damage with a longitudinal strip to suppress crack opening. A photograph of the fatigue loading tests is shown in Fig. 21 for the half-scale girders. Figures 22, 23, and 24 show the fatigue behavior of the repaired girders PS-11, PS-12, and PS-13. Table 4 represents the test

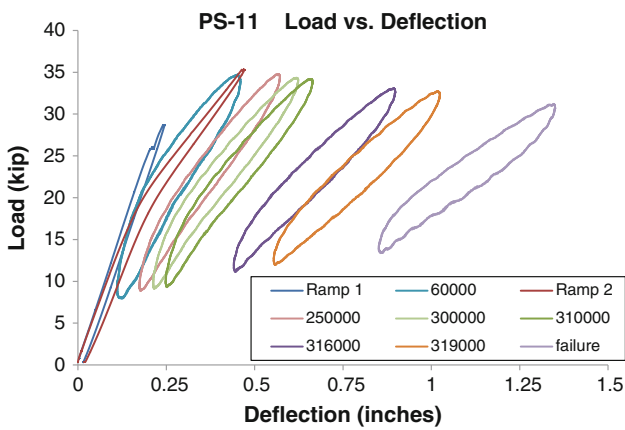
**Fig. 22** Fatigue behavior and degradation until failure for girder PS-11 (conversion: 1 kip = 4.45 kN; 1 in. = 25.4 mm).

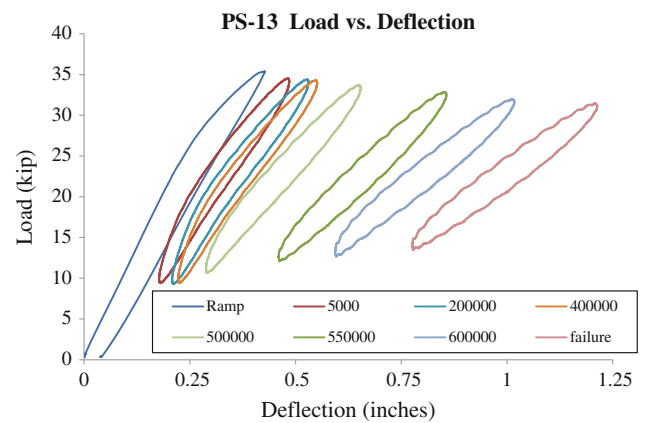
**Fig. 24** Fatigue behavior and degradation until failure for girder PS-13 (conversion: 1 kip = 4.45 kN; 1 in. = 25.4 mm).

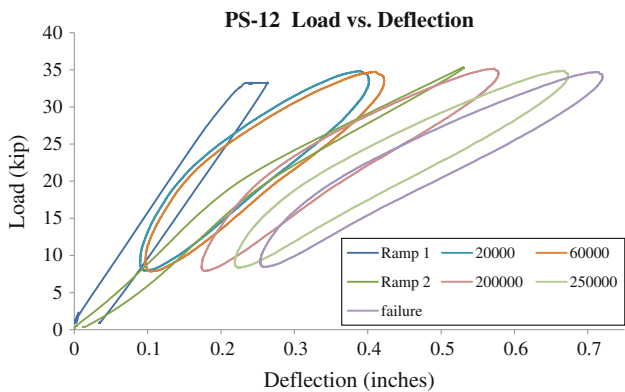
**Fig. 23** Fatigue behavior and degradation until failure for girder PS-12 (conversion: 1 kip = 4.45 kN; 1 in. = 25.4 mm).

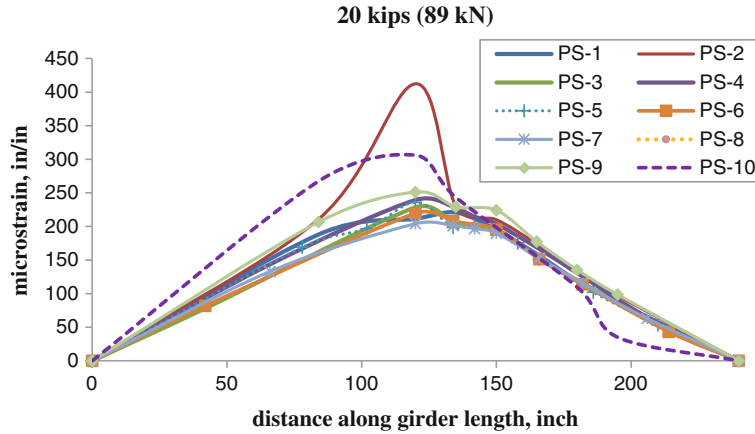
**Fig. 25** Strain at extreme bottom fiber of girder soffit versus length for all girders (conversion: 1 in. = 25.4 mm).

Figures 25 and 26 show the strains measured at a load level of 20 kips (89 kN) and 70 kips (311.5 kN). Half of the span lengths of the symmetrical girders were instrumented

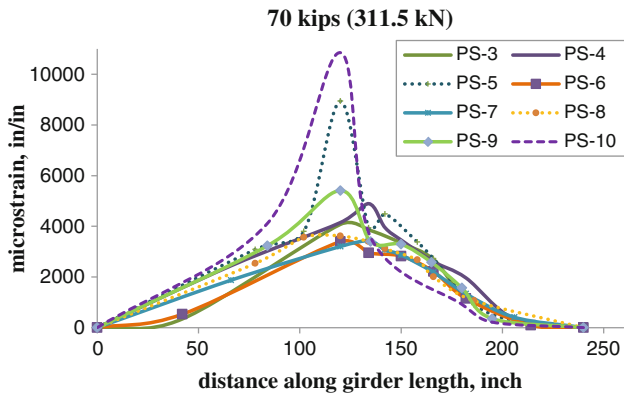
**Fig. 26** Strain of CFRP at girder soffit versus length for repaired girders (conversion: 1 in. = 25.4 mm).

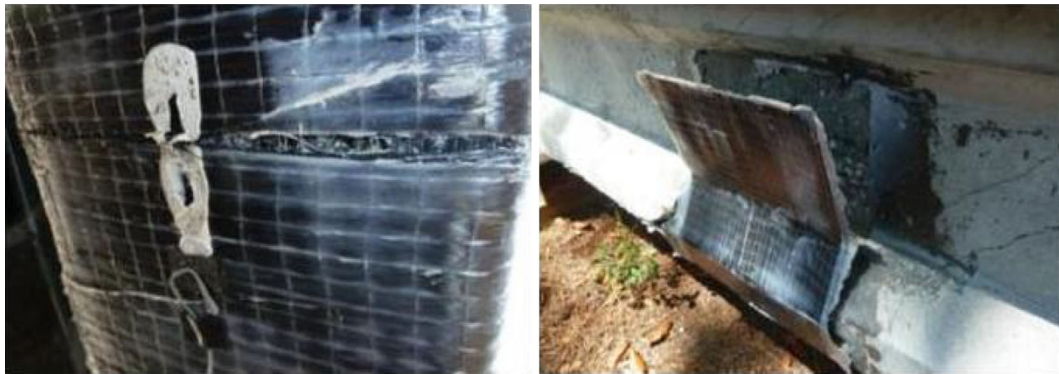
**Fig. 27** (left) Rupture of longitudinal CFRP; (right) debonding of CFRP U-wrapping.

The modes of failure for the girders were recorded. The control girders PS-1 and PS-2 experienced ductile flexural failure with excessive deflection and cracking. The repaired girders experienced CFRP rupture or localized debonding followed by rupture of CFRP; as shown in Figs. 27 and 28. Figure 27 (right) shows some repaired girders that

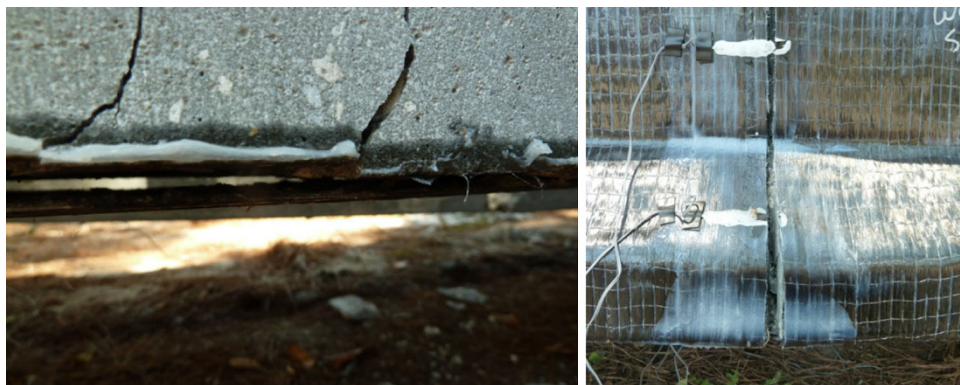
**Fig. 28** (left) Debonding of soffit CFRP; (right) rupture of longitudinal and transverse CFRP.

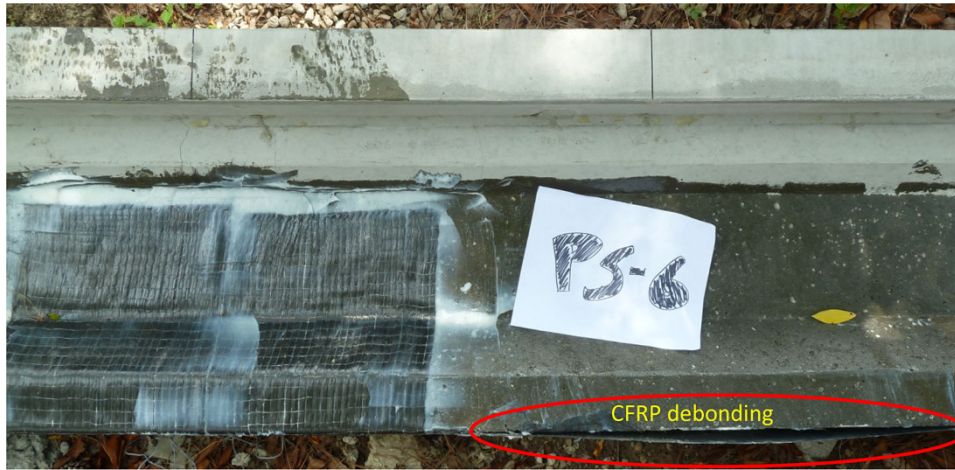
**Fig. 29** Half-scale girder displaying debonding failure of CFRP laminates.

experienced debonding of some of their U-wrappings. Figure 29 shows debonding failure of CFRP laminates for girder PS-6.
