# Structural performance of notch damaged steel beams repaired with composite materials

Boshra El-Taly<sup>1</sup>

**Abstract** An experimental program and an analytical model using ANSYS program were employed to estimate the structural performance of repaired damaged steel beams using fiber reinforced polymer (FRP) composite materials. The beams were artificially notched in the tension flanges at mid-spans and retrofitted by FRP flexible sheets on the tension flanges and the sheets were extended to cover parts of the beams webs with different heights. Eleven box steel beams, including one intact beam, one notch damaged beam and nine notches damaged beam and retrofitted with composite materials, were tested in two-point loading up to failure. The parameters considered were the FRP type (GFRP and CFRP) and number of layers. The results indicated that bonding CFRP sheets to both of the tension steel flange and part of the webs, instead of the tension flange only, enhances the ultimate load of the retrofitted beams, avoids the occurrence of the debonding and increases the beam ductility. Also the numerical models give acceptable results in comparison with the experimental results.

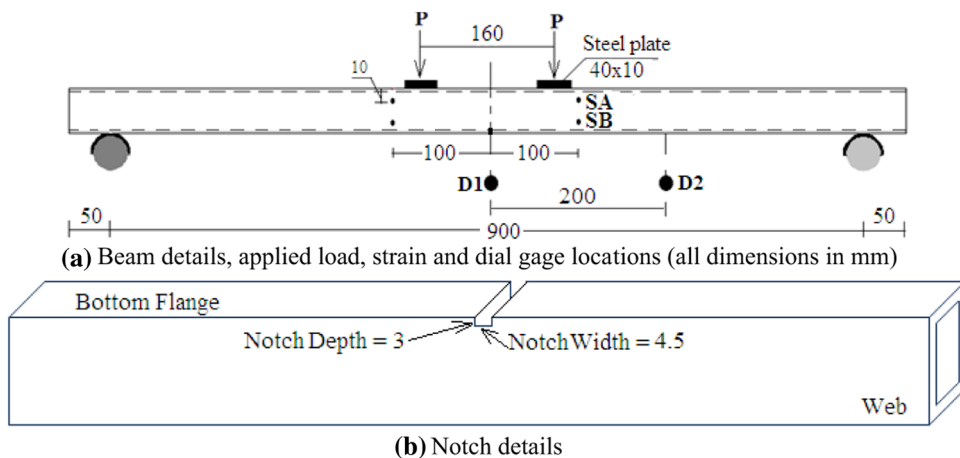
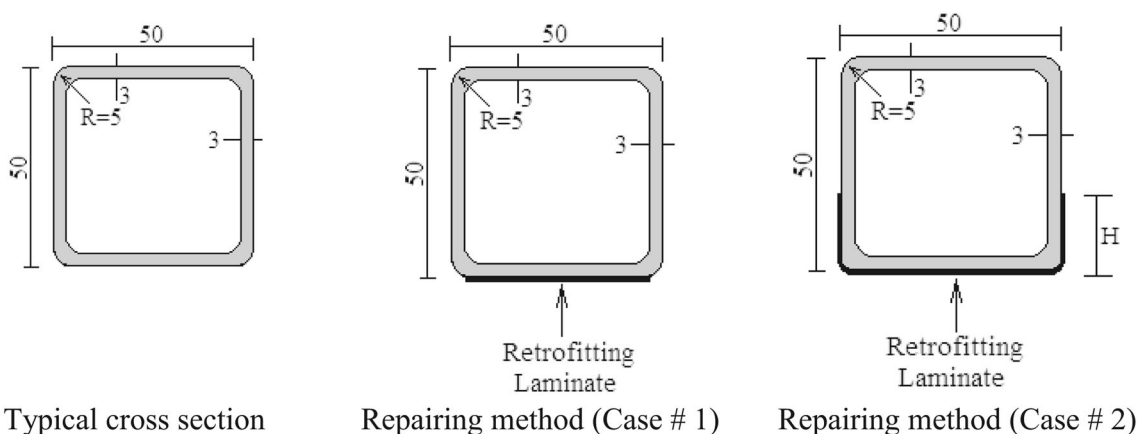
**Fig. 1** Beam details, strain and dial gage locations and notch details

Eleven steel box beams were tested in two-point loading. All beams are of length 1000 mm and they have box cross section with  $50 \times 50$  mm and with 3 mm thickness. A schematic diagram of the typical beam (CB) and the locations of strain and dial gages are shown in Fig. 1. The specimens were categorized into four groups. The first group (Set 1) is the control specimens and it includes the control intact beam (CB) and the damaged beam (DB). The second group (Set 2) contains four artificially damaged beams and then they were repaired with FRP composite material. In this group, the damaged beams were repaired by externally bonded the composite material on the tension flange only (repaired method Case # 1) as shown in Fig. 2. The type of FRP; glass fiber or carbon fiber and the number of layers are the parameters. In the third group (Set 3), the specimens were retrofitted by attaching the composite material in the tension-side flanges and the FRP flexible sheets were wrapped around the beams web to cover parts of them with H height as shown in Fig. 2. The fourth group (Set 4) included one retrofitted beam. This beam was repaired by attaching two layers of CFRP sheets on the lower tension flange and applied four GFRP strips with 20 mm width at the CFRP ends. These strips were wrapped around the whole section of the beam as shown in Fig. 3. In all the damaged specimens, the tension flange is saw-cut at mid-span to simulate section loss due to a fatigue crack or a localized severe corrosion. The width and depth of the

The specimens were simply supported with a span of 900 mm between the two supports and tested under two-point bending static loading using flexural testing machine of 100 kN capacity. The spacing between the two concentrated point loads was 160 mm (see Fig. 1). The beams were tested under an increasing load up to failure at 1 kN a constant loading rate. The behavior of beams was monitored by measuring the deflection at mid-span and at 200 mm distance from the mid-span using two dial gauges with an accuracy of 0.01 mm. A set of four DEMEC strain gauges were fixed in one side of the specimen to allow

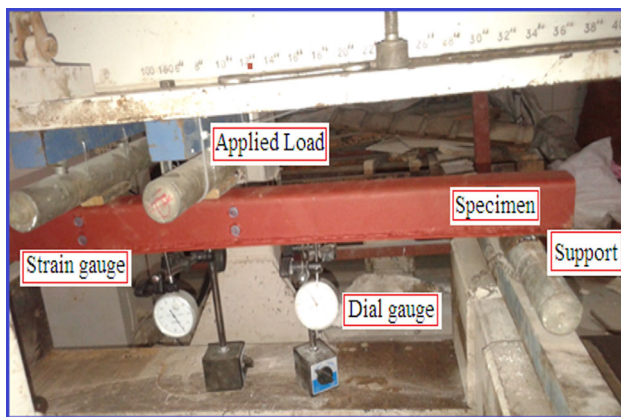
**Fig. 4** Specimen test

measuring the strain versus load during the test. Typical test set-up and instrumentation is shown in Fig. 4.

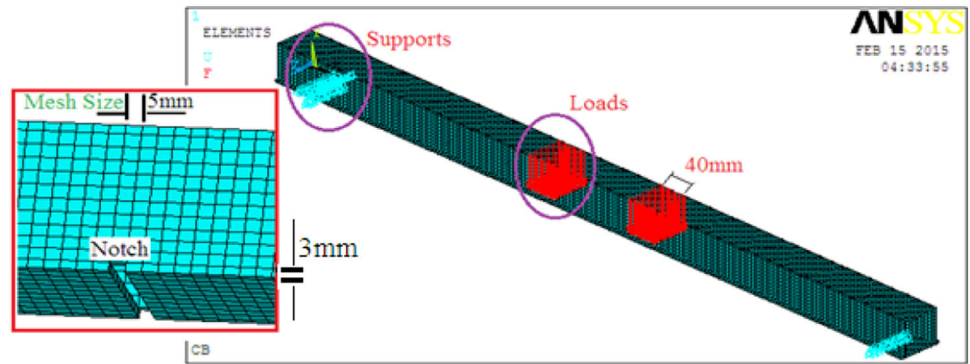
**Fig. 5** Geometry of the FE model

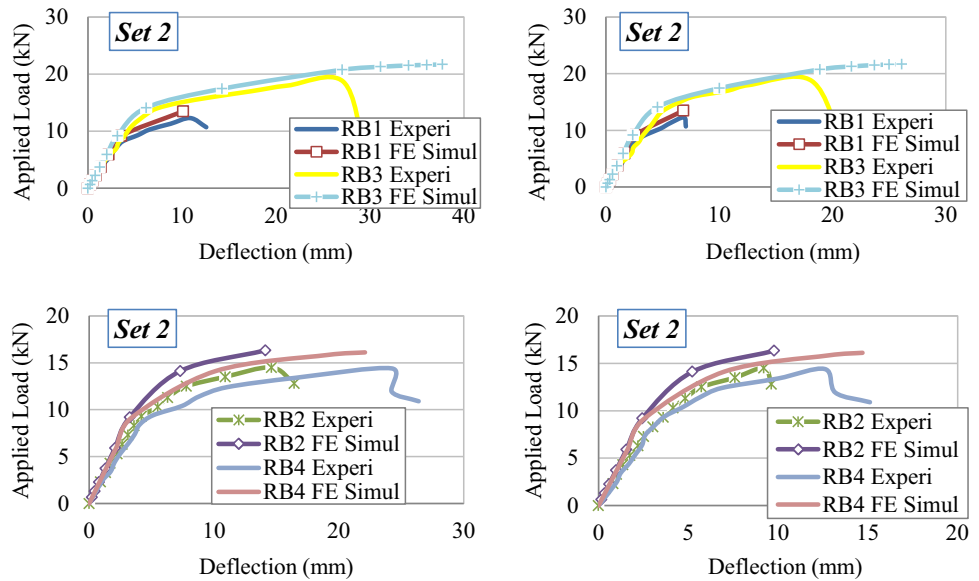
**Fig. 10** Load-deflection curves of retrofitted specimens (Set 2); left at D1 and right at D2 point

The results of repaired beams with the composite materials bonded on the lower side of the tension steel flange only (Set 2) in terms of load–deflection curves, load-strain curves, failure modes and normal stresses distributions are presented in Figs. 10, 11, 12, 13. Figure 10 shows the comparison between the experimental and numerical results in terms of load–deflection curves for retrofitted specimens (Set 2). This figure shows that the numerical and the experimental results are close; the difference between

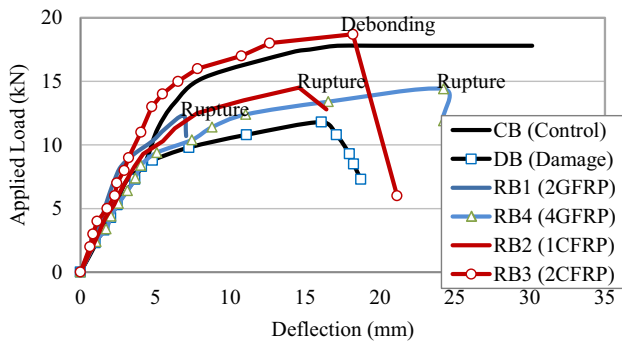
**Fig. 11** Experimental total load-deflection curves of retrofitted specimens (Set 2)

the results not exceed than 15 %. Figure 11 shows the responses of specimens Set 2, compared to beams CB and DB. The figure shows that beam RB3 reached flexural stiffness values higher than the intact beam, which is attributed to the high value of elastic modulus of CFRP. Table 3 shows gains in ultimate load of 5.1 %. This beam failed at 17.8 kN ultimate load and 27.15 and 18.18 mm corresponding deflections at points D1 and D2 due to the occurrence of the debonding CFRP as shown in Fig. 13. Also Fig. 11 indicates that the retrofitted beams (RB1, RB2 and RB4) give higher responses than the notch damaged beam but they not achieve the full stiffness and ductility of beam CB and their ultimate load was 30.9, 18.54 and

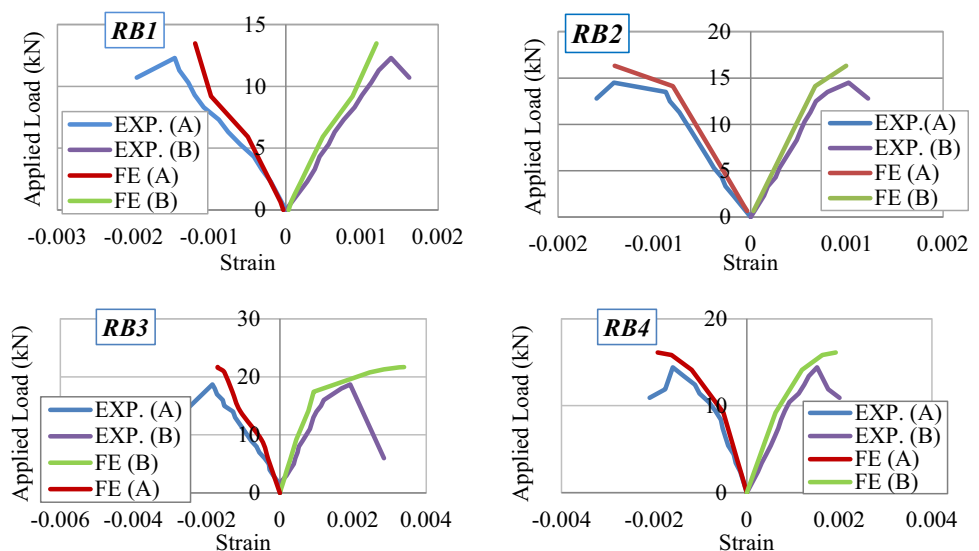
**Fig. 12** Load-strain curves of retrofitted specimens (Set 2); Load-strain curves of retrofitted specimens (Set 2)

19.10 % lower than the ultimate load of the intact beam, as indicated in Table 3. Also these results showed that increasing the number of FRP layers increases the ultimate load. Figure 12 shows the load versus strains at two different locations (SA and SB) of Set 2 specimens. From these figures, it can be clearly seen that the numerical model gives a good outcome compared to the experimental tests results. The failure mode of beams RB1, RB2 and RB4 occurred by rupture of the FRP sheets at mid-span, as shown in Fig. 13 due to reaching the maximum strength of FRP (see Fig. 14).

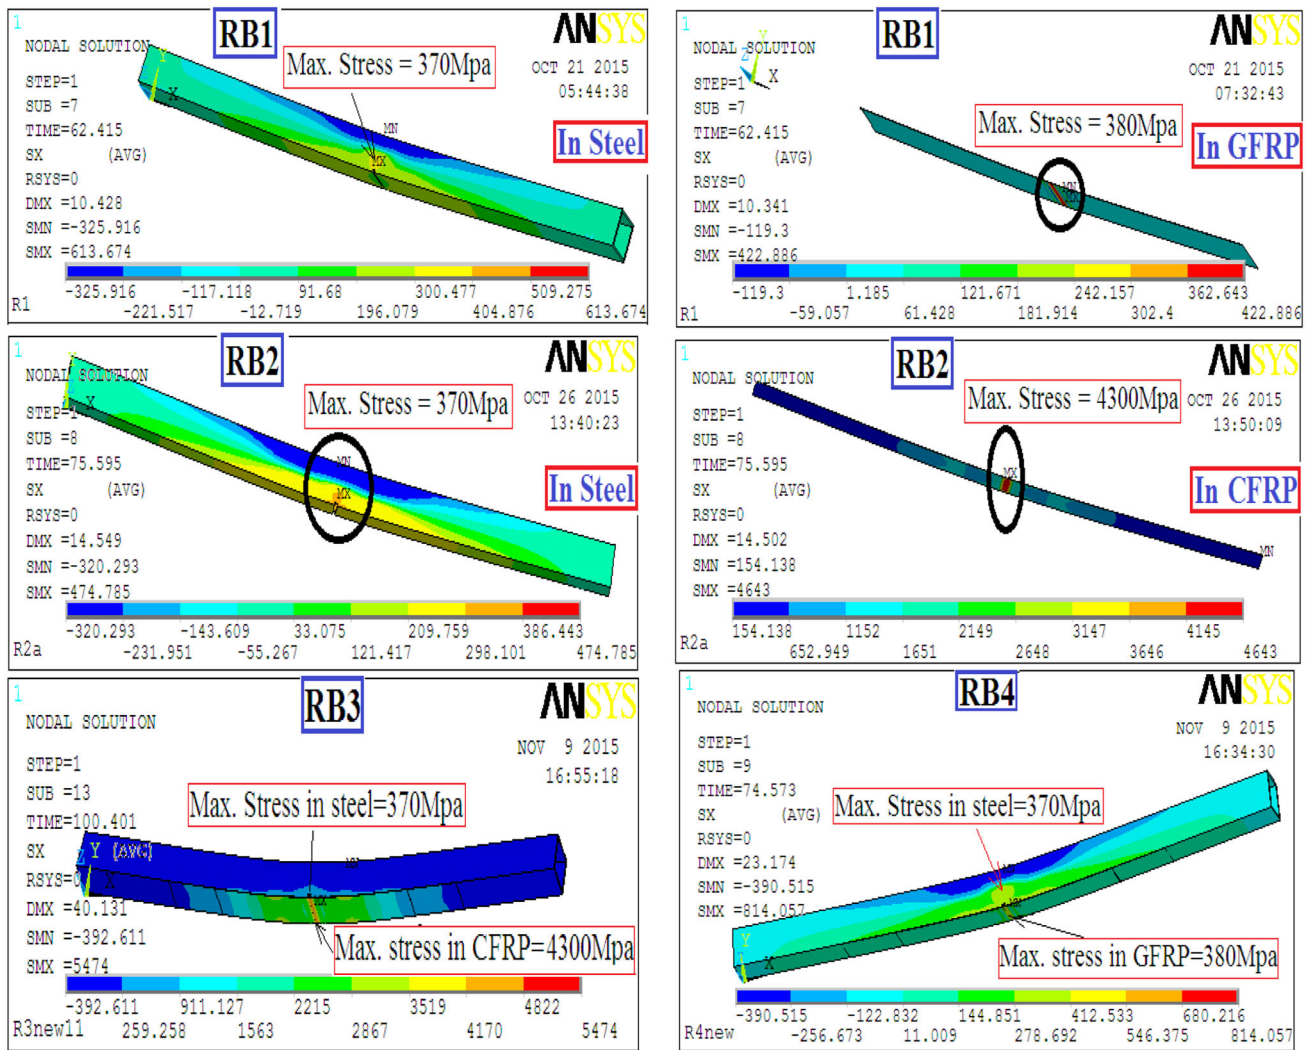
Fig. 14 Numerical normal stresses at the ultimate load of (Set 2) retrofitted specimens

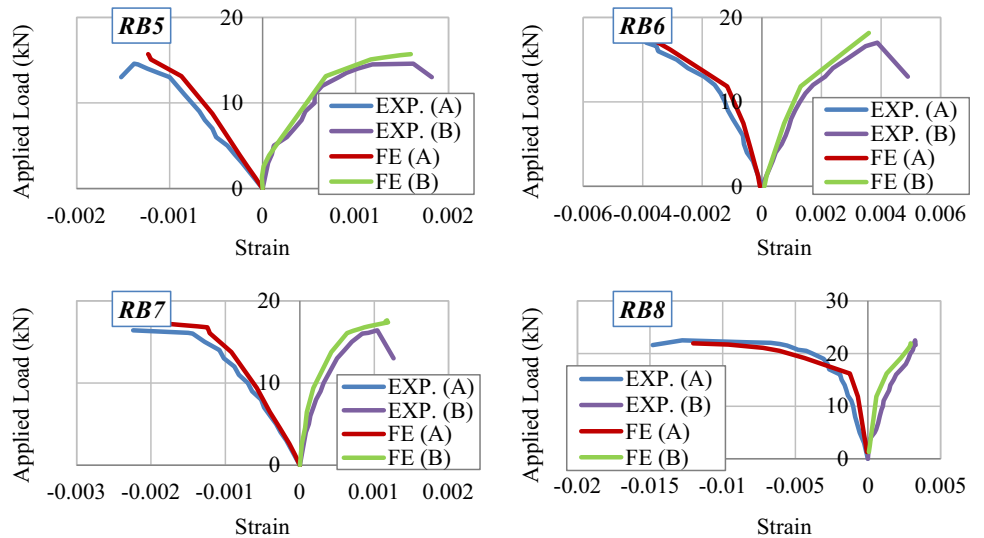
**Fig. 16** Experimental and FE simulation load-strain curves of retrofitted specimens (Set 3)

tension steel flange and on a part of the two webs with height ( $h$ ) (Set 3) are presented and discussed in this section. Figure 15 shows the experimental and numerical load–deflection curves at points D1 and D2 and Fig. 16 presents the comparison between experimental and numerical results of beams Set 3 in term of load versus strain. These figures showed that the FE simulation gives good results compared to the experimental results. Figure 17 shows the experimental load–deflection curves of specimens Set 3 (RB5, RB6, RB7 and RB8), compared to the reference control intact beam and the damaged beam. This figure and Table 3 indicate that beam RB8 achieves ultimate load values higher than beam CB by about 26.4 %. Also beam RB8 has an increase in ductility in comparison with beam CB. This beam failed at 22.5 kN ultimate load and 32.04

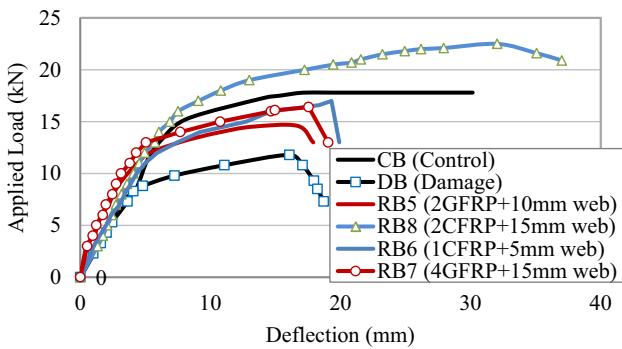
**Fig. 17** Experimental total load–deflection curves of retrofitted specimens (Set 3)

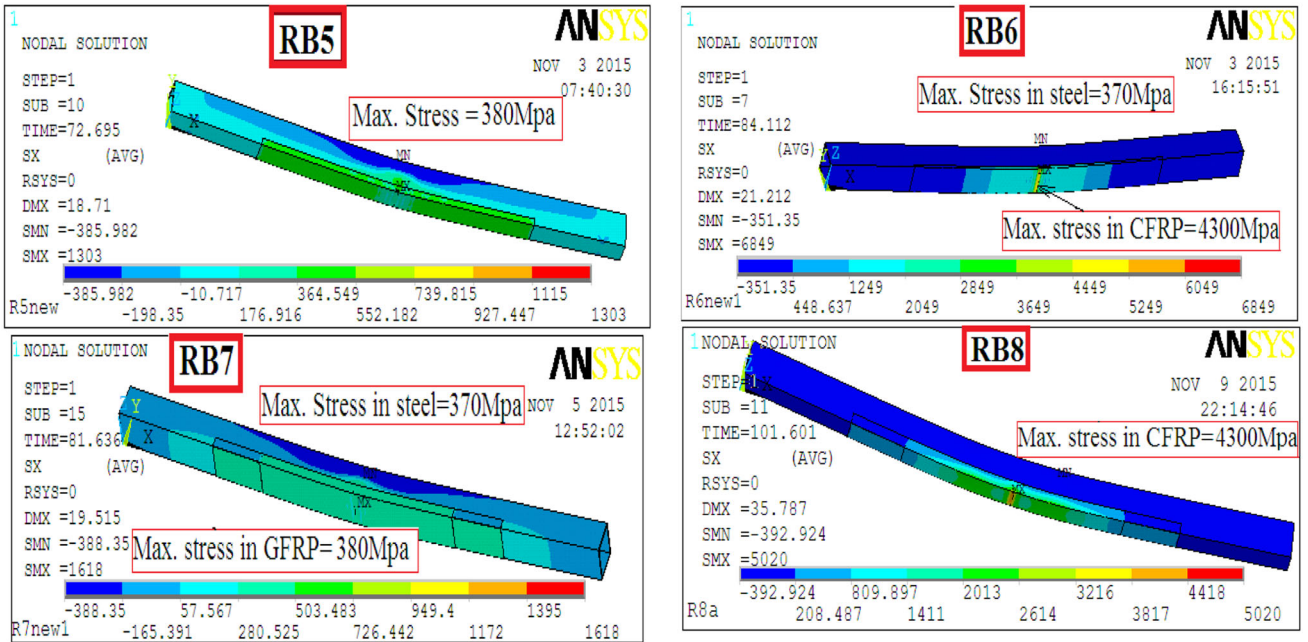
Fig. 19 Numerical normal stresses at the ultimate load of retrofitted specimens Set 3

and 23.37 mm corresponding deflections at points D1 and D2 due to the occurrence of the rupture CFRP at the mid-span as shown in Fig. 18. The failure mode of all beams Set 3 occurred by rupture of the FRP sheets at mid-span, as shown in Fig. 18. Figure 19 presents the numerical normal stresses of retrofitted beams Set 3.

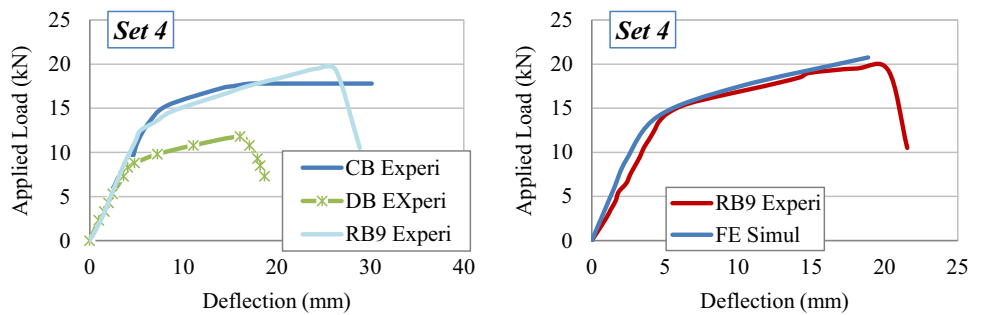
Fig. 20 Load-deflection curves of retrofitted specimens Set 4

The results of the specimen RB9 are presented in Figs. 20, 21, 22, 23. This specimen was repaired with two layers of CFRP and four externally bonded GFRP strips. These strips were wrapped around the whole section of the beam at the ends of the CFRP layers. Figure 21 indicates that the repaired specimen RP9 achieves ultimate load value higher than beam CB by about 9.55 %. Figure 22 shows that the end debonding is avoid in this beam and the debonding initially appeared at the mid-span.

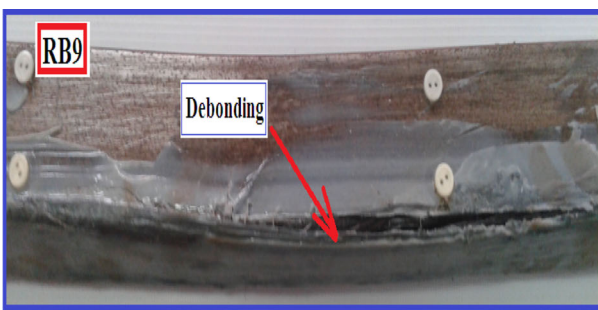
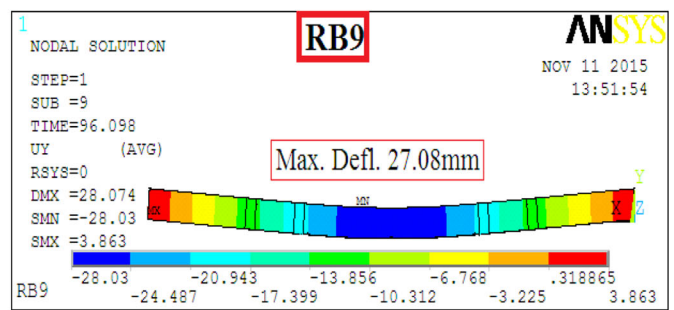
Fig. 21 Failure modes of specimens Set 4

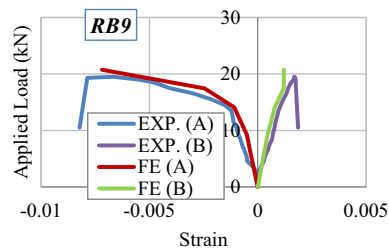
**Fig. 22** Load-strain curves of beam RB9

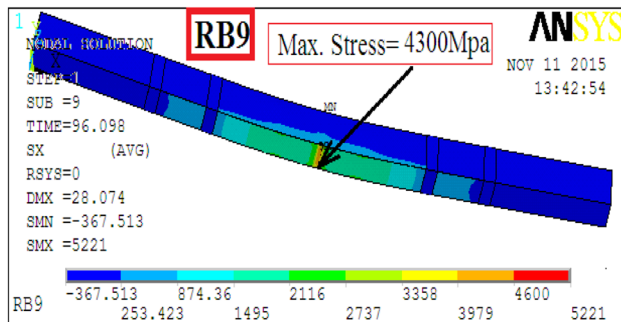
**Fig. 23** Normal stresses at the ultimate load of beam RB9
