# High Temperature Behavior of Cr<sub>3</sub>C<sub>2</sub>-NiCr Coatings in the Actual Coal-Fired Boiler Environment

RAKESH BHATIA, HAZOOR SINGH SIDHU, and BUTA SINGH SIDHU

Erosion-corrosion is a serious problem observed in steam-powered electricity generation plants, and industrial waste incinerators. In the present study, four compositions of Cr<sub>3</sub>C<sub>2</sub>-(Ni-20Cr) alloy coating powder were deposited by high-velocity oxy-fuel spray technique on T-91 boiler tube steel. The cyclic studies were performed in a coal-fired boiler at 1123 K ± 10 K (850 °C ± 10 °C). X-ray diffraction, scanning electron microscopy/energy dispersive X-ray analysis and elemental mapping analysis techniques were used to analyze the corrosion products. All the coatings deposited on T-91 boiler tube steel imparted hot corrosion resistance. The 65 pctCr<sub>3</sub>C<sub>2</sub> -35 pct (Ni-20Cr)-coated T-91 steel sample performed better than all other coated samples in the given environment.

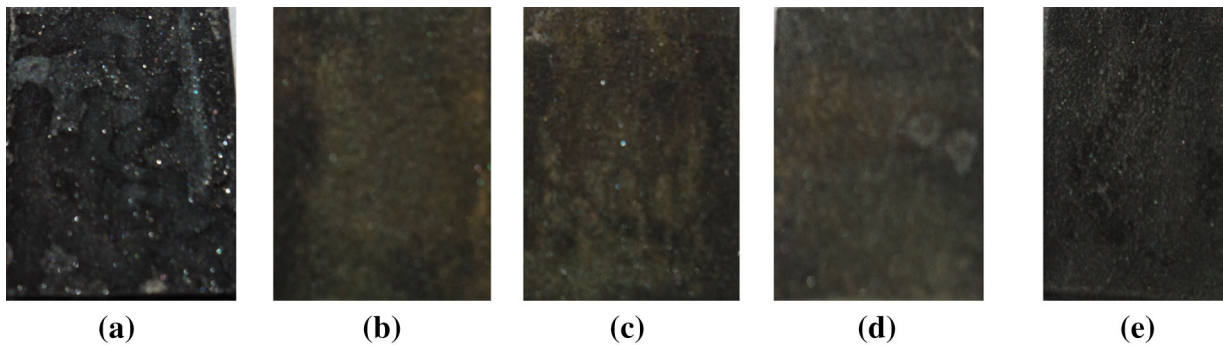
The macrograph of uncoated T-91 boiler tube steel and the coated samples after 1500 hours exposure in the coal-fired boiler is shown in Figure 1. Uncoated T-91 boiler tube steel changed to blackish grey after the very 1st cycle of exposure. This might be due to the formation of oxides. A layer of ash was seen to be

Fig. 1—Macrograph of the samples subjected to an actual boiler environment at 1123 K (850 °C) for 1500 h: (a) uncoated, (b) CC1, (c) CC2, (d) CC3, and (e) CC4.

deposited on the surface and the surface seems to be rough. The colour of the sample turned dark black by the end of the 2nd cycle. This might be due to the formation of oxides. The process of scale formation seems to increase by the end of the 5th cycle and a shining black colour was observed at the corners of the sample at the end of the 6th cycle. The process of scale formation and spalling of scale continued until the 15th cycle. The colour of the CC1-coated T-91 boiler tube steel sample turned blackish grey at the end of the 1st cycle. This might be due to formation of oxides of Cr and Ni. The coating was found to be intact with ash deposits without any cracks appearing in the surface of the sample. The surface of the coating appeared to be smooth at the end of the 2nd cycle. No signs of spallation were observed throughout the study, the CC2-coated sample turned light blackish grey with ash deposits on all the surfaces. The colour turned dark black by the end of the 5th cycle and with the progress of the experiment the colour further darkened to dark grey. No visible cracks were observed on the surfaces of specimens during or after the exposure of 1500 hours. A thin layer of scale can be observed at the top surface. The scale formed on the coated sample was found to be intact without any spallation. A light blackish grey colour at the end of the 1st cycle was observed for CC3 sample. Ash deposits were also seen at the surface of the sample. At the end of the study, the coating was found to be intact with a visible layer of scale and without any visual cracks. The colour of the CC4-coated sample turned light blackish grey by the end of the 1st cycle, and to dark black by the end of the 3rd cycle, indicating the formation of oxides. The formation of scale started and progressed slowly with no major or minor cracks appearing on the surface until the 15th cycle.

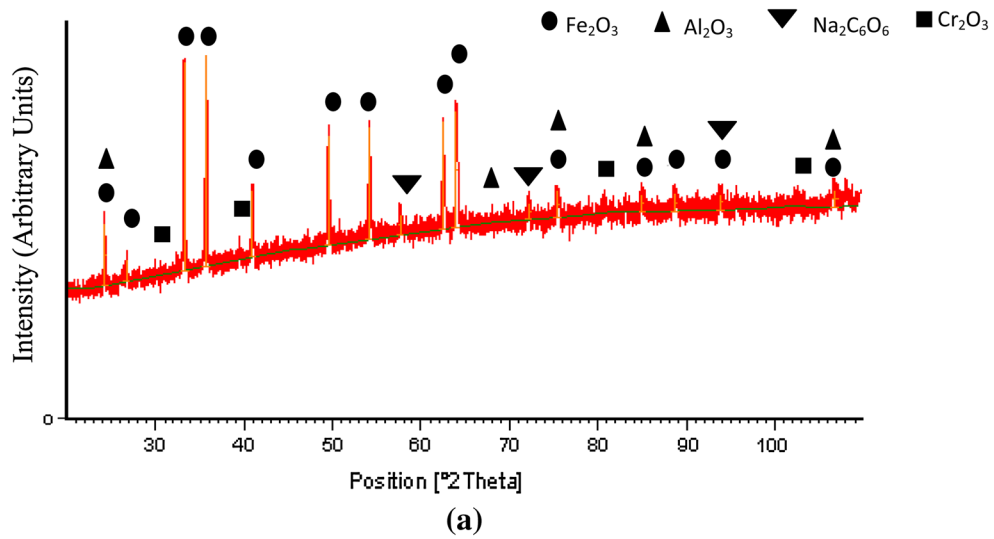
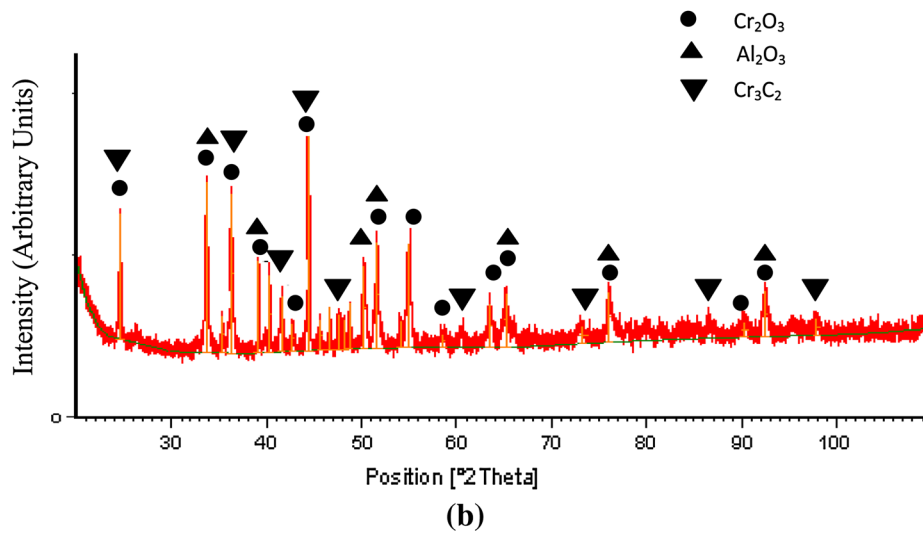
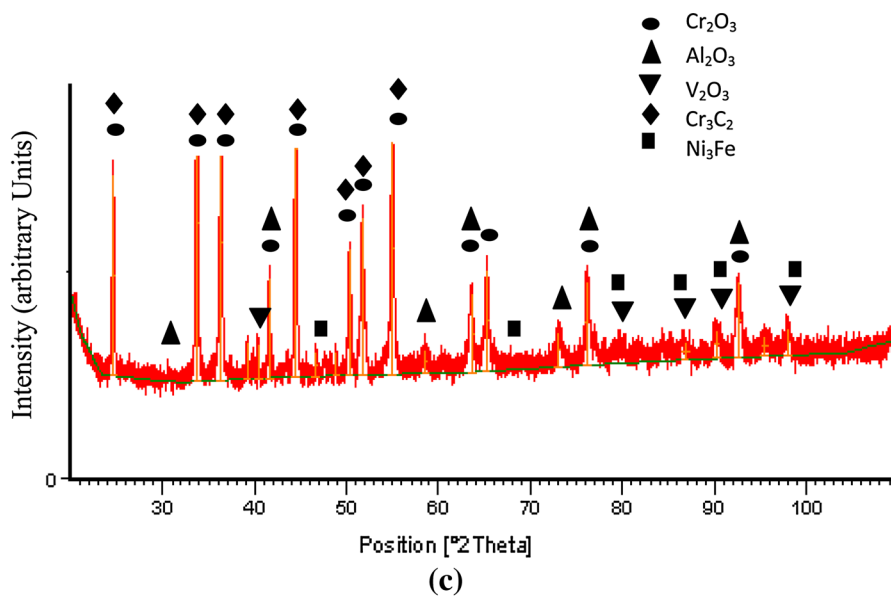
◀ Fig. 2—(a) X-ray diffraction profiles for the uncoated boiler tube steel subjected to an actual boiler environment at 1123 K (850 °C) for 1500 h. (b) X-ray diffraction profiles for the CC1-coated T-91 boiler tube steel subjected to an actual boiler environment at 1123 K (850 °C) for 1500 h. (c) X-ray diffraction profiles for the CC2-coated T-91 boiler tube steel subjected to an actual boiler environment at 1123 K (850 °C) for 1500 h. (d) X-ray diffraction profiles for the CC3-coated T-91 boiler tube steel subjected to an actual boiler environment at 1123 K (850 °C) for 1500 h. (e) X-ray diffraction profiles for the CC4-coated T-91 boiler tube steel subjected to an actual boiler environment at 1123 K (850 °C) for 1500 h.

The XRD analysis of the oxide scale of uncoated and coated T-91 boiler tube steel samples exposed to the erosion-corrosion at 1123 K (850 °C) for 15 cycles is shown in Figures 3(a)–(e). Oxide scale of the uncoated steel mainly comprise  $\text{Fe}_2\text{O}_3$  phase along with weak intensity of  $\text{Al}_2\text{O}_3$  and  $\text{Na}_2\text{C}_6\text{O}_6$  phase. Some weak peaks corresponding to  $\text{Cr}_2\text{O}_3$  have also been observed.

The XRD analysis of the oxide scale of the coated sample exposed to the erosion-corrosion mainly comprise phases of  $\text{Cr}_2\text{O}_3$  and  $\text{Al}_2\text{O}_3$ , along with some weak peaks of  $\text{Cr}_3\text{C}_2$ ,  $\text{Ni}_3\text{Fe}$ ,  $\text{V}_2\text{O}_5$ ,  $\text{Fe}_2\text{O}_3$ ,  $\text{Cr}_7\text{C}_3$  and  $\text{SiO}_2$  phases.

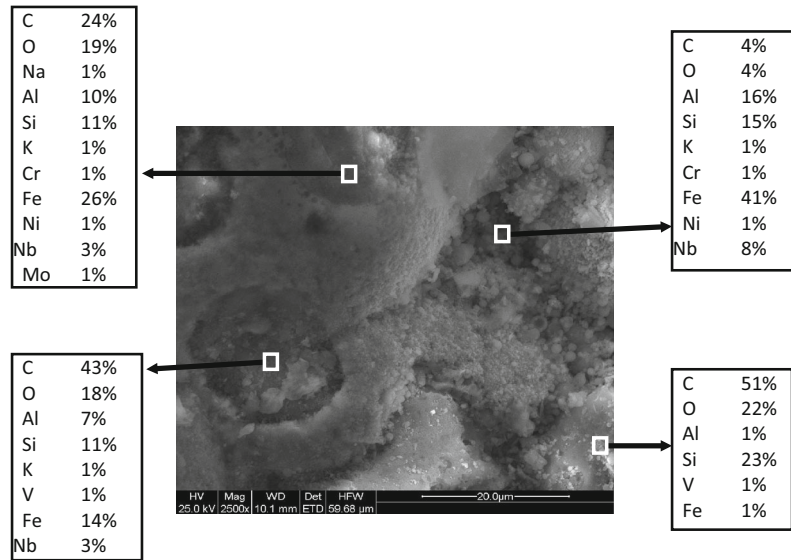
(a)

The oxide scale for the uncoated T-91 shown in Figure 3(a) seems to have a granular morphology. The EDS analysis reveals that the scale mainly contains Fe and O, with significant amounts of C. Significant amounts of Si and Al are also observed. Minor amounts of Na and K are also visible throughout the scale, which are the basic constituents of the boiler environment.

◀Fig. 3—(a) FE-SEM along with EDS analysis for the uncoated T-91 boiler tube steel subjected to an actual boiler environment at 1123 K (850 °C) for 1500 h. (b) FE-SEM along with EDS analysis for the CC1-coated T-91 boiler tube steel sample subjected to an actual boiler environment at 1123 K (850 °C) for 1500 h. (c) FE-SEM along with EDS analysis for the CC2-coated T-91 boiler tube steel sample subjected to an actual boiler environment at 1123 K (850 °C) for 1500 h. (d) FE-SEM along with EDS analysis for the CC3-coated T-91 boiler tube steel sample subjected to an actual boiler environment at 1123 K (850 °C) for 1500 h. (e) FE-SEM along with EDS analysis for the CC4-coated T-91 boiler tube steel sample subjected to an actual boiler environment at 1123 K (850 °C) for 1500 h.

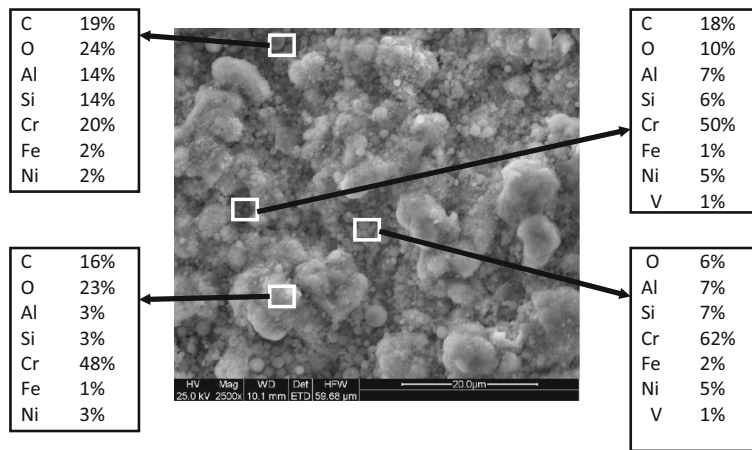
(b)

FE-SEM analysis of the CC1-coated T-91 boiler tube steel sample subjected to the boiler environment shows uneven scale morphology as shown in Figure 3(b). Granular growth of oxide scale is evident from the

Significant amounts of Si and Al were also noticed at the points of investigation. A marginal presence of V can also be noticed on the surface of the sample. Protective oxides of Cr and Ni might have been formed at the surface after the exposure.

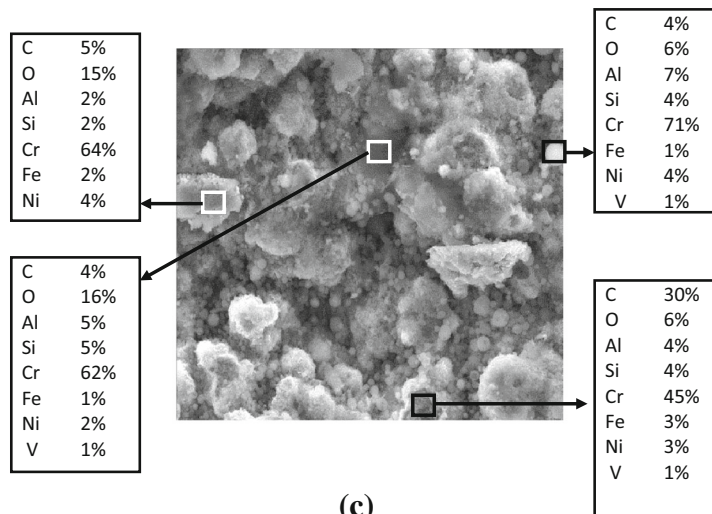
(c)

Figure 3(c) shows the growth of oxide scale on the surface of the CC2-coated T-91 boiler tube steel sample after exposure to the boiler environment. Some tiny spherical particles are also seen at many places on the surface of the sample. The EDS analysis reveals the presence of a high percentage of Cr at all the points of investigation. FE-SEM analysis of the CC3-coated T-91 boiler tube steel sample is presented in Figure 3(d). The EDS analysis reveals the presence of O, C, Cr, Fe and Ni as the main elements, with minor amounts of Si, Al, and V.

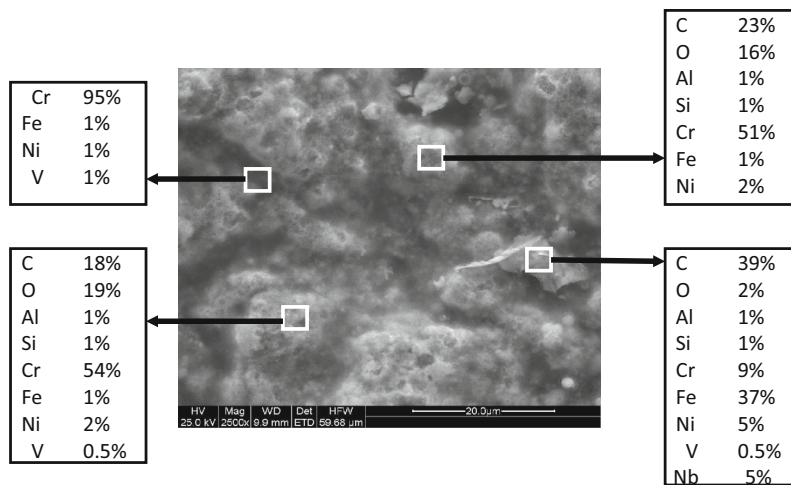
(e)

FE-SEM analysis of the CC4-coated T-91 boiler tube steel sample subjected to the boiler environment shows uneven scale morphology as shown in Figure 3(e). Growth of oxide scale along with signs of spalling of

FE-SEM analysis on the surface after exposure to boiler environment. Some tiny spherical particles along with irregular shaped particles are also seen on the surface of the sample at many places. The EDS analysis reveals the presence of high percentage Cr at all the points of investigation. Fe percentage is below 2 pct at all points. C and O are present in significant percentages with maximum percentage as 19 and 24 pct, respectively.

Cracks parallel to the substrate surface are visible in the top layer of the CC4-coated sample as shown in the BSE image in Figure 3(e). These cracks might be due to some stresses generated in the scale due to differences in the specific volume of the oxides and the coating. Stresses can also develop with time as a result of mechanical/physical properties changes in the coating due to reaction with the corrosive environment as suggested by Heath *et al.*<sup>[38]</sup> They further opined that, due to stresses, cracks are formed in the scale and through these cracks the corrosive species reach the base metal quickly and cut its way under the coating to result in adhesion loss.

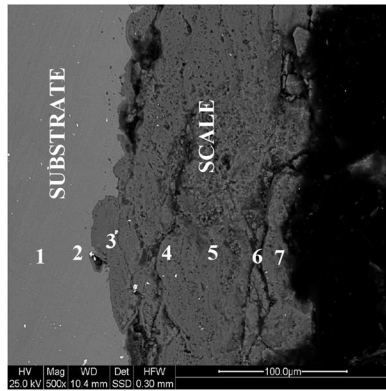
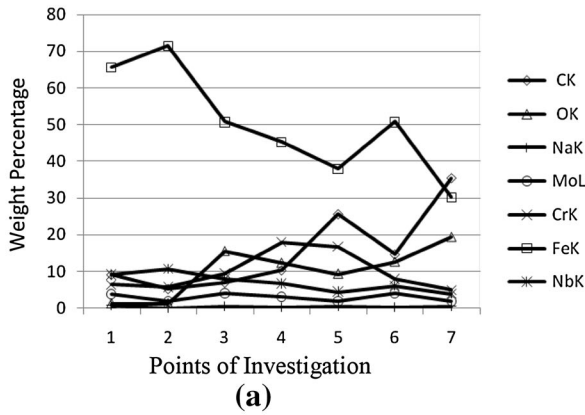
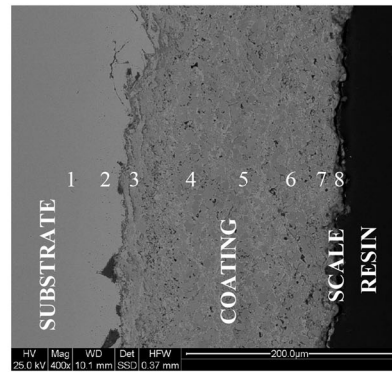
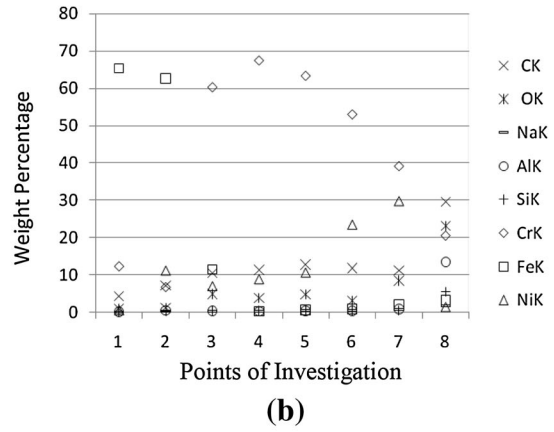
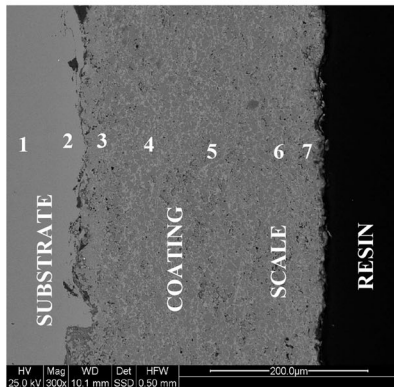
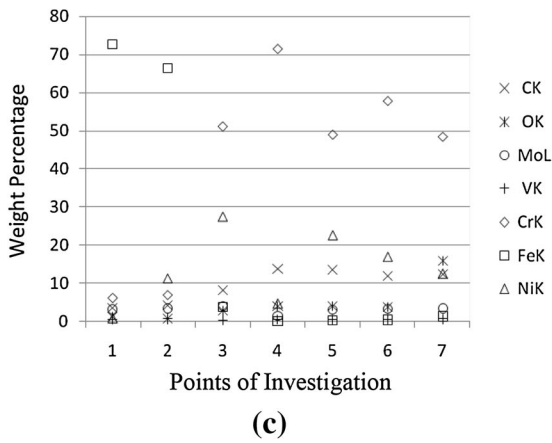
The FE-SEM micrograph in Figure 4(a) shows the uncoated sample with a thick oxide scale having cracks appearing in both parallel and perpendicular directions with respect to the substrate. Spallation of scale can also be observed with the scale breaking in shapes of granular particles due to the exposure. The cross-sectional oxide scale is mainly rich in Fe and O. Fe content is very high in the intact part of the substrate. Significant amounts of Cr and C are also visible at all points of the investigation along with Nb and Mo. Minor amounts of Na, K and V (up to 1 pct) have also been observed.

The scale morphology and EDS analysis for the corroded cross-section of CC1-coated steel sample (Figure 4(b)) shows a high weight percentage of Fe in

◀ Fig. 4—(a) Oxide scale morphology and variation of elemental composition across the cross-section of uncoated T-91 boiler tube steel subjected to an actual boiler environment at 1123 K (850 °C) for 1500 h. (b) Oxide scale morphology and variation of elemental composition across the cross-section of the CC1-coated T-91 boiler tube steel sample subjected to an actual boiler environment at 1123 K (850 °C) for 1500 h. (c) Oxide scale morphology and variation of elemental composition across the cross-section of the CC2-coated T-91 boiler tube steel sample subjected to an actual boiler environment at 1123 K (850 °C) for 1500 h. (d) Oxide scale morphology and variation of elemental composition across the cross-section of the CC3-coated T-91 boiler tube steel sample subjected to an actual boiler environment at 1123 K (850 °C) for 1500 h. (e) Oxide scale morphology and variation of elemental composition across the cross-section of the CC4-coated T-91 boiler tube steel sample subjected to an actual boiler environment at 1123 K (850 °C) for 1500 h.

substrate (65 and 62 pct at points 1 and 2, respectively) and a rich content of Cr and Ni in the coating area with maximum percentages of 67 and 29 pct, respectively. The EDS analysis show the topmost layer consisting of Cr (20 pct) and Al (13 pct) along with C (29 pct) and O (23 pct). The analysis indicates the formation of protective oxides of Cr and Ni, along with  $Al_2O_3$ .

The scale morphology and EDS analysis for the corroded cross-section of CC4-coated T-91 boiler tube steel sample after exposure to the boiler environment is shown in Figure 4(e). A dense and uniform scale is visible in the micrograph. The Cr content in the coating is almost 70 pct at all the points except at point 8, the top layer of oxide scale. At the top surface, the weight percentage of the elements is C (26 pct), O (31 pct), Cr (31 pct), Ni (1 pct), Fe (2 pct), Na (2 pct) and Al and Si (1 pct). The weight percentage of O is highest at point 8, the top layer of the scale. EDS analysis across the cross-section of the sample validates the formation of  $Cr_2O_3$ , NiO and  $Fe_2O_3$  at the top oxide layer, along with oxides of Si and Al. The coating has developed cracks parallel to the substrate surface.

The BSE image of the CC3-coated sample (Figure 4(d)) obtained after 1500 hours of exposure shows the formation of uniform and continuous oxide scales without any indications of any adherence loss between the coating and the substrates. The surface morphology shown in Figure 3(d) indicates the presence of Cr along with ash contents in the form of Al and Si. The scale formed shows granular growth with pits inbetween the mounds. The XRD analysis shows the presence of  $\text{Cr}_2\text{O}_3$  and  $\text{Al}_2\text{O}_3$ , along with some peaks corresponding to  $\text{Cr}_3\text{C}_2$  and  $\text{Fe}_2\text{O}_3$  phases. The presence of phases of Al and Fe in the top scale is confirmed by the X-ray mapping shown in Figure 5(d), indicating the formation of  $\text{Fe}_2\text{O}_3$  and  $\text{Al}_2\text{O}_3$ , which is further validated by the EDAX analysis shown in Figure 4(d).
