Experimental and simulation study of the effect of cut-out defect in carbon fibres twill weave composite

Abstract

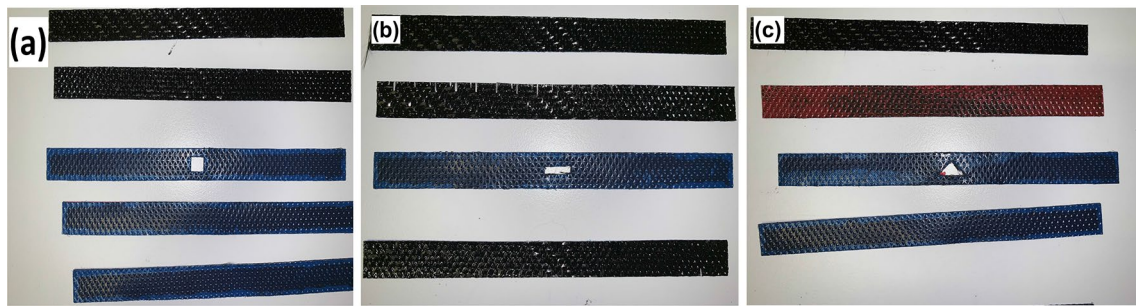
Fig. 1 Prepreg strips of the specimens have **a** square cut-out, **b** rectangular cut-out, **c** triangular cut-out defect

The material used in this study is woven pre-preg Carbon Fibre reinforced composite known as MTM[®] 56 manufactured by Solvay advanced composite. MTM56 series prepregs are based on 120 °C (248°F) curing toughened, epoxy matrix resins that have fibre orientations Twill 2×2, 0°/90°, 12 k fabric. The sheet has a linear density of 120 gsm and 50% fibre/resin ratio. Two groups of samples were manufactured, group1 includes five samples of dimensions 140×15×3 mm prepared for bending test and group 2 includes five samples of dimension 80×15×3 mm prepared for impact test. Four samples from each group have geometrical cut-out of circle, rectangle, triangle, square shapes and one sample from each group is a reference sample (virgin) that does not have any flaws. The square, rectangular, triangular and circular shapes were cut-out from the 3rd ply as shown in Fig. 1a–c respectively.

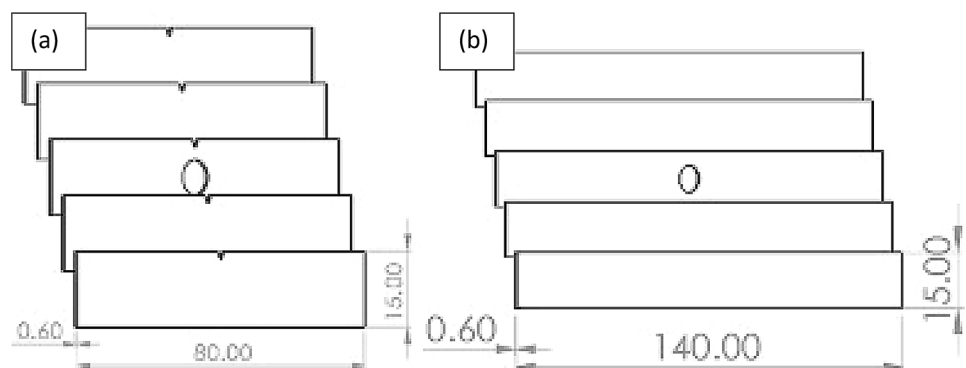
Fig. 2 Schematic view of **a** top Circular embedded flaw for impact test **b** top circular embedded shaped flaw for bending test

The shaped flaws were cut-out using Zund 3S digital sheet cutter that have an accuracy of ±0.1 mm. These plies were stacked together to form a beam, for illustration, the schematic of the circular cut-out defect specimens is shown in Fig. 2.

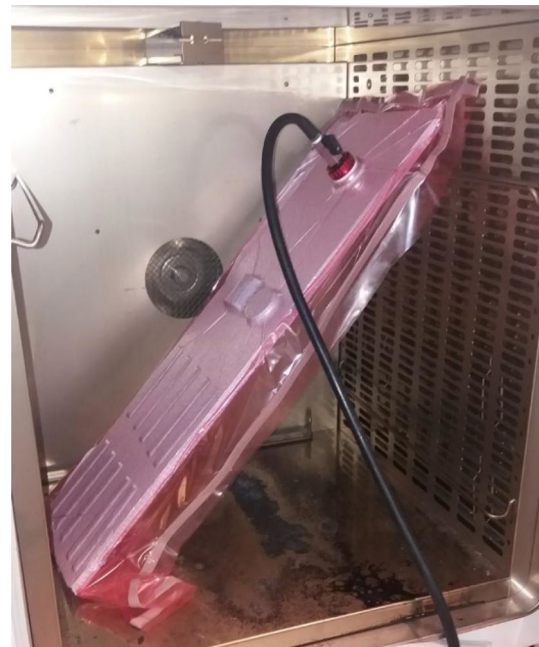
Fig. 3 Specimens curing in a vacuum bag and undergo curing cycle in an oven

All the specimens were prepared and cured using vacuum bagging system and cured in an oven as is shown in Fig. 3. Laminate plies or layered material were placed over an open mould surface and it was sealed in an airtight envelope bag. Specimens were cured in 3

stages. The first stage is a heat ramping at 2 °C/min to 70 °C and hold for 180 min. The second stage is a heat ramping at 2 °C/min to 110 °C and hold for 180 min. The last stage is a cooling to room temperature at 1 °C/min.

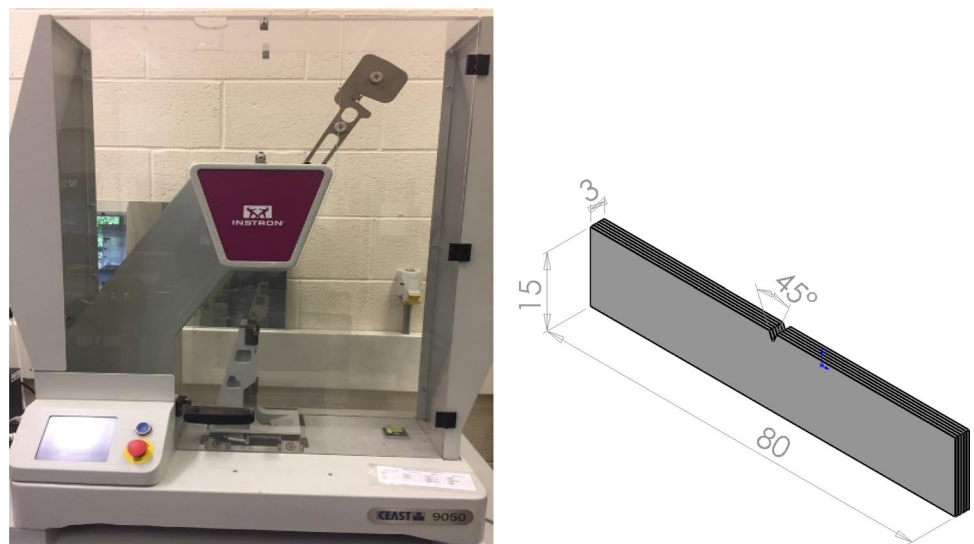
Fig. 4 Instron CEAST 9050 Charpy test equipment and the test specimen and V- notch

The specimens were tested using Instron CEAST 9050 Charpy test equipment as shown in Fig. 4a. The instrumented hammer is able to test nominal impact energies up to 7.5 J, impact velocities of 3.8 m/s and fall angle of 150°. The specimens were notched to specified V-shape of 2 mm depth, opening angle of 45° and a tip radius of 0.25 mm (Fig. 4b) according to BN EN ISO 179-2 standard for instrumented impact test of polymer composites.

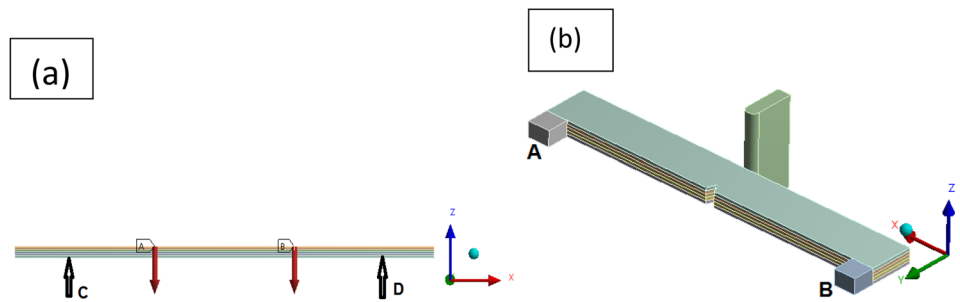
Fig. 7 **a** Bending test configuration, **b** Impact test configuration

For bending and impact test simulations, the beam was considered as a simply supported beam as is illustrated in Fig. 7a and b. For bending test, a displacement in the z-axis was applied of 6 mm according to the failing deflection obtained from the experimental curve in Fig. 8, while displacements and rotations were restricted in other directions. The bending analysis was carried out using roller diameter of 5 mm that located in the support and loading span and friction factor of 0.4. The total step set to be 100 steps of each interval of 0.02 s. The maximum z-direction stress was obtained from both tension and compression sides. While, the impact analysis was carried out using a V-notch specimen and the energy-time-displacement were monitored. The sample has been supported from A, B ends of span 60 mm set as a deformable object, while the hammer set as rigid object that has an impact velocity of 3.8 m/s and impact time of 0.001 ms. For the damage criteria and crack initiation in the impact test, the material properties were set for tensile, compression and shear stress of 600, 570, 90 MPa respectively.

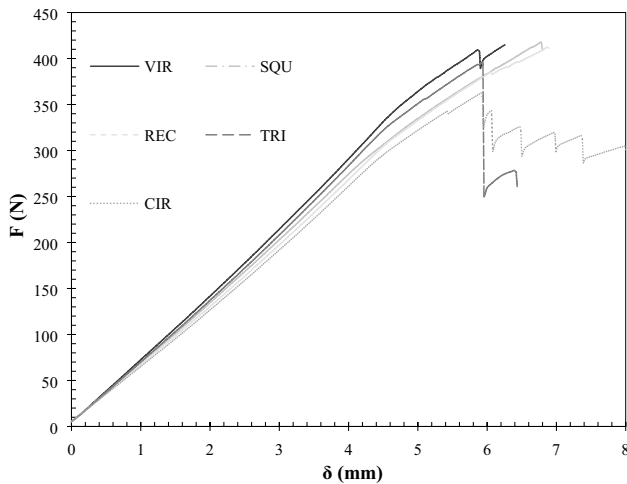
Fig. 8 Plot shows the correlation of the applied Force with deflection obtained from Zwick Roel 1474 testing rig

Force displacement plots in Fig. 8 shows the stiffness of all specimens that fail at 6 mm deflections. The maximum force is the force at the fracture. The maximum force for

each specimen was obtained from averaging 3 specimen tests from same category, it was found that standard deviation was ± 5 N from the fracture force listed in Table 4. The evolution of phases of deformation in all specimens have three phases as shown in Fig. 8. The three phases deformation are: the linear phase due to elastic modulus, second phase where curve loses its linearity and exhibit non-linear deformation, which considered is the beginning of damage and later phase is the rupture of the specimen.

The experimental results of flexural strength of all specimens were found in the range of 185.78–161.38 MPa, which below the specified flexural strength (300 MPa) that provided by Solvay advanced composite. The circular cut-out defect shows a significant reduction in its strength. Among the various shaped embedded flaws, circular specimen has minimum fracture strength of 161 MPa. This is 13% reduction in the strength compared with virgin sample. The square hole has the highest incur failing stress of 184.4 MPa.

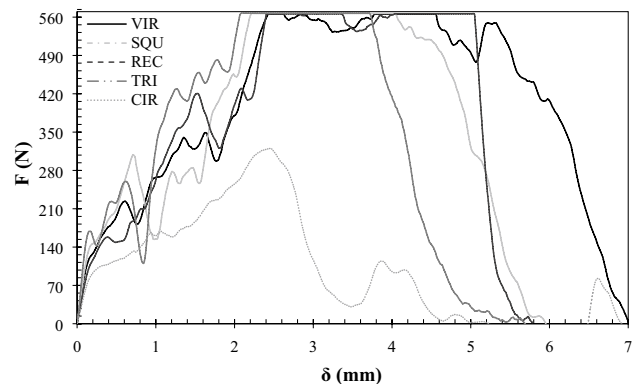
Fig. 9 Force displacement profile from experimental impact test

The impact strength on all specimens provide Force-Energy-Displacement correlations. Figure 9 shows a plot of force–displacement of virgin specimen and cut-out defect specimens and Fig. 10 shows the correlation of energy absorbed with the hammer penetrate and break the sample width.

It is of significant interest to observe from the plot that the circle flaw specimen exhibits minimum force as compared to the rest of the specimens. Similarly, in the Fig. 10 Energy-displacement plot, circular defect specimen absorbs least energy (0.5 J) compared to 3.53 J to the virgin sample. According to Solvay advanced composite data sheet, the fracture strength should be with 5.82 ± 0.1 J to the virgin sample. However, the measured value was 65% less than the reported one. In addition, the fracture forces of the flaw samples varied and reduced according to the type of embedded flaws. The maximum impact force of

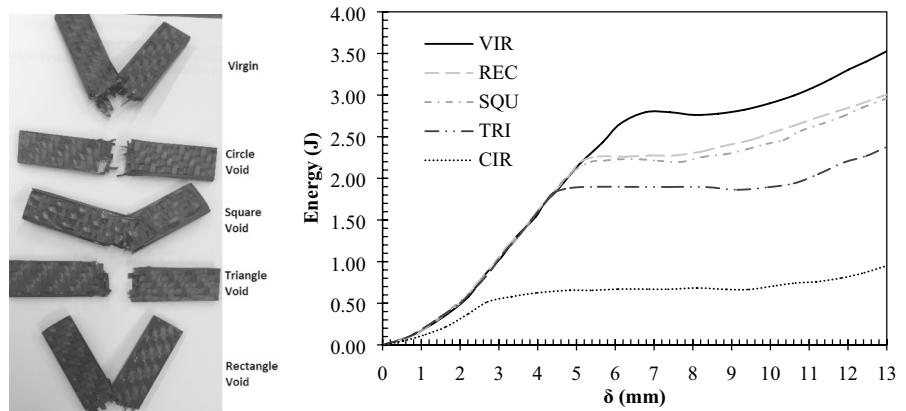
Fig. 10 Energy-displacement curve recorded of the test specimens

circular, rectangular, square and triangular, virgin specimens found to be 320 N, 566 N, 565 N, 567 N and 566 N respectively. The effect of circular cut-out defect caused 73% reduction in absorbed energy due to multiple stress concentration points. The impact strengths are listed in Table 5

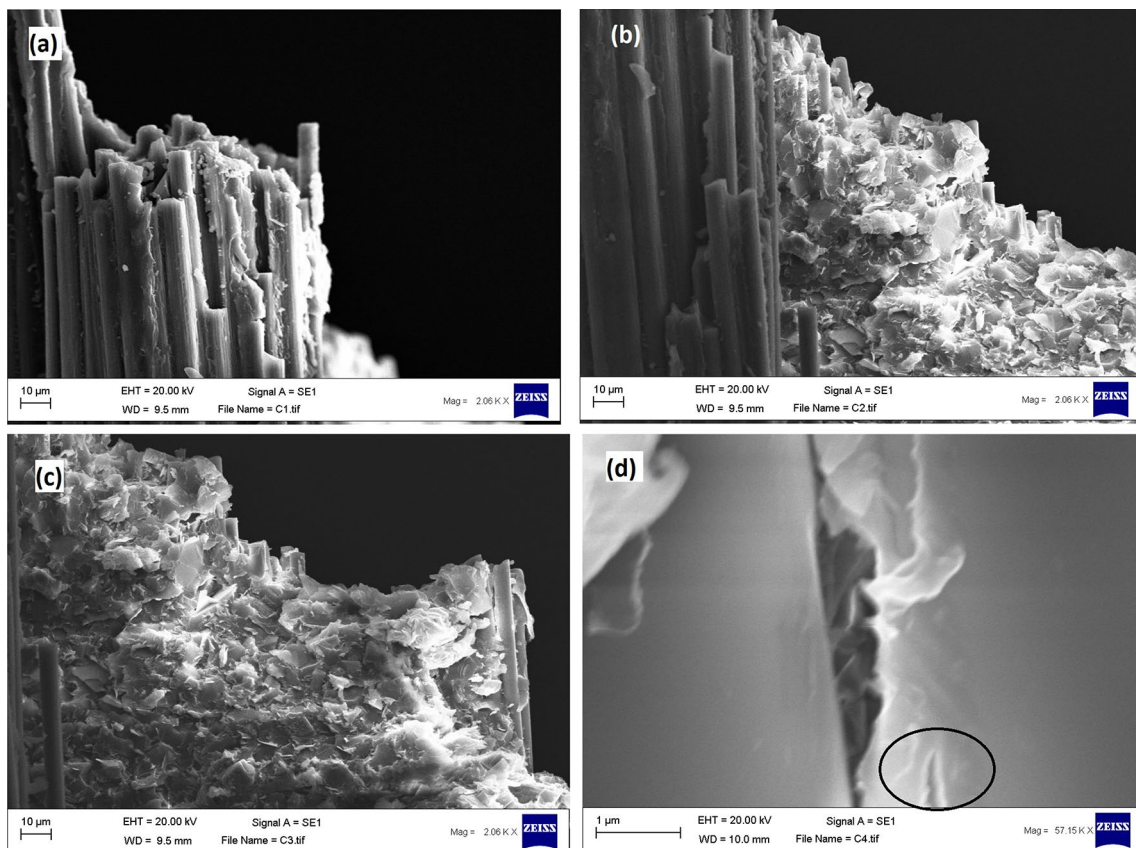
Fig. 11 SEM image of the fracture area in circular void specimen **a** Bulk virgin specimen fracture area, **b** matrix fracture area taken from circumferential area of the defect cut-out, **c** matrix and fibre fracture area **d** Matrix Nano crack along the direction of the fibre

In the circle shape, the stresses will be experienced in the main (weft yarn) direction and in the bias (45°) direction

of the circular specimen. A simple approach to calculate the effective stress concentration factors and axial stress in major axes direction in circular defect in composite laminates called the 'Point Stress Criterion'. It is assumed that failure around the circle occurs when the stress at some distance away from the circle is equal to or greater than the virgin laminate strength of the specimen. The other reason for the failure of the circle shape is explained using 'Average Stress Criterion'. It is assumed here that the failure occurs when the average stress over some distance ahead of the circle is equal to the virgin laminate strength of the specimen. However, the third criterion of strain concentration around circle can be explained with the damaged weave, a higher value of strains is found in areas where fibres are oriented perpendicular to the loading direction [14]. A lower value of strain is observed in areas where fibres are oriented parallel to the loading direction. The 2 × 2 Twill fibres weaving pattern is oriented so that the weft yarn skip two wrap yarns and go over the third one, hence, the strain concentrations in laminates with circles are influenced by the loose end fibres that will easily break in the direction of load circle, leaving the main stress carried out by the matrix. The angles of the loose fibre will

The scanning electron microscope images shown in Fig. 11 indicates: (a) a fibre pull-out in the virgin sample as bulk visual inspection, while the microstructure failure analysis of defect cut-out area indicate a matrix crack as shown in Fig. 11b. In the circular sample, all fibres were intact, and no fibre pull-out has been observed at the fracture area as shown in Fig. 12c and a Nano matrix crack has been identified in Fig. 11d.

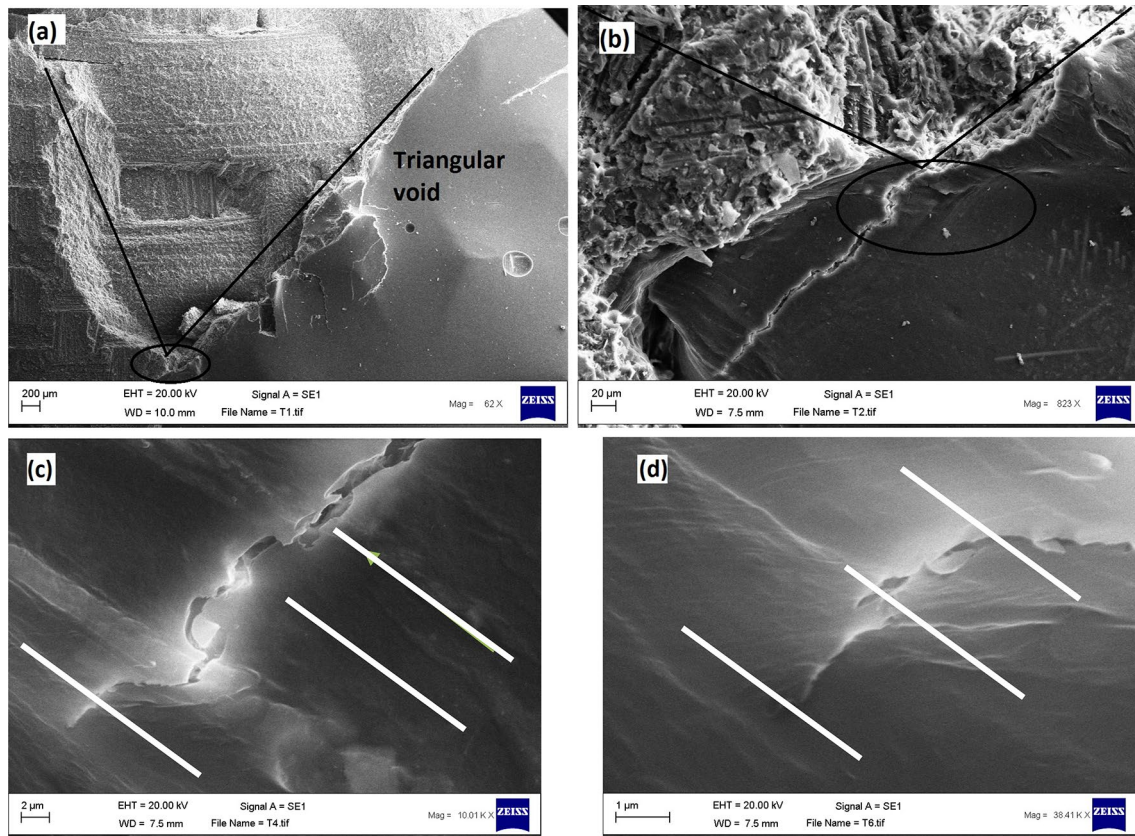
Fig. 12 SEM images of the crack propagation in triangular sample, **a** bulk stage, **b** crack root, **c** crack propagation, **d** Nano crack path between the fibres

The fractography examination of the triangular void specimens using scanning electron microscopy shows the cracking area of the specimen in Fig. 12a. In Fig. 12b confirms that a crack exists at tip of the triangular cut-out and progressed across the specimen width in the axial direction with a kink shear band through the ply thickness. A further investigation to the crack growth roots in that fracture area leads to spread smaller longitudinal cracks shown in Fig. 12c. Then, the crack transformation from longitudinal to transverse direction along the fibres

were in Fig. 12d. This has been confirmed that matrix crack has been arrested by the fibres that highlighted in white lines in Fig. 12c and d. However, there is no evidence of this crack of being the first crack that material due to fail. A future work should focus on in-depth fractography analysis that use in-situ CT stage mounted in a high-resolution CT X-ray tomography might reveal the root of the first initiated crack.

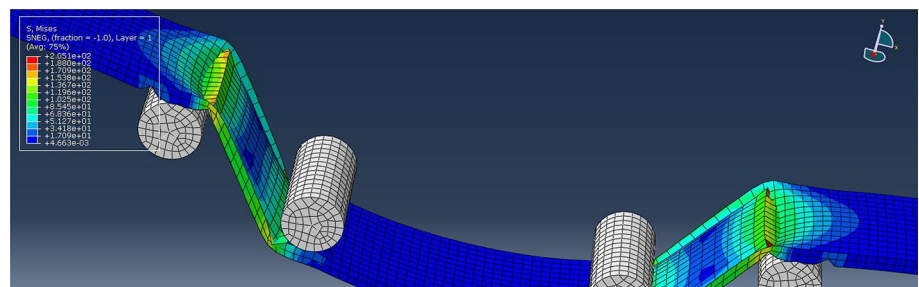
Fig. 14 Failure mode of virgin sample at 8 mm deflection

All tension stresses were higher than the compression stress in all specimens and they were listed in Table 6. No failure mode has been observed, however, a failure in virgin sample has occurred once the deflection increased from 6 to 8 mm as shown in Fig. 14, a maximum stress of

300 MPa has been noted. That value is in agreement with the Solvay material data sheet for flexural strength.

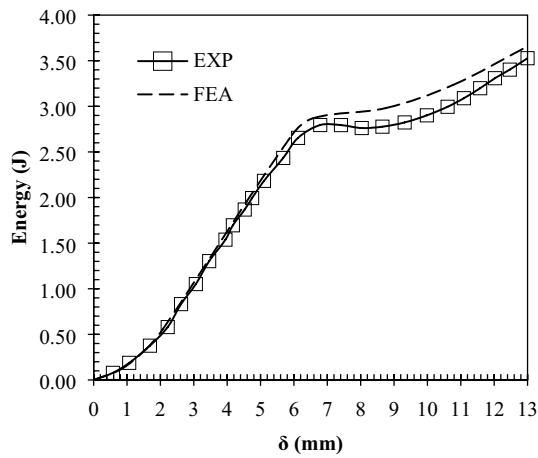
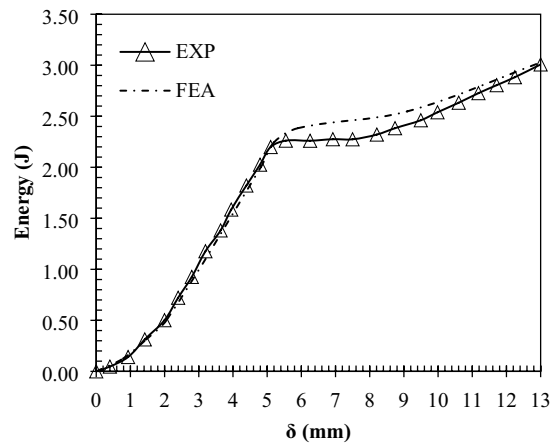
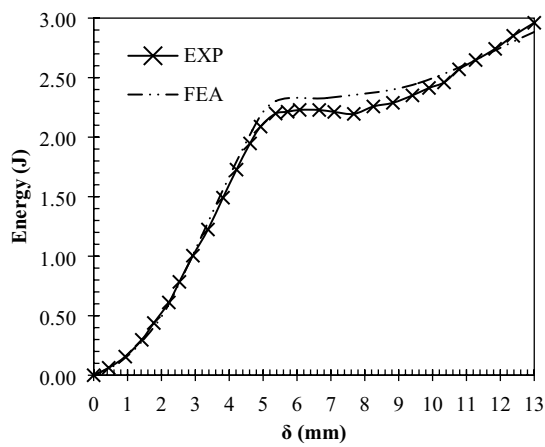
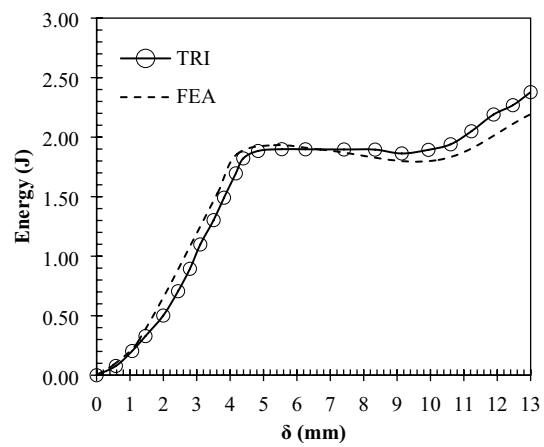
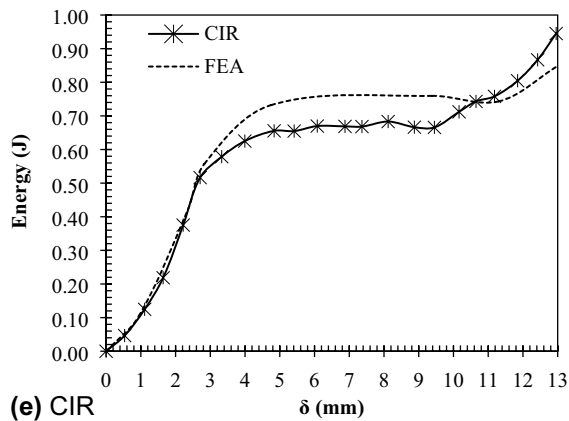
Fig. 15 Comparison of energy-displacement curve between experimental and FEA results, **a** virgin, **b** rectangular, **c** square, **d** Triangular, **e** circular. Though the surface area of the cut-out defect represents 1.8% ($2100 \text{ mm}^2/38.4 \text{ mm}^2$) from the entire surface area

Figure 15 shows the FE simulated Energy-displacement plots along with the experimentally acquired results. Plots seem to be in reasonable agreement however as can be seen from Table 7, the specimen with circle embedded flaw is visibly deviated with an error of 10%. This discrepancy between FE analysis and experimental results could be explained due to the micro buckling that occurred at the notch that is not represented in the FE analysis. The experimental result shows the lower energy absorbed for the damage. FE simulations did not capture the fracture surfaces at the notch and at the cut-out defect hence, precise calculation and interaction between both the cracks could not be accurately captured and analysed.

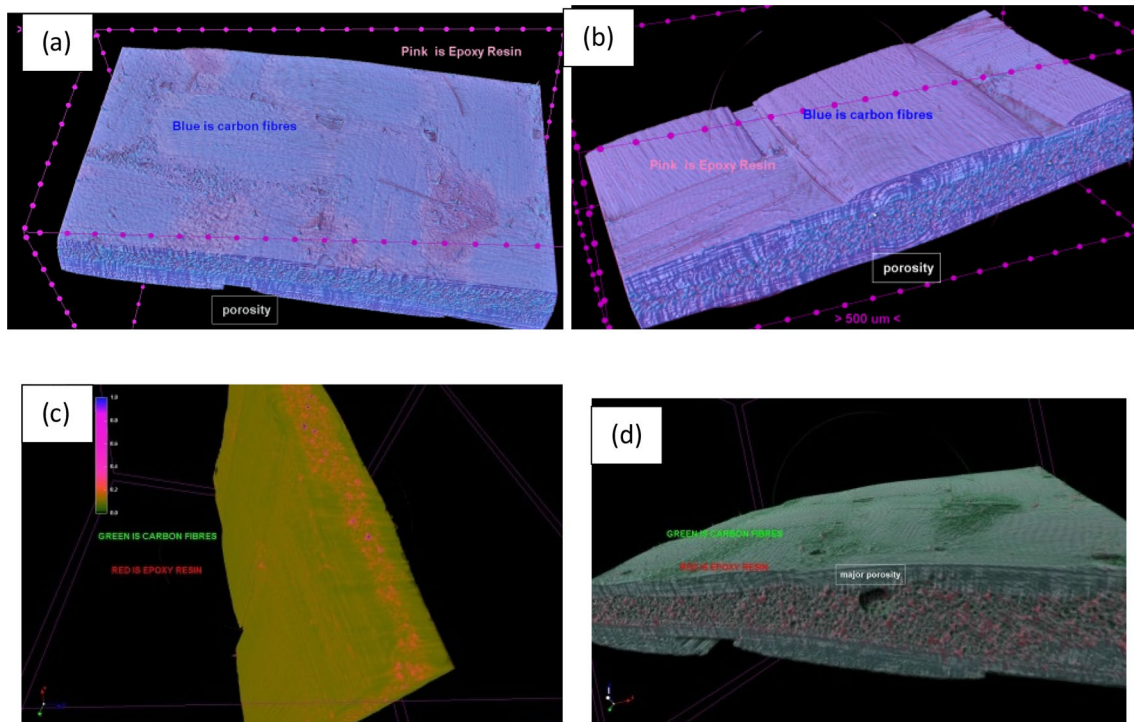
Fig. 16 Images taken from X-ray tomography of specimen size 1 mm × 1 mm × 1 mm size VRE **a** virgin sample, **b** rectangular sample, **c** triangular sample, **d** circular sample

At the final stage of the analysis, a micro computed X-ray tomography has been deployed using CT scan Bruker Sky scan 2211 to look at 3D imaging of the fibre orientation. This is necessary to ensure that cut-out defect is correctly positioned after curing. A volume representative element (VRE) has been selected from the scan data to achieve high

resolution image of 2 microns that shown in Fig. 16. The x-ray source voltage was set 30 kV, no filter was used, and sample was mounted on a precision air bearing rotation stage with less than 50 nm accuracy to achieve the high-resolution images that shown in Fig. 16. Figure 16a shows VRE of the virgin sample cross section, no twist, Knick in the fibre have been observed. While, a circular defect specimen is shown in Fig. 16d at the 3rd ply using sectional clip in CT Analyser software. A considerable porosity has been detected and highlight in red colour in Fig. 16c and d. Other defect samples were CT scanned, and the cut-out defects were not identified. We suggest that the epoxy resin might flow into the defect during curing and fill completely that make it a difficult to detect in this test.
