Research Article

Corrosion of stainless steel coated with a ZrO_2 film in a hydrogen sulfide gas environment

A zirconia sol was prepared by the sol–gel method and coated on the surface of stainless steel substrates. The gas corrosion test was carried out for the stainless steel substrates and for the coated samples using a high-temperature and high-pressure reactor. The coated samples and the substrates were placed in the reaction kettle, and it was filled with the H_2S gas at the pressures of 0.6, 0.8, and 1 MPa. After standing at room temperature for 24 h, the samples were observed by optical microscopy and a scanning electron microscopy, and it was found that as the pressure increases, the corrosion of the stainless steel substrates are more severe, while the film samples show only slight pitting corrosion. The experimental results show that in the corrosive H_2S gas environment, the stainless steel samples coated with the ZrO_2 film can effectively block the H_2S gas corrosion on the stainless steel substrate and reduce the hydrogen bubbling and hydrogen-induced cracking caused by gas corrosion. This finding has important practical significance for improving the service life

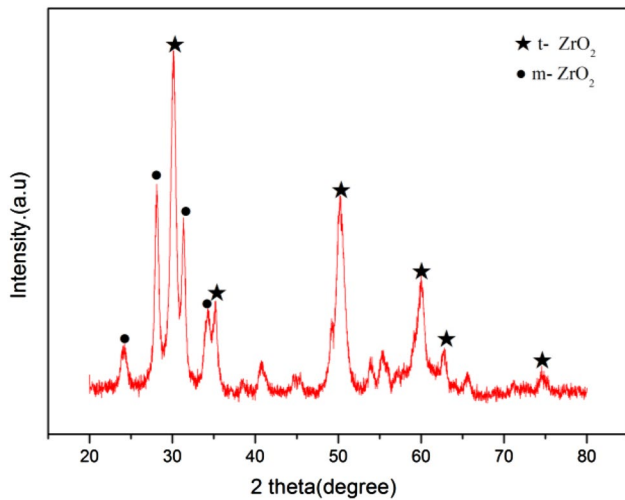
ZrO₂ was coated on a stainless steel substrate and sintered at a high temperature of 600 °C to form a dense zirconia film. During the sintering process, ZrO₂ undergoes a phase transition. Figure 1 shows the XRD pattern of the zirconia xerogel at 600 °C, indicating that two zirconia crystal structures are present at this temperature, namely, the tetragonal phase (t-ZrO₂) and the monoclinic phase (m-ZrO₂). It is clear that ZrO₂ has mostly completed the transition from amorphous to crystalline. The surface morphologies of the samples coated with ZrO₂ film at a sintering temperature of 600 °C were observed by AFM. An examination of the AFM image (Fig. 2) shows that the ZrO₂ film of the coated samples is found in the shape of a sharp cone, and a few grid-like depressions are observed on the surface [9]. The

Fig. 1 XRD pattern of ZrO₂ xerogel at 600 °C sintering temperature

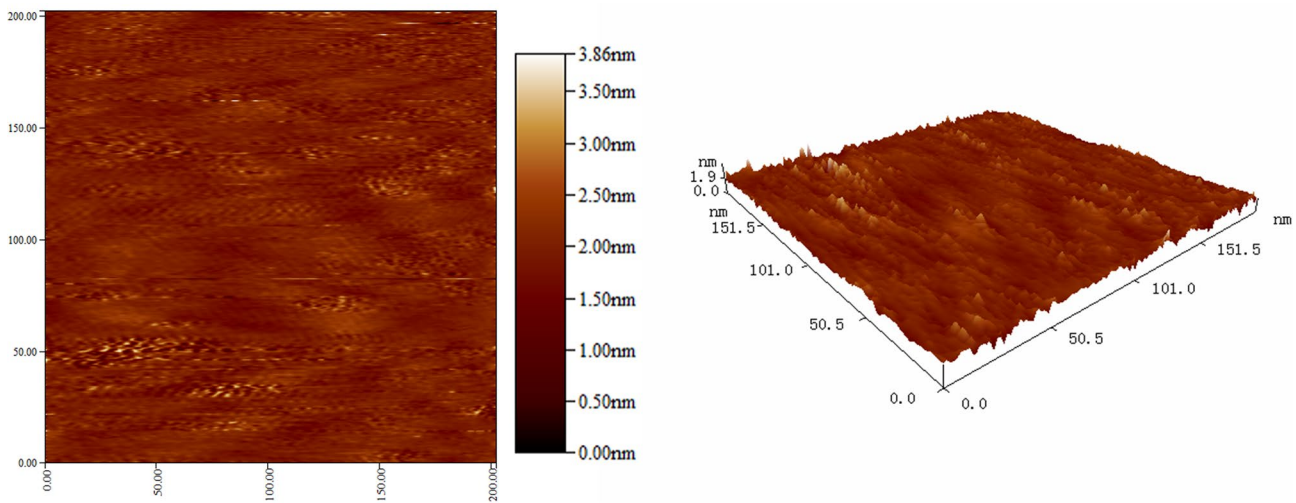
Fig. 2 Surface morphology of ZrO₂ film coated at 600 °C

connected, resulting in crack extension and expansion. The number of hydrogen bubbles in the coated samples (Fig. 2f) increases, and black corrosion spots appear on the surface. Hans-Arm and his team found that a large fraction of the H₂ produced by Fe and H₂S is adsorbed on the metal surface, reducing the likelihood of effective contact between the metal and H₂S, so that the reaction rate is gradually reduced, and this decrease favors adsorption to the metal. The amount of surface H₂ is reduced. After the two competing processes reach equilibrium, the corrosion is carried out at a certain speed. Therefore, the short-term experimental data cannot accurately reflect the long-term degree of corrosion. It is generally considered that the test results obtained after 50 or more hours are close to the actual value and can be used for the evaluation of long-term vulcanization corrosion [10].

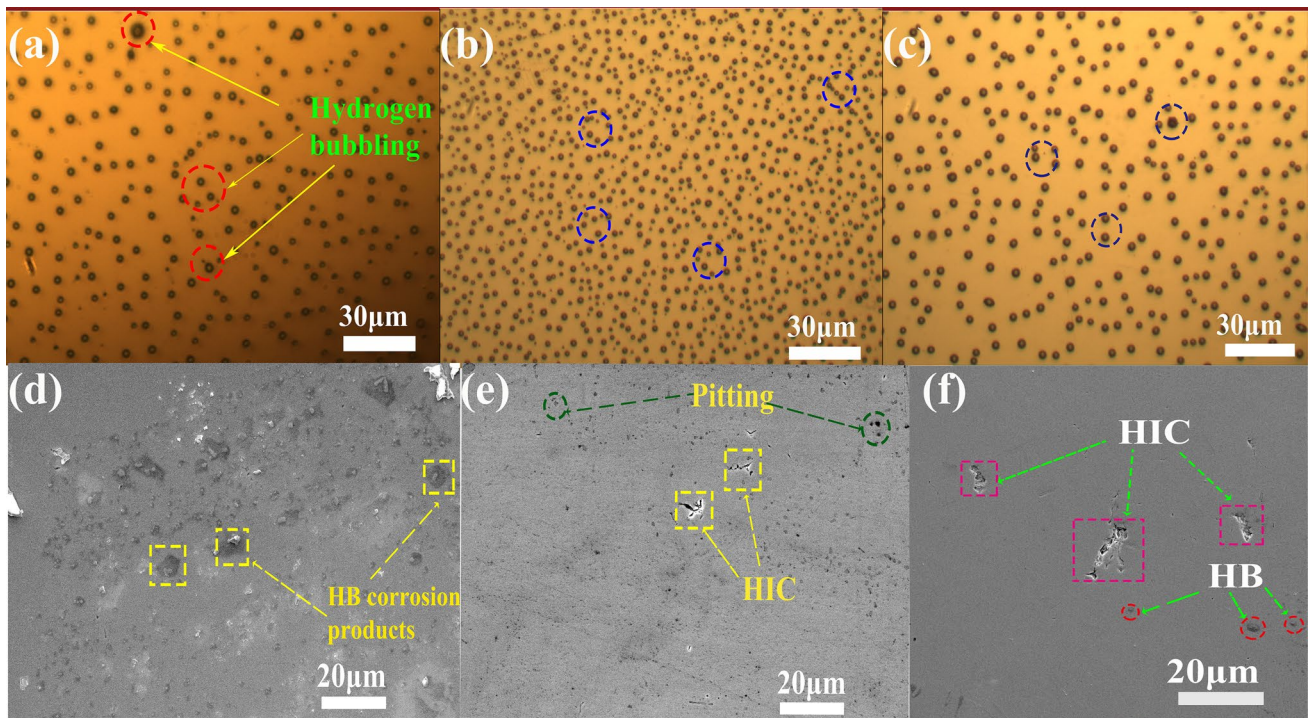
were observed with a metallurgical microscope. Figures 3 and 4 show the surface morphology after the corrosion of the stainless steel substrates and the coated samples, respectively.

Figure 3a–c show the morphologies of stainless steel substrates, and Fig. 4a–c show the morphologies of coated samples. Images were taken immediately after the gas corrosion test, and the specimens were observed under a metallurgical microscope. The bubbles on the surface of the specimens were not broken, and the bubble morphology can be seen clearly observed. After a period of time, the bubble were broken and placed under a scanning electron microscope (3400 SEM, Japan). The bubbles morphologies are shown in Figs. 3d–f and 4d–f. The corrosion of the stainless steel matrix becomes more severe with the increase in the H₂S pressure, and cracks appear. When the H₂S pressure is 0.6 MPa, the gas causes significant corrosion to the stainless steel substrates, while the coated specimen (Fig. 2d) show essentially no bubbles. When the pressure is raised to 0.8 MPa, the number of bubbles significantly increased in the same unit area, and the substrate is severely corroded by the bubbles and starts to show the generation of cracks. At the same time, as observed from Fig. 1e, the bubble rupture gives rise to corrosion pits in the substrate, and some dark black tissue appears. The coated sample (Fig. 2e) showed only small gas bubbles in some areas. When the pressure rises to 1 MPa, the number of bubbles on the surface of the substrates increases, and the hydrogen sulfide bubbles become

Fig. 3 Metallurgical microscope micrographs of the stainless steel samples and SEM micrographs of the stainless steel samples: **a, d** 0.6 MPa; **b, e** 0.8 MPa; **c, f** 1.0 MPa

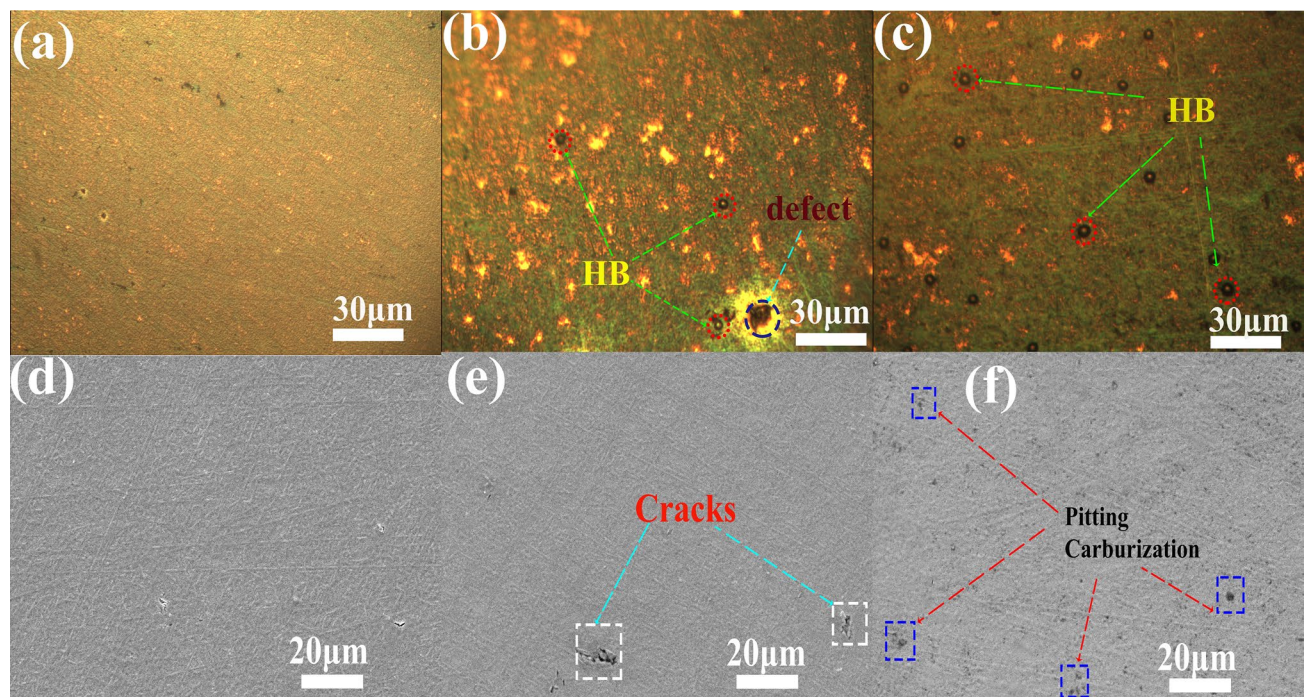
Fig. 4 Metallurgical microscope micrographs of the coated ZrO_2 film samples and SEM micrographs of the coated ZrO_2 film samples: **a, d** 0.6 MPa; **b, e** 0.8 MPa; **c, f** 1.0 MPa

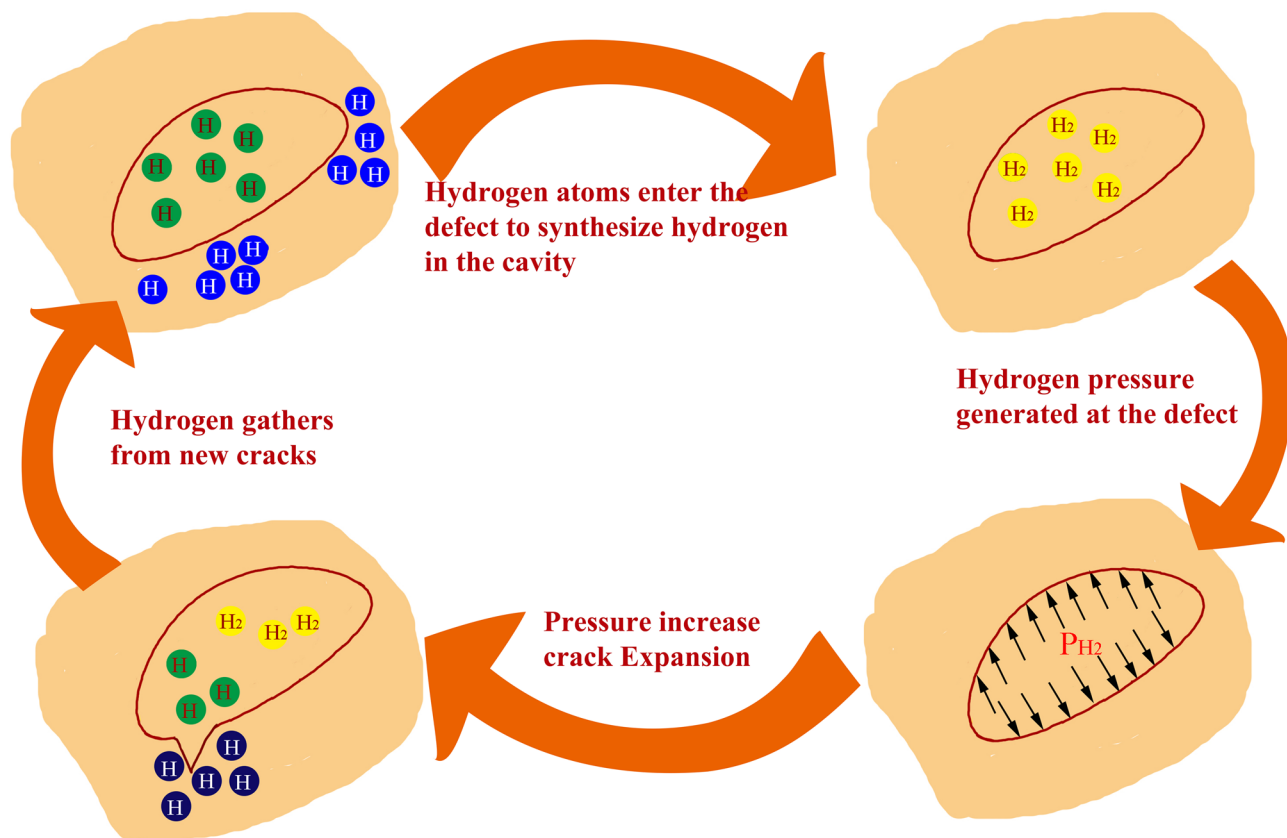
Fig. 6 Schematic diagram of hydrogen induced cracking mechanism

ZrO₂ film sintered at 600 °C has many penetrating cracks in the coating. Organic components are completely decomposed and volatilized at 600 °C. The difference of thermal expansion coefficient between ZrO₂ coating and low carbon steel substrate will cause larger internal stress in the coating ($ZrO_2 \approx 12 \times 10^{-6}/^\circ C$, $\alpha_{Mild\ Steel} \approx 16 \times 10^{-6}/^\circ C$), eventually leading to cracks [29, 30]. When the matrix at the crack is exposed to hydrogen sulfide, hydrogen bubbles will be generated along the crack corrosion matrix, and the bubbles will lead to the separation the ZrO₂ film from the matrix. With the increase in the H₂S gas pressure, the bubble diameter and the number of bubbles formed at the crack increases continuously ZrO₂ can prevent corrosion by blocking the contact area between the gas and the stainless steel matrix. The gas can reach the surface of the matrix through the crack and corrode the stainless steel matrix. When the H₂S gas pressure increases to 0.8 MPa, hydrogen-induced cracking occurs on the surface of the test sample, and the hydrogen induced cracking corrosion mechanism is shown in Fig. 6. First, diffusion analysis is needed to simulate the absorption and transportation of hydrogen from the inner wall (in contact with the acidic environment) to the gap

point. The hydrogen distribution near the crack tip and the hydrogen flux of the crack flank can be obtained by analysis. The hydrogen distribution also controls the complex reaction of the hydrogen on the crack surface, thus affecting the formation mechanism of the pressure. The pressure in the crack can be determined by the current crack volume and the total mass of hydrogen molecules in the cavity. According to the stress level near the crack tip, when the hydrogen reacts, the fracture toughness of the steel is affected, thereby further advancing the HIC process. Finally, when the increase in the volume of the cavity is sufficiently large to give to a pressure drop, crack propagation is suppressed. The entire cycle is performed until the final conditions are reached (the predetermined amount of crack propagation is achieved) [31].

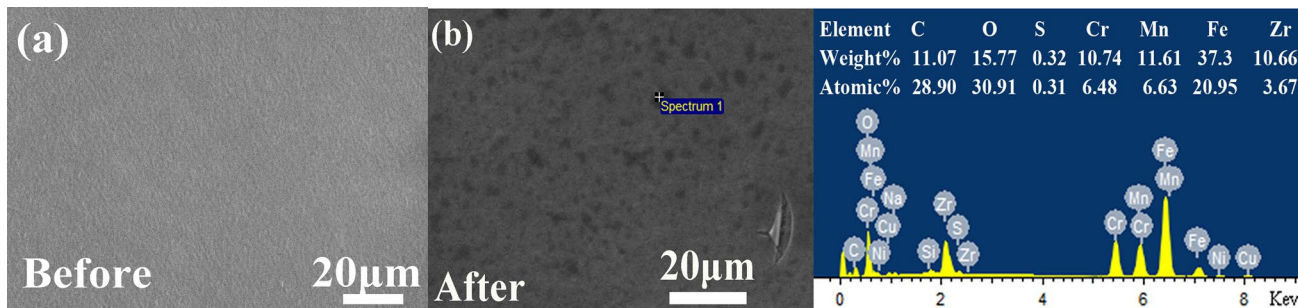
According to Fig. 7a, b, not only microcracks but also dark black structures at present on the surface of the coated samples. According to EDS analysis, these black areas contain high amounts of C and O and a very small amount of S. Some of these dark black materials are due to the precipitation of chromium carbide in the carburized layer when the stainless steel temperature exceeds 540 °C, not only reducing the free chromium content on the stainless steel surface but also making the original single austenite phase of stainless steel become a multiphase

Fig. 7 Morphology of the coated specimen before and after corrosion

weave with new phase formation, thus reducing the corrosion resistance of the stainless steel. This is the reason for the appearance of the dark black tissue [32]. There are still some black spots that did not appear prior to the corrosion. This is because these black spots are caused by the H₂S gas. When the H₂S gas pressure increased to 1 MPa, black substances appeared on the ZrO₂ film surface. Therefore, the coated sample was corroded, resulting in corrosion points. The ZrO₂ thin film is a porous ceramic thin film. Although it can prevent the outward diffusion

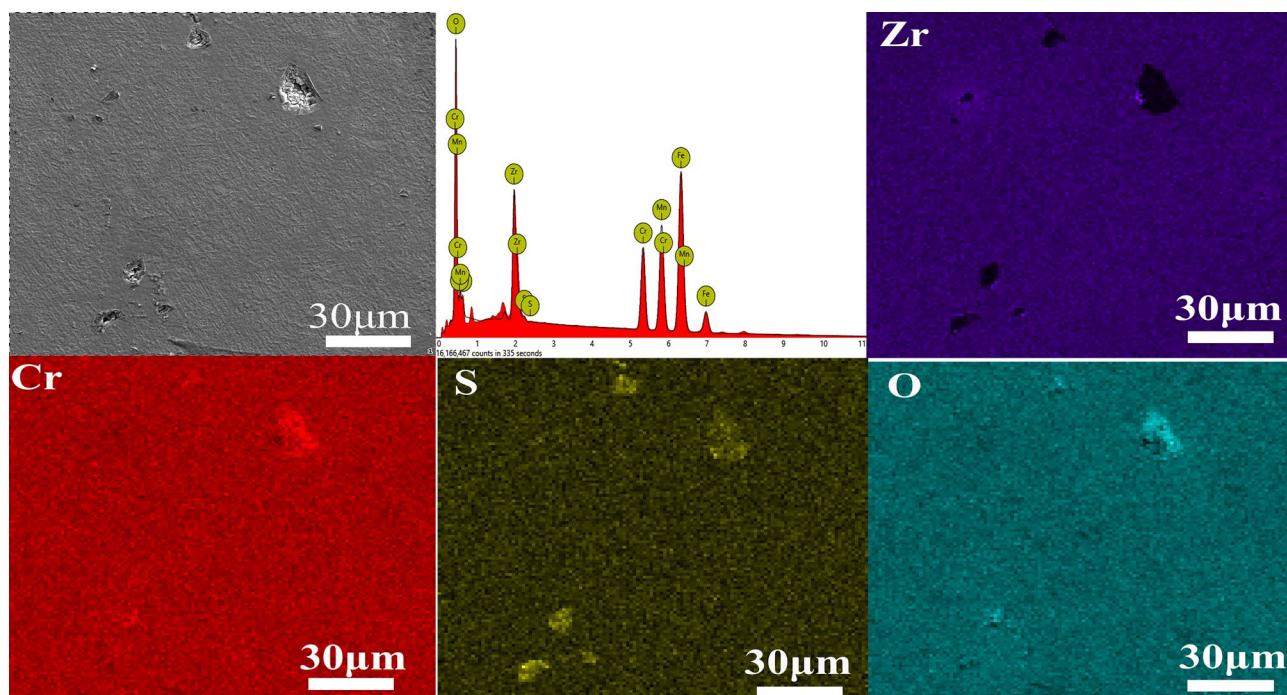
Through EDS spectrum analysis, it was determined that the film rupture is caused by the entry of the hydrogen sulfide gas. Figure 9 shows the energy spectrum scanning analysis of the sample coated with the ZrO_2 film. It is clearly observed from the scanning results that sulfur is present in the rupture zone while zirconium is absent. The hydrogen sulfide gas enters the ZrO_2 film through the defects in the substrate and in the film to generate hydrogen bubbling, and the zirconia film no longer protects the substrate after the rupture. The ZrO_2 film often generates microcracks due to the phase transition between the low-temperature monoclinic and mesothermal tetragonal phases. While this phenomenon is unavoidable, the microcracks produced

by the phase transformation have no effect on the corrosion. This is observed from Fig. 9. While S was detected in the rupture zone, it was not detected in the other areas of the coating, indicating that the zirconia film can effectively hinder the corrosion of the stainless steel substrate by the H_2S gas.

Fig. 9 Surface morphology and EDS spectrum of laminating samples under 1 Mpa H_2S gas

bubbling is located at the position of the crack, showing the bubbling from elemental analysis. There is no distribution of elements such as Fe, Cr, and Zr (Fig. 9h, i), and the element S, C and O (Fig. 9e–g) are detected in the edge region of the bubble, and the oxide in the ZrO_2 film is excessive during the sintering process. Growth causes significant internal stresses that cause the film to rupture, and the substrate at the cracks oxidizes at high temperatures [33]. C and O only appear in the rupture or bubbling of the film. C and O are not detected around the matrix bubbling. Only two elements are detected in the hydrogen bubbling of the coated samples. It is further observed from the energy spectrum presented in Fig. 8 that Fe and Cr carbides and oxides are not formed, So C and O originally existed in the coated sample.
