# Influence of fibre reinforced polymers in the rehabilitation of damaged masonry wallettes

Júnia Soares Nogueira Chagas\* and Gray Farias Moita

**Keywords:** Rehabilitation; CFRP; GFRP; Masonry; Damage

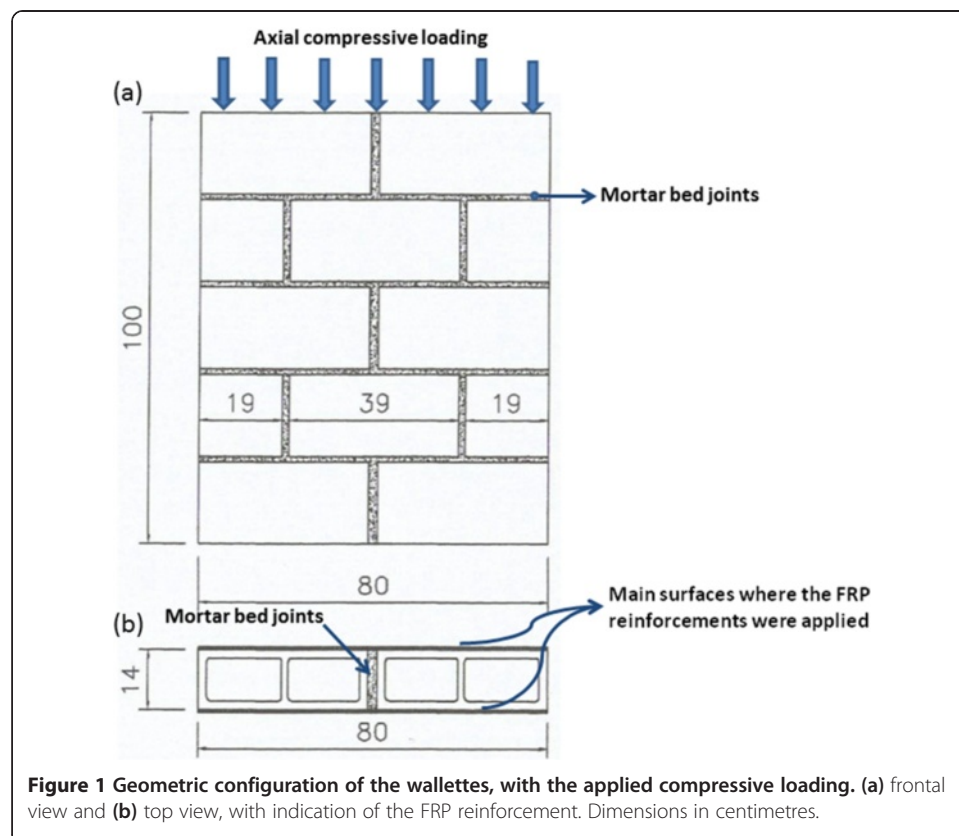
The masonry wallettes used in this research were built using concrete blocks and 1:2:6 (cement: hydrated lime: sand) mortar and had the following dimensions: height = 100 cm; length = 80 cm; thickness = 14 cm, as shown in Figure 1. Two different block sizes were utilised to build of the wallettes: (a) single-hole blocks (dimensions: 14 cm x

The damaged specimens were then prepared and strengthened by the application of carbon fibre reinforced polymers (CFRP) or glass fibre reinforced polymers (GFRP), completely covering both their two main surfaces, as shown in Figure 1. An adequate chemical and physical bonding between the polymeric fibre and the substrate of the masonry was utilized. After the application of the reinforcement system, the wallettes were once again subjected to a vertical compressive load up to their collapse. This study measured the maximum loading bearing capacity of the wallettes and assessed the possible structural rehabilitation in the damaged masonry structures after the reinforcement with the FRP.

Three specimens of the wallettes, namely RW1, RW2 and RW3, were built as schematic illustrated in Figure 1. Subsequently, they were subjected to axial compressive loading up to failure, which meant a mean load of 427 kN. The load was applied perpendicularly to the bed joints, in increments of the 2 kN, in an universal testing machine under vertical displacement control. During the loading, the strains along the loading axis were calculated using the average displacement measurements obtained from four dial gauges placed in the panels, two in each of the main sides. The test setup was established in accordance with the Brazilian standard NBR 15961-2/2011 [17]. These samples were considered the reference wallettes.

Before the application of the fibre reinforcement, the wallettes were prepared using high pressure water blasting in order to remove the powder and any other particles from the substrate. They were dried in room temperature for 7 days. Subsequently, the damaged specimens were strengthened by the application of one-directional fabric of CFRP. These wallettes were denominated CW1, CW2, and CW3. The specimens GW1, GW2, GW3 and GW4 received two-directional fabric of GFRP. The FRP layers covered both the two main surfaces of all damaged specimens, according to Figure 1.

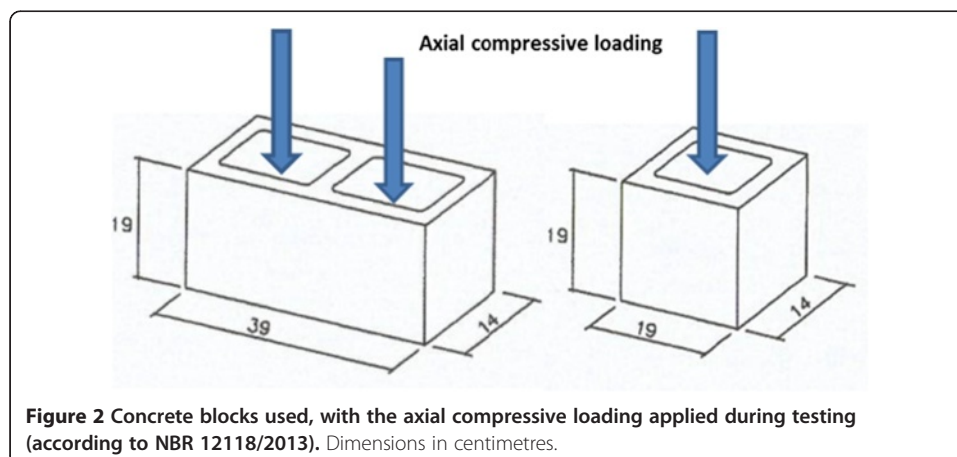
19 cm x 19 cm), and (b) two-hole blocks (dimensions: 14 cm x 19 cm x 39 cm), depicted in Figure 2, in order to allow the desired geometric configuration of the panels. Their average compressive strengths were, respectively, 6.30 MPa and 5.64 MPa. The mean compressive strength for the mortar specimens was 6.49 MPa. The experiments for the characterisation of the mechanical properties of these materials were conducted according to the Brazilian standards NBR 12118/2013 [15] and 13279/2005 [16], respectively.

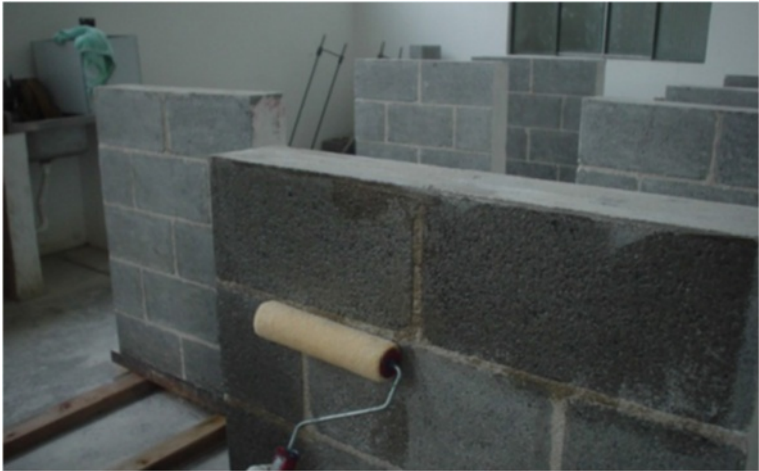
**Figure 3** Application of the primer on the damaged wallets.

An adequate chemical and physical bonding between the FRP and the substrate of the masonry was established. Firstly, the substrate of the wallettes was prepared with the application of one layer of the primer. This primer is a two-component solvent-less epoxy system which when mixed yields a penetrating medium viscosity compound. This primer is used to penetrate the pore structure of the cementitious substrates and to provide a high bonding base coating for the FRP system. The drying of the primer on the substrate took around 1 hour in room temperature. Figure 3 illustrates the primer application. Since the damaged wallettes did not present crushed parts, only cracks or micro-cracks, there was no need to fill the collapsed regions with mortar.

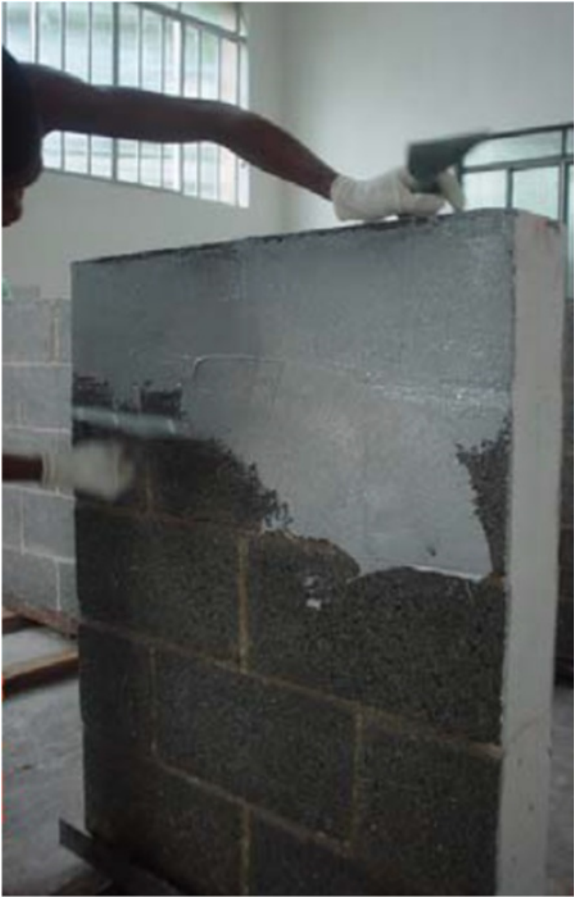
**Figure 4** Putty application.

Within a 48-hour period after the drying of the primer, a second layer of the adhesion system was applied, with a thickness of around 2 mm. This epoxy resin is known as putty. It was useful for the regularisation of any small surface imperfections and to provide a smooth surface to which the reinforcement system would be applied. The drying/hardening of the putty is an exothermic process that lasts around an hour. Figure 4 depicts the substrate regularisation when the putty was used.

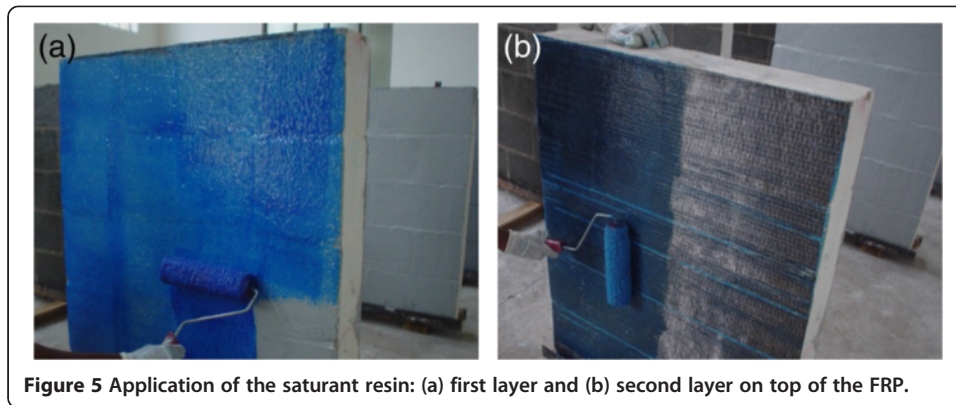
**Figure 5** Application of the saturant resin: (a) first layer and (b) second layer on top of the FRP.

The system was glued with a resin denominated saturant applied in two coatings, again within a 48-hour period to ensure the proper adhesion. This saturant is epoxy based, solvent free, high strength adhesive. One layer is applied over the primer, or the putty, already dried. At around one hour, before the saturant became tacky, the FRP fabric was applied. Within 2 hours, a second layer of saturant was applied on top of the FRP (Figure 5). Finally, a roller was used to expel any bubbles (Figure 6). The whole cure process took 7 days in room temperature, ranging between 25 to 35°C.

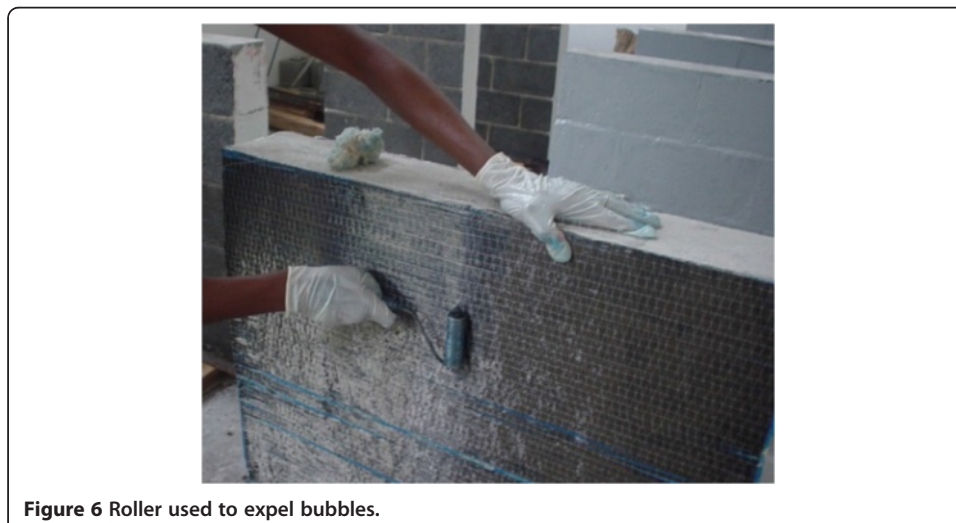
**Figure 6** Roller used to expel bubbles.

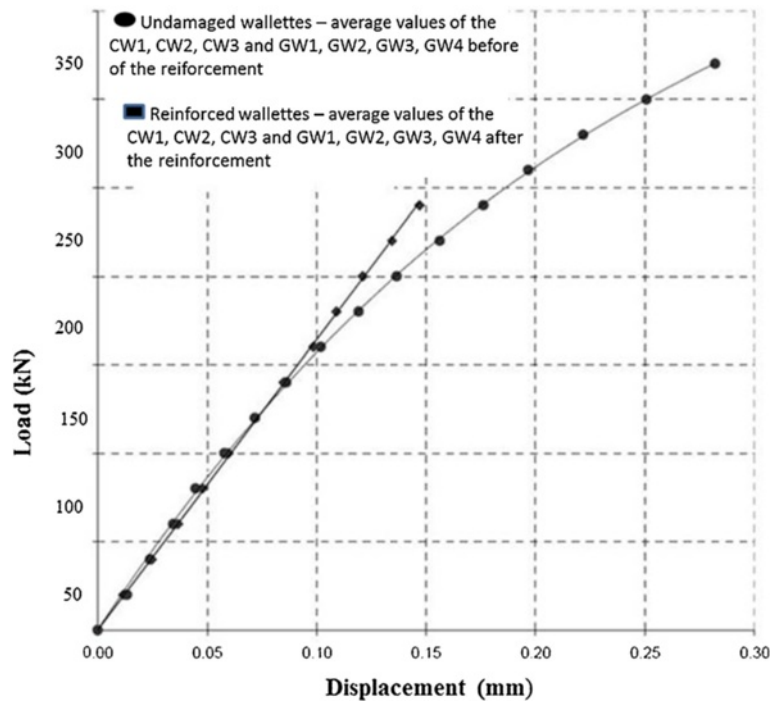
**Figure 8** Mean values for the load-displacement curves of the wallettes behaviour before and after the FRP reinforcement.

After the application of the reinforcement system onto the damaged wallettes, they were again subjected to a vertical compressive loading, up to their collapse. In this second loading, the relative vertical displacement was measured until the total load reached approximately 250 kN, which was around 60% of the reference collapse load. This procedure prevented damage in the measurement equipment if a sudden structural fail should occur. The experiments were performed in accordance with the Brazilian standard NBR15961-2/2011 [17]. For comparison with the reference wallettes experimental results, the Young's modulus was also determined for these reinforced wallettes.

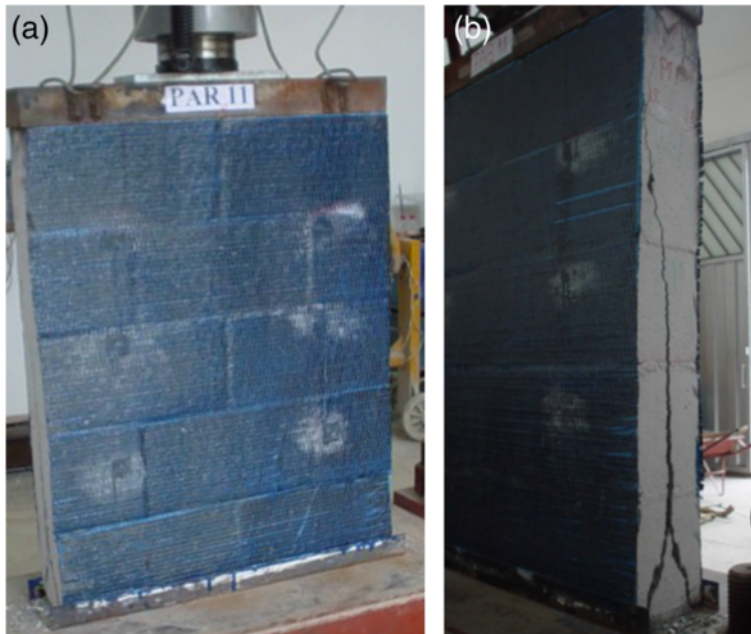
**Figure 9** Failure of the CW2 wallette reinforced with CFRP (with putty). (a) Frontal view and (b) lateral view.

Moreover, from the experiments in this study, it could be observed that the FRP reinforcement applied did not exhibit, during the entire loading process, faults or fracture of the adherent that could be visible to the naked eye. Figures 9 and 10 show that the CFRP reinforced wallettes that received the putty treatment (CW2 and CW3)

presented failure of the reinforcement system only after the total collapse of the structures, without presenting fibre debonding, neither between the FRP and the adhesive system, nor between the concrete substrate and the adhesive system. The failure mode of the specimen CW2 (Figure 9) suggests that the fibre reinforcement allowed for the structural masonry wallette to reach its maximum working loading capability, even after suffering the imposed damaging. Figure 10 brings the failure mode of the CW3 structure, where the fragile rupture of the concrete blocks can be seen. Here, again, no debonding between the substrate and the adhesive or between the adhesive and the FRP can be observed. This fact, combined with the maximum loading bearing capacity shown by the CW2 and CW3 specimens (as in Table 5), implies that the application of the putty contributes to the rehabilitation, as well as to the increase of the loading bearing capacity, as the result of a better bonding of the reinforcement system to the substrate. However, the CW1 specimen (Figure 11) that did not receive the putty treatment offered a premature failure when compared with the specimens CW2 and CW3, as shown in Table 5. From this figure, it is possible to observe the debonding of the reinforcement fibres, when the wallette reached its original failure loading, i.e., the lack of bonding of the FRP limited its performance and it only displayed a small loading capacity improvement.

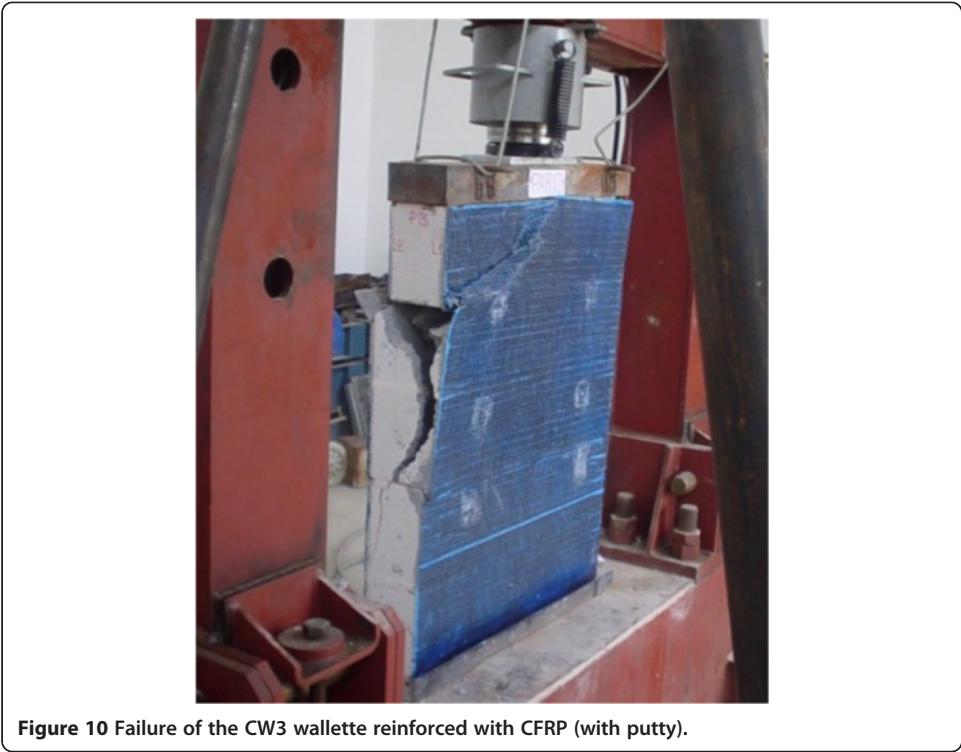
**Figure 10** Failure of the CW3 wallette reinforced with CFRP (with putty).

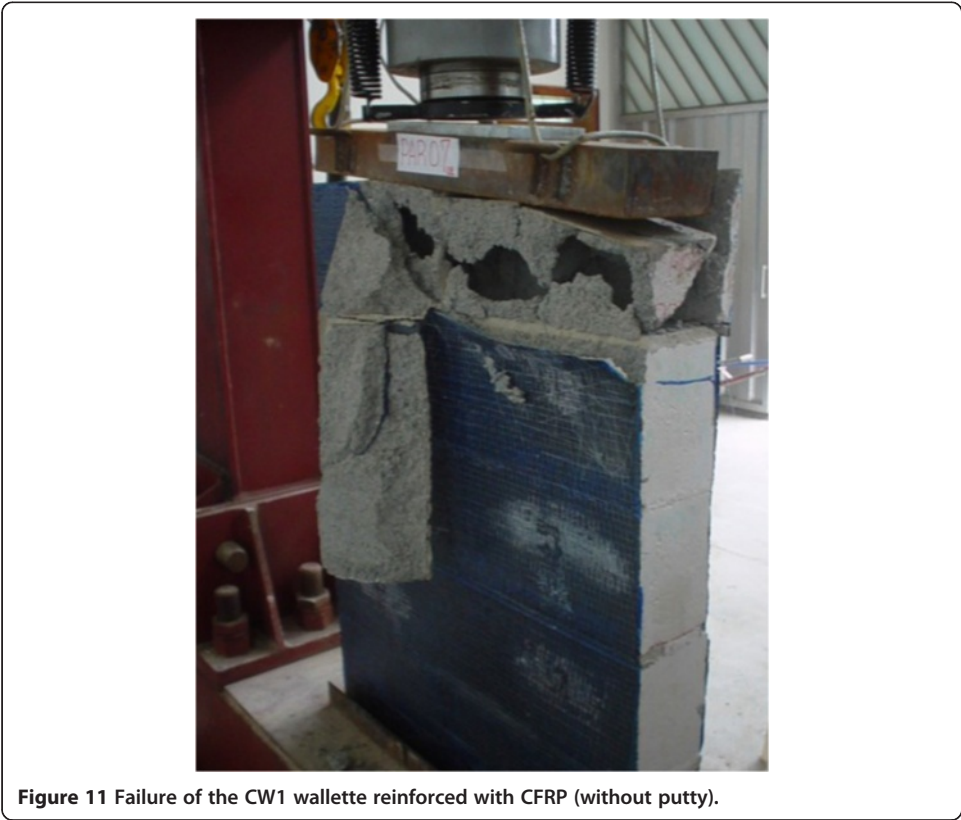
**Figure 11** Failure of the CW1 wallette reinforced with CFRP (without putty).

removal of a material layer during debonding. These behaviours have been widely studied for applications to concrete columns and beams, both from the experimental and numerical points of view, but, as far as masonry is concerned, only a limited number of studies can be found in literature [20]. In the current investigation, this fact can be observed and confirmed (see Figure 11).
