Hydromechanical constraints on piping failure of landslide dams: an experimental investigation

Austin Chukwueloka-Udechukwu Okeke* and Fawu Wang

Abstract

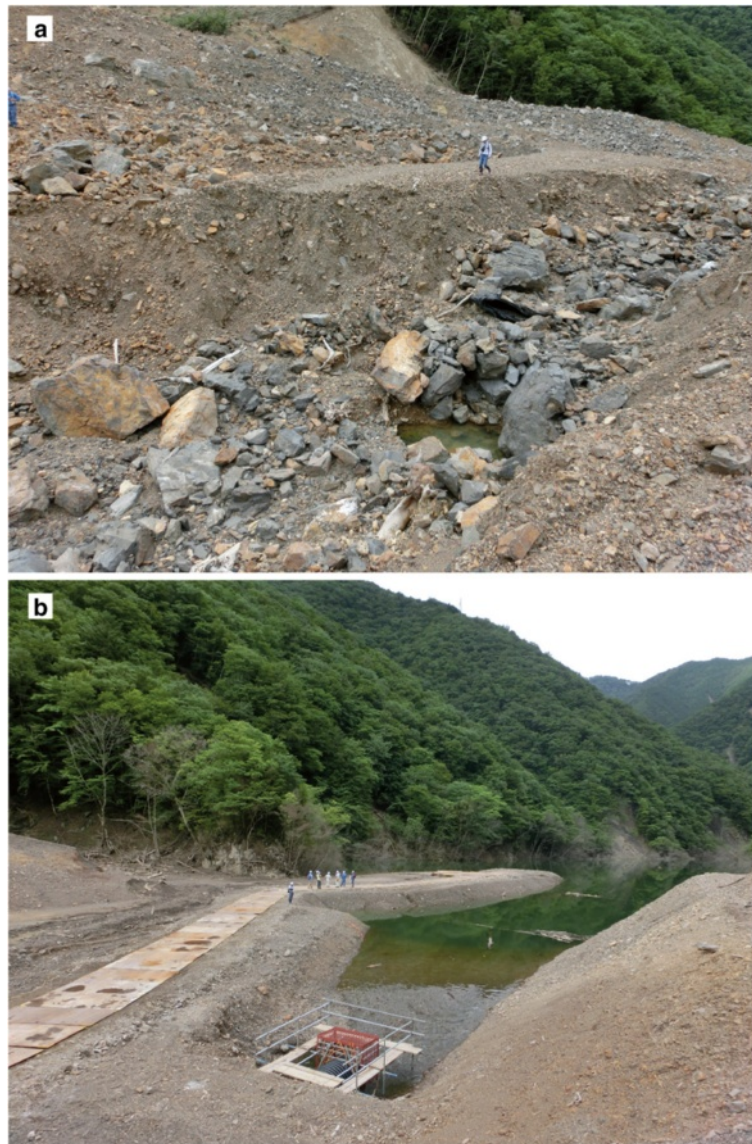
Fig. 1 **a** Exposed section of the materials composing the Akatani landslide dam **b** Upstream side of the Akatani landslide dam showing water inflow into the dam through an artificial drainage pipe. Note: People for scale (photo by Wang FW)

Trapezoidal-shaped landslide dams were built in the laboratory after a series of field investigations were carried out on two recent landslide dams (Akatani and Kuridaira landslide dams) formed in 2011, in the Kii Peninsula of southwest Japan. The choice of these sites as reference cases for this study was prompted by several factors, including (1) the relatively large volume of the two impoundment materials, of 9.4 million m³ and 13.9 million m³, respectively, (2) the characteristic nature of the landslide dam materials, which are dominantly composed of disjointed angular boulders (averaging 1 ~ 10 m in diameter), and cobble-sized clasts sutured in a fine-grained matrix (Fig. 1a), and (3) the significance of drainage pipes buried in the two sites, which function as artificial drainage channels for lowering of the upstream lake, so as to avoid potential overflow (Fig. 1b). The experimental dams were built to partially reproduce the geometry of landslide dams in real case scenarios, with efforts made to minimize unavoidable scaling issues resulting from space and time constraints.

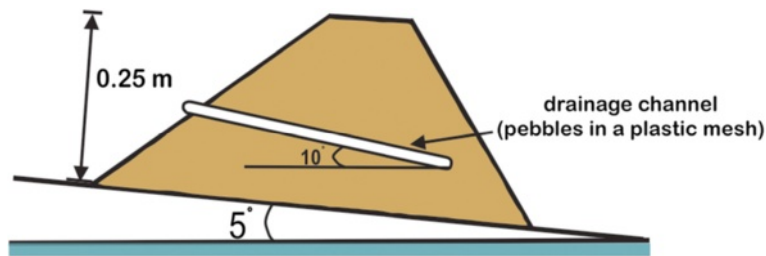
Fig. 3 Schematic diagram of the landslide dam geometry

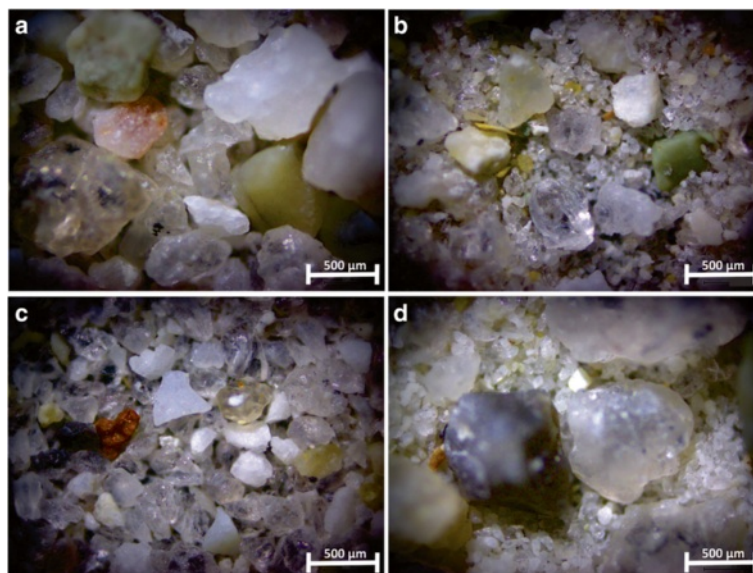
Fig. 4 Photomicrographs of reconstituted materials of dam mixes (a, b, c and d) (photo by Okeke AC)

Consequently, the materials used in this study comprised mixed and homogeneous samples of industrial silica sands (numbers 4, 5, 6, 7, and 8) in varying proportions (Figs. 4 and 5). The mechanical and hydraulic properties of the dam materials are given in Table 1. In the first step of the experiments, 2000 ml of water and 40 kg of each material were rigorously mixed using a mechanical mixer. The soil samples were used to build dams of a uniform crest and height (H_d) of 0.1 m and 0.25 m, respectively (Fig. 6). Summaries of the characteristics of the experiments carried out on dams built with mixed and homogeneous materials are given in Tables 2 and 3, respectively. The initial discharge rate Q_i was constant in all experimental runs, whereas T_e and T_b represent the time of onset of internal erosion and time of dam crest collapse, respectively.

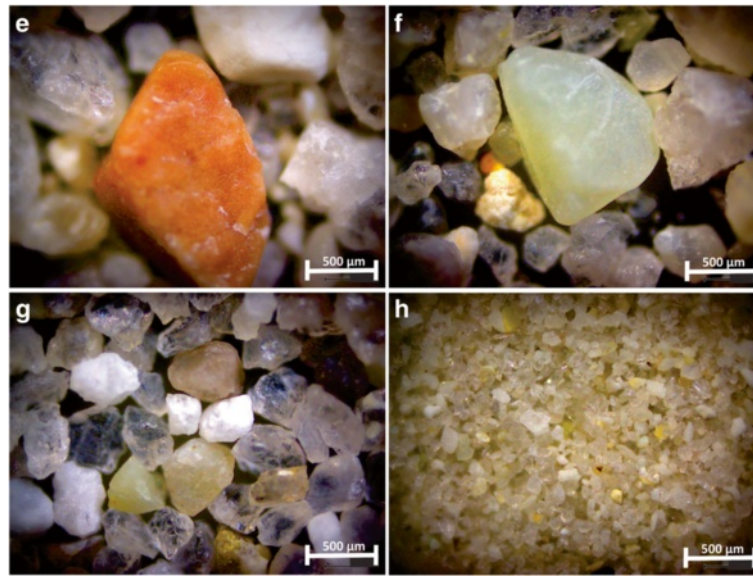
Fig. 5 Photomicrographs of homogeneous materials of dam mixes (e, f, g and h) (photo by Okeke AC)

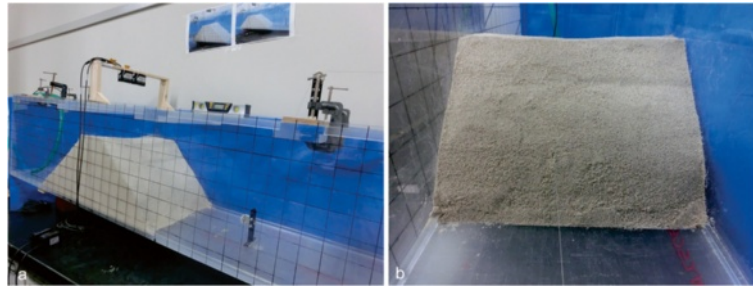
Fig. 6 **a** Side view of the flume tank. **b** Front view of a dam showing the downstream slope prior to commencement of an experiment (photo by Okeke AC)

0.3 m × 0.5 m (Awal et al. 2009), 1.5 m × 1 m (Wilson 2009), 1.4 m × 1 m (Wilson 2011), and 0.5 m × 0.5 m × 0.5 m (Fox et al. 2014) flumes. The upstream lake was recharged from a drainage hose fed by a water tap. Pre-failure crest settlements associated with the onset of internal erosion and piping were measured with two CMOS multi-function analog laser displacement sensors attached to a wooden overboard. Concave-upward depressions observed during the initiation of internal erosion and piping were monitored by positioning one of the sensors (H_{d1}) directly above the center of the dam crest, while the other sensor (H_{d2}) was fixed 0.07 m from the central part of the crest. These measurements were made by allowing a maximum vertical distance of

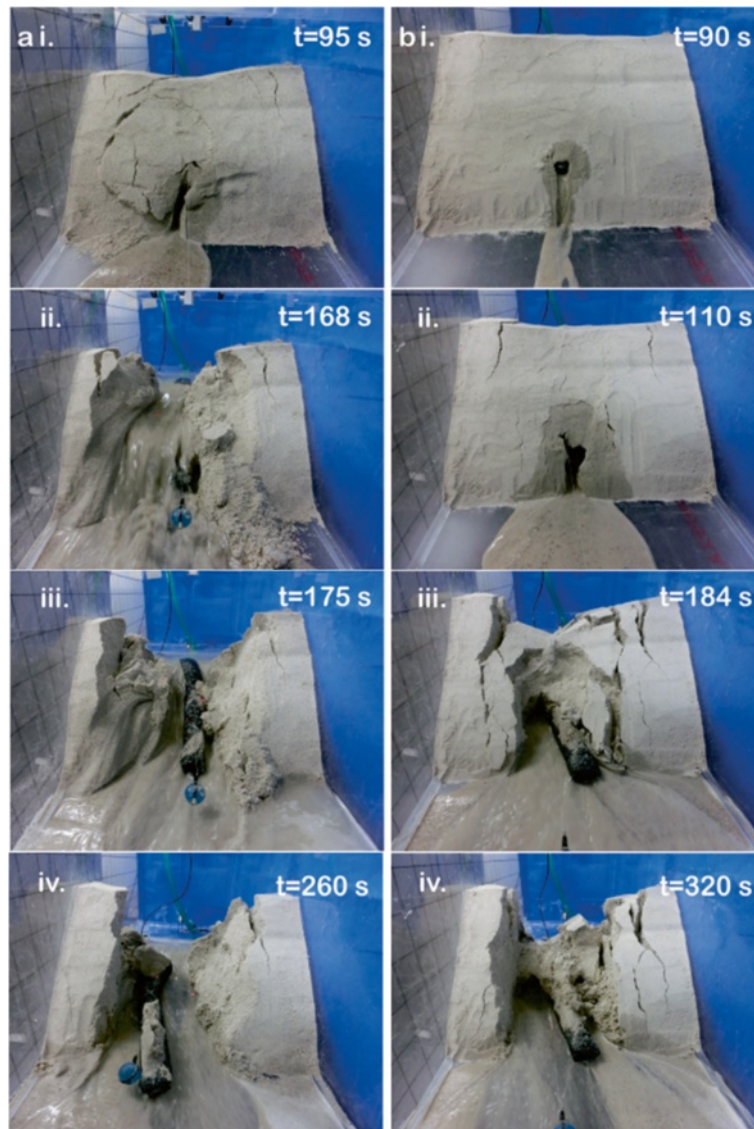
Fig. 9 Failure mechanisms of dams built with **a** dam mix A and **b** dam mix D showing piping and subsequent collapse of the dam crest (photo by Okeke AC)

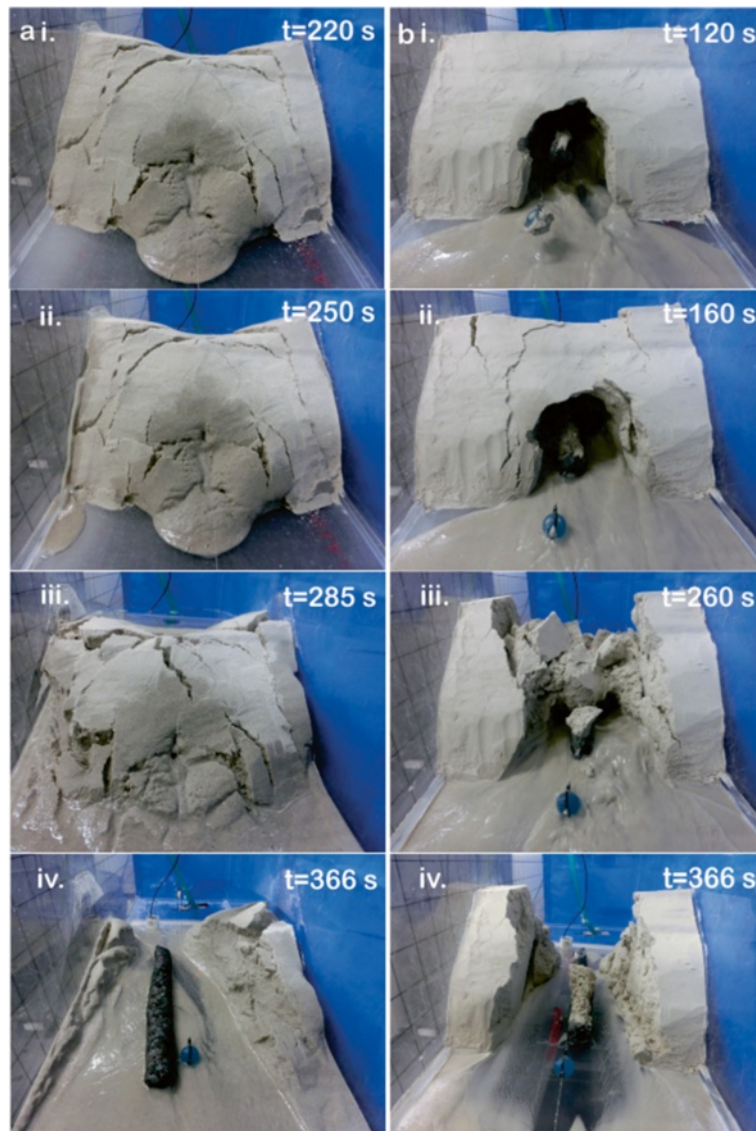
Fig. 11 Failure mechanisms of dams built with **a** dam mix G and **b** dam mix H showing hydraulic cracking, downstream face saturation and piping (photo by Okeke AC)

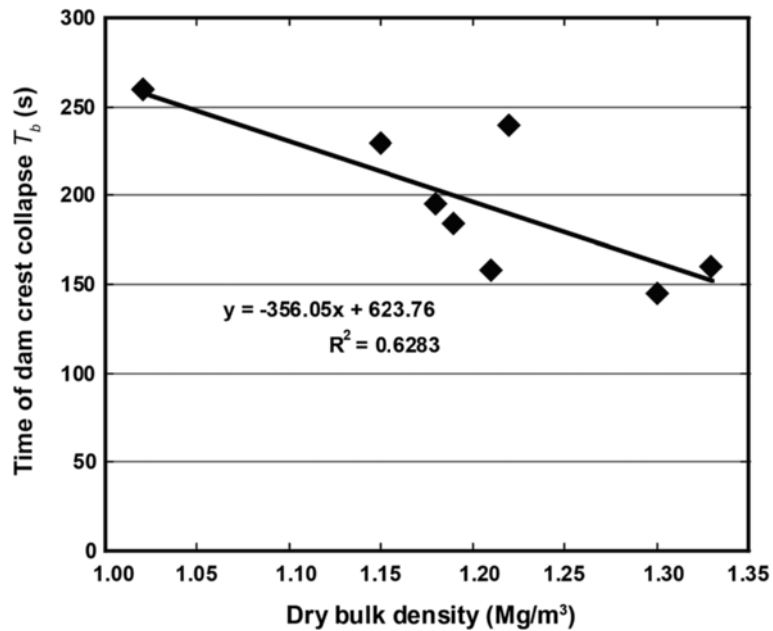
Fig. 12 Relationship between time of dam crest collapse T_b and dry bulk density

Figure 12 shows the relationship between the time of collapse of the dam crest, T_b and dry bulk density of the various soils composing the dams. Variations in hydro-mechanical behaviour were more evident in dams composed of soils of lower density than in those built with soils of higher density. An exception to this case was dam mix D (T_b , 184 s), where the interlocking bonds between very fine particles of silica sand 8 and coarser particles of silica sand 4 at optimum water content seemed to be stronger than in other soil samples. Previous studies of internal erosion and soil erodibility observed that progression of the piping hole and erodibility of material at the periphery of the piping hole depended

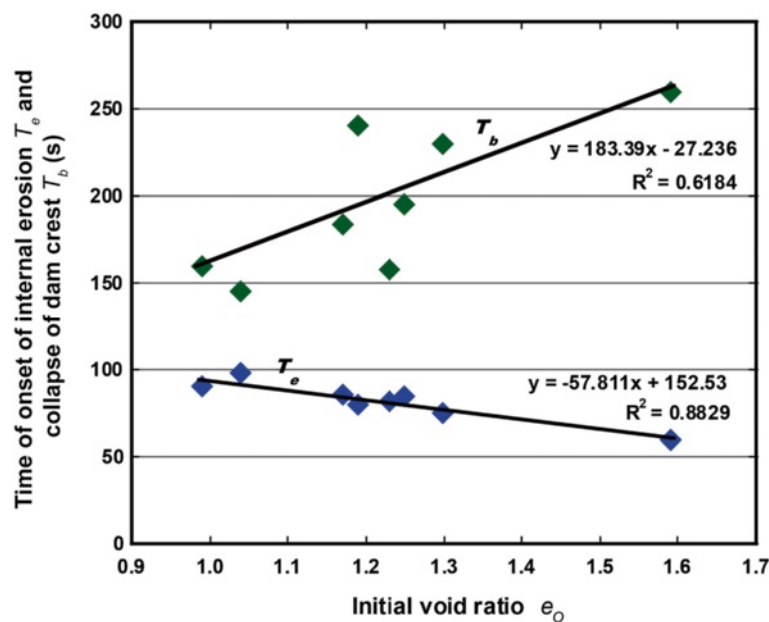
Fig. 13 Relationship between time of onset of internal erosion T_e , time of collapse of dam crest T_b and initial void ratio e_o

Similarly, a comparison between the failure process of run series 4 (dam mix D) and run series 2A (dam mix F) shows that even at a higher erosion rate q_s , the breach evolution process of the two dams varied greatly. Figure 13 shows the relationship between the initial void ratio of the dam materials and the time of collapse of the dam crest (T_e and T_b). The time of onset of internal erosion, T_e , and the time of dam crest collapse, T_b , reveals the effect of internal instability caused by suffusion. This led to early initiation of internal erosion in dams composed of mixed materials, even at lower void ratios, due to selective removal of fines from the soil matrix and subsequent destabilization of the soil structure. This result indicates that void ratio and other physical properties such as permeability, percentage fines content, and density affect the initiation and progression of internal erosion in dams. Furthermore, the relationship between initial void ratio and the dimensionless settlement index S_I (Fig. 14), clearly shows the behaviour of the dam materials as pore-water pressure and seepage gradient increased through the dams:

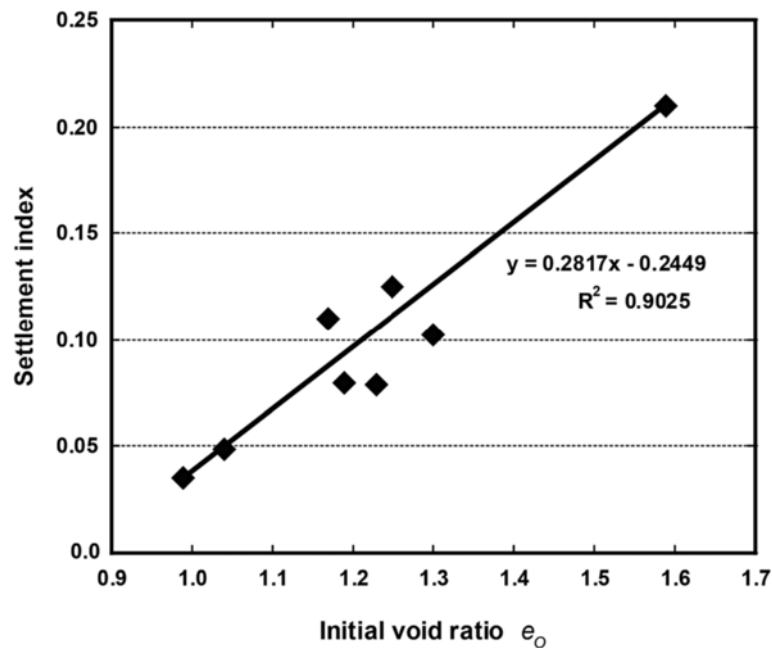
Fig. 14 Relationship between settlement index and initial void ratio e_0

$$S_I = \frac{s}{1000 \times H \log \left[\frac{t_2}{t_1} \right]} \quad (3)$$

where s is crest settlement in mm between times t_1 and t_2 , and H is the dam height in meters (Charles 1986). The general deformation behaviour of the dams shows that settlement increased with an increase in void ratio. Low density cohesionless soils with high void ratios, such as silts, are generally brittle, and thus are prone to cracking during differential settlement. This process is usually associated with the formation of tension cracks and other weak zones of low stress condition. A typical example is the Red Willow Dam in southwest Nebraska, USA. The dam is a 38.4-m high homogeneous embankment made up of low plasticity silts. Emergency investigations conducted by the US Bureau of Reclamation discovered sinkholes at the downstream face, whereas cracks appeared above the outlet works conduit and other locations near the right abutment. The brittle nature of the embankment material coupled with the low
