THE EUROPEAN PHYSICAL JOURNAL PLUS

Iveron Icon of the Mother of God: reconstruction based on physical–chemical tests as an element of conservation

Danuta Stępień^a, Anna Nowicka^b

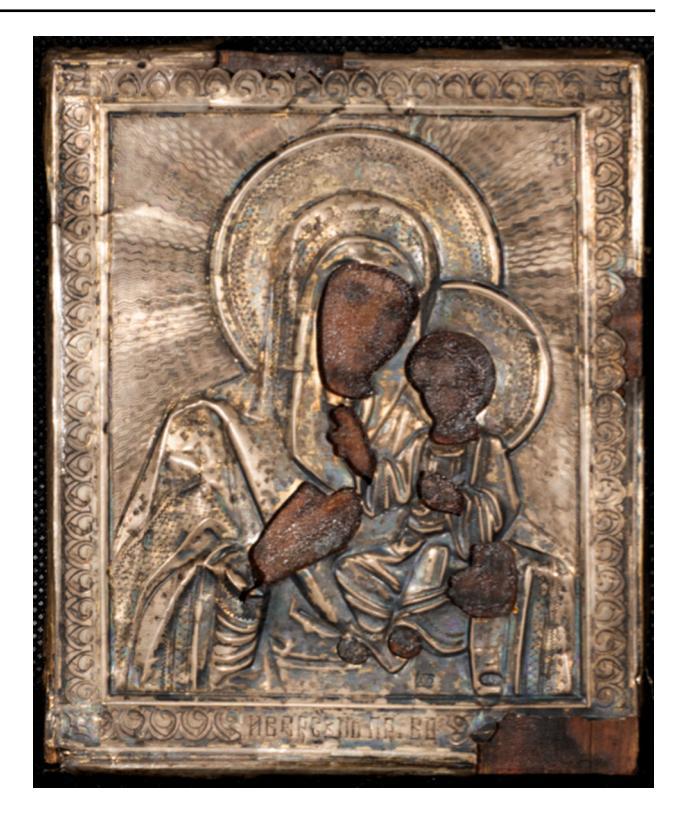
Fig. 1 *Iveron Icon of the Mother of God*, face side with silver oklad, photographed using VIS. Photograph by Roman Stasiuk

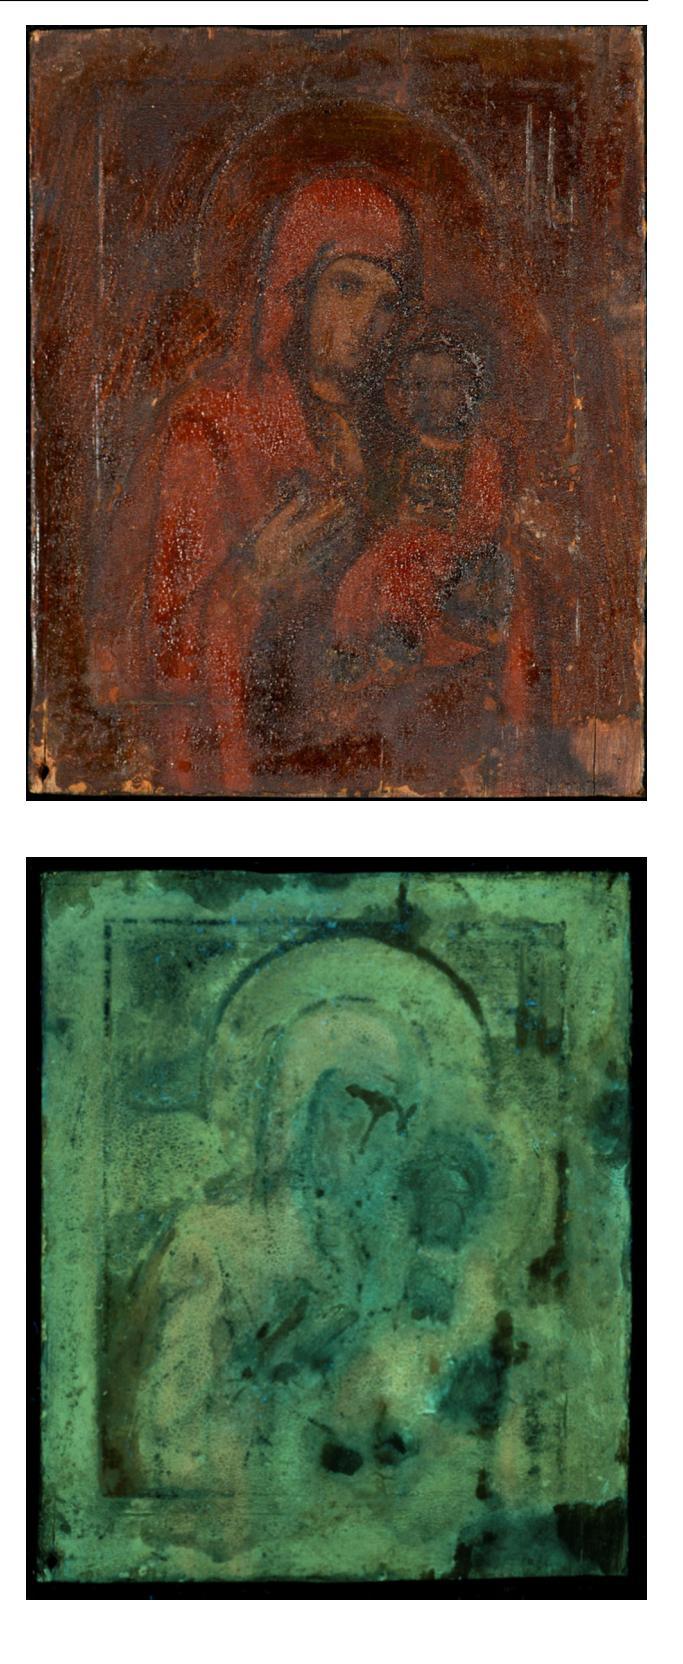
A VIS observation of the face both with the naked eye and with the use of a microscope leads to the conclusion that the paint layer has suffered considerable irreparable damage (Fig. 2).

It has shrunk, shrivelled and even darkened (see the face of Jesus) probably as a result of exposure to candle flames or fire. But it is difficult to determine the extent of the damage—does it apply to all the paint layers, or just the varnish?

Traces of soot and carbon an also be seen in the bottom right edge, directly on the wooden base. The general outline of the composition and its coloring are discernible, but no details are visible. The face of Jesus has suffered the most. The facial features are completely invisible.

The paint layers have melted in parts, so that some sections of the icon are covered in paint "spilled over" from neighboring sections. This makes an iconographic analysis difficult.

Fig. 2 Face of icon prior to removing the oklad for conservation (VIS). Photograph by Roman Stasiuk

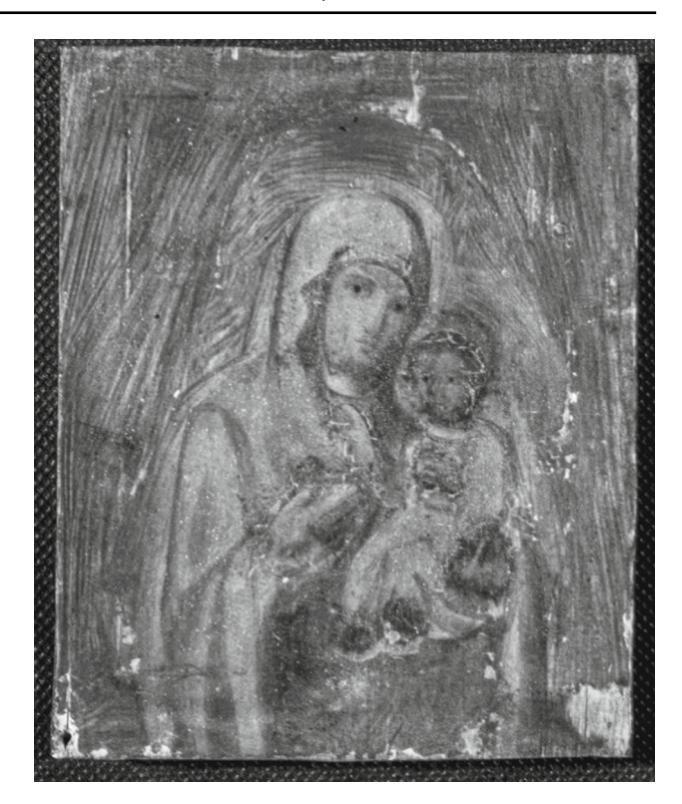
Infrared light lets us see deep layers of paint invisible to the naked eye. In this case, we can see the careful artistry, very useful when producing a reconstruction of the icon (Fig. 4).

Fig. 4 *Iveron Icon of the Mother of God*, IR image. Photograph by Roman Stasiuk

It has been noted that the hand of the Child is positioned differently compared to the original version. The right hand is somewhat higher and larger. Originally, the left hand leaned gently on the robe covering the Child's feet, and after the change—*pentimento*—it is raised (enlarged), pointing toward the Mother. An iconographer did not always match the composition of the image to the casing and did not always perform a *pentimento*.

On Mary's right cheek, we notice two slanting lines representing scars—a typical feature conforming to the original pattern of the *Iveron Icon of the Mother of God*.

The brushstrokes with which the dark-ochre background was painted can also be seen.

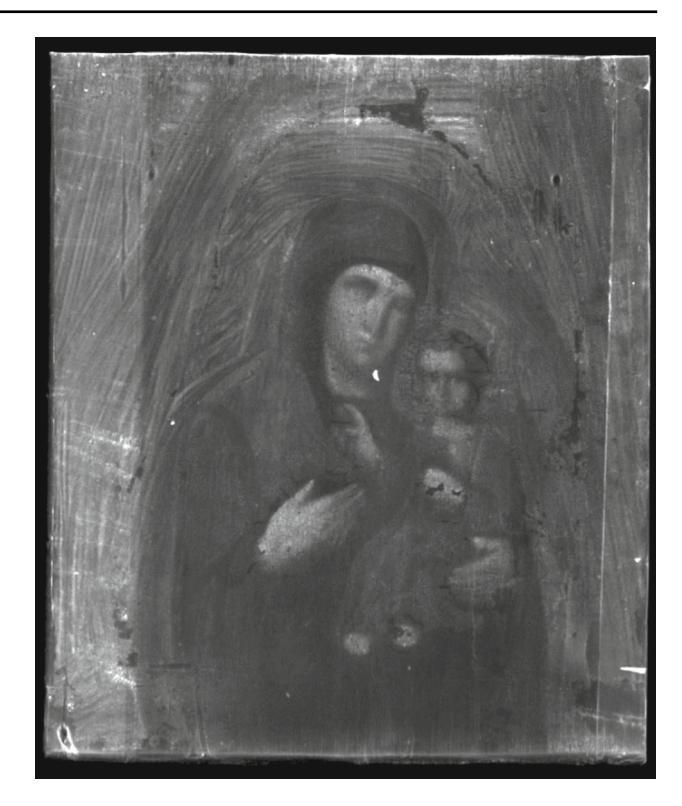
An X-ray of the icon provides valuable information about the layer of paint. Because pigments that contain heavy elements absorb X-rays well, the delicate shading of the face, hands and feet can be seen. This shows that the paint in these places is better preserved than an observation in ordinary light would suggest. The intense absorption of radiation in these places suggests that white paint with a lead ($Pb_3(CO_3)_2(OH)_2$) or baryte (BaSO₄) content was used (Fig. 5).

The brushstrokes visible in the background exactly match the strokes observed in IR, except that the latter represents a negative image. This means rather, we are dealing with a single coat of opaque paint.

We can also see the structure of the wood, the place where the boards were joined (despite the small size, the background wasn't a single board) and small fragments of nails.

Fig. 5 *Iveron Icon of the Mother of God*, X-ray image. Photograph by Roman Stasiuk

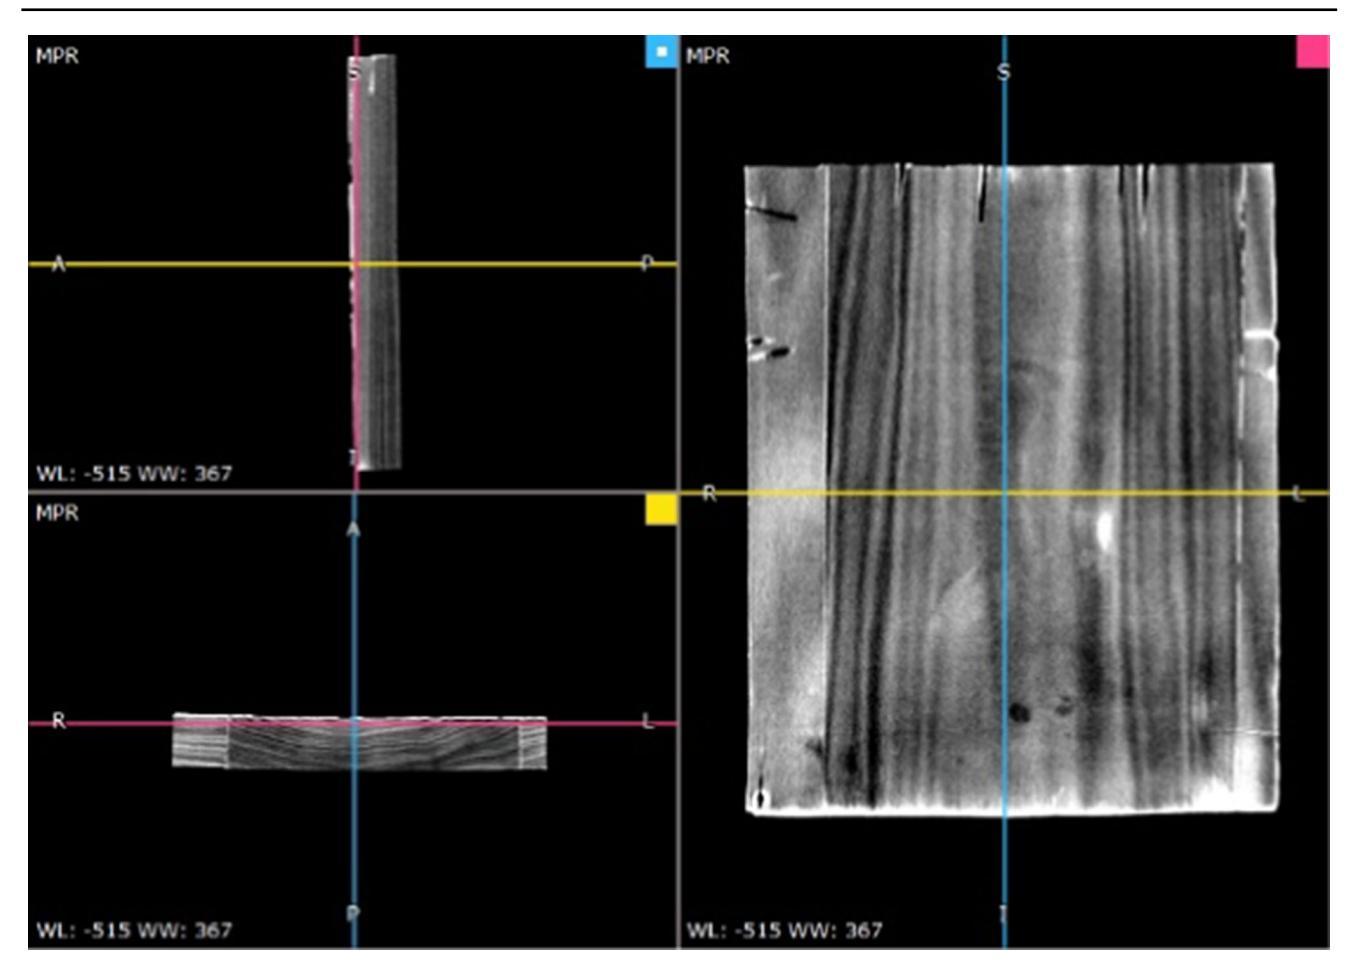
The CT tests have allowed to identify the structure of the wooden base. The joints of the three elements of the board appear very clearly. The tests on the *Iveron Icon of the Mother of God* have shown that the base is in a very good condition and that the layer of paint adheres well to it.

Fig. 6 Image generated by the RadiAnt DICOM Viewer 5.5.0. Longitudinal section. Here we can view the object from any point and examine it layer by layer. The left of the image shows the place where the scan was performed. The grain and very good condition of the board are visible

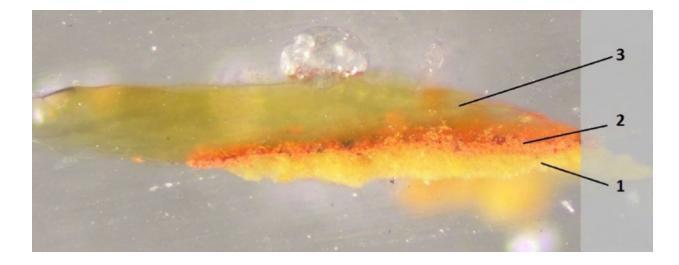
It was determined that in the stratigraphic structure one can identify a maximum of three paint layers. Directly on the wood lies a layer containing iron yellow of natural origin ochre ($Fe_2O_3 \cdot nH_2O$). Above this, in the dark part of Mary's coat, sample 1, is a layer containing cinnabar (HgS), while sample 2, taken from the brighter section of the coat, contains cadmium red (n·CdS·CdSe).

It is worth noting that the icon is covered with a disproportionately thick layer of semi-yellowed varnish, 0.70 mm thick, whilst the yellow layer is about 0.020 mm thick and the red layer about 0.010 mm thick (Fig. 7).

Fig. 7 Stratigraphic section of sample 1(red from Mary's coat) in visible light. Thickness of the individual layers: 1-0.020-0.030 mm; 2-0.002-0.009 mm; 3-0.060-0070 mm. Magnification: ×210. Photograph by Anna Nowicka

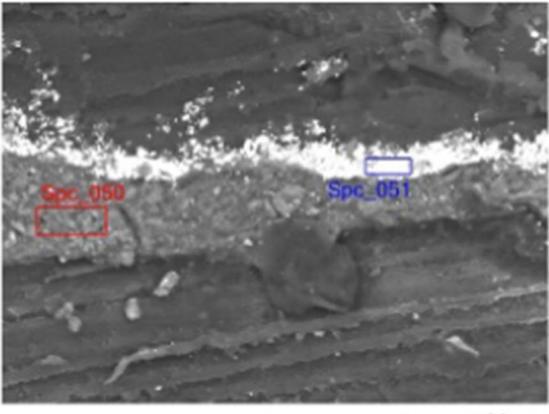
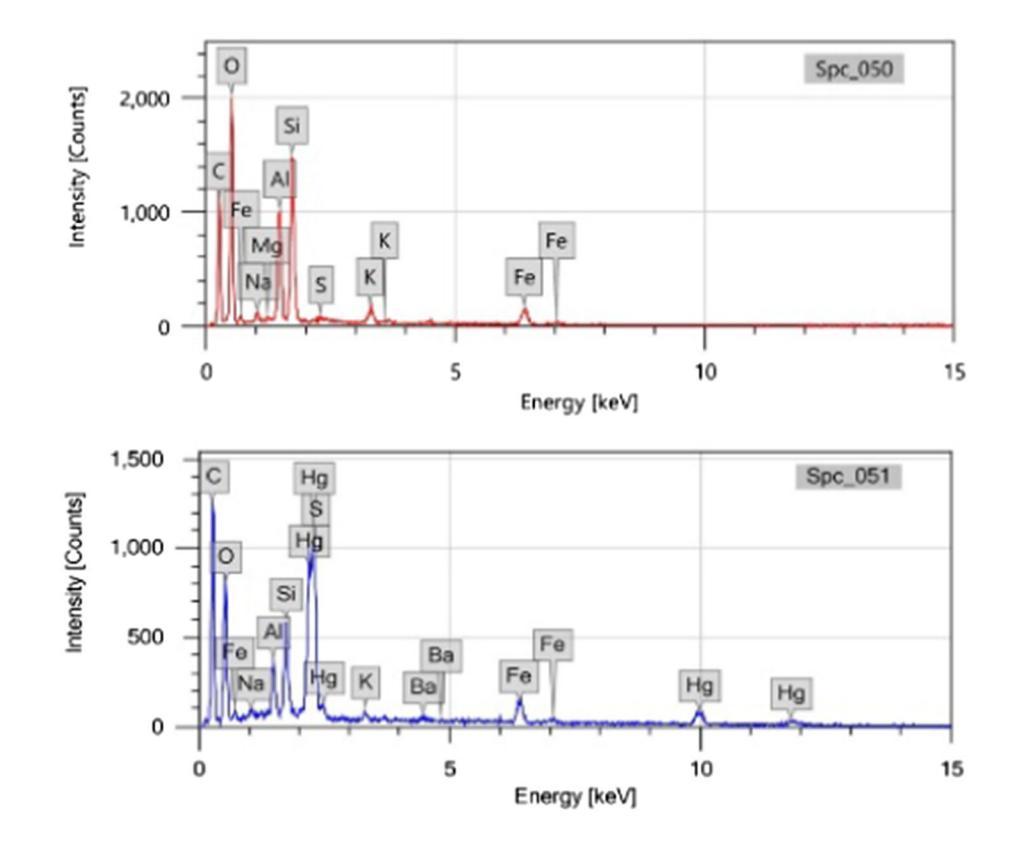
Próbka 1

Fig. 8 SEM-EDS analyses of sample no. 1-SEM picture and spectrum. In both analyses, we see a high peak caused by carbon and oxygen. This is typical of layers containing an organic adhesive. The Spc_050 analysis concerns an ochre layer (no. 1 on the VIS image). The high silicon and aluminum content indicates a pigment of natural origin. The Spc_051 analysis relates to the end layer (no. 2). The high mercury and sulfur content results from the use of cinnabar. The presence of the remaining elements (Si, Al, Fe, K, Ba) may suggest that the pigment is of natural origin, but may also result from the addition of yellow or iron red. Test performed by Anna Nowicka

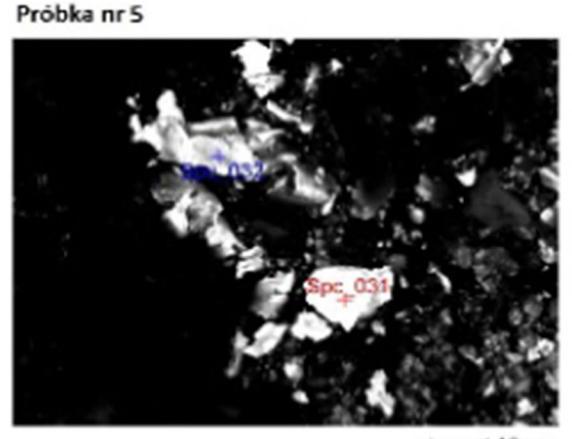
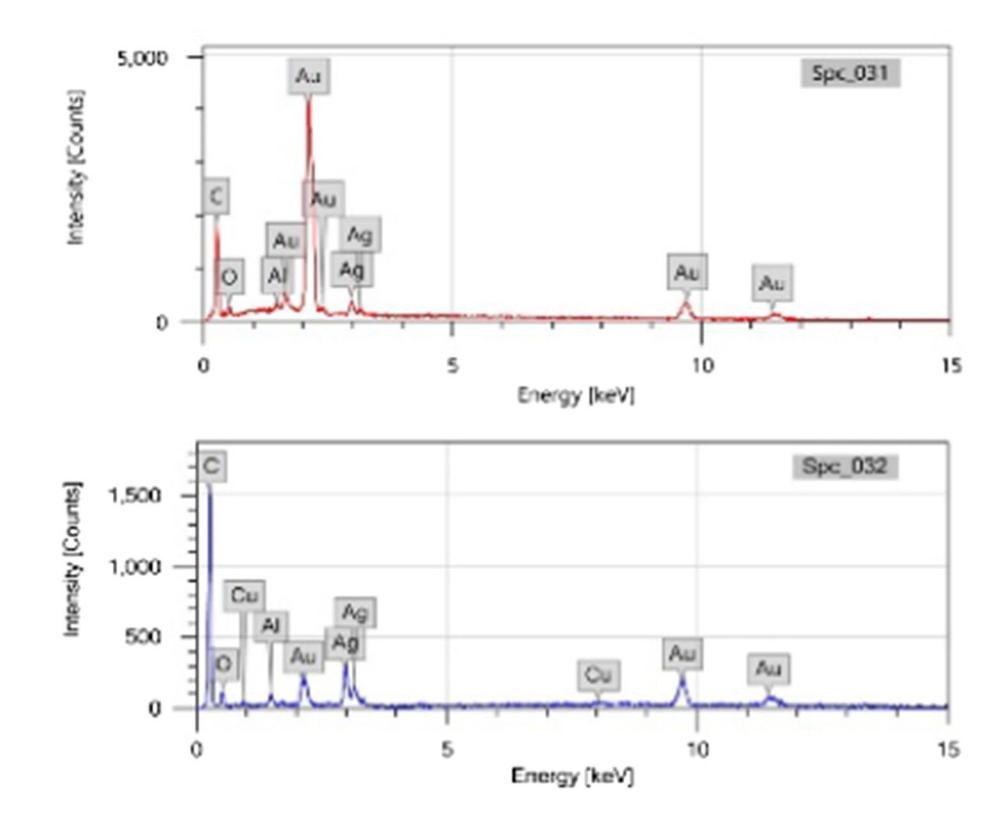
The white metal of which the oklad is made is a silver and copper alloy, with a predominant silver content. The surface of the metal is covered in sulfides and oxides in part Engravings can be seen on the entire front of the silver oklad.

Yellow metal is preserved in the depths of the engravings, just like on the smooth part of the surface. The yellow metal is gold. A microscope examination of the object permits the assumption that originally, the entire front of the oklad was gilded, but the gilding is very worn now.

Fig. 9 SEM–EDS analyses of sample no 5—SEM picture and spectrum. They confirm the presence of silver (Ag), gold (Au) and copper (Cu). Test performed by Anna Nowicka

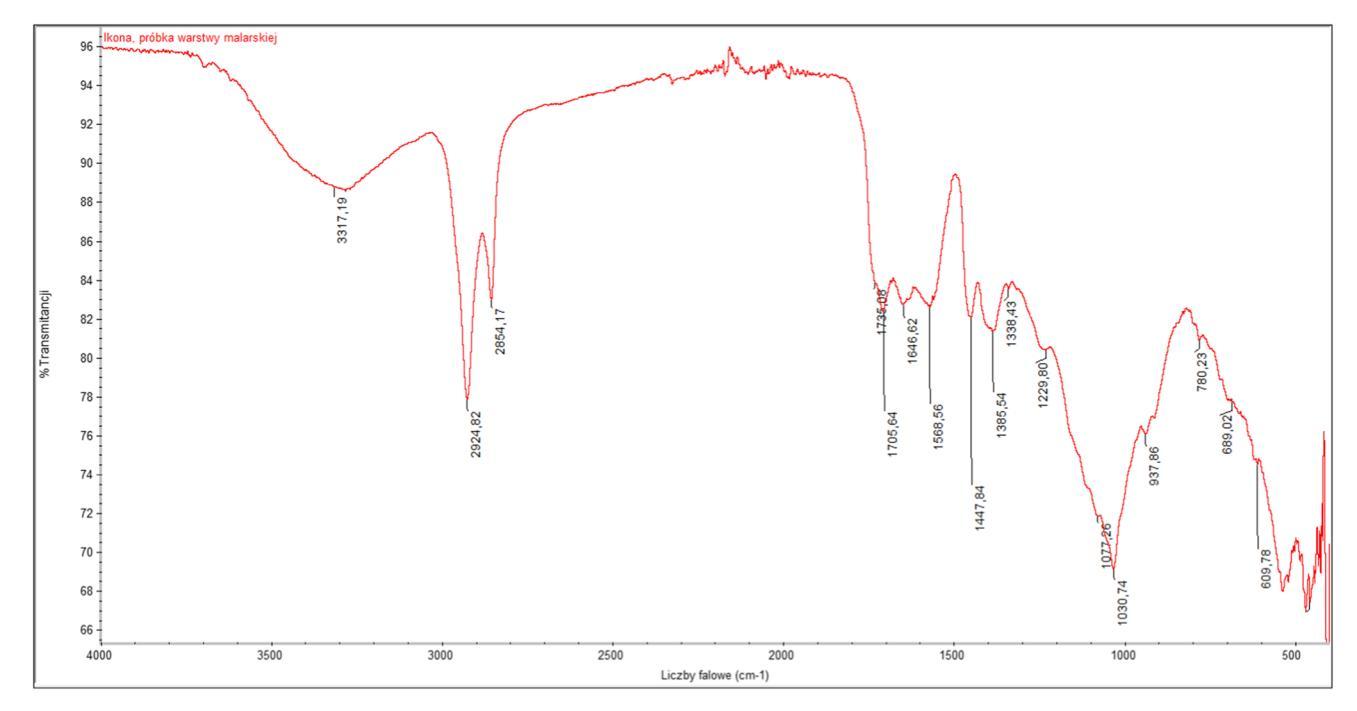
In this case, characteristic shape of the spectrum in FTIR obtained from the sample confirms the presence of lipids and proteins, which can indicate the use of a tempera binder [14]. Moreover, a signal corresponding to natural resin was interpreted (probably from varnish).

Fig. 10 FTIR spectre obtained for a sample of the red paint layer

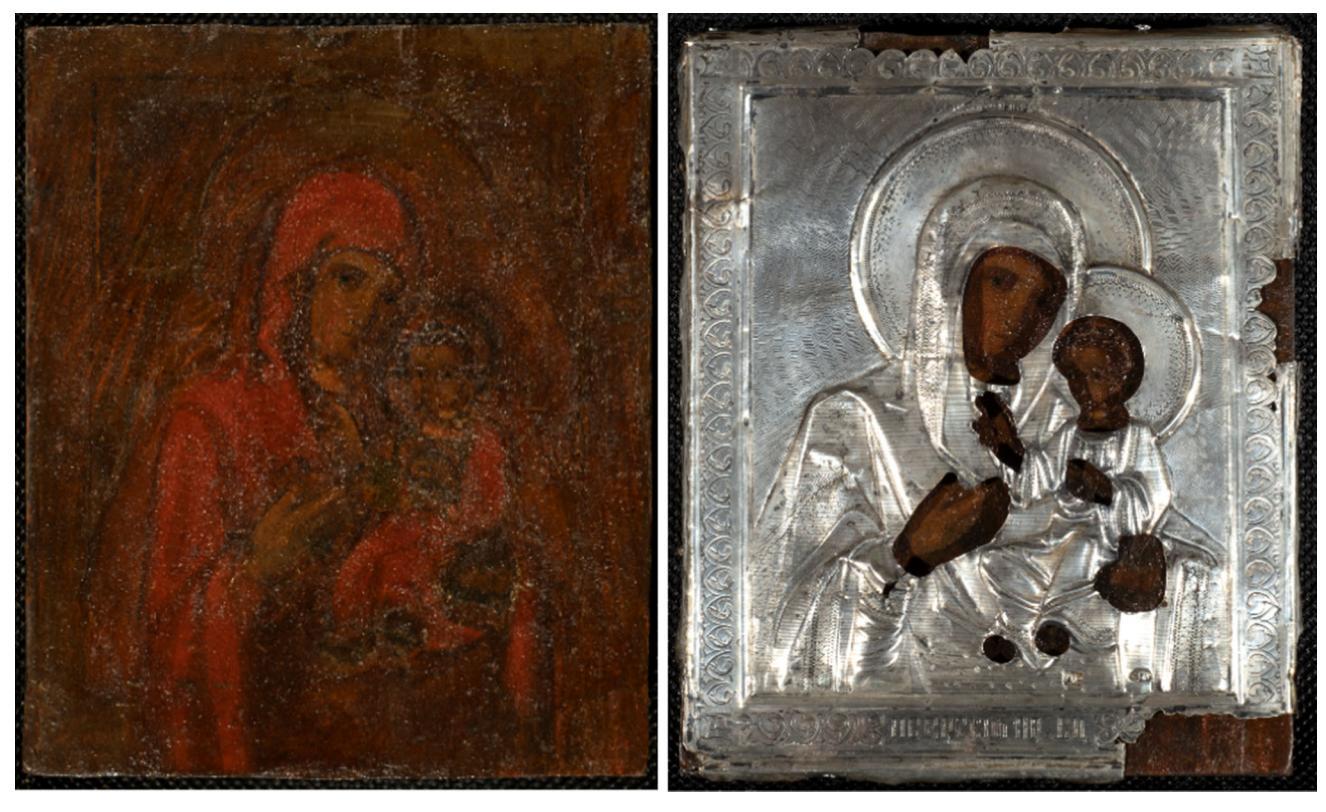
Fig. 11 Iveron Icon of the Mother of God, after conservation (left-before attaching the oklad, right-after attaching the restored oklad)

Before work commenced, tests were carried out to determine the appropriate method of cleaning. The most effective cleaning substance proved to be silva sintetica from the firm Bresciani (undiluted). Next, missing portions of wood were filled with small lime tree wedges. Cracks were repaired with bonding water (rabbit glue).

Retouching imitating the background of the icon was performed. In those places with skin, scoring was done only to highlight the complexion.

An important process was the retouching of the scars on the cheeks of Our Lady.

The same pigments were used as those identified as having been used originally, and tempera paint was prepared on the basis of an egg-yolk binder.

The surface received a coat of orange shellac as protection.

The silver oklad [15] was cleaned of dirt and deposits with *Silvo Duraglit*. Once the silver had been carefully cleaned, it was polished with a soft tissue. Next, the bent parts of the metal were carefully straightened out. Cracks in the metal were soldered from the reverse of the oklad. The soldering was performed using a soldering tool and tin–lead TOPEX solder with a diameter of 1 mm. When this work was completed, the entire metal was protected against repeated oxidization with acetone-based Paraloid B44 (Fig. 11).

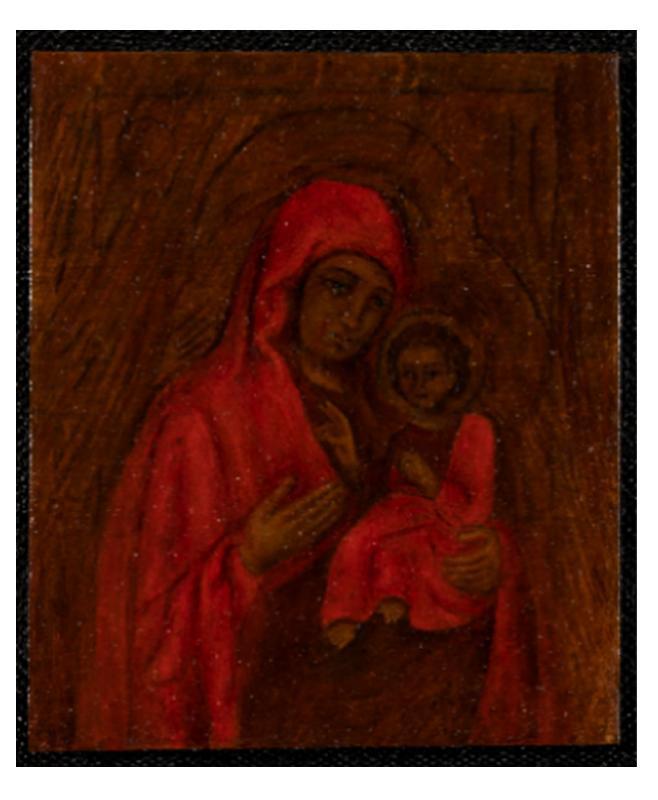
A copy of the icon was made on the basis of physic-chemical tests. The drawing was interpreted, and the stratigraphic structure of the original and the use of the base, pigments and adhesive identified. On the copy, the Child has a bright red robe. It was not possible to identify the original color because of the damage to the paint surface. Mary probably wore an azure cap. The blackening caused by high temperature make it impossible to determine its outline or color, despite a series of tests (Fig. 12).

Fig. 12 Copy of the icon. Author: Danuta Stępień
