Landslides

DOI 10.1007/s10346-022-01866-y Received: 12 January 2022 Accepted: 18 February 2022 © The Author(s) 2022, corrected publication 2022 L. Picarelli<sup>®</sup> · A. Santo · G. Di Crescenzo · R. Vassallo · G. Urciuoli · F. Silvestri · L. Olivares

# A complex slope deformation case—history

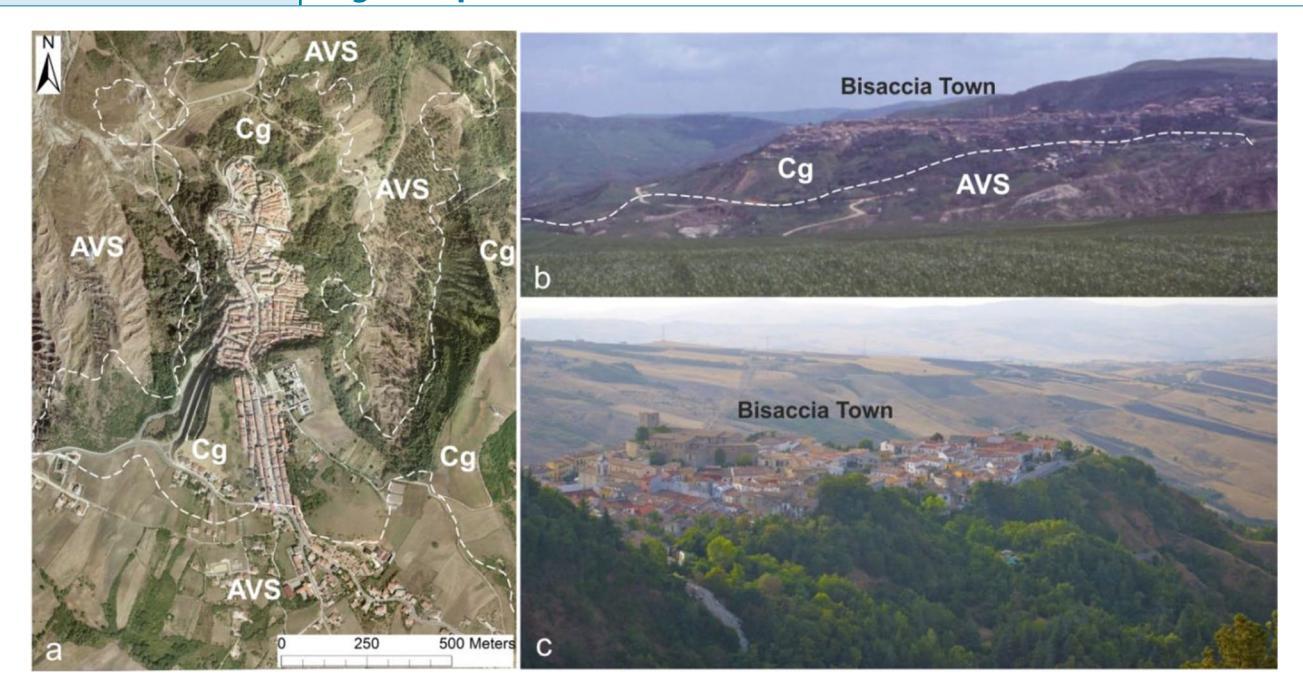
Fig. 1 The Bisaccia hill: a ortophoto, b the Western and c the North-Eastern hillslope. Cg Poligenic conglomerates within a sandy matrix (Pliocene); AVS "Argille Varicolori" formation (Miocene-Oligocene)

Bisaccia hill (Fig. 1) is located in the Southern Apennines chain, 135 km North-East to Naples, Italy. It is a thick elongated platform extending in the South-North direction, which consists of slightly cemented polygenic Pliocene conglomerates overlying the Tertiary tectonized "Argille Varicolori" formation, a deep deposit essentially constituted by high plastic clay shales (Ogniben 1969; D'Argenio et al. 1973; Bonardi et al. 1988).

parallel valleys that bound the eastern and western sides of the hill (Fig. 1a), the eastern "Vallone dei Corvi" and the western "Vallone Ferrelli". As a matter of fact, erosion has completely dismantled the conglomerates and is rapidly deepening into the fine-grained bedrock. The hill is cyclically hit by earthquakes. The last strong events occurred on July, 23, 1930 (M = 6.7), on August, 21, 1962 (M = 6.4), and on November, 23, 1980 (M = 6.9). The 1980 earthquake, which killed about 3000 people in a vast area of Southern Apennines, is known as the Irpinia-Basilicata earthquake.

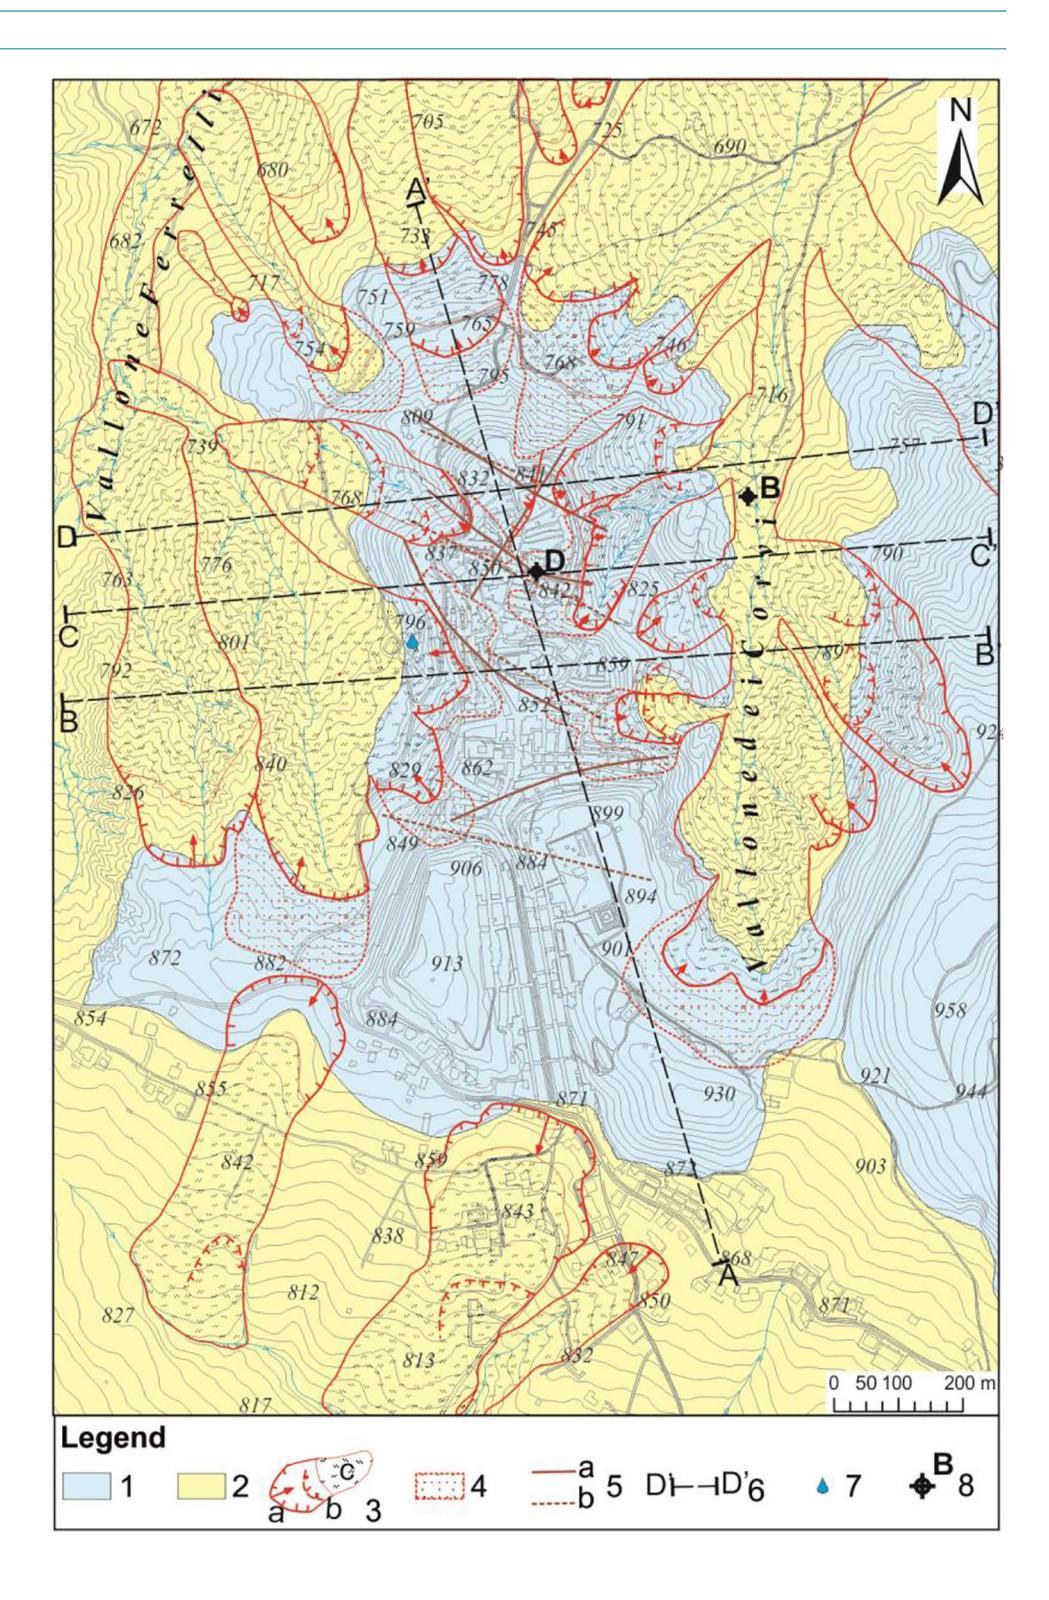
Significant elements about the field pore pressure regime were captured through a set of piezometers. A borehole was drilled **Fig. 2** Geological map of the Bisaccia area: 1 poligenic conglomerates with a sandy matrix; 2 "Argille Varicolori" formation; 3 landslide (**a** main scarp; **b** minor scarp; **c** accumulation zone); 4 retrogression sector; 5 major fractures recognized after earthquakes (**a** 1980 earthquake; **b** 1930 earthquake); 6 geological cross section (see Fig. 3); 7 spring; 8 borehole

Figure 2 reports a geological map of the zone. The upper conglomerates consist of polygenic pebbles floating into a brown sandy matrix; this material is only slightly cemented and includes thin sandy lenses. The lower "Argille Varicolori" formation consists of highly tectonized gray clay shales. Their typical fabric consists of platy millimetric to centimetric fragments bounded by polished surfaces (Picarelli et al. 2002).

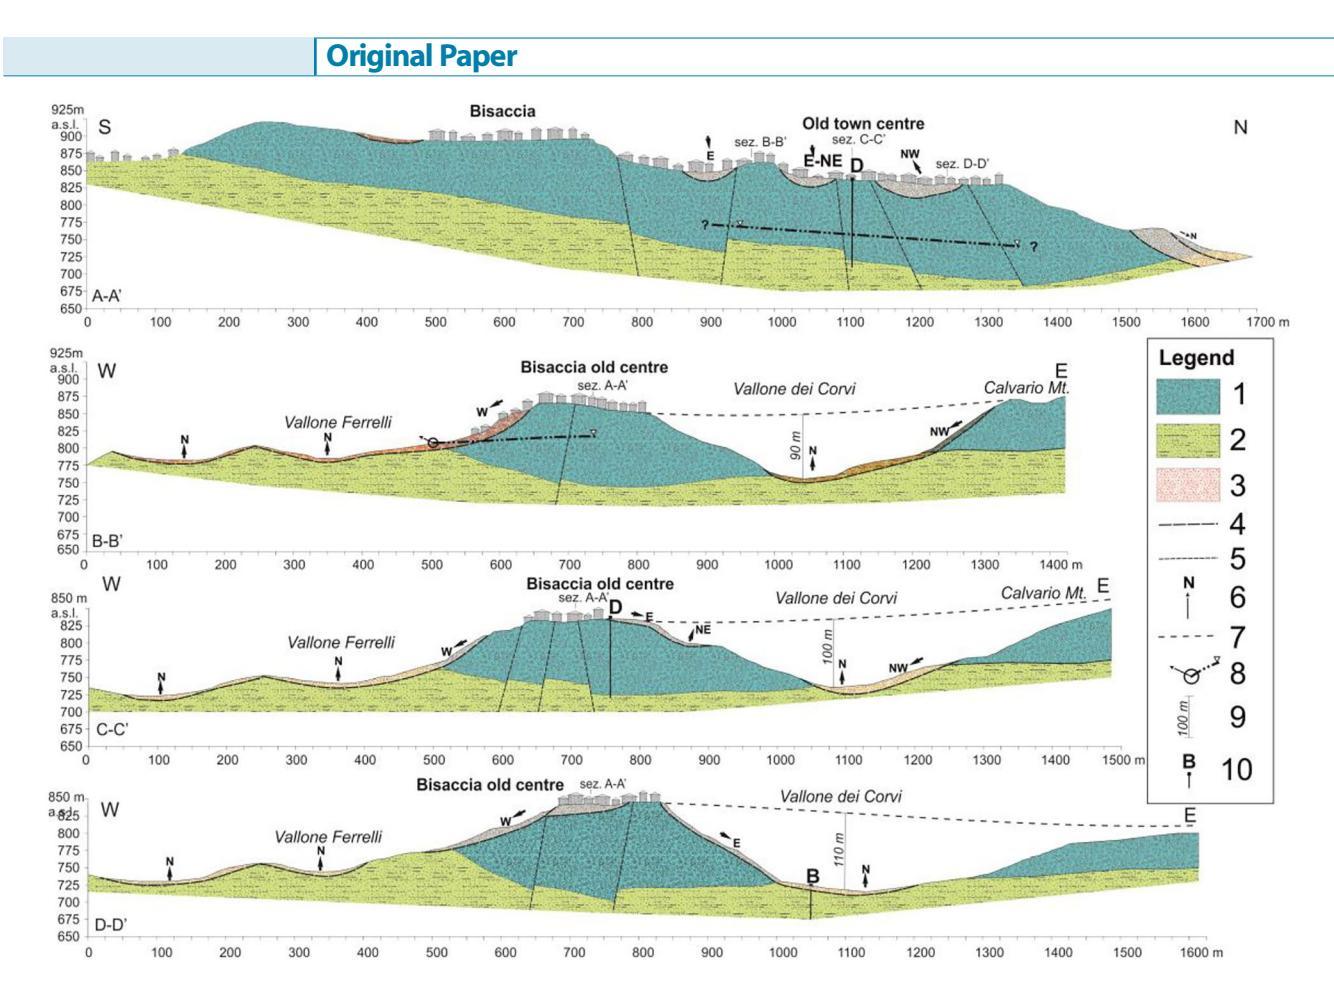
**Fig. 3** Geological cross sections of the hill (see Fig. 2): 1 poligenic conglomerates with a sandy matrix; 2 Argille Varicolori formation; 3 accumulation zone; 4 failure surface; 5 major fracture; 6 direction of

landslide movement; 7 presumed original profile of the conglomerate top; 8 spring and water table surface based on data from borehole D; 9 presumed original conglomerate thickness; 10 borehole

The geological sections in Fig. 3 show some subvertical fractures crossing the platform, which displays a stepped morphology characterised by some escarpments and by three terraces located at elevations ranging between 825 and 900 m a.s.l. (Fig. 3a). A major escarpment, about 40 m high, subdivides the town into two parts: the historic downtown (located in the northern sector) and the more recent urban centre located on the highest terrace (southern sector). According to Crescenti et al. (1984), the major escarpment might bound a South-North ancient landslide.

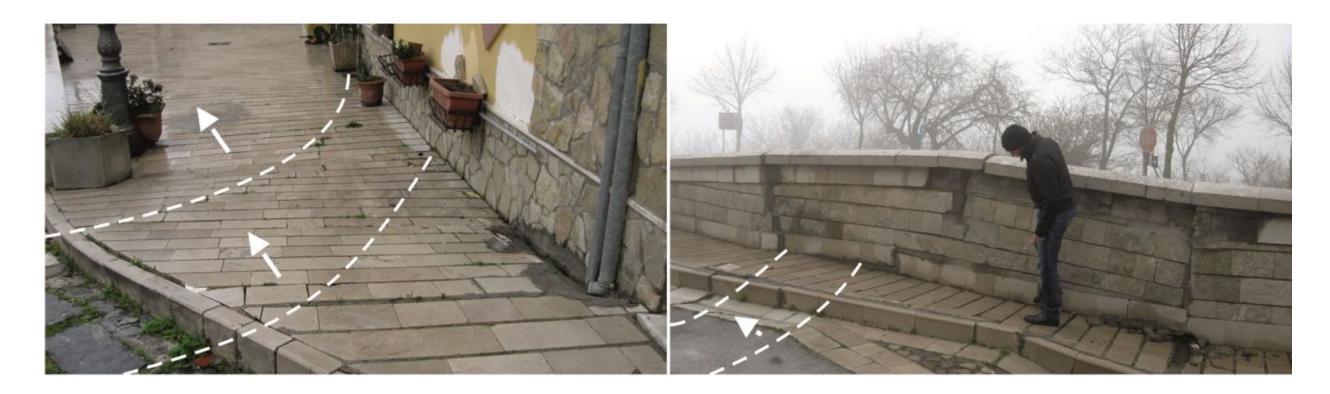
Fig. 4 Effects of ongoing slope movements

As a result of erosion, the boundaries of the platform are subjected to shallow landslides, which generally have their toe into the basal fine-grained deposit. The consequence of these phenomena is a progressive irregular thinning of the hill top, especially in the northern sector (Figs. 2 and 7). The main landslides are shown in Figs. 2 and 3. Figure 4 shows the effects of landslides involving the platform.

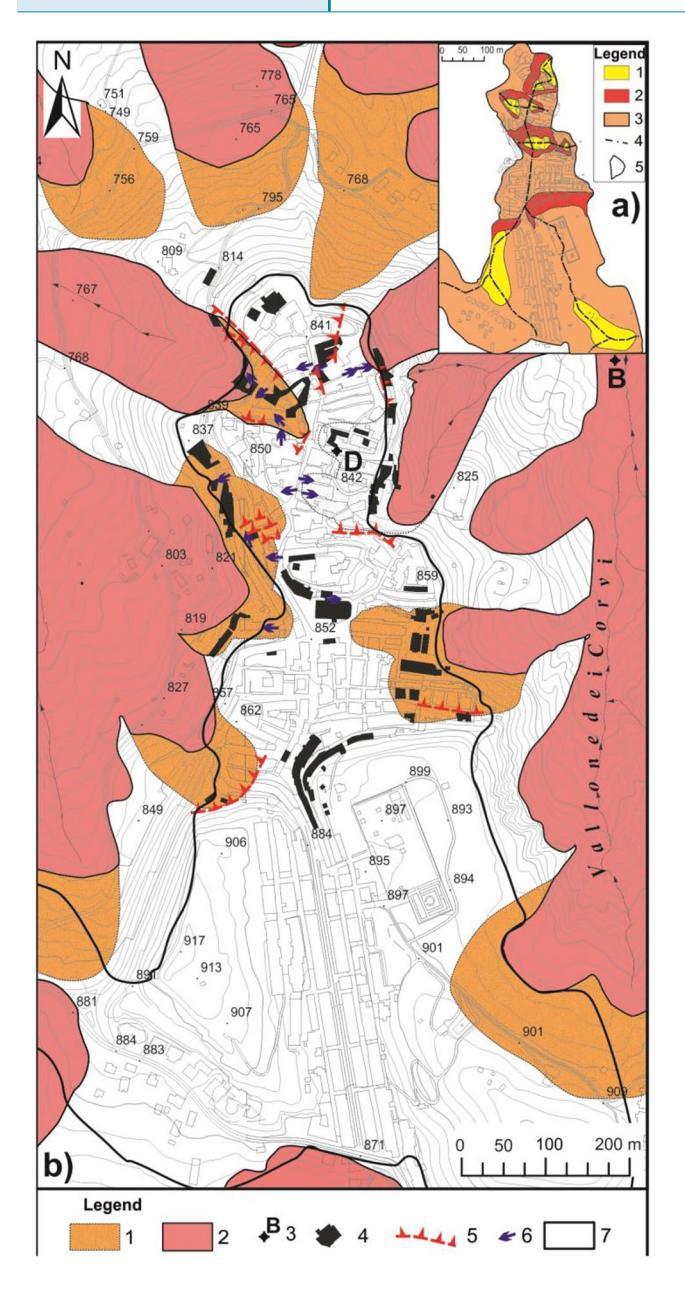
**Fig. 5 a** Geomorphological map: 1 morphological height; 2 escarpment; 3 morphological depression or sub-horizontal surface; 4 watershed; 5 morphological top limit of the hill. **b** Landslide effects: 1 retrogression sector; 2) zone of depletion or accumulation; 3 borehole; 4 heavily damaged building; 5 macro-fracture; 6 presumable displacement vector of surveyed fracture; 7 morphological hilltop

The map in Fig. 5 summarises the main geomorphological data including the zones of the town that are subjected to retrogressive landslides, the main cracks on pavements and the presumable direction of slope movements. The figure shows that some damaged buildings are located in retrogression sectors of landslides having the toe in the basal formation. However, even internal zones present sharp changes in ground surface elevation, fractures in roads

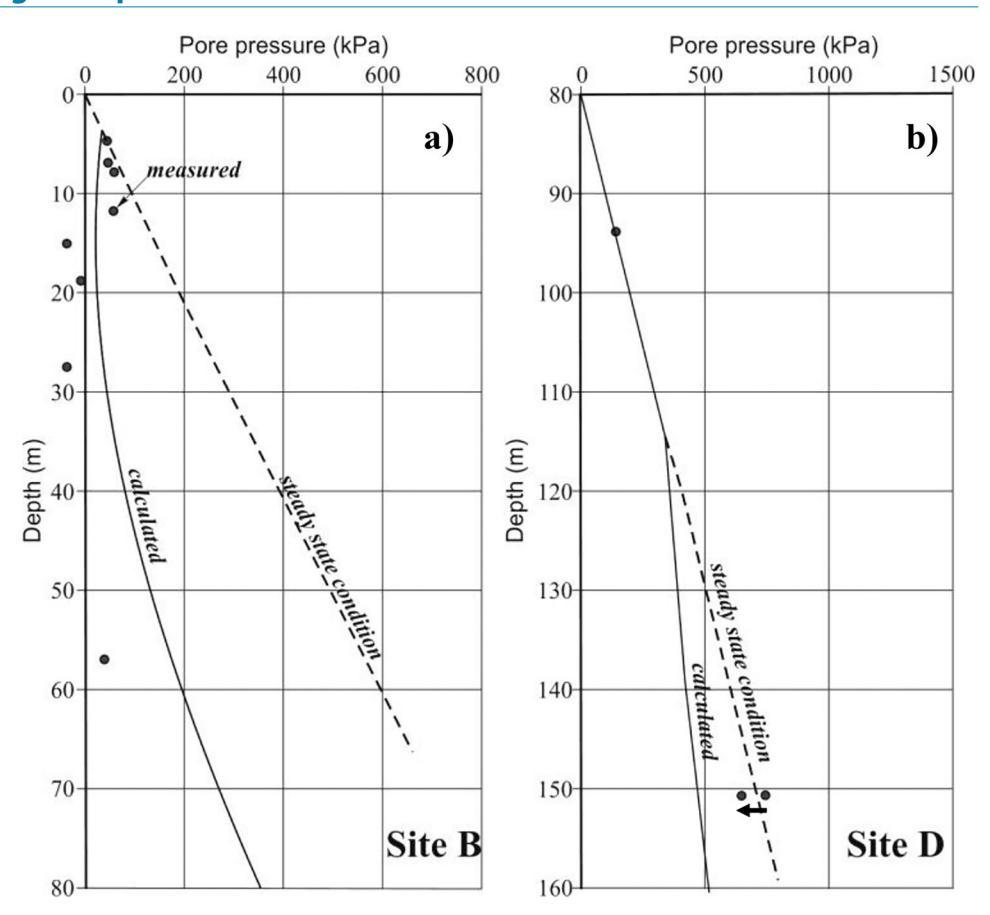
**Fig. 6** Pore water pressures measured below the Vallone dei Corvi bed (**a**) and below the conglomerate platform (**b**), compared to results of numerical simulations (after Di Nocera et al. 1995)

in the figure are the stable value (around -10 kPa) measured through the last cell at a depth of 27.5 m and those measured before cavitation at the other two cells. In the borehole D located in the town, a Casagrande piezometer was installed at a depth of 95 m within the conglomerate formation, while a vibrating wire cell was placed in the clay shale deposit at depth of 149.5 m, i.e. 54.5 m below the basal surface of conglomerates. The first piezometer allowed measuring the water level, in the conglomerate slab, 35 m above the top of clay shales (Fig. 6b). Surprisingly, the cell installed in clay shales recorded a continuously decreasing level. In fact, as indicated by the small black arrow in the figure, the pore pressure measured in 1991 (i.e. 11 years after the 1980 earthquake), which is quite higher than the presumed value calculated for steady-state conditions (dotted line), in the following years progressively decreased below the steady-state value.

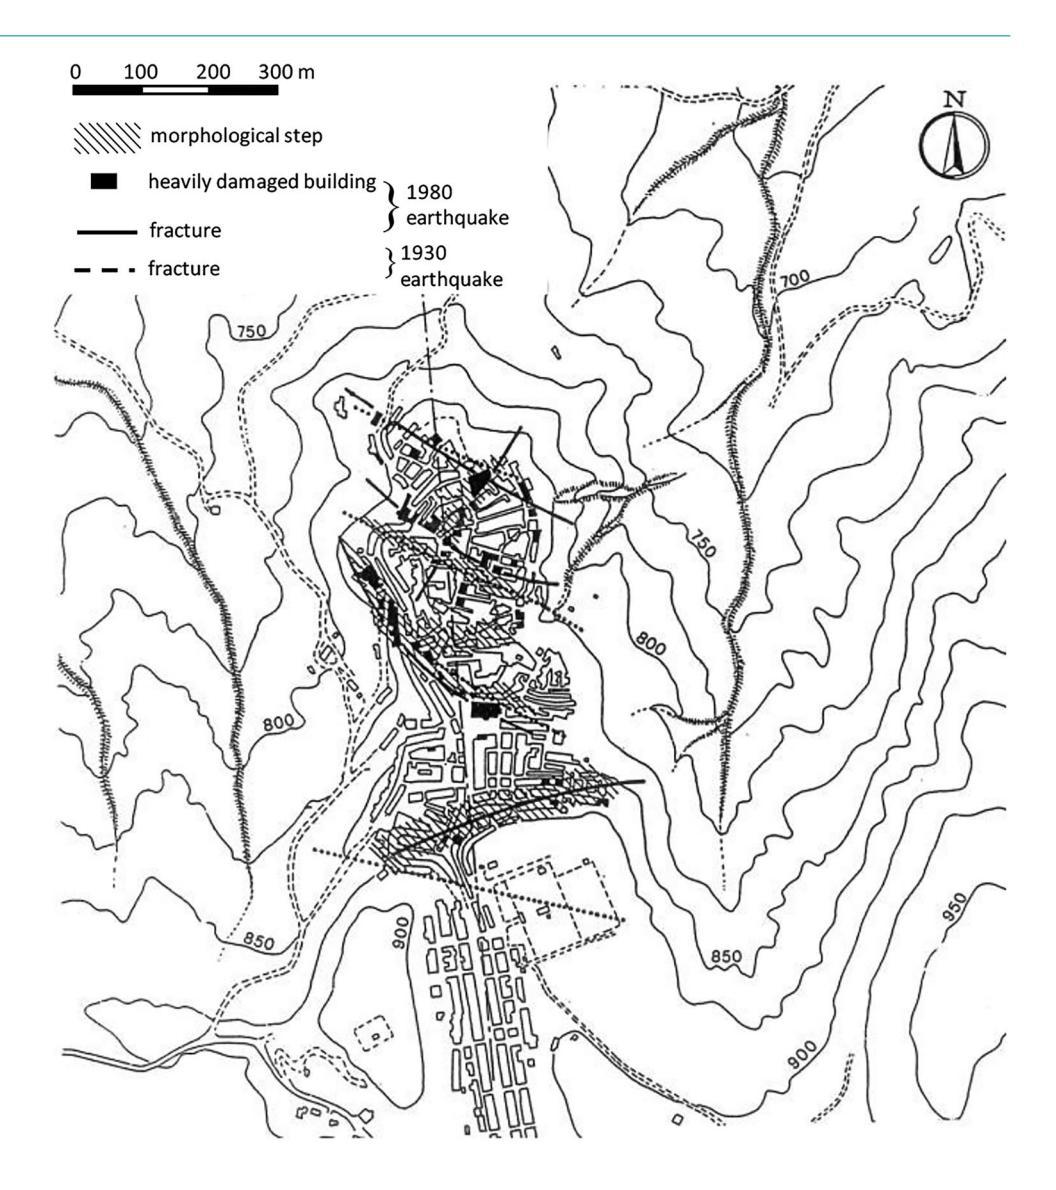
**Fig. 7** Main damages caused by the 1930 and 1980 earthquakes (Fenelli et al. 1992)

On November, 1980, a wide area of Southern Italy was shaken by a strong seism (M = 6.9), the so-called Irpinia-Basilicata earthquake. As a result, long cracks appeared on pavements of the town, and a number of buildings were damaged even though no casualties were recorded. It was soon evident that the most severely damaged buildings were all located in vicinity of the cracks (Fig. 7).

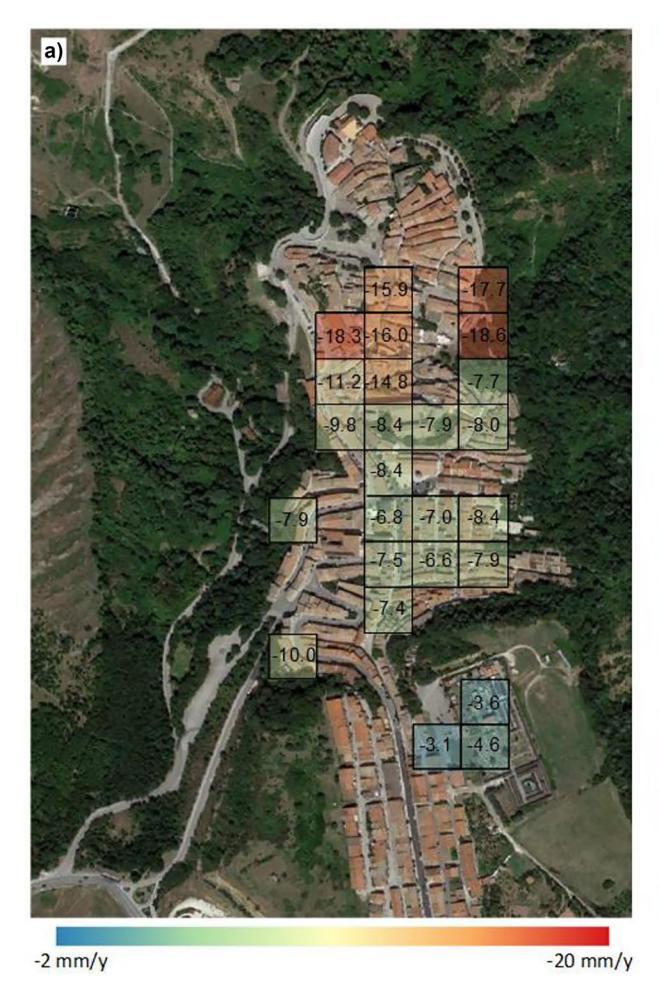
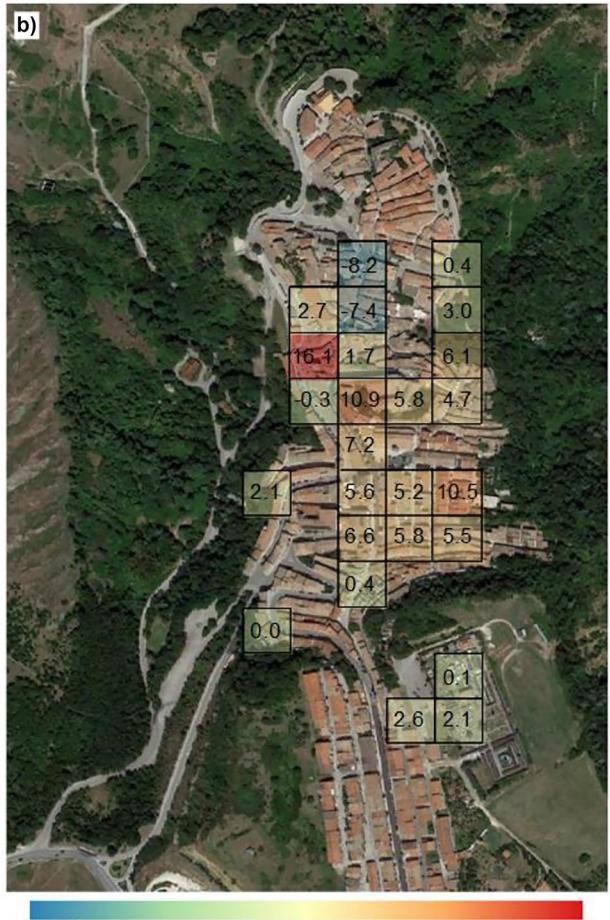
**Fig. 10** Average displacement rates in the period 2003–2010 in the vertical **a**) and West–East **b**) directions obtained from Envisat satellite data, superimposed to a Google Earth view-Landsat/Copernicus

image (negative rates correspond to downward and westward dis-

placements; positive values correspond to eastward displacements)

Figure 10 shows the elaboration of data for the 2003–2010 time interval (Envisat). Ascending and descending displacement rates reported in Fig. 9d–e were averaged on 50 m  $\times$  50 m pixels and then processed using Eqs. (1) and (2) so as to obtain raster maps in the vertical and West–East directions. Vertical rates range between -3 and -19 mm/year. Similar values (0–16 mm/year) are

estimated for the horizontal components in the E-W direction, which point to East or to West depending on the zone, with a prevalence of eastward displacements. The moduli of vertical displacement rates clearly increase moving from South to North with a significant step through the cross section located at an elevation of about 885 m, where is present the high escarpment mentioned above, which might bound an ancient landslide. The highest values of the E-W rate are observed in the northern sector and, locally, in the vicinity of hillslopes. LOS displacement rates for the descending CSK orbit (Fig. 9f) seem to confirm that the values increase in proximity of scarps and retrogression sectors. As mentioned above, available data do not allow obtaining reliable information about the South-North component of displacements, i.e. in the direction of the longitudinal hill axis. In any case, the entire set of data highlights an active deformation process of the entire platform possibly including local effects along its contour. Based on a rough review of data concerning other towns in the same area, the examined case appears to be a unique situation (Di Marino 2011).

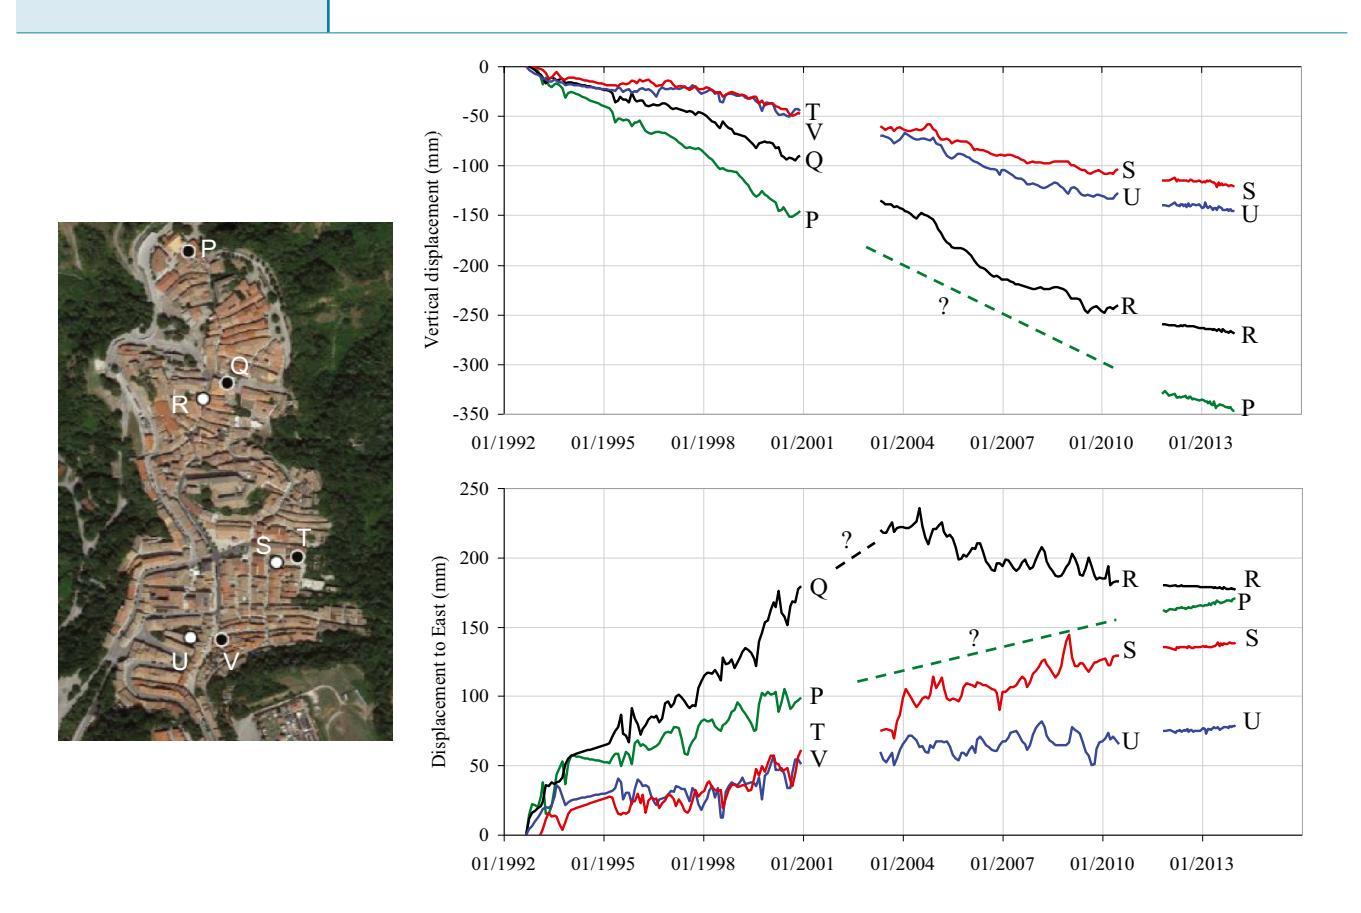
Fig. 11 Time series, for a number of buildings, of vertical displacement (negative if directed downwards) and displacement to East, obtained from satellite ERS, Envisat and CSK data

To further deepen the subject, Fig. 11 shows vertical and West-East displacements of a number of representative buildings for which data are available for both ascending and descending satellite passes in different time intervals. Such an information can be considered more accurate than that provided by Fig. 10, being the data related to specific buildings rather than averaged on wider areas although, of course, more discontinuous in space. For CSK satellite data (2011-2013), since only descending orbit data are available, vertical and W-E displacements were obtained under the hypothesis that their ratio is equal to that obtained in the Envisat monitoring period 2003-2010. The displacement field appears consistent over the entire 20 years observation period (1992-2013), with some evident rate changes in time. For instance, in the zone of buildings Q and R, which are quite close to each other, higher vertical displacement rates have been recorded in the period 2003-2007 than in the interval 1992-2003. On the other hand, if the whole monitoring period is considered,

displacement rates globally seem to decrease with time in the entire built area. The trend of horizontal displacements in the W-E direction appears more complex, with more evident variations in the average yearly rate in some zones than in others, and an apparent change of sign in the zone of buildings Q and R.

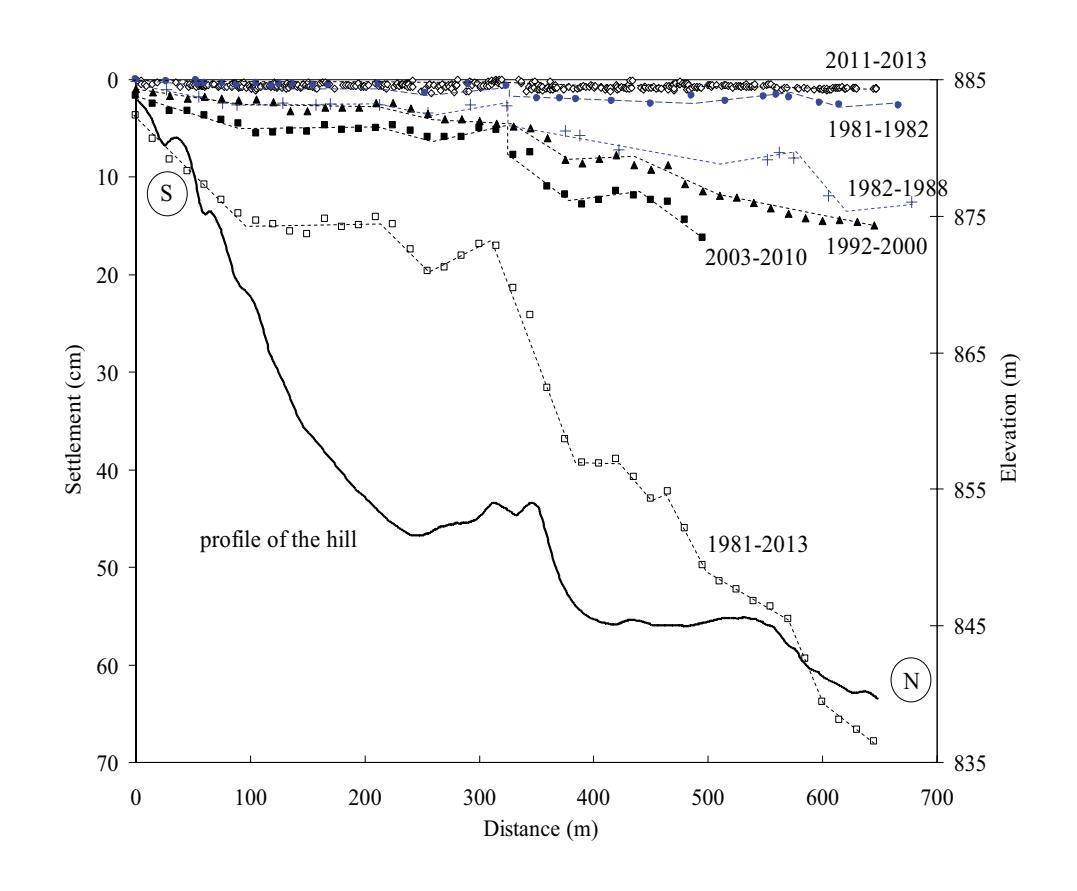
Fig. 12 Summary of data available about vertical displacements along the main axis of the downtown: topographic readings (1981–1982; 1982–1988); satellite images (1992–2000; 2003–2010; 2011–2013); total (1981–2013)

An updated profile of vertical displacements in the South-North hill axis is plotted in Fig. 12 where it is again compared to the platform profile. As a first useful consideration, the trend of recent readings is fully consistent with the previous one. The figure also shows the cumulative 1981–2013 displacements obtained by summing the data from satellite images to those obtained from topographic readings (Fig. 8), integrated with extrapolated values that cover the "black holes" in the time intervals 1988–1992, 2001–2003 and 2010–2011. The obtained plot again suggests a long-lasting deformation process, presumably started well before the 1980 earthquake and characterized by apparently independent movements of single blocks, which led to the present platform profile. The peak Fig. 9 a) Schemes of InSAR reference geometries on ascending and descending orbits (mod. from Di Traglia et al. 2021); LOS average displacement rates (superimposed to a Google Earth view-Landsat/Copernicus image) from: ERS ascending **b**) and descending **c**) orbits (1992-2000); Envisat ascending d) and descending e) orbits (2003-2010); CSK descending orbit f) (2011-2013). A negative value indicates that the scatterer is moving away from the sensor. White squares in **b**), **c**), **d**), **e**) show buildings for which both ascending and descending data are available. Landslide contours (Fig. 2) also reported in f)

settlement value from 1981 to 2013, just at the northern boundary of the platform, is approximately 70 cm, which corresponds to a rate a little higher than 2 cm/year.

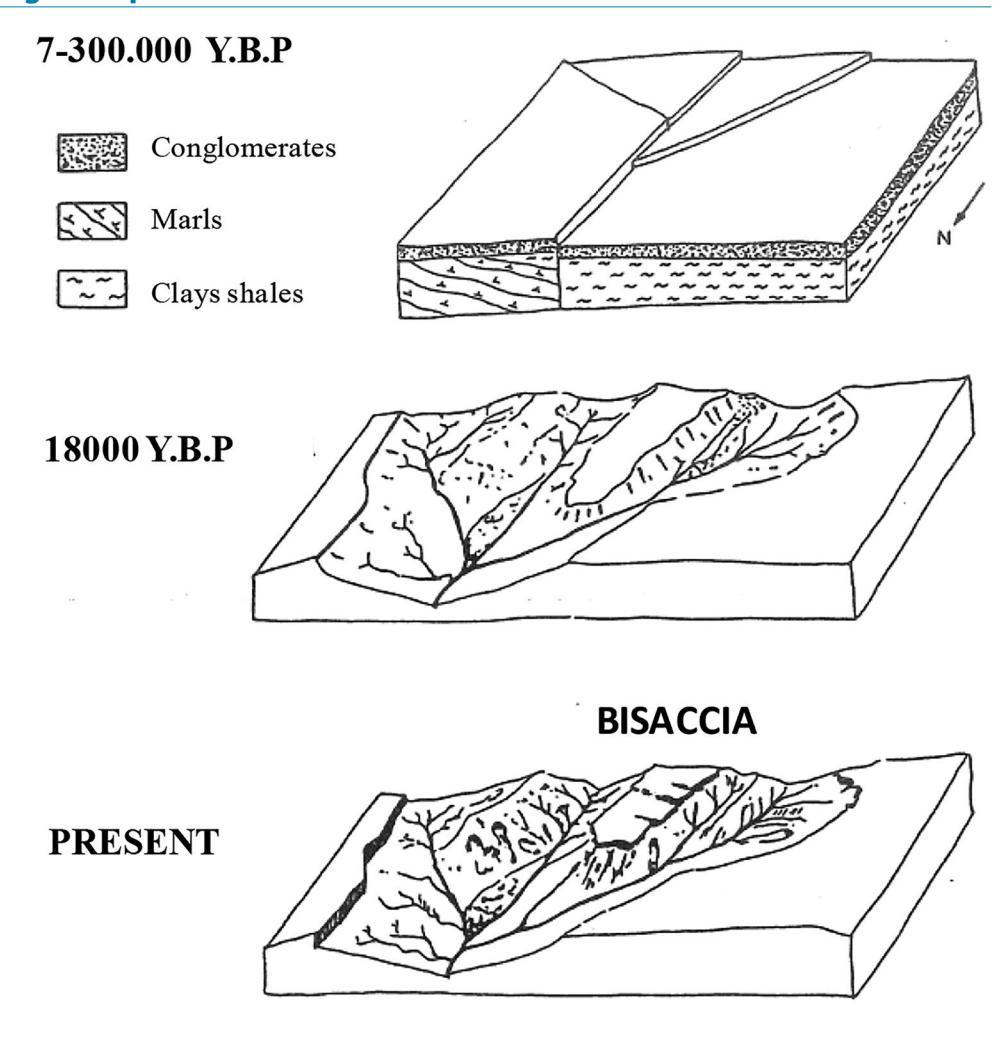
**Fig. 13** Evolution of the Bisaccia area (after Di Nocera et al. 1995)

Based on geological data, erosion is supposed to have started about 300,000 years ago along two parallel faults more or less corresponding to the axes of the lateral valleys. Figure 13 schematically reports the geological evolution of the area. Such a process was simulated through a 2D FEM numerical analysis (Picarelli and Urciuoli, 1993). The initial top of conglomerates was assumed to be horizontal, and then these were gradually removed in order to reproduce the present morphology of the area. The rate of conglomerate erosion was considered to be either constant or variable assuming a threefold increase after complete dismantling of the slab in order to account for the different erodibility of conglomerates and of clay shales. The groundwater table was initially located at the top of clay shales, then, after removal of the uppermost conglomerate layer, it was gradually lowered following the deepening of the valley floor. The main vertical cracks in the platform were reproduced by thin (30 cm) vertical deformable elements; finally, an interface allowing horizontal relative displacements was located at the contact between the platform and the bedrock. The conglomerate slab was simulated as a linear elastic medium while the clay shale behaviour was reproduced through the Cam Clay model adopting the soil parameters

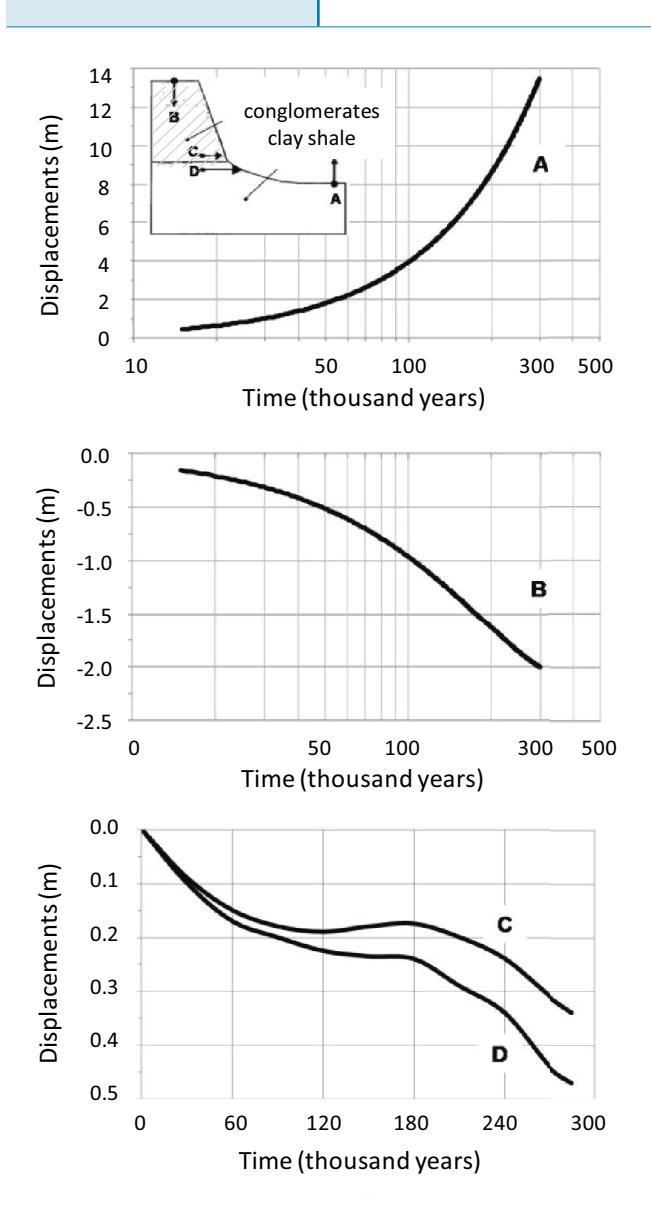
**Fig. 14** Calculated time-dependent swelling of the centre of the valley's bed (**A**), settlement of the hill (**B**) and horizontal displacements of conglomerate bed (**C**) and clay shale top (**D**) (Urciuoli 1992)

The main result of the analysis was a strong and delayed swelling of the valley floors (a in Fig. 14) and some sinking of the hill within the basal formation (b in Fig. 14) due to the combined effect of unloading caused by erosion and both high deformability and low permeability of clay shales (Urciuoli 1992; Picarelli et al. 2002). Another important output was some lateral spreading of the hill due to decrease of the lateral confinement; in particular, the analysis suggests the formation of a shear zone at the top of the basal formation (c and d in Fig. 14). Some clues about that might be provided by the water content profiles of clay shales (Fig. 15) obtained from measurements on samples taken from the boreholes B and D, compared to the values calculated through the numerical analysis (Picarelli and Urciuoli 1993). In particular, while these last can

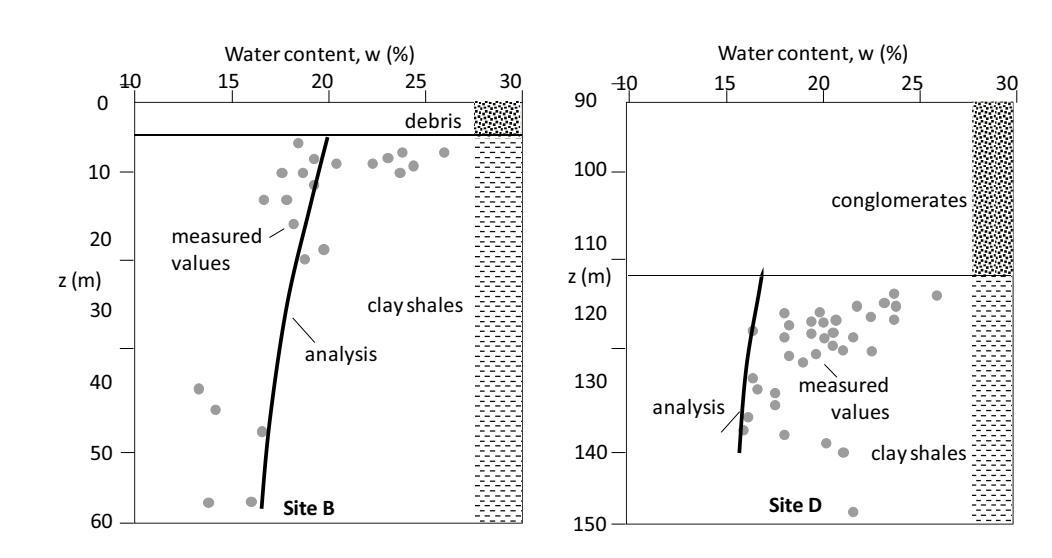
Fig. 15 Measured and calculated water content profiles in the subsoil of eastern valley (site B) and under the conglomerate bed (site D) (redrawn after Picarelli and Urciuoli 1993)

capture the trend of the water content profile along the vertical B, they underestimate the water contents measured within a depth of about 15 m under the platform. This might just indicate the presence of a thick shear zone generated by the process of lateral spreading discussed above.

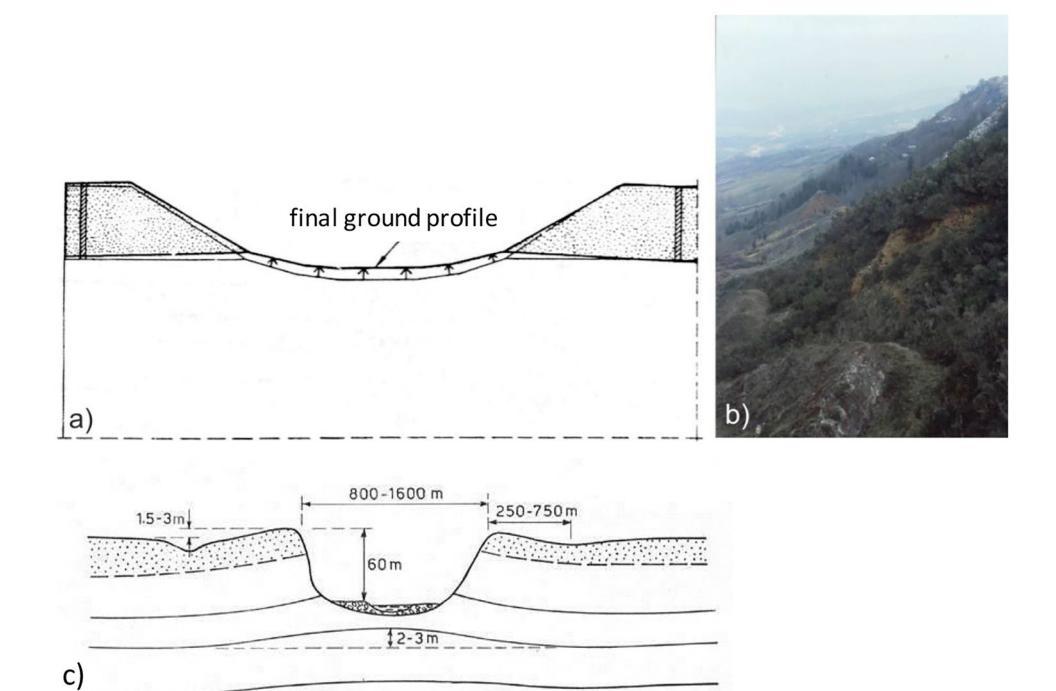
Fig. 16 a) Simplified cross section of the Bisaccia hill and displacement vectors obtained from numerical analysis (Picarelli and Urciuoli 1993); b) the Eastern Bisaccia hillslope that is sinking in the clay shale deposit; c) effects of erosion in the Saskatchewan river valley (Matheson and Thomson 1973).

Figure 16a shows the calculated deformation of a cross section of the platform. In particular, it shows that the lateral blocks are subjected to some rotation, which implies a distortion of the slab and formation of a concave interface at the conglomerate-clay shale contact. The figure also suggests the development of tensile stresses at the base of the platform, which might lead to formation of further vertical cracks. Interestingly, a similar deformation field as in Fig. 16a has been observed in some Canadian river valleys indented in highly plastic clay shales (Fig. 16c).

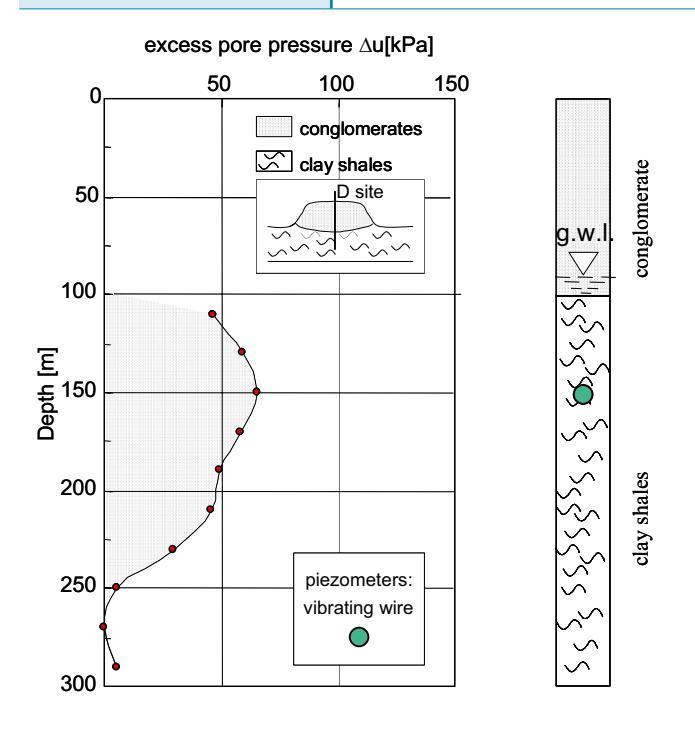
**Fig. 17** Calculated excess pore pressures induced by the Irpinia-Basilicata earthquake (Olivares and Silvestri 2001)

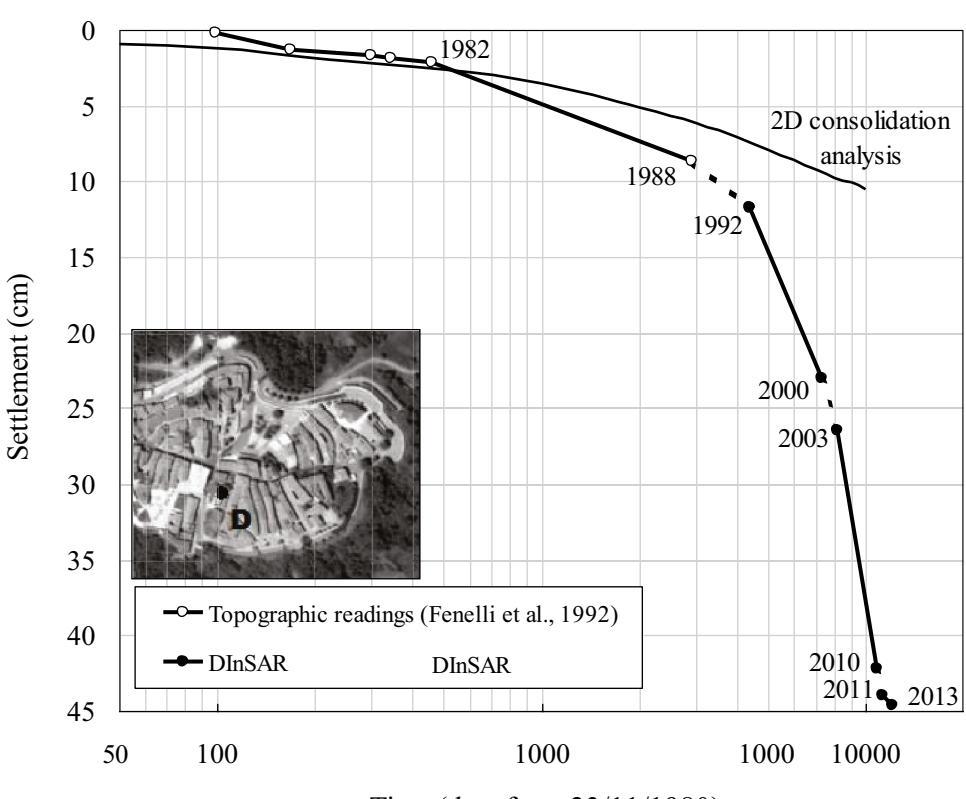
**Fig. 18** Temporal evolution of the vertical displacement at point D based on both topographic readings and satellite images compared to calculated post-seismic consolidation (modified after Lampitiello et al. 2001)

The temporal evolution of vertical displacements of the platform since February, 1981, until 2013 (thus ignoring the deformation cumulated in the time interval between November, 1980, and February, 1981) can be obtained coupling the readings obtained by topographic measurements and satellite data. A plot of settlements at site D in the northern sector of the town is shown in Fig. 18. In the same figure are reported the results of numerical analyses based on the results of laboratory tests on natural samples (Lampitiello et al. 2001), in the assumption of 2D dissipation of the calculated excess pore pressures triggered by the 1980 earthquake. The evolution of the settlement rate is characterized by a typical decreasing trend, even though the monitored displacement is higher than the predicted one well before the availability of satellite images. Such a difference might be explained by the presence of a thick compressible shear zone. These considerations suggest that any strong earthquake occurring in the area at hand can lead to similar effects contributing to the ongoing deformation process.
