The Microstructure and Properties of Laser Shock Peened CMSX4 Superalloy

MAGDALENA ROZMUS-GÓRNIKOWSKA, JAN KUSIŃSKI, ŁUKASZ CIENIEK, and JERZY MORGIEL

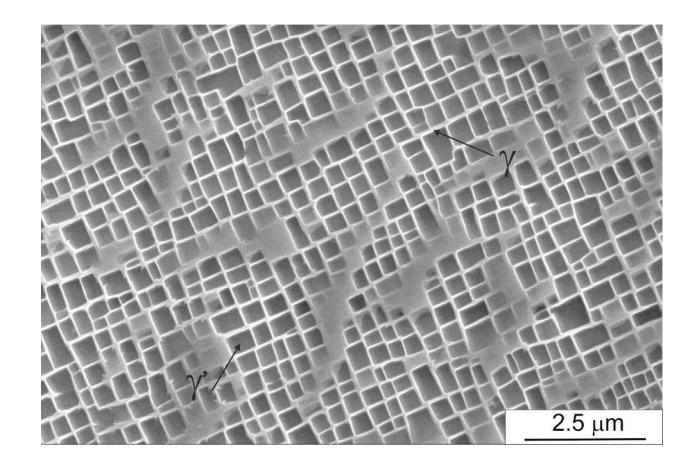
Figure 1 is a SEM image showing the microstructure of CMSX-4 superalloy before laser treatment. The cuboidal γ' precipitates surrounded by channels of γ

Fig. 1—SEM image showing the microstructure of CMSX4 alloy before laser treatment.

phase are marked with arrows. According to the literature, the cuboidal precipitates of γ' phase (Ni₃Al-based) are coherent with the γ phase matrix (Ni-based solid solution).^[1,2] Figure 2(a) shows a SEM image of a sample surface with four laser-shocked areas (indicated with arrows), with a sufficiently large distance between their centers, *i.e.*, so that the laser spots do not overlap. Figure 2(b) shows the structure at a higher magnification of the area marked in Figure 2(a). The numbers I–IV are designated in the following order: I, the melted area; II, the area of the γ/γ' interface melting; III, the deformed material area (without remelting); IV, the initial material 1.

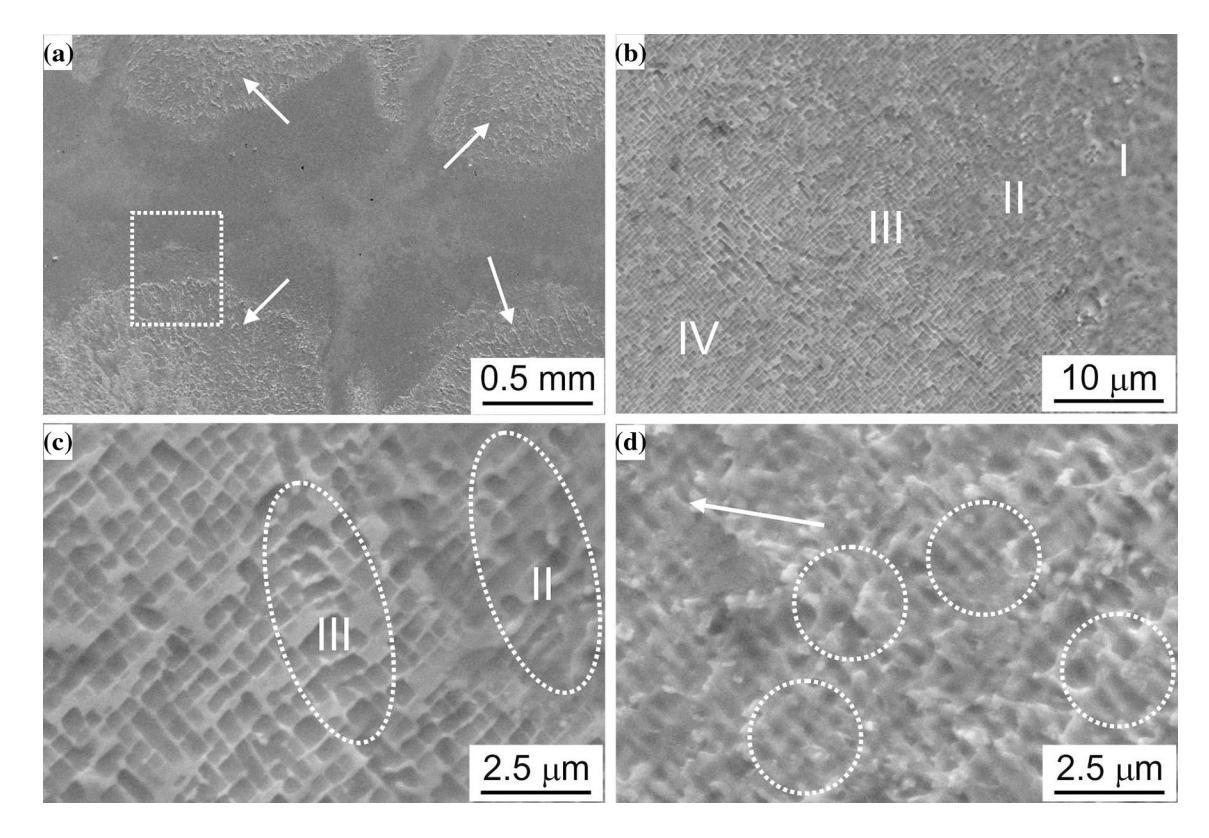
Figures 2(c) and (d) shows the microstructure at higher magnification in areas II and III. In Figure 2(c), the deformed areas are indicated with ellipses. The areas in which the alloy melting starts at the γ/γ' interfaces are marked with circles in Figure 2(d). Distortion of the regular γ/γ' cell structure, as compared to initial alloy structure (Figure 1), is observed in the peripheral area (III) of the laser-shocked spot. It should be noted that before the LSP (Figure 1), γ' phase (gray region) and γ phase (bright region) can be observed with clear and sharp interfaces, as shown also in Figure 2(b) (in area IV) and Figure 2(c) (in the lower left corner). Blurred

Fig. 2—SEM images show the surface morphology of the CMSX4 alloy after LSP. Arrows in (*a*) indicate laser-shocked spots, while numbers in (*b*) mean: I, melted area; II, area of the γ/γ' interphase melting; III, deformed material area (without remelting); IV, initial material; (*c*) is the magnified image of areas II and III in (b); (*d*) typical SEM image of the area where the γ/γ' phase interphase melting was observed (arrow shows the direction in which plasma spread, while circles indicate melted phase interphases).

fluence of 10 J/cm² and wavelength 1064 nm, the maximum surface temperature at the beam center, during ablation of tungsten and boron, enriches 11,700 K and > 10,000 K adequately. Also, Tan *et al.*^[26] showed that the Al surface temperature during laser ablation reaches > 8000 K. Since for Ni (main superalloy component) the boiling point is 3186.15 K and critical temperature 8000 K, $^{[27]}$ one may expect even some evaporation of the thin surface layer. Thorslund *et al.*^[28] applying a developed mathematical model show that the surface temperature of LSP 304 steel (14,500 K) exceeds its boiling temperature (3000 K). If surface melting occurs in the central area of a laser-shocked spot, a part of the melted material is explosively ejected as the liquid forming splashes (spreading in all directions from the central zone), which resolidifies on the sample surface (see Figure 2(d)).

γ/γ' interfaces are observed in Figure 2(c) (circulated area in the top right corner) and in Figure 2(d). This could be caused by the melting at the γ/γ' interfaces. The temperature in the ring area, lying ~ 0.8 to 1.3 mm from the spot center, is lower than the alloy melting point, 1654.5 K ± 4 K,^[29] but higher than the γ' solvus temperature. According to Reference 29 the γ' precipitates dissolve during heating in a wide temperature range between 1523 K and 1623 K, depending on the heating rate, adequately 1 °C to 10 °C/min. Taking into account a laser heating rate of ~ 10⁸ K/s,^[30,31] the γ' phase could not dissolve in solid state below the alloy melting point. Indeed, in this zone γ' phase remelting begins in areas of the increased energy state, *i.e.*, at the γ/γ' interfaces. This is probably why the interfaces look blurred in the SEM images (in Figures 2(c) and (d)). The consequence of surface melting and spreading of a portion of the melted material—which resolidified on the sample surface—is an increase in the roughness of the surface. The surface morphology of a sample before and after treatment was characterized using an optical profilometer. The example of the surface profiles after the LSP process measured along two perpendicular lines is shown in Figure 3. It was found that both *R*a and *Rz*, originally estimated at 10 and 100 nm, increase because of the LSP to 460 nm and 11.4 μ m, respectively. A representative shear band, visible on the surface in the laser shock-peened area, is shown in the AFM

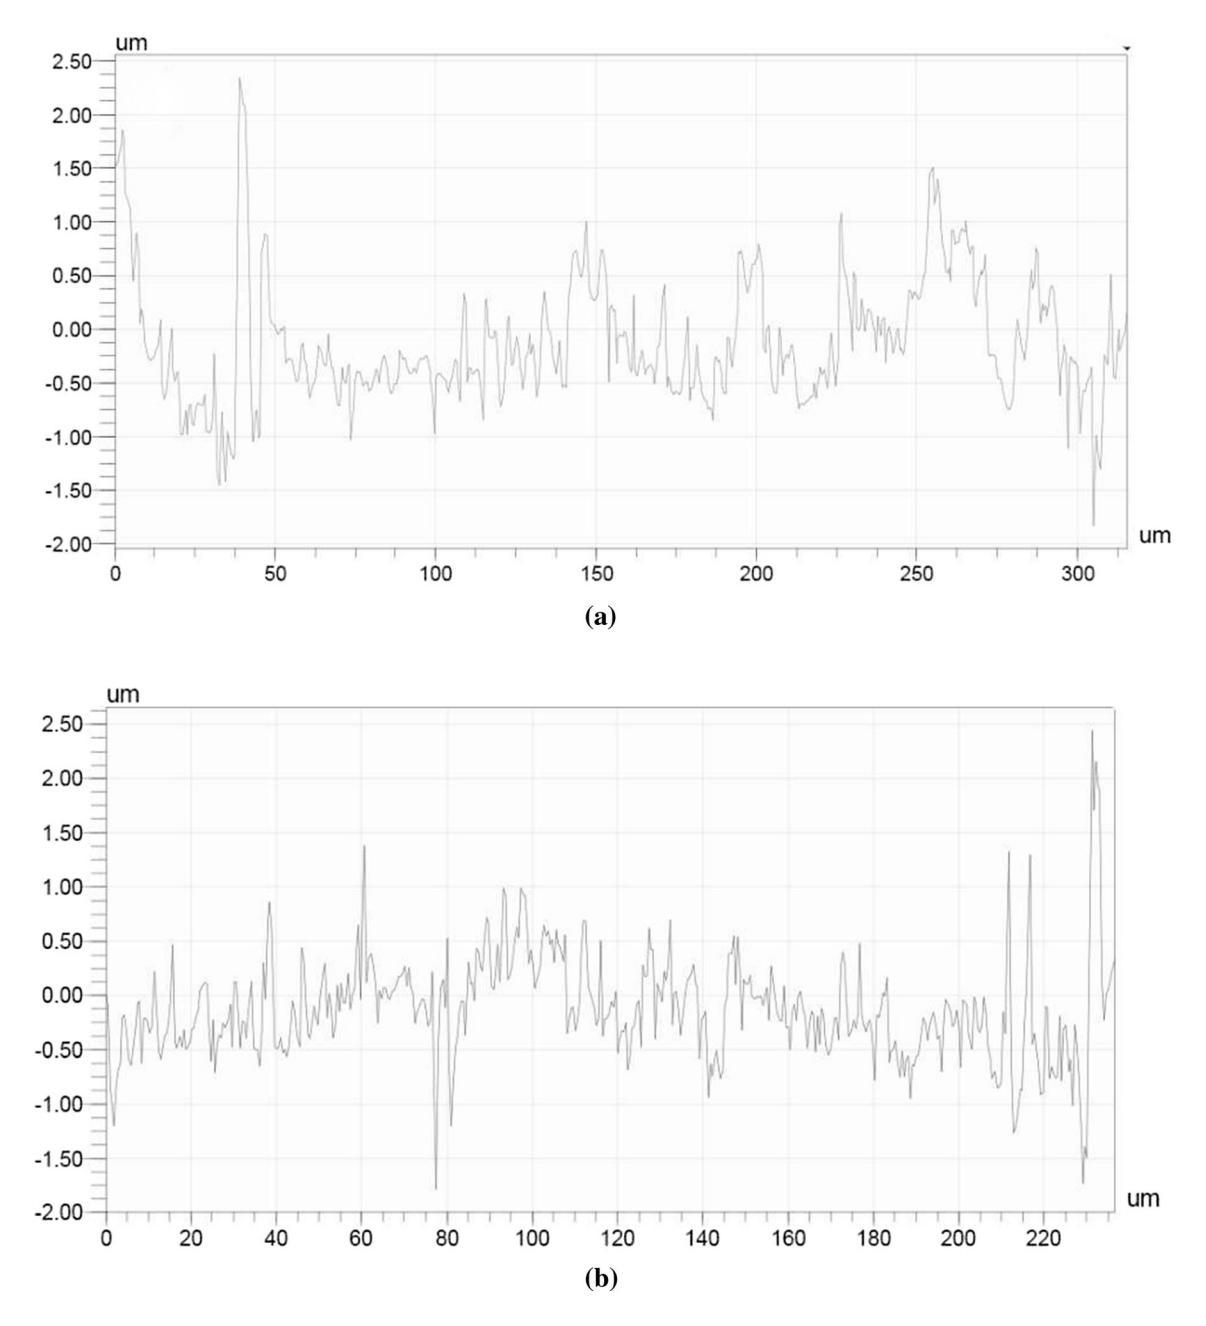
Fig. 3—Profiles of surface roughness after laser treatment measured along two perpendicular lines [horizontal (a) and vertical (b)] passing through the laser spot (optical profilometer).

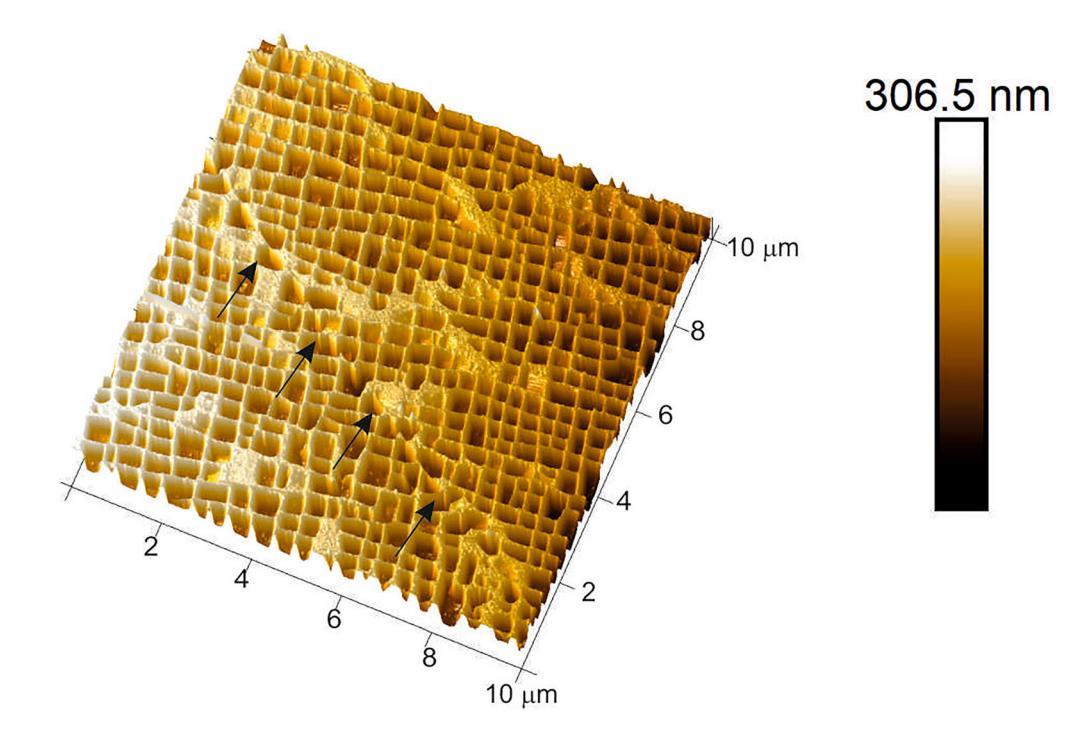
Fig. 4-Typical AFM micrograph of shear bands (arrowed) in CMSX4 alloy after LSP process.

micrograph (Figure 4). This AFM micrograph was taken from the peripheral area of the laser-shocked spot.

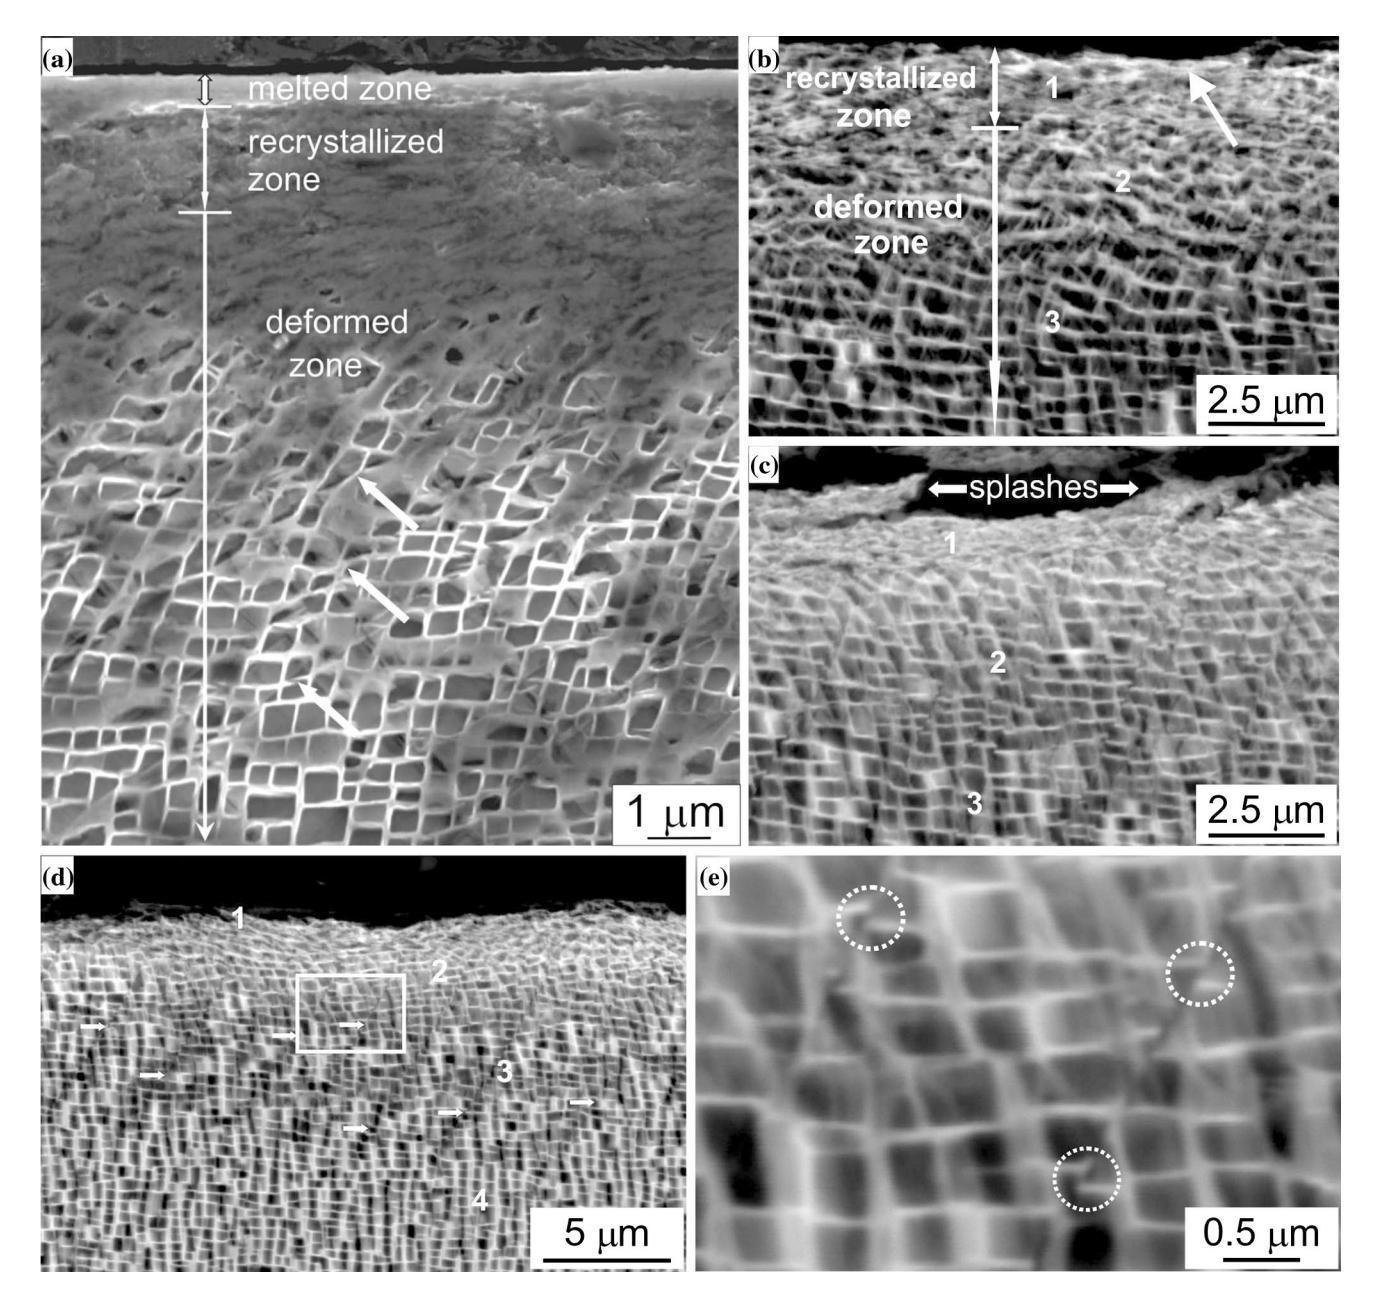
In Figures 5(b) through (d), the microstructure of the peripherals of the laser-shocked spot is shown. The surface layer consists of two different zones, recrystallized (1) and deformed (2 and 3), with only signs of melting (arrowed in Figure 5(b) and as splashes in Figure 5(c)). As the distance from the center of the spot increases, the thickness of the recrystallized zone decreases, respectively (Figures 5(b) to (d)). The thickness of the recrystallized zone is gradually reduced from ~ 1 μ m to 100 to 200 nm with the distance from the center of the spot. This is probably due to both the lower temperature and level of stresses generated at the spot peripherals. Below this ultrathin recrystallized zone (1), there is a zone of deformed material with numerous shear bands (2 and 3). Figure 5(e) is a magnified image of the region marked by the rectangle in Figure 5(d). The areas denoted by circles at the shear bands show γ phase displacement of about 150 nm, which proves quite severe alloy deformation caused by LSP. As Lu et al.^[32] showed during laser shock peening, the γ' precipitates deform by lateral expansion (parallel to the sample

Fig. 5—SEM presenting the microstructure of the surface layer formed in different areas of the laser-shocked spot in the plane perpendicular to the treated surface: (a) in the melted zone, (b, c and d) in the peripheral area of the laser-shocked spot. (e) Region marked by a rectangle in (d) at higher magnification. Numbers indicate: 1: the recrystallized zone; 2: heavily deformed zone (with narrow γ phase channels oriented perpendicular to surface); 3: partially deformed zone (with narrow γ phase channels in the vicinity of slip bands, indicated with arrows in (d); 4: matrix (not affected by LSP).

surface, roughly parallel to the $\langle 001 \rangle$ orientation), and therefore γ channels are directly extruded. Moreover, they are also reoriented (both γ' and γ phases, Figures 5(b) and (c)). As a result, the SEM image in these areas looks different from that in the non-laser-treated alloy matrix.

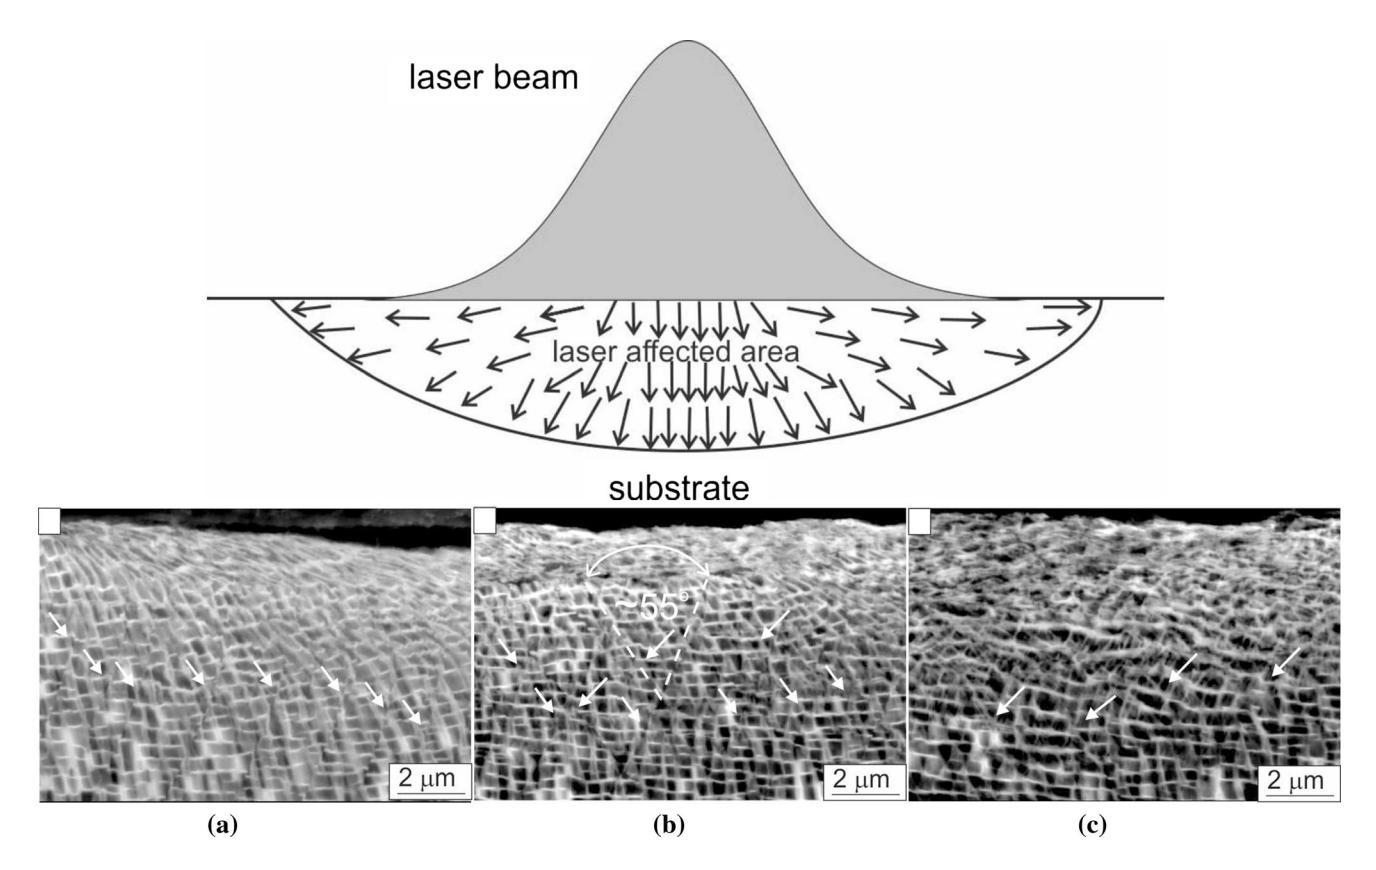
Figure 6 presents the schematic view of the multidirectional shock wave expansion in the laser-affected area. The SEM images show the microstructure in the plane perpendicular to the treated surface in three different areas: (a) the left side area, (b) central laser affected area and (c) right side area. In the images taken in the areas (a) and (c), it could be observed that the γ/γ' interfaces are bent in the impact direction. SEM analysis revealed that in the subsurface areas, the regular arrangement of the γ' and γ phases is totally destroyed. This is due to severe plastic deformation induced by the plasma pressure generated during the laser pulse/substrate interaction. It should be emphasized that, as a result of severe plastic deformation, there was a significant distortion of the cuboidal γ' phase. In the areas near the surface (up to ~ 5 to 6 μ m beneath the surface),

Fig. 6—Schematic view with arrows showing the shock wave expansion in the laser-affected area illustrated by SEM images of the microstructure in the plane perpendicular to the treated surface; images show the structure in: (a) the left side area, (b) central area and (c) right side area.

they assume diamond-like shapes. The shear bands are indicated with arrows in the SEM images (a), (b) and (c). The shear bands and the γ/γ' interfaces in the image (a) are oriented to the left of the center, while in image (c) to the right of the center of the laser pulse. In image (b) taken in the central part of the laser-affected area, where the greatest deformation occurred, the shear bands run in different directions and are oriented both to the right and to the left of the sample surface. In Figure 6(b), a subsurface zone (~ 2 μ m thick) of the recrystallized material is visible. Electron diffraction analysis (TEM examination) as well an angle of ~ 55 deg between the slip bands marked in Figure 6 indicates that the shear bands are parallel to {111}. The laser shock peened specimen experiences an extremely high strain rate $(> 10^6 \text{ s}^{-1})$ during a short period of time (10 to 20 ns). Moreover, spread of the shock wave in the laser affected area is multidirectional. This could cause other slip systems to operate than those appropriate for the A1 structure $\{111\}\langle 110\rangle$.

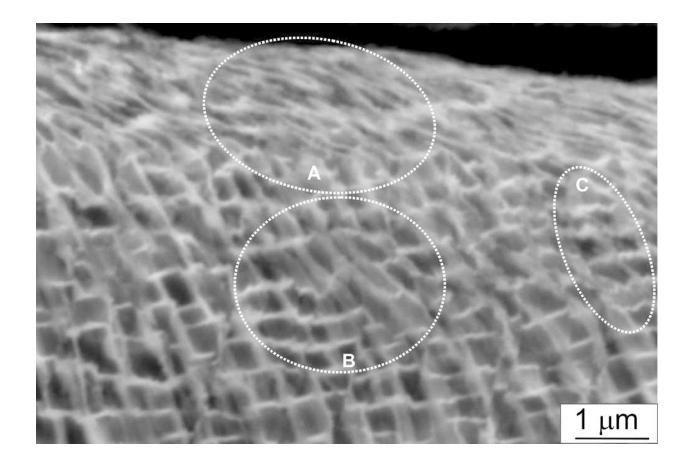
Figure 7 shows the microstructure in the left side periphery, ~ 1.5 mm from the spot's center. The studies show that, in the ~ 1 to 2 μ m sub-surface zone (encircled as A), the simultaneous interaction of severe plastic deformation and temperature resulted in considerable γ' and γ grain refinement and their alignment. In the areas B and C, marked with ellipses, a serrated distortion of

Fig. 7—SEM image shows the microstructure in the left side periphery of the laser-affected area (areas marked with ellipses, showing a serrated distortion of γ/γ' interfaces).

the γ/γ' interfaces (those parallel to the surface) is visible. This type of deformation can be explained using the mechanism proposed by Ting *et al.*^[33] The rhombohedral (diamond-like) shape of γ' precipitates can be formed during LSP because of multidirectional yielding and the influence of high temperature. As shown by Wen *et al.*,^[34] this deformation mode was observed in fractured samples of a nickel-based single-crystal superalloy. In this work, the authors examined the fracture

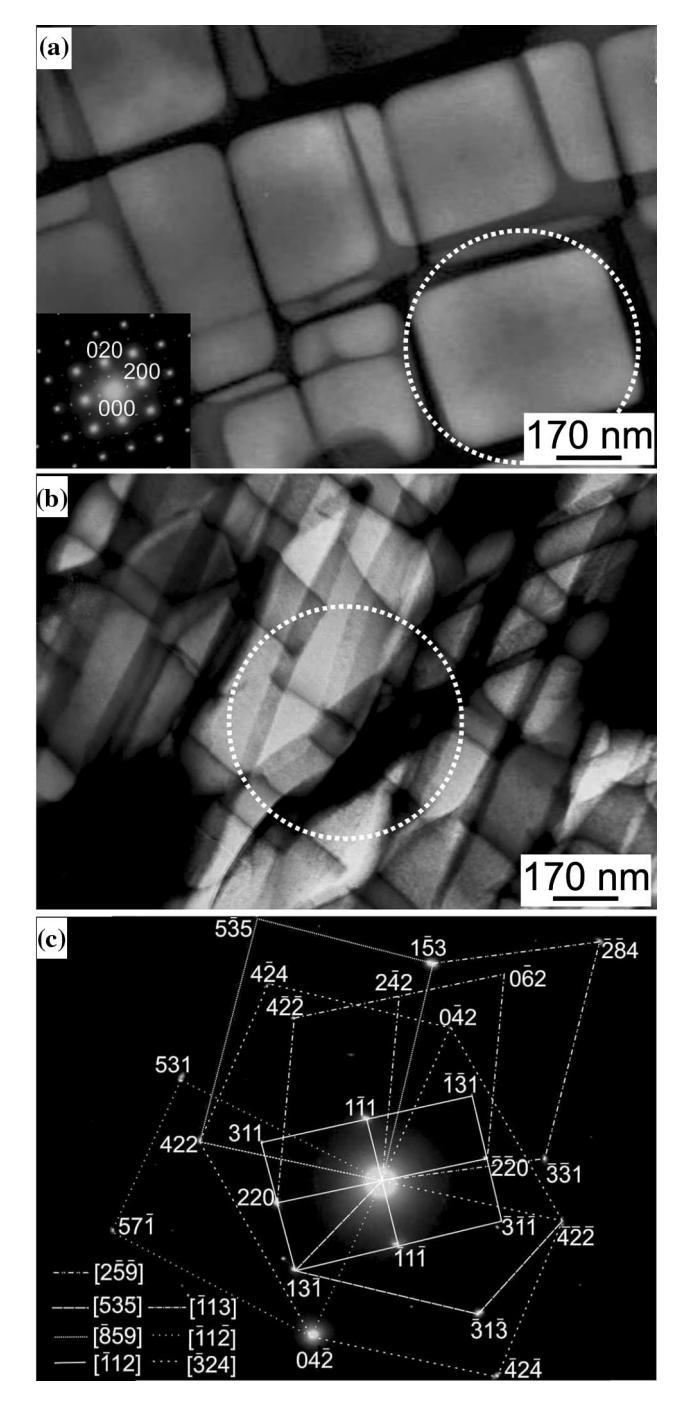
Fig. 8—Plain view TEM images presenting the microstructure for CMSX-4 single-crystal superalloy: (a) substrate (inset is the SAED pattern of the γ' phase along the [001] zone axis), (b) microstructure of the heavily deformed zone after the LSP experiment; (c) SAED pattern from a few deformed γ' phase precipitates; circles in micrographs a and b indicate areas in which diffraction was performed.

Figures 8(a) and (b) presents the plain view TEM images of the single-crystal CMSX-4 superalloy in the as-fabricated state (Figure 8(a)) and in the highly deformed zone after the LSP (Figure 8(b)). Figure 8(a)shows a typical two-phase γ/γ' microstructure of the CMSX-4 superalloy substrate. After annealing, the γ' -Ni₃Al precipitates (average size ~ 500 nm) have a cuboidal shape with unimodal distribution in the γ -Ni matrix. The inset is the SAED pattern of one large γ' precipitate (encircled in Figure 8(a)) oriented along the [001] zone axis. Figure 8(b) is a TEM plane view image of the highly deformed zone (marked as 2 in Figure 3) after LSP. A distortion of the regular γ/γ' cell structure, in the laser shocked region, as compared to the initial alloy structure (Figure 8(a)), is evident. The SAED pattern in Figure 8(c) of the central part of the image (from the area marked with a circle in Figure 8(b)) represents few differently oriented (probably superimposing), deformed γ/γ' particles.

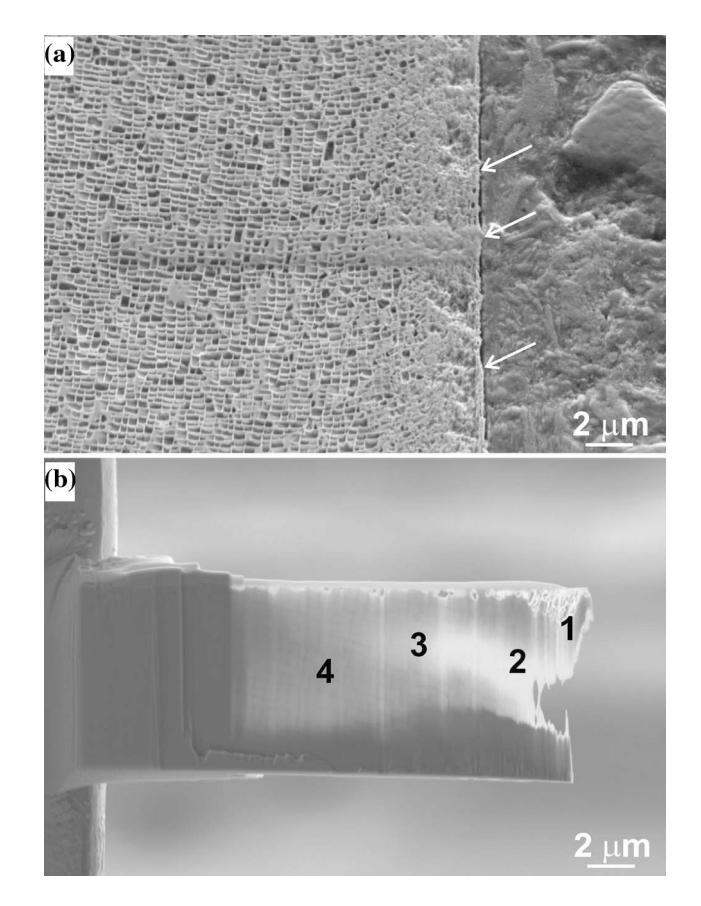
Fig. 9—SEM images (a and b) show two stages of lamella preparation in the LSP deformed surface layer (a: sample surface coated with a platinum bar and b: lamella cut using the FIB technique; arrows indicate a thin melted surface layer), numbers 1 to 4 indicate areas of TEM analysis.

To analyze in detail the structural changes in the surface layer of the CMXS-4 alloy after LSP, FIB lamellas were cut from the deformed area in a plane perpendicular to the treated surface. Figure 9 shows SEM images of the sample surface coated with a platinum bar [up to ~ 15 μ m beneath the surface (Figure 9(a))] and the lamella cut with FIB (Figure 9(b)). The numbers 1 to 4 in Figure 9(b) indicate individual zones on the lamella, in which detailed TEM observations were carried out at a higher magnification. Figure 9(a) clearly shows that right next to the heated surface the sample is porous. Indeed, in these areas, holes are also observed on the cut lamella (SEM image in Figure 9(b)).

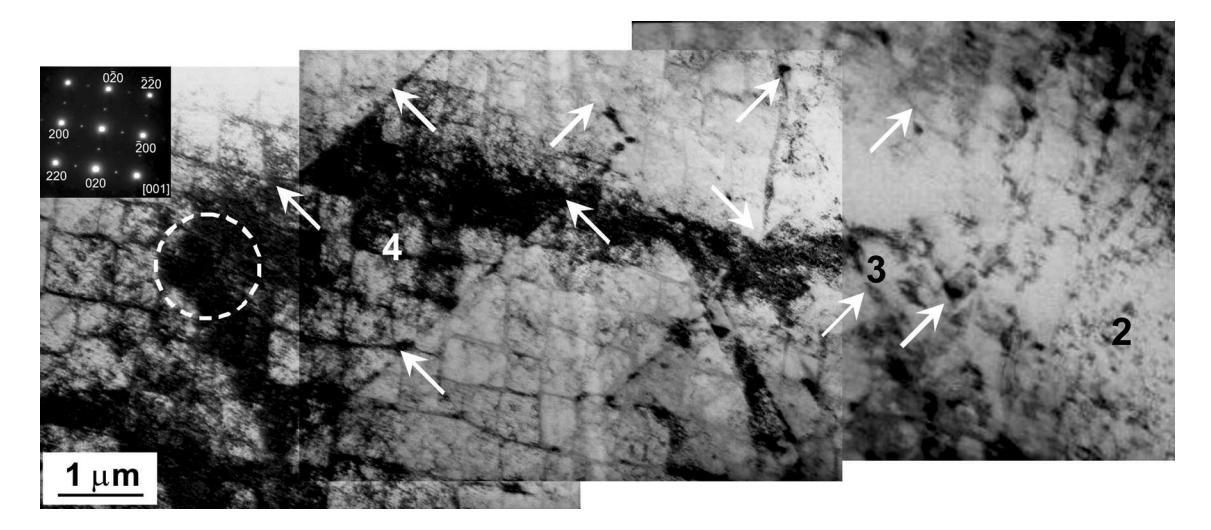
Fig. 10—Low-magnification TEM image showing the structure of the subsurface deformed layer in zones 2 to 4; arrows indicate slip bands; inset is the SAED pattern registered in the circulated area.

Figure 10 shows a typical low-magnification TEM image of the surface layer resulting from a single LSP impact. Arrows in the TEM micrograph indicate slip bands, while the inset is the SAED pattern, which was registered within the circulated area. Image analysis shows that the structure of the surface layer clearly

changes along its cross section, from nanocrystalline (right next to the surface, in zone 2), through heavily deformed rhombohedra of γ' phase (zone 3) to cuboidal γ' with high dislocation density (zone 4). The deformed surface layer shows numerous shear bands (arrowed) parallel to {111}, the density of which increase near the sample surface (in zone 3). Analysis of the electron diffraction patterns allows to conclude that the shear bands are parallel to {111} (inset in Figure 10).

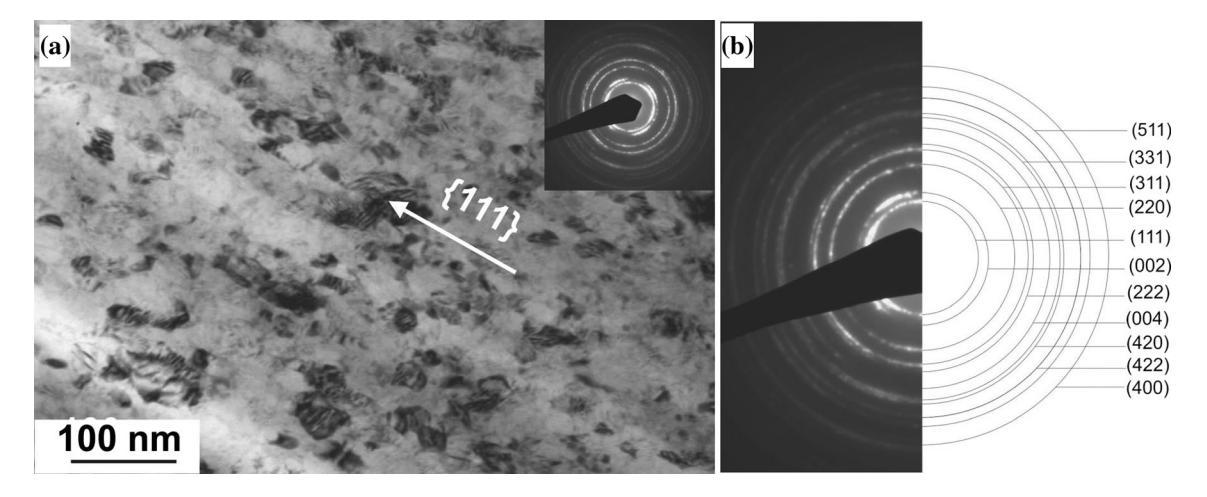
Fig. 11—TEM image (a) shows the nanostructure of the CMSX-4 alloy in the heavily deformed surface zone (in the area marked as 1 in Fig. 9(b)); the inset shows the ring-type SAED pattern characteristic for nanostructures; (b) shows the identified ring pattern of γ/γ' phases.

Figures 11 through 15 are magnified TEM images of the lamella taken in zones 1 to 4 indicated in Figure 9(b). TEM analysis of zone 1 (Figures 11 and 12) indicates that the plastic strain caused by LSP treatment induced grain refinement, with the characteristic ring diffraction pattern of nano-grains present in the area of ~ 6 μ m² (see inset and resolved SAED pattern in Figure 11(b)). In this figure, diffraction spots form concentric ring patterns characteristic of a polycrystalline structure. This indicates the presence of an ultrafine structure and high disorientation between

grains. The average size of grains is much smaller than 50 nm. The rings are discontinuous. Some spots have a different brightness and spread, which may suggest a preferred orientation of the grains, an accumulation of dislocations and the existence of lattice distortions.

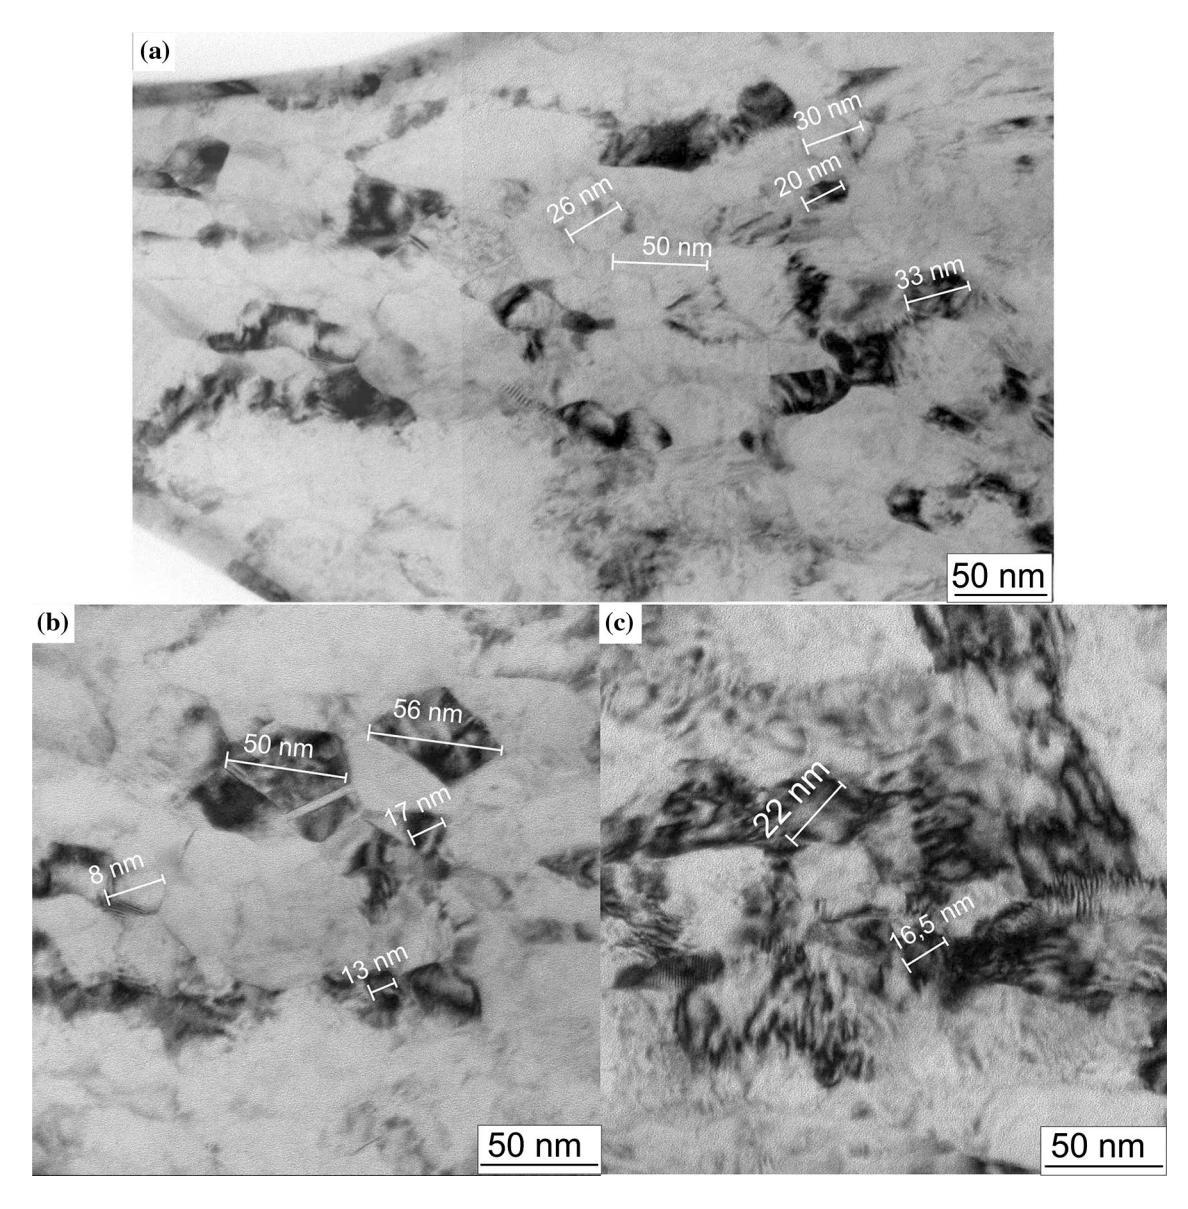
Fig. 12—TEM images showing a recrystallized area located next to the LSP surface: (a) area lying approximately 100 to 300 nm beneath surface, (b) area 300 to 500 nm from surface and (c) area 600 to 900 nm below the surface, where highly strained grains were observed.

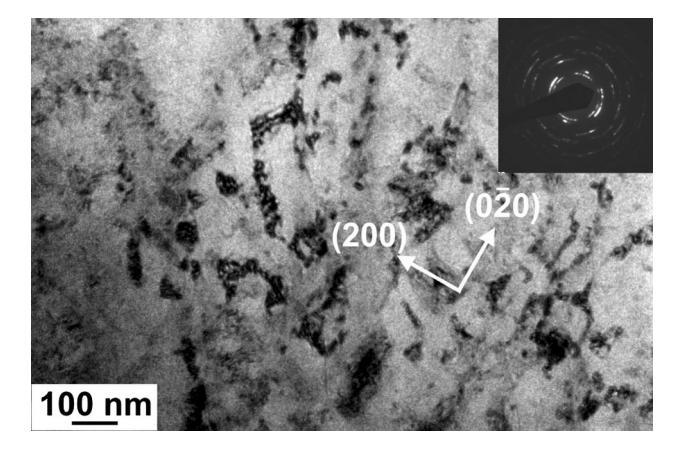
Fig. 13—TEM image shows coarser nanostructure of the CMSX-4 alloy in the deformed surface zone (in the area marked as 2 in Fig. 9(b)).

Figure 13 shows a magnified TEM image of zone 2 in which grains are coarser than in zone 1 (with diameter larger than 100 nm). A corresponding diffraction pattern (inset in Figure 13) also indicates that these grains are preferentially oriented. The contrast inside grains is non-homogeneous and often undergoes complex changes. This may indicate a high level of internal stresses and elastic distortions of the crystal lattice. In the surface layer (in zones 1 and 2), LSP caused the formation of a highly disperse structure.

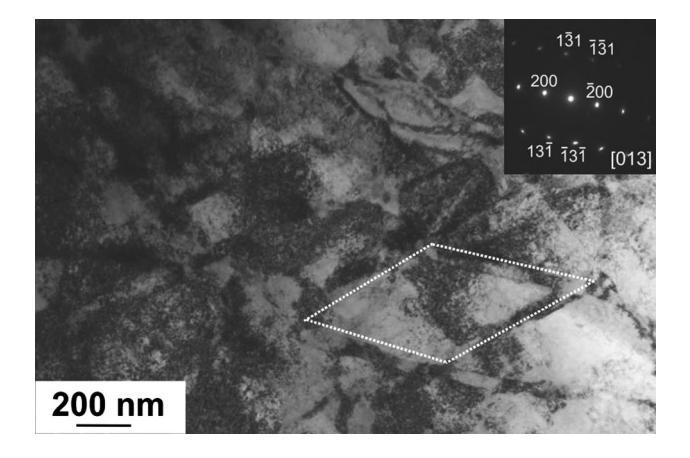
Fig. 14—TEM image shows the structure of the CMSX-4 alloy in the deformed surface zone (in the area marked as 3 in Fig. 9(b)). Note: cuboidal γ' precipitates deformed to rhombohedral shape (diamond indicated with dotted sides).

In Figure 14, the microstructure of the zone 3 (lying ~ 6 μ m beneath the surface) shows the presence of significant and strong distortions of the cuboidal γ' crystals. In this zone the cuboidal γ' precipitates are deformed to a rhombohedral shape (the diamond is indicated with dotted sides). In zone 4 (Figure 15), γ' particles have the same regular shape as in the matrix (compared with Figure 8(a)), but of high dislocation density. Also, slip bands, aligned in one direction, are present in this zone (Figures 10 and 14).

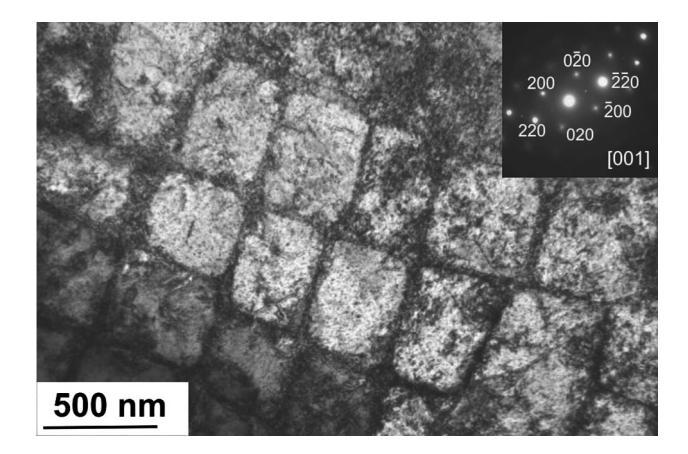
Fig. 15—TEM image showing the microstructure for CMSX-4 in the deformed surface zone (in the area marked as 4 in Fig. 9(b)); inset is the SAED pattern of γ' phase (two beam condition close to the [001] zone axis).

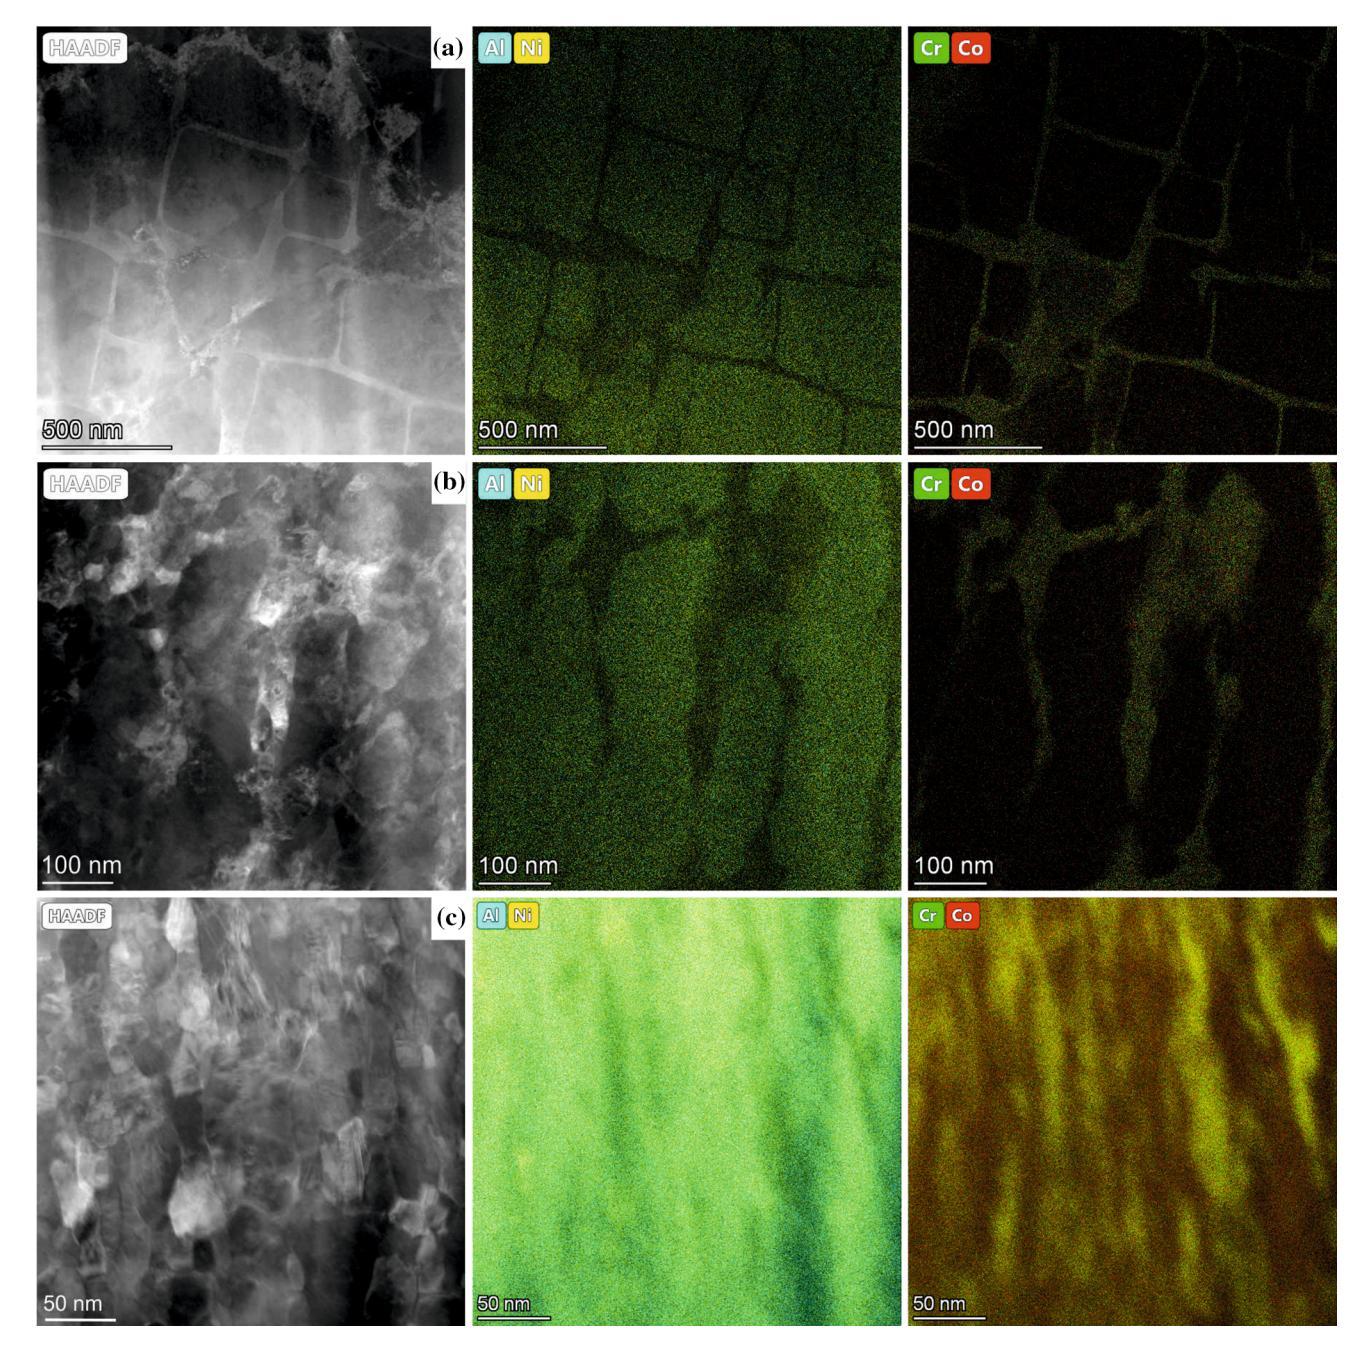
Figures 16(a) through (c) shows the STEM-HAADF microstructure images of the CMSX-4 surface layer with the corresponding EDS combined maps of elements forming the γ' phase (Al, Ni) and the γ phase (Cr, Co). As in the work of Dubiel *et al.*,^[37] in our research, we also noted the presence of Co, Cr, Re, Mo and W in the γ phase and Al, Ti, Ta and Ni in the γ' phase. However, to show the influence of LSP on changes in the alloy surface layer, we limited ourselves to only presenting the complex maps of Cr + Co and Al + Ni. The intensity of the γ phase in the STEM-HAADF images in Figures 16(a) through (c) is brighter than that of the γ' phase (this type of image contrast intensity is closely related to the atomic number Z), since this phase contains Co, Cr and other heavy elements while γ' phase mainly contains Ni and Al. In Figure 16(a) (recorded in zone 3), Co and Cr are distributed in γ phase surrounding the cuboidal γ' precipitates containing mainly Ni and Al. Shear of γ phase, caused by bands cutting both the γ and γ' phases, is also visible in Figure 16(a). Figure 16(b) shows the STEM-HAADF image and EDS maps recorded in zone 2 (as marked in Figure 9(b)). As shown in Figures 11 and 12, due to severe plastic deformation, the structure is refined and preferentially oriented. Indeed, the γ and γ' phases form isolated channels, well visible in the combined distribution maps of Al + Ni and Cr + Co. Figure 16c was performed in zone 1, at much higher magnification than those in zones 2 and 3. The icrostructure in this zone is strongly refined, with the grain size well below 50 nm. Nanograins of γ/γ' phases are arranged in the isolated, nanometric size bands. In fact, the distribution of elements (as shown in the combined maps of Al + Ni and Cr + Co) in this area is more homogeneous than in zones 2 and 3.

Fig. 16—STEM-HAADF images of CMSX-4 superalloy as deformed by the LSP surface layer (images a-c were recorded adequately in areas 3–1, as marked in Fig. 9(b)) and EDS combined maps of chemical element distribution in γ' (Al + Ni) and γ (Cr + Co) phases. Note: due to structure refinement images and maps were recorded at different magnifications.

From the above, it can be stated that the homogenizing process in the surface layer in zones 1 and 2 results from microstructure refining due to severe deformation but not from diffusion. During the diffusion-controlled process, the γ' precipitate dissolution can

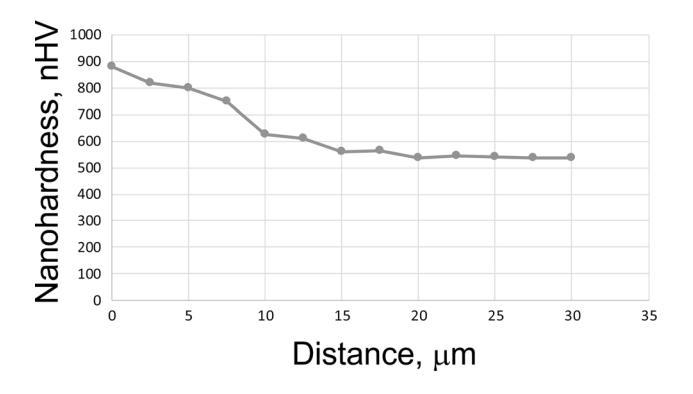
Nanohardness tests were conducted on the cross sections of the LSP-treated samples as well as the untreated material. The nanohardness as a function of the distance from the treated surface is presented in Figure 17. It shows that the laser shock substantially increased the nanohardness of the laser-shocked

Fig. 17-Nanohardness as a function of distance from the surface.

samples. The nanohardness values of the CMSX4 alloy measured on the polished cross sections without LSP treatment were approximately 530 \pm 3 nHV. The laser-treated alloy showed ~ 40 pct increase in hardness values as documented in Figure 17. An increase in hardness is probably associated with the grain refinement, high density of dislocations and slip bands generated in the surface region during the LSP. The shock hardening effect decreases gradually with increasing distance from the surface. At a distance of 15 μ m from the surface, the nanohardness approaches values proper for the core material. A similar trend of hardness increasing after the LSP process was also observed in previous reports on various alloys after laser shock peening.^[38] Nath *et al.*^[38] examined the influence of laser shock peening on the microstructure, residual stress and hardness of Hastelloy-X superalloys. Using the 10 J Nd:YAG laser for the LSP experiments, the authors observed a microhardness increase from 260 to 360-380 μ HV in the ~ 600- μ m-thick surface layer. They related the increased microhardness to the strain hardening caused by increased dislocation density. It should be emphasized that the authors^[38] used the Nd:YAG laser with an energy ten times greater than that used in our experiments; thus, the range of microhardness changes in their case goes much deeper under the surface.
