Bending moment distribution estimation of an actual steel building structure by microstrain measurement under small earthquakes

J. Iyama¹ · O. Chih-Chun¹ · K. Araki²

Journal of Civil Structural Health Monitoring (2021) 11:791-807

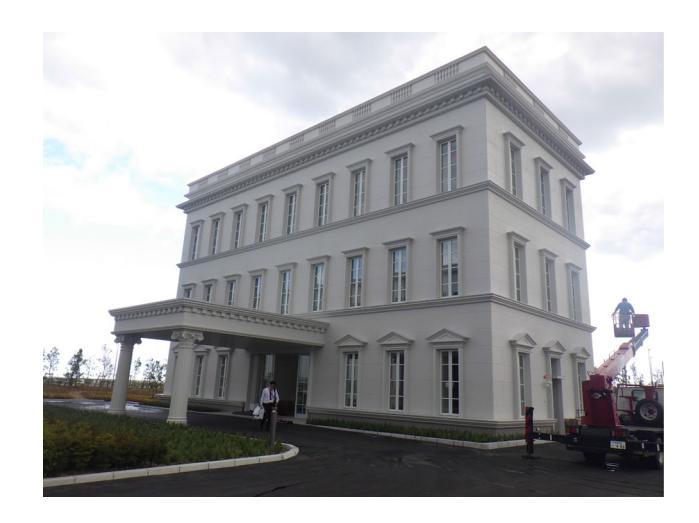
Figure 1 shows a photograph of the target structure. It is a three-story steel moment frame building in Fukushima Prefecture, Japan. This area is close to the epicenter of the 2011 Tohoku earthquake and experiences more earthquakes than other areas in Japan. The target structure was constructed with web-clamp-type beam–column rigid joints [27–29] in June 2018 and has been in use since its construction. Figure 2a-d shows the floor plan of the second floor, X2 axis structural frame, floor slab detail, and details of the outer walls. Table 1 presents the list of cross sections of the structural frame. Some beam-column joints are pin joints, wherein only the beam web were connected to the column with high-strength bolts. As shown in Fig. 2c, the floor is a composite slab with a concrete thickness of 80 mm; it is connected to the beam through headed studs. The distance between the centroids of the steel beam and concrete slab is 409 mm.

Fig. 1 Photograph of the building

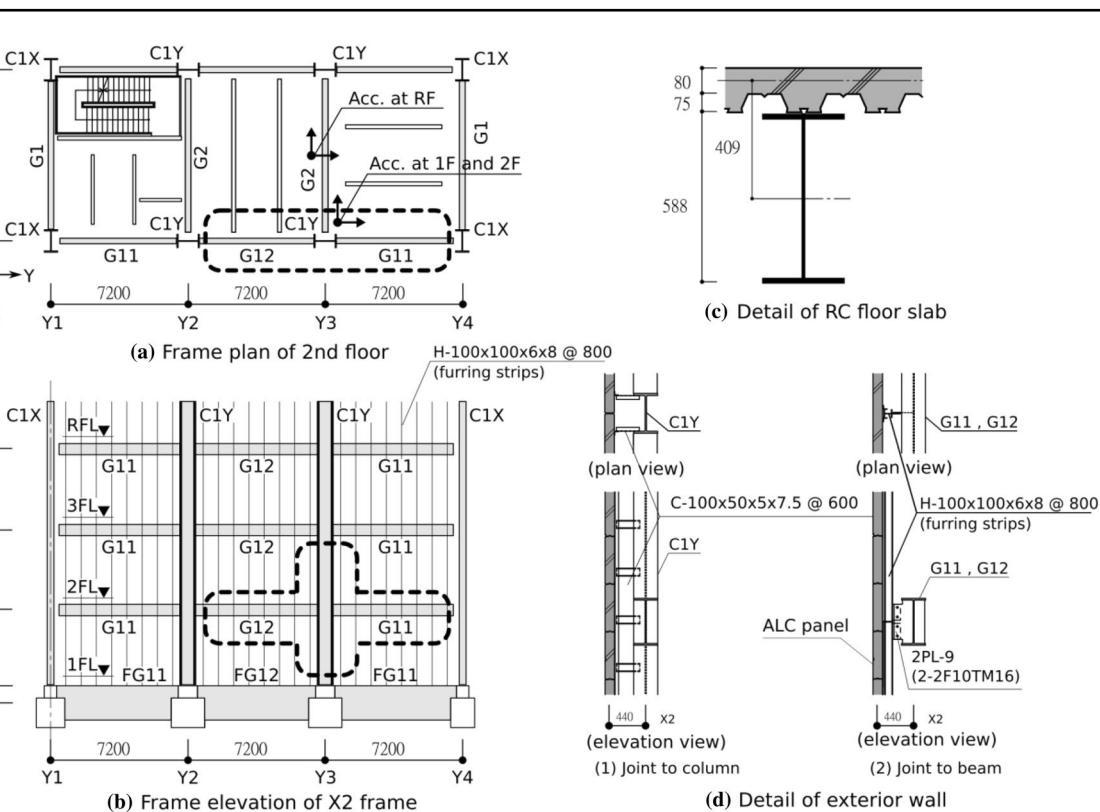
Fig. 2 Structural frame of the target building

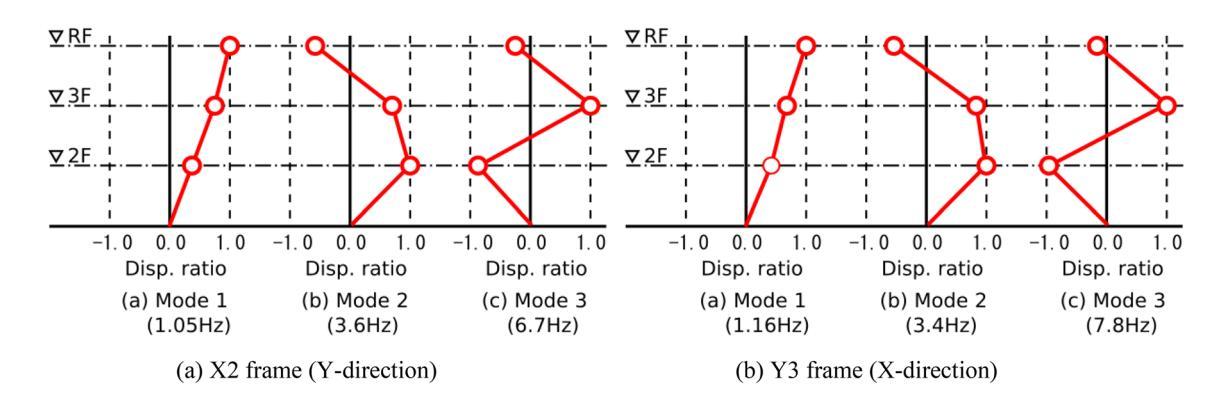
Fig. 5 Eigenvalue analysis [26]

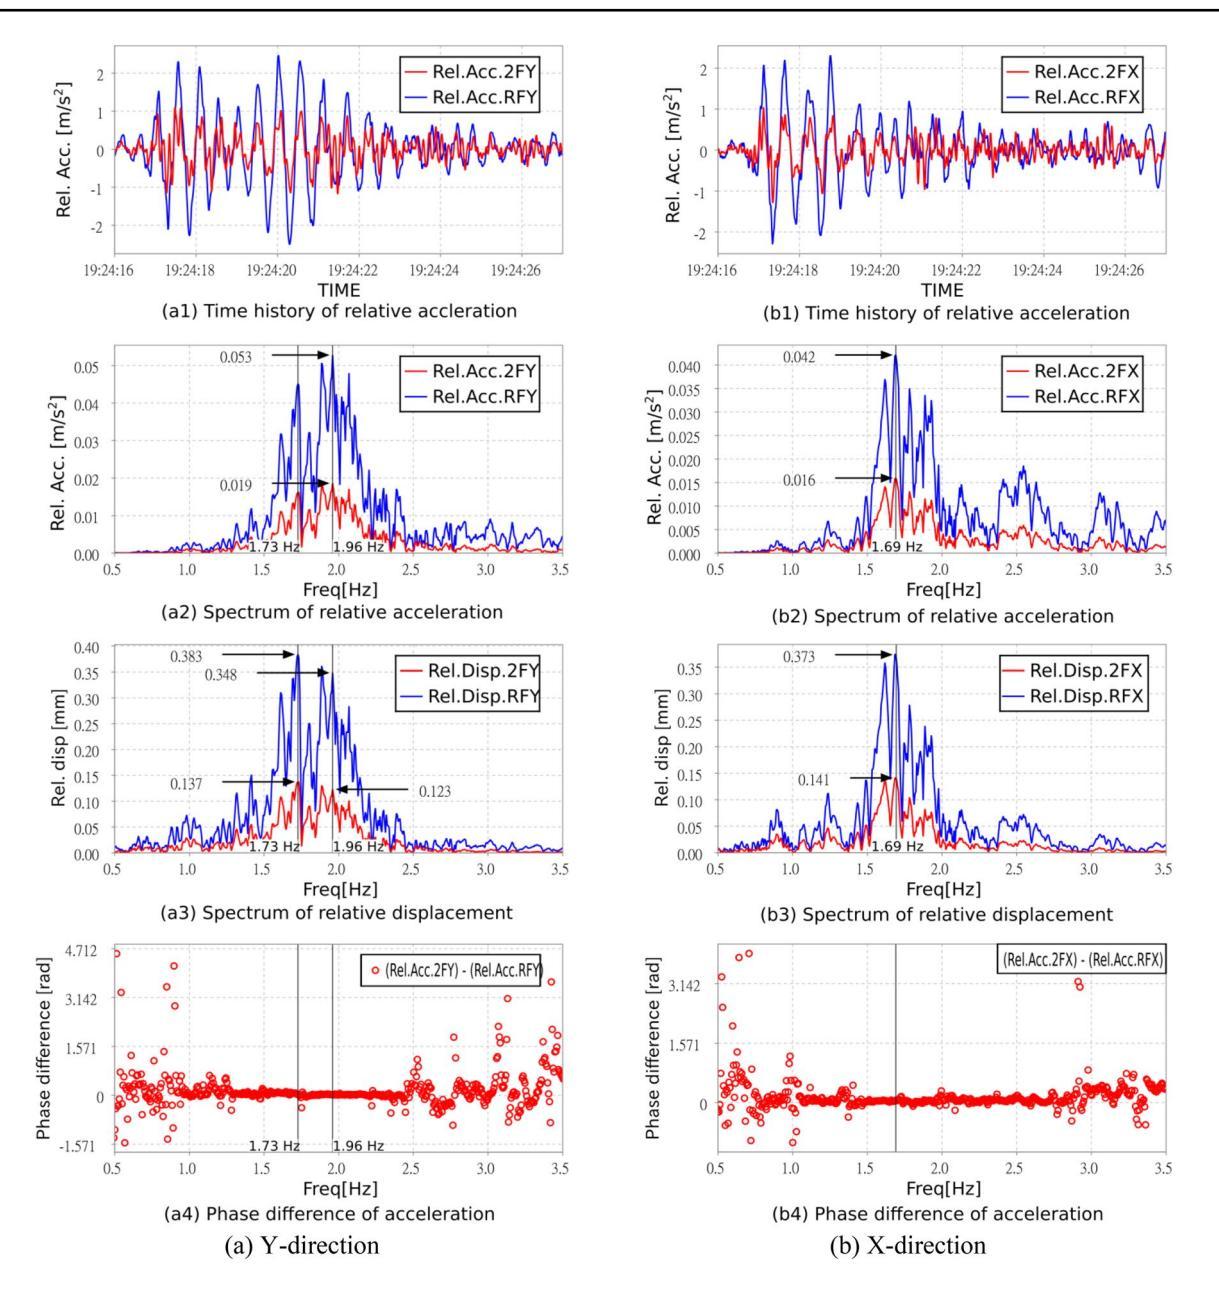
Figure 6 shows examples of the time histories of the accelerations measured on RF and 2F relative to the acceleration measured on the ground; it also depicts the Fourier amplitude spectra for these relative accelerations. Figure 6(a1) and (b1) shows the time history of the recorded acceleration. Figure 6(a2) and (b2) shows the Fourier amplitude spectra of acceleration $|\hat{a}_i(f)|$. Figure 6(a3) and (b3) shows the pseudo-displacement spectra $|\hat{a}_i(f)|$, and Fig. 6(a4) and (b4) shows the phase difference between the Fourier transforms of the accelerations measured on 2F and RF. These are calculated as follows:

Figure 6(a2) shows the acceleration spectrum in the Y-direction; a peak frequency can be observed at 1.96 Hz. However, Fig. 6(a3) shows the pseudo-displacement spectrum obtained by dividing by ω^2 ; here, the peak frequency is 1.73 Hz. For both frequencies, 2F and RF vibrated in the same phase, as shown in Fig. 6(a4). Moreover, the ratios between the displacement amplitudes of 2F and RF were almost the same (0.357 and 0.353) for these two frequencies. Regardless of the frequency selected, the mode shape of the structure could be obtained. In the following sections, these two peak frequencies are considered, and the effect of the peak selection is discussed.

Fig. 6 Relative acceleration recorded for the RF earthquake that occurred at 2019-08-04T19:23+0900

Figure 7 shows the vibration mode shape obtained from the spectra depicted in Fig. 6. The horizontal axis represents the ratio of the displacement amplitude at a given floor to that at RF at the peak frequency. As shown in Fig. 6, because different peaks were observed in both the acceleration and displacement spectra, the measured data are provided for both frequencies (1.73 and 1.96 Hz). Figure 7 also includes the displacement distribution obtained by the eigenvalue and static analyses described above. Because this was not measured on 3F, only the values on 2F can be compared, which can be seen to match roughly. Thus, although the frequency differed, the calculated vibration mode shapes were almost the same.

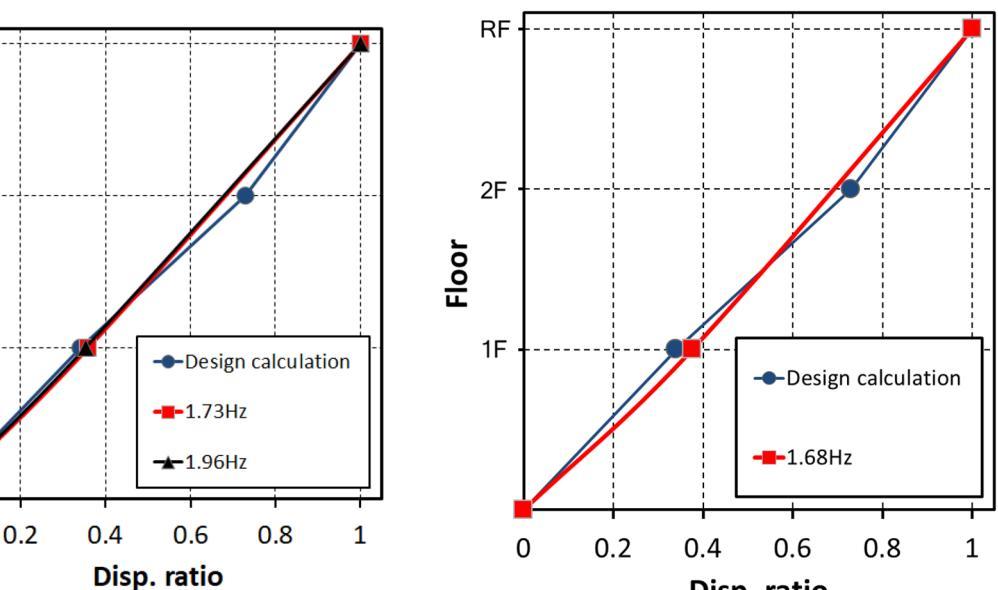
(a) Y-direction (at 1.73 Hz and 1.96 Hz)

(b) X-direction (1.68 Hz)

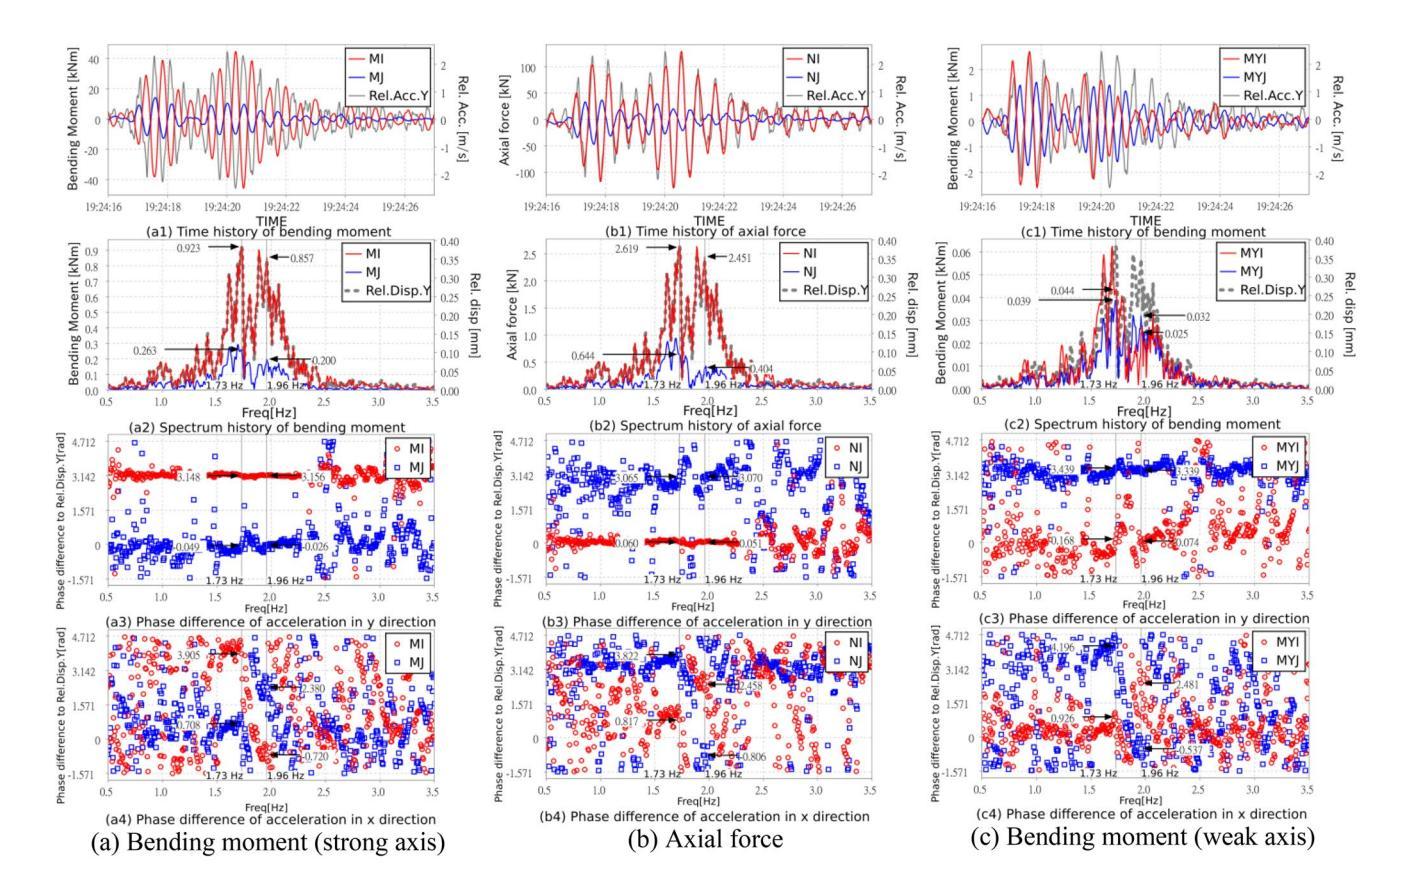
Fig. 8 Time history and frequency characteristics of the section forces for RB

Figure 8(a1)-(a4) shows the recorded data of the bending moment. MI and MJ represent the bending moments at sections I and J, respectively, of the right beam, which are calculated with Eq. (5). Figure 8(a1) shows the time histories of MI, MJ, and the relative acceleration in the Y-direction. The phases of MI and MJ were opposite to each other, and the phases of MJ and the relative acceleration were the same. This indicates that the bending moments and acceleration were almost proportional. Figure $8(a^2)$ shows the spectra of MI, MJ, and the relative displacement. The values at 1.73 and 1.96 Hz (i.e., the peak frequencies of the relative acceleration and relative displacement spectra, respectively) are shown. The ratios of the values (0.923 / 0.263 and 0.857 / 0.200, respectively) are similar yet slightly different, which implies that the estimated bending moment distribution may differ slightly for different peak frequencies. In this paper, as the bending moment distribution is considered proportional to the displacement (not the acceleration), the frequency at which the displacement spectrum peaks (i.e., 1.73 Hz) is used hereinafter. Figure 8(a3) shows the phase differences of MI and MJ with the relative acceleration in the Y-direction. The phase difference between MI and the relative acceleration was very stable at π around the peak frequencies, which indicates that they were almost proportional but with opposite signs. The phase difference of MJ was not as stable as that of MI, but the value was close to zero at the peak frequencies; this indicates that MJ and the displacement were also proportional. Figure 8(a4)shows the phase differences of MI and MJ with the relative acceleration in the X-direction. These plots show large scatter, which indicates that MI and MJ were not proportional to the displacement in the X-direction. These figures show that MI and MJ were mostly proportional to the relative displacement in the Y-direction but not to that in the X-direction. In addition, although the peak frequencies for the relative acceleration and relative displacement were different, the bending moment and local stiffness distributions did not change regardless of the peak frequency. Similarly, the axial force shown in Fig. 8b shows the same properties as the bending moment in Fig. 8a. Figure 8c shows the spectrum of the weak-axis bending moment; the phase difference in Fig. 8(c3) is not as stable as those in Fig. 8(a3)and (b3), but it is about 0 or π near the peak frequency. This indicates that the weak-axis bending moment of the beam also oscillated approximately in proportion to the displacement in the Y-direction. The above analysis indicates that not only the strong-axis bending moment but also the axial force and weak-axis bending moment are proportional to the displacement in the Y-direction. It is considered that the axial force was generated by the composite effect with the floor slab. The exact cause of the weak-axis bending cannot be determined using the data obtained in this study; however, given that the measured beams faced the outer wall, we can speculate that the unsymmetrical geometry of the slab and wall may have generated the weak-axis bending moment according to the strong-axis bending moment.

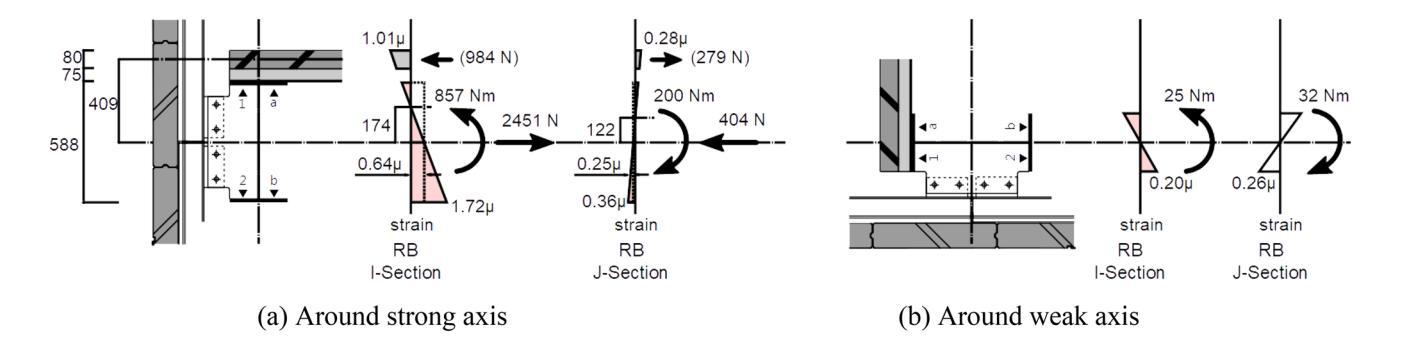
To investigate the magnitude of stress due to the strongaxis bending moment, axial force, and weak-axis bending moment, Fig. 9 shows the strain distributions of the beam sections at a vibration frequency of 1.73 Hz. These were calculated from the values shown in Fig. 8a, b based on the Bernoulli-Euler theory. The values for the bending moment and axial force without parentheses are for the steel beam sections. The axial force value in parentheses is for the concrete floor slab, which was estimated using the effective width of the slab (1045 mm) as calculated from the design formula in the current Japanese design code [30]. Figure 9a shows that the steel beams were subjected to a considerable amount of axial force, which was undoubtedly the effect of the concrete slab. Thus, calculations of the bending moment of a composite beam including a concrete slab need to consider the effect of this axial force. It also shows that the estimated axial force of the concrete slab (984 N in I-section) was much smaller than that of the steel beam (2451 N), and the two forces were not balanced. This indicates that more axial force was transferred by the slab in the section measured under this small earthquake than estimated from the design formula. Figure 9b shows the estimated bending moment around the weak axis. In general, the bending moment along the weak axis was much less than that along the strong axis.

Fig. 9 Estimated strain amplitude distribution in RB at the dominant frequency

For section I, the weak-axis bending moment was only 3% of the strong-axis bending moment. However, the maximum strain caused by the weak-axis bending moment (0.2μ) was up to 11% of that caused by the strong-axis bending moment (1.71μ) . This indicates that the strain owing to the weak-axis bending moment should not be neglected even if this moment is small.

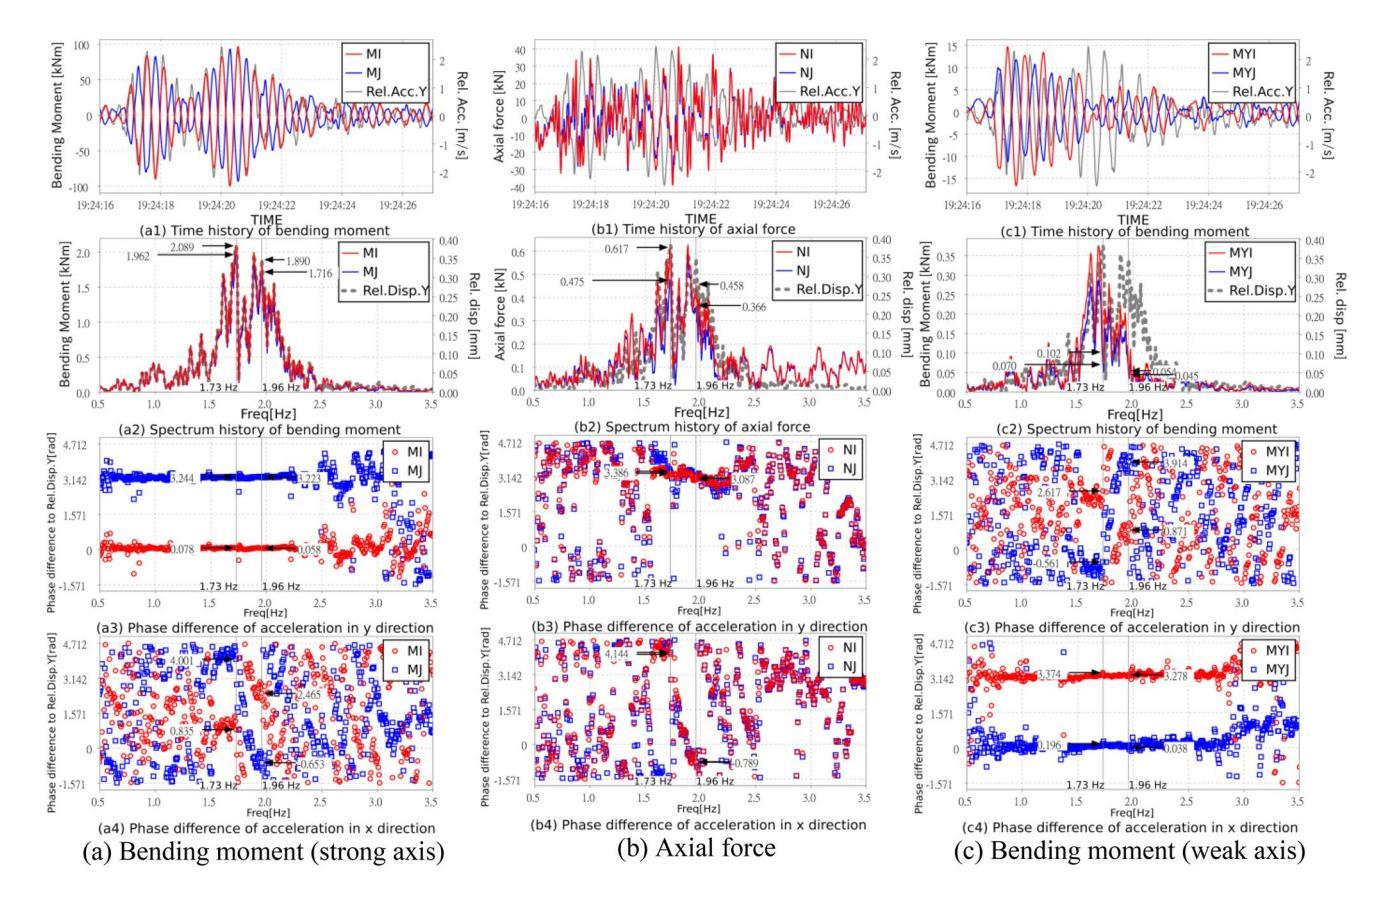
Figure 10 shows the time histories for the bending moment and axial force, the Fourier amplitude spectrum, and the phase spectrum of the LC. For the bending moments shown in Fig. 10a, the phases at the I- and J-sections of the column were opposite to each other; this indicates that the bending moment distribution was antisymmetric. In contrast, for the

Fig. 10 Time history and frequency characteristics of the section forces for the LC

axial forces in Fig. 10b, the phases at the peak frequency were the same, suggesting that the axial force inside the column was constant. The phase of the axial force was also almost the opposite of that of the Y-direction acceleration, which indicates that the axial force vibration was proportional to the displacement vibration in the Y-direction (i.e., strong-axis bending direction). It is seen in Fig. 10c that the phase of the weak-axis bending moment almost matches that of the X-direction acceleration, indicating that the weak-axis bending moment of the column accompanies the vibration in the X-direction.

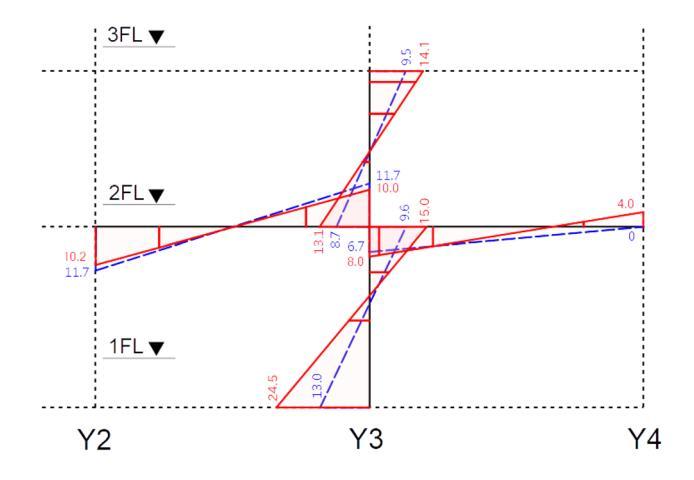
Figure 11 shows the local stiffness distribution when calculated as explained above. The values represent the local stiffness at the beam and column ends extrapolated from the measured section data. The locations of the measured sections are indicated by the transversal lines in the diagram. The broken line in Fig. 11 shows the local bending stiffness distribution obtained from the structural calculations shown in Fig. 4.

Because the local bending stiffness is proportional to the bending moment, the sum of the local bending stiffness values of the column and the sum of the local bending stiffness values of the beam should theoretically match at the beam–column joint. However, the sum of the measured values of the column was approximately 1.6 times that of the beam. Although the cause cannot be determined solely from the current measurement results, one hypothesis is that some unidentified members bore the stress in parallel to the beam. Figure 12 illustrates a very simple example of this hypothesis. For this measurement, the strain gauge was attached only to the two sections of the column and beam. Only the stress (axial force and bending moment) could be measured at these sections. For this reason, the stress at the

Fig. 11 Local stiffness distribution [kN-m/mm] of the bending moment in frame X2 measured during an earthquake that occurred at 2019-08-04T19:23+0900

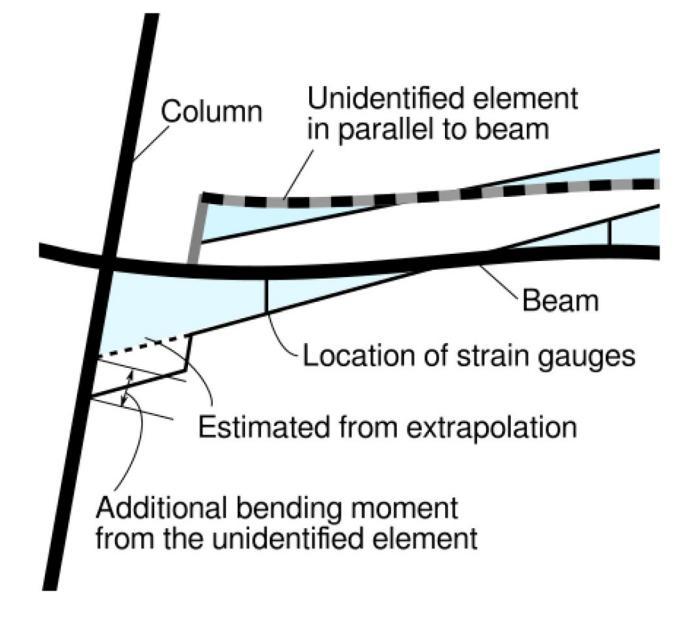
Fig. 12 Presumed cause of unbalanced local stiffness values for the beam and column

beam-column joint was estimated by linearly extrapolating the stresses of the two cross sections. However, if some unidentified elements parallel to the beam also bore stresses (as shown in Fig. 12), then the stress would be transferred to the column but not captured by these measurements. As shown in Fig. 2d, the target building has autoclaved lightweight concrete panels attached outside the beams via vertical furring strips of H-section steel (H-100×100×6×8) at 800 mm intervals. These furring strips are quite rigid and may have transferred some stress to the columns.

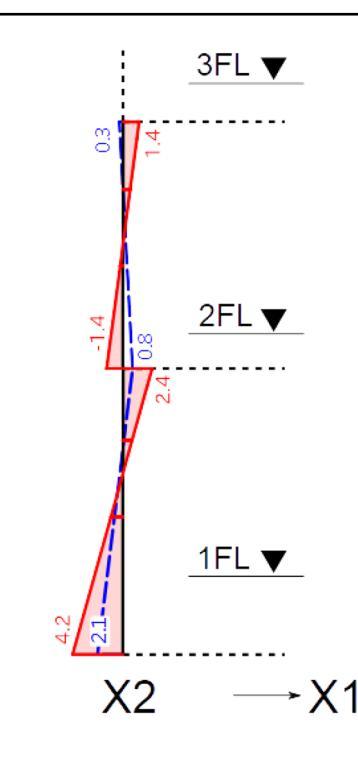
Figure 13 shows the local stiffness distribution calculated from the bending moment along the weak axis of the column. The amplitudes of the weak-axis bending moments for sections I and J (0.374 and 0.286 kN-m, respectively) at the dominant frequency in the X-direction (i.e., 1.86 Hz, as shown in Fig. 10c) were divided by the displacement amplitude (0.373 mm, as shown in Fig. 6b) to obtain the local stiffness values. These were then extrapolated to the edges of the column elements under the assumption of a linear distribution. The measured local stiffness was greater than the analytical value. In addition, the transmitted bending moment was larger than expected. The analytical results also indicated that the shear forces of the columns between 1 and 2F were in opposite directions; however, the measurement results did not indicate such a reversal of the shear force. One explanation is that the analysis assumed that the beam was pin-jointed to the column, such that the bending

Fig. 13 Measured local stiffness distribution [kN-m/mm] in frame Y3 (X-direction loading)

moment is not transmitted; however, some bending moment was indeed transmitted in the actual building.

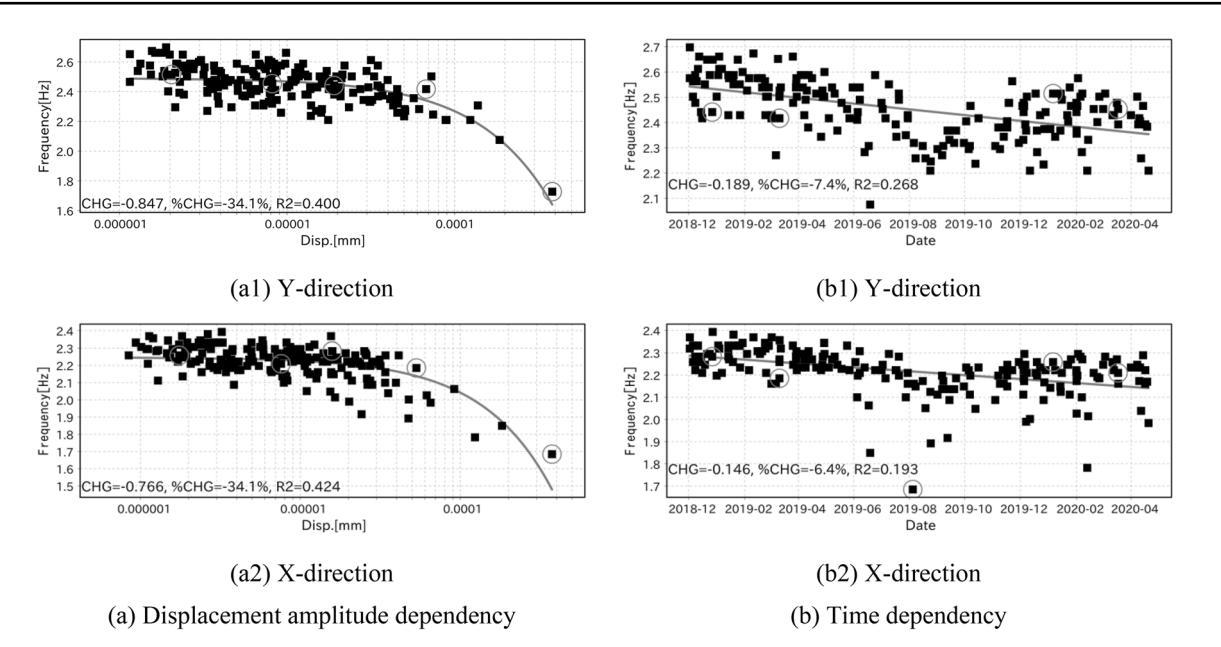
Figure 14a shows the dominant frequency and displacement amplitude for the 198 small earthquakes measured during the study period. The horizontal axis represents the pseudodisplacement amplitude obtained by Eq. (2). The solid line represents the regression straight line, although it appears as a curve, because the horizontal axis is logarithmic. CHG indicates the amount of change in the displayed regression line from start (left) to end (right); %CHG represents the ratio of the CHG value to the value of the regression line at the start (left); and R2 indicates the coefficient of determination (i.e., square of the correlation coefficient). The dominant frequency tended to decrease as the displacement amplitude increased. When the displacement amplitude was small, the dominant frequency was approximately 2.6 Hz. However, it decreased to approximately 1.8 Hz as the displacement amplitude increased. The coefficient of determination was approximately 0.27, which indicates a certain degree of correlation. The rate of change was approximately -34%; if the mass was constant and the dominant frequency was simply calculated as the square root of the change in stiffness, then the stiffness would have dropped by approximately half.

Fig. 14 Dominant frequency

Figure 14b shows the long-term changes in the dominant frequency over the entire measurement period. Although the variation is not small, the regression lines indicate a downward trend, with a coefficient of determination of 0.268 and 0.193 for the Y- and X-direction, respectively.

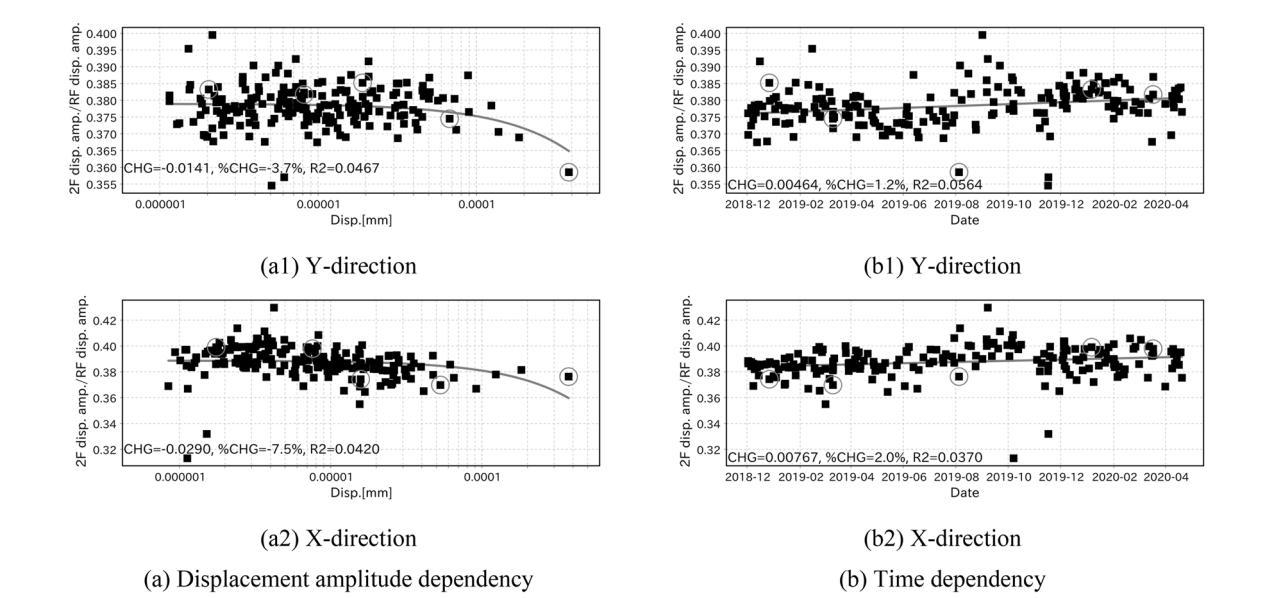
To visualize the amplitude dependency of the mode shape, the ratio of the displacement amplitudes at 2F and RF is shown in Fig. 15a. For the Y-direction, although a slight downward trend is observed, many earthquakes show stable values between 0.37–0.38, which indicates that the structure vibrated in the primary mode shape obtained by analysis. Figure 15b shows the long-term changes in the mode shape. The coefficient of determination (shown as "R2" in the figures) is very small, and few long-term trends could be observed. This indicates that the mode shape hardly changed during the study period.

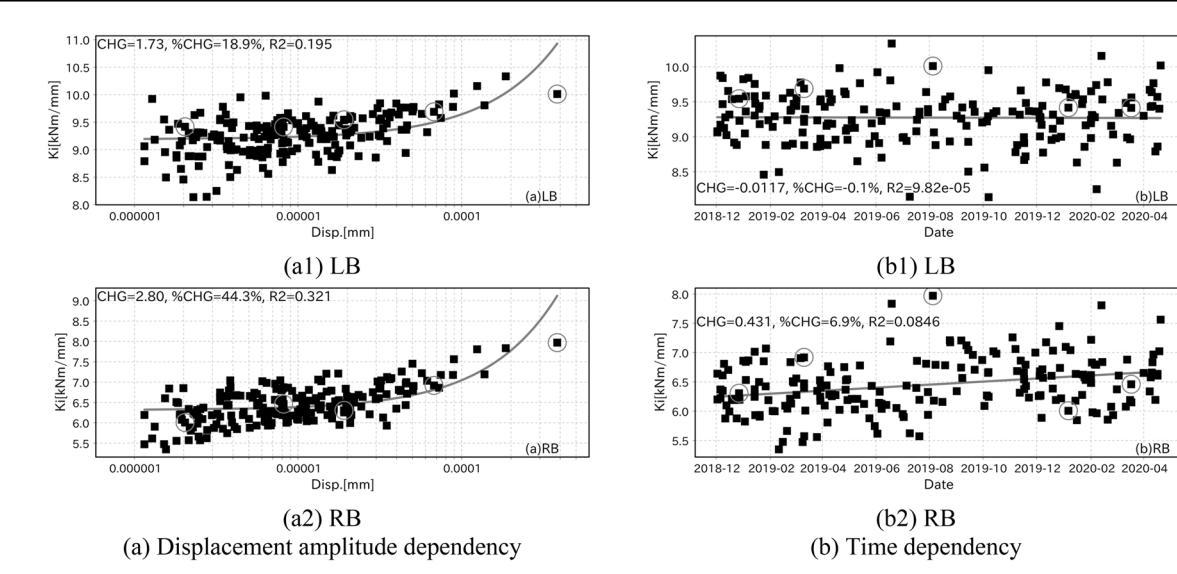
Fig. 16 K_i values for bending moment of beams

Figures 16a and 17a show the relationship between the response displacement amplitude at RF and the calculated local bending stiffness at the beam–column joints for all measured seismic responses. The solid line, CHG, %CHG, and R^2 have the same meanings as for Figs. 14 and 15. The local stiffness of the beam was calculated with Eq. (2) to include the additional bending moment by the floor slab. As the displacement amplitude increased, the local bending stiffness tended to increase for the beams and decrease for the columns. The regression lines in Figs. 16a and 17a indicate that the ratio of the sum of the local bending stiffness

Figures 16b and 17b show the long-term changes in the local bending stiffness of the beam and column at the beam-column joint. The coefficient of determination for the beams is less than 0.1, which indicates no clear correlation between the time and local stiffness of the beams. On the other hand, the coefficients of determination for the columns are approximately 0.27 and 0.13, which indicates a slight correlation. The change ratio was approximately 5%, corresponding to the decrease in the dominant frequency by approximately 2.5%. The estimated value was smaller than the observed value by 10%, as shown in Fig. 13. This result shows that column stiffness change may be a factor for the change in the dominant frequency but is not the only cause. Other causes may not have been captured by these measurements.

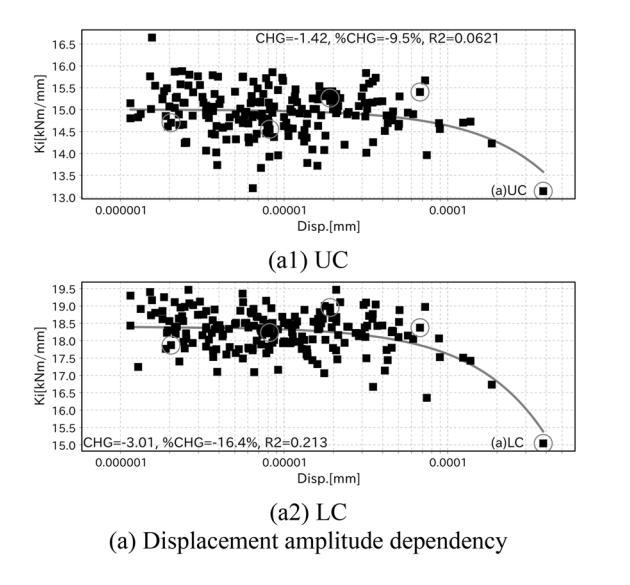
Fig. 17 K_i values for bending moment of columns in the Y-direction

values for UC and LC to the sum of those values for LB and RB was approximately 2.1 when the amplitude was small and 1.4 when the amplitude was large. This indicates that the difference between the local bending stiffness values of the beam and column decreased as the displacement amplitude increased. This may indicate that the effect of unidentified members parallel to the beam bearing some bending moment would decrease as the displacement increases. The average rate of decrease in the local bending stiffness of the columns was approximately -13%. This change is considerably smaller than the change in local stiffness estimated from the change in the dominant frequency, as mentioned in Sect. 3.3.1. This implies that the change in the dominant

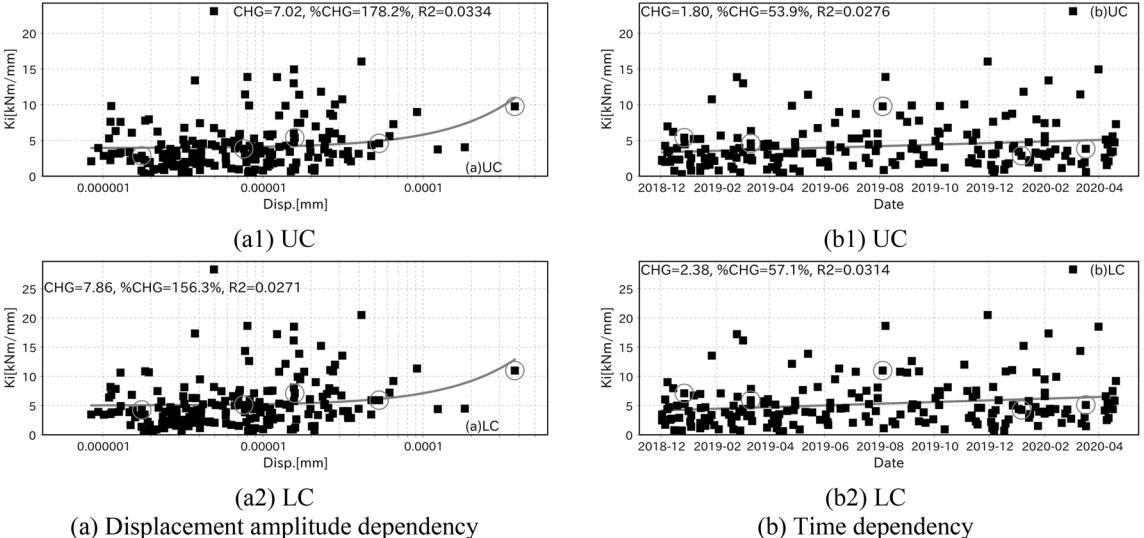
Figure 18 shows the amplitude dependency and long-term trend for the local stiffness of the bending moment along the weak axis of the column. Little correlation can be observed for the time and weak-axis bending moment with the column displacement.

Fig. 18 K_i values for bending moment of columns in the X-direction

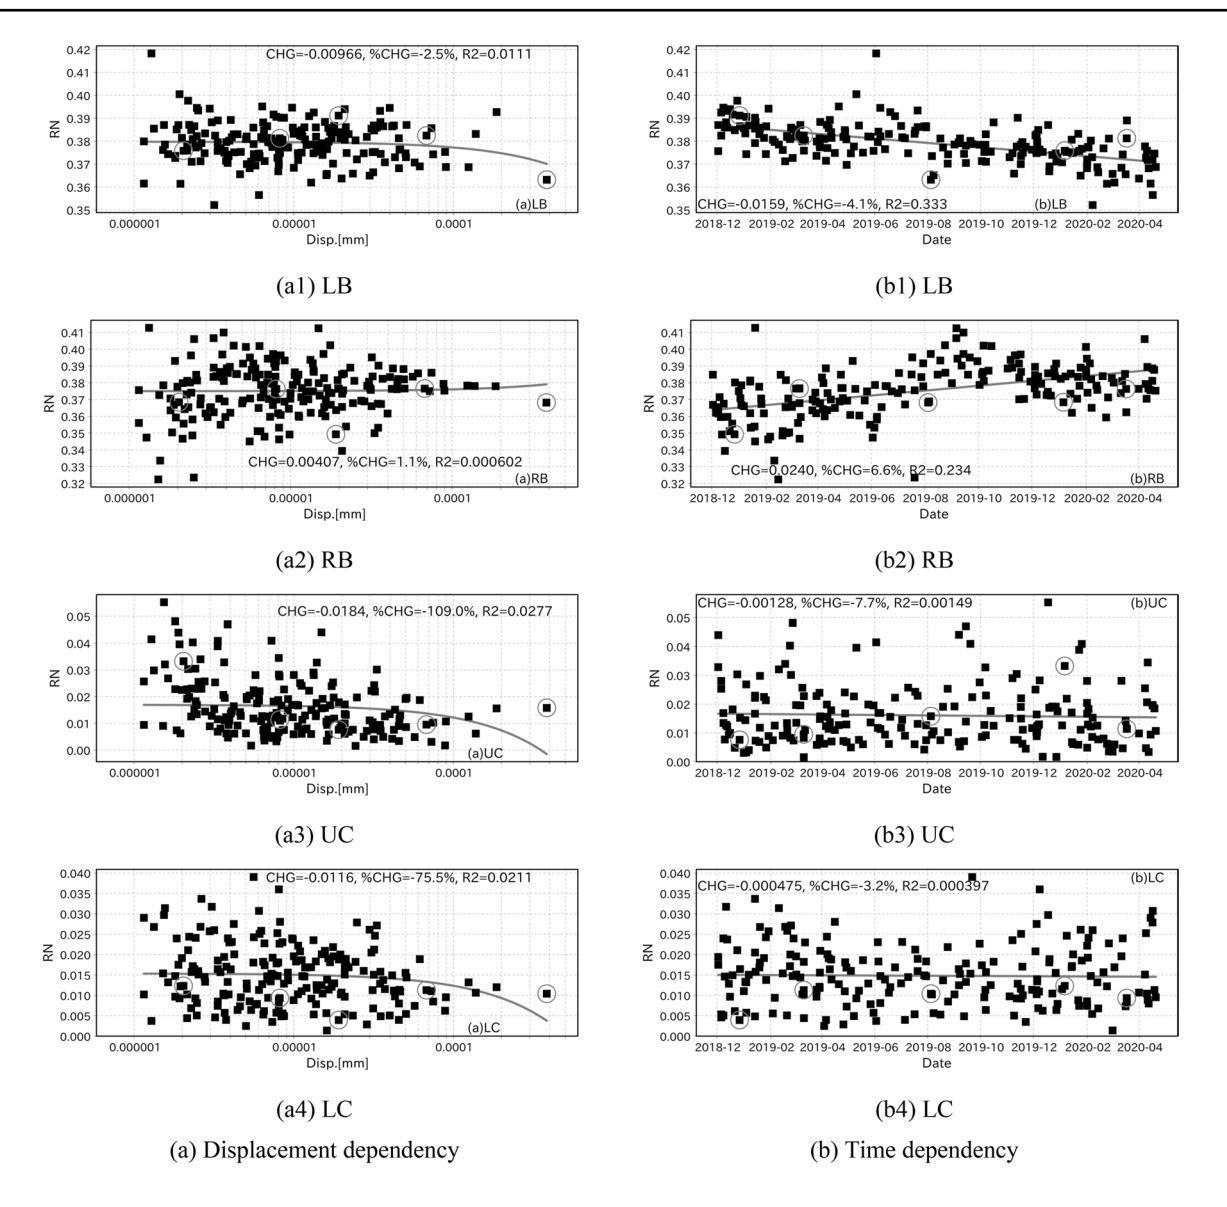
Figure 19 shows the amplitude dependency and long-term trend of R_N . Figure 19(a1)–(a4) shows little amplitude dependency. Figure 19(b1) and (b2) shows a slight time dependency in the beams. Considering that the axial force in the beams is mainly owing to the effect of the floor slab, this trend may be attributed to any damage or aging of the floor slab. However, the reason why LB exhibits a decreasing tendency, while RB exhibits an increasing tendency cannot be explained. Therefore, further long-term observation is necessary. Figure 19(b3) and (b4) shows almost no dependency in the columns. These figures indicate that the ratio of the axial stress to the total stress has little dependency on the displacement amplitude, but there may be some time dependency in the beams.

Fig. 19 R_N values

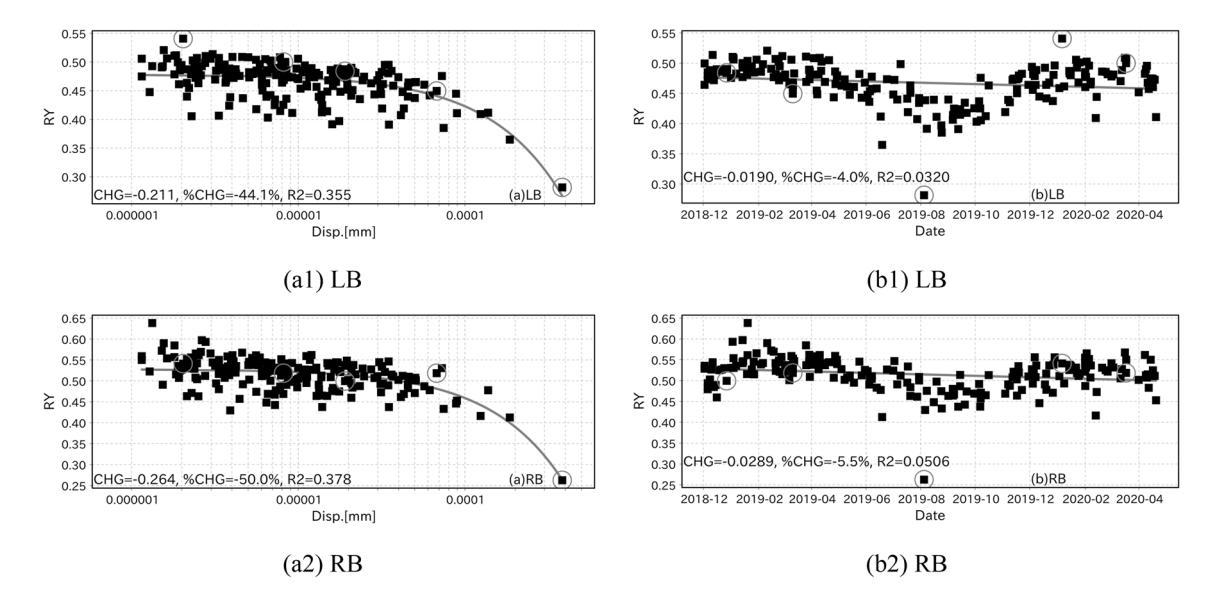
Figure 20 shows the amplitude dependency and long-term trend of R_{y} . Figure 20(a1) and (a2) shows a strong relationship between R_{y} and the displacement amplitude. Considering that the weak-axis bending moment may originate from walls, slabs, and other nonstructural elements, the amplitude dependency may also originate from such elements. The effect may decrease when the displacement amplitude increases. For small earthquakes, R_{y} was as high as 0.5; however, R_{y} decreased significantly for strong earthquakes. This indicates that the weak-axis bending moment is a less significant concern for structural integrity against stronger earthquakes. Figures 20(b1) and (b2) show a small and gradual variation over time, but R^2 is smaller than 0.1 and the trend is not clear. A seasonal variation can be observed, wherein R_{y} decreased during the summer; however, the study period was not long enough to clarify the reason. Continuous measurement is required to observe more long-term tendencies;

however, the results of the current study indicate that R_Y does not have a strong time dependency.

Fig. 20 R_Y values
