Surface Roughness Evolution to Identify Incubation Time for Hot Corrosion of Nickel-Base Superalloys: CMSX-4, CM247LC DS and IN6203DS at 550 °C

Neil Chapman^{1,2} · Simon Gray² · Joy Sumner² · John Nicholls²

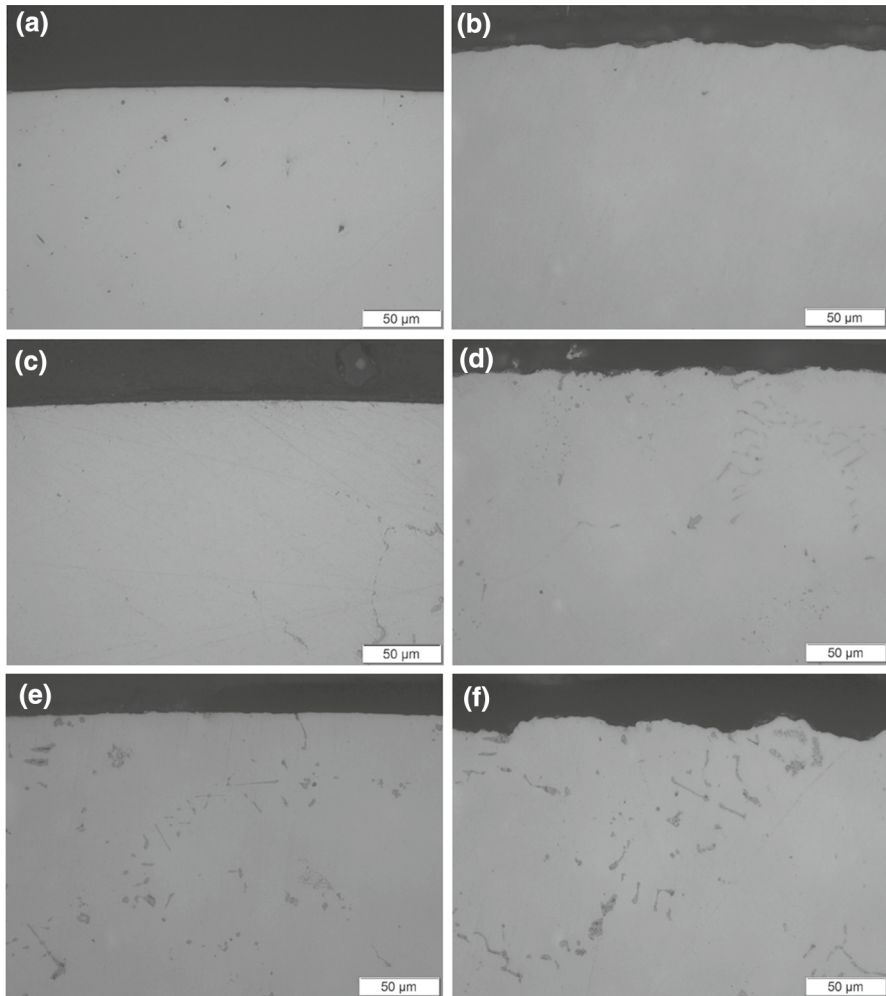
Fig. 1 Cross sections of superalloys showing surface roughness comparisons before and after exposure to the tested 550 °C hot corrosion conditions. Images include CMSX-4 before (a) and after 800 h exposure (b), CM247LC DS before (c) and after 800 h exposure (d), and IN6203DS before (e) and after 800 h exposure (f)

Each superalloy under investigation, CMSX-4, CM247LC DS and IN6203DS, experienced non-uniform metal loss giving rise to an increase in surface roughness (Fig. 1) during the 800 h of exposure to the 550 °C hot corrosion conditions. Figure 2 illustrates the evolution of the Ra and Rz surface roughness during this period in the form of boxplots. Visual assessments of the boxplots revealed a similar pattern for both the Ra and Rz data from each superalloy. That is, the Ra and Rz surface roughness initially appeared to show an extremely subtle positive trend with exposure time, albeit with significant overlap of the data with that of the as-machined specimen (0 h exposure). After the initial period, both the Ra and Rz data experienced an increase in the rate of the surface roughening over time, with the respective boxplots suggesting this may have occurred after approximately: 400 h for CMSX-4, 500 h for CM247LC DS and 200 h for IN6203DS.

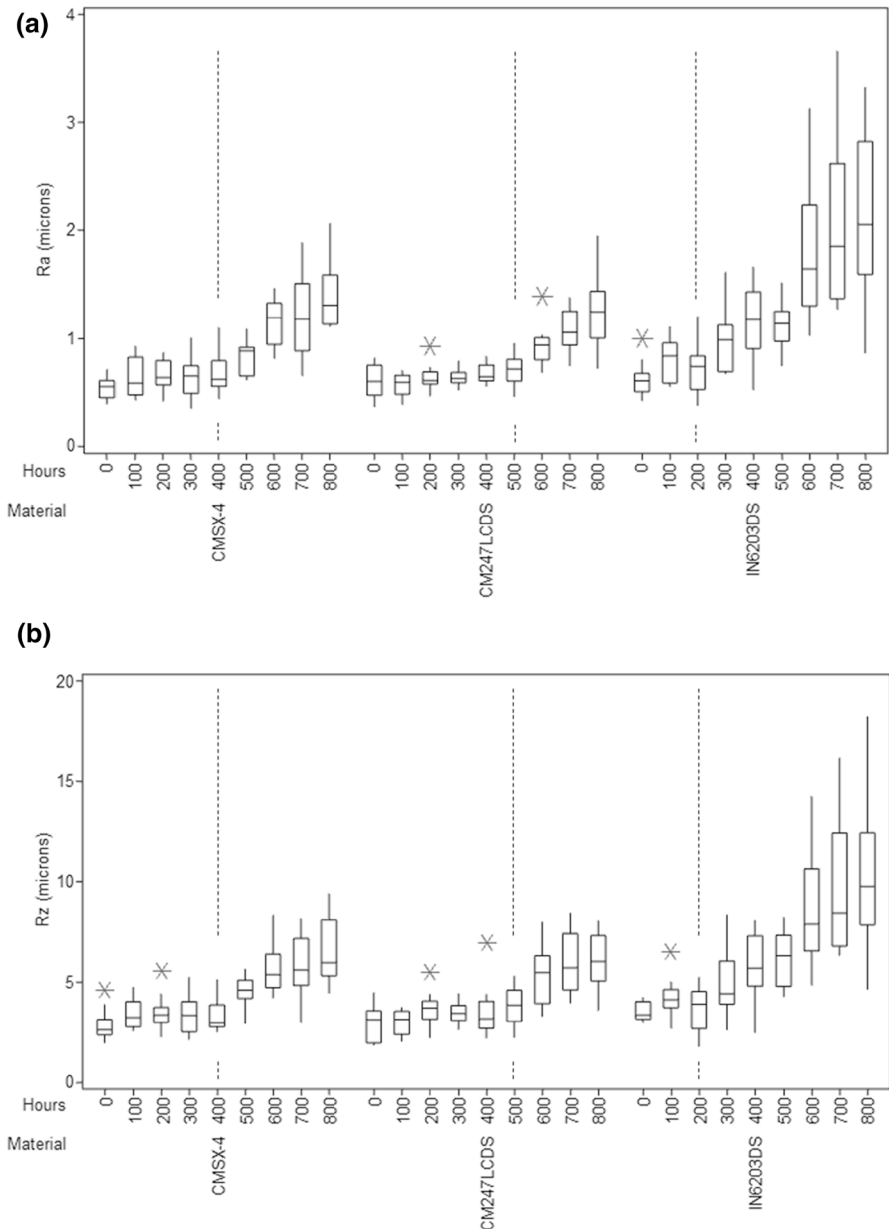
Fig. 2 Illustration of the evolution of the (a) Ra and (b) Rz surface roughness with respect to exposure to the tested 550 °C hot corrosion conditions. The vertical dashed lines represent the approximate duration when the transition of hot corrosion from incubation to propagation occurs. The asterisks denote the outliers within the respective datasets

The equations describing the trend lines within Fig. 3 also provided an estimation of the maximum penetration rate of the 550 °C hot corrosion attack during the incubation and propagation stages. For both stages, the rate was greatest for IN6203DS which provided further confirmation that this superalloy had the least resistance to the 550 °C hot corrosion conditions. This resulted in IN6203DS suffering greater levels and variance of surface roughening (Fig. 2) than the CMSX-4 and CM247LC DS superalloys at the end of the testing.

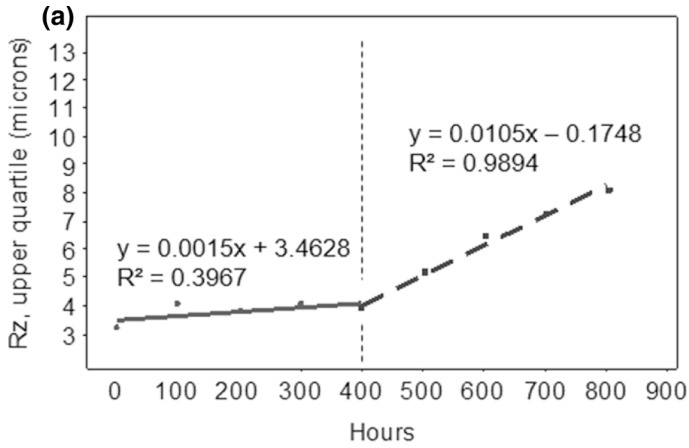
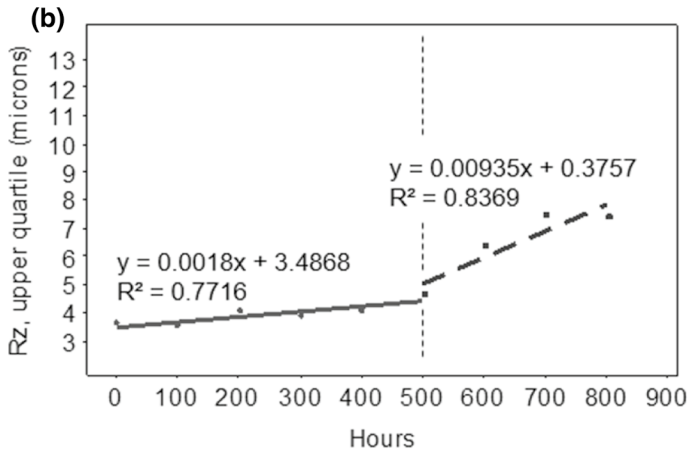
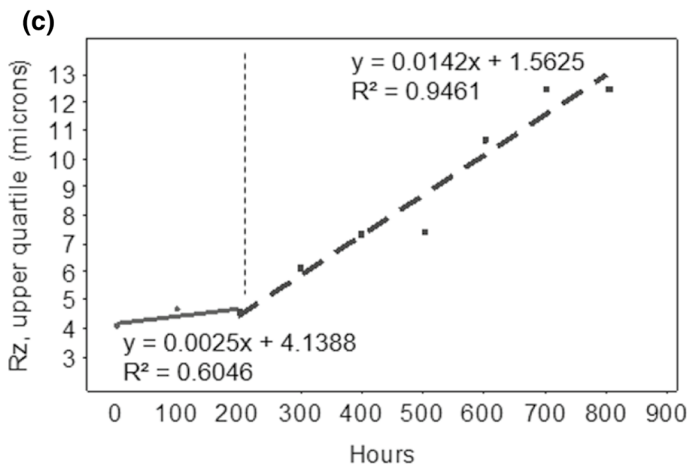
◀ **Fig. 3** Illustration of the Rz upper quartile data points, split into two series approximating the maximum 550 °C hot corrosion penetration rates during the incubation and propagation stages in (a) CMSX-4, (b) CM247LC DS and (c) IN6203DS superalloys. The vertical dashed lines represent the approximate duration when the transition of hot corrosion from incubation to propagation occurs

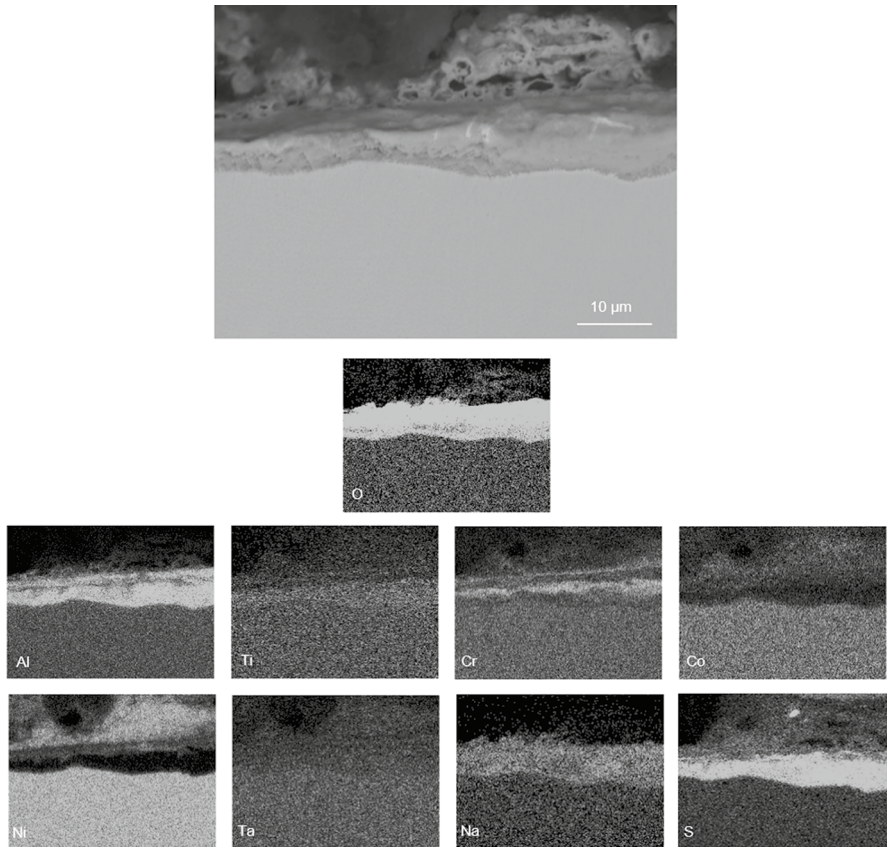
Fig. 4 Back-scattered electron images and EDX elemental maps of the scale on CMSX-4 superalloy after 800 h exposure to the tested 550 °C hot corrosion

The EDX mapping performed on the CMSX-4 specimen (Fig. 4) indicated an external surface consisting mainly of nickel, cobalt, sulphur and oxygen suggesting sulphates formed. Underneath this, an aluminium/chromium oxide had formed which appeared to be non-protective as evidenced by the sodium and sulphur levels within the oxide.

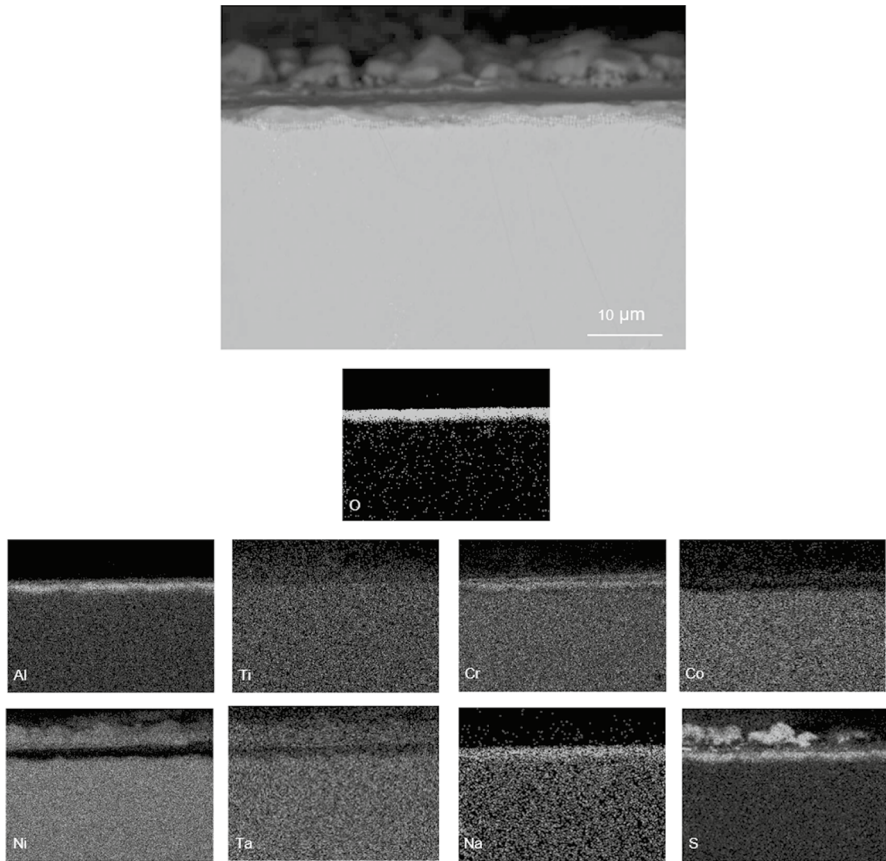
Fig. 5 Back-scattered electron images and EDX elemental maps of the scale on CM247LC DS superalloy after 800 h exposure to the tested 550 °C hot corrosion conditions

A similar EDX map of the CM247LC DS superalloy (Fig. 5) led to similar conclusions as for the CMSX-4 superalloy with the exception that the external surface appeared to be mainly nickel and sulphur. Although oxygen did not appear to be associated with these elements, it was thought that these were still sulphates based on the test temperature.

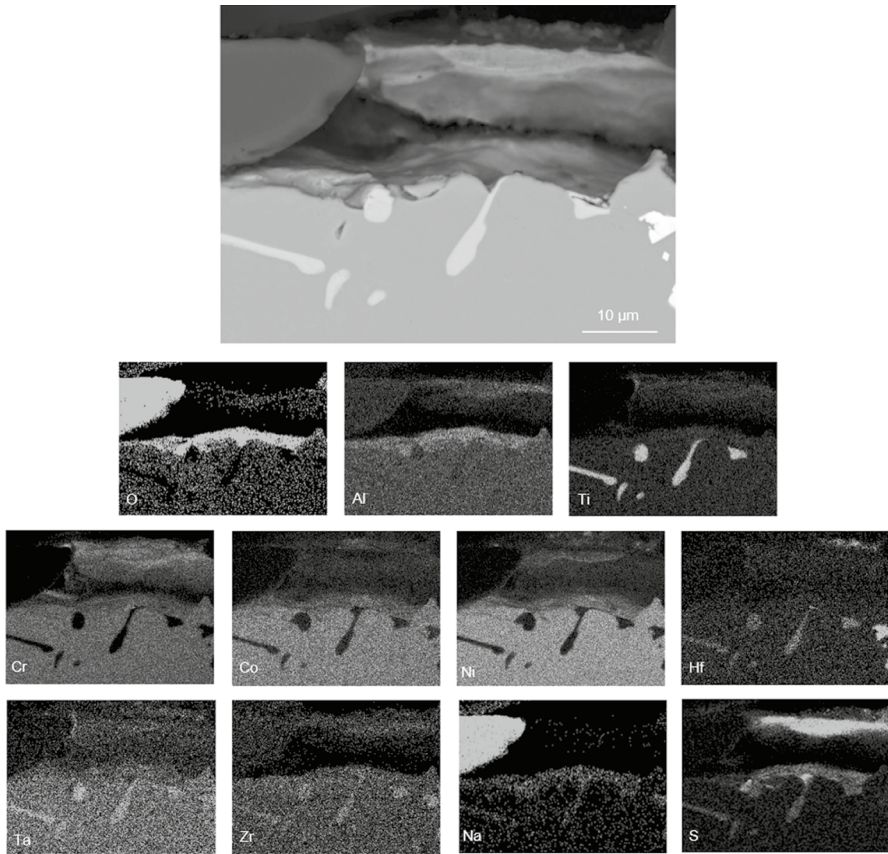
Fig. 6 Back-scattered electron images and EDX elemental maps of the scale on IN6203DS superalloy after 800 h exposure to the tested 550 °C hot corrosion conditions

The EDX mapping of IN6203DS (Fig. 6) indicated that a protective chromia scale had not formed on this superalloy. Instead, a complex scale involving the elements: oxygen, aluminium, chromium, cobalt, nickel, titanium, hafnium, tantalum and zirconium appeared to be present. This complex scale also provided little protection against the 550 °C hot corrosion as evidenced by the sodium and sulphur within the scale leaving IN6203DS prone to surface roughening. In addition, the EDX mapping revealed phases within the IN6203DS microstructure which contained the refractory elements: titanium, hafnium, tantalum and zirconium. These phases were most likely carbides and the surface roughening appeared to be at its greatest in the material adjacent to these carbides (Fig. 6). SEM investigations of similar refractory metal carbides that were remote from the surface (Fig. 7) suggested a mismatch in the lattice structure with the matrix. This was possibly caused by the thermal cycling during the 550 °C hot corrosion exposure creating micro-cracking around the carbides owing to a difference in the thermal expansion coefficients as compared to the matrix, or may have been due to sample preparation. It is therefore proposed that for refractory metal carbides connected to the surface, the respective interfaces with the matrix acted as short-circuit diffusion paths. This was most likely due to the dislocation arrays which exist at these locations, or possibly the potential thermal cycle micro-cracking, which enabled sulphur to diffuse into and combine with the sulphur attack from

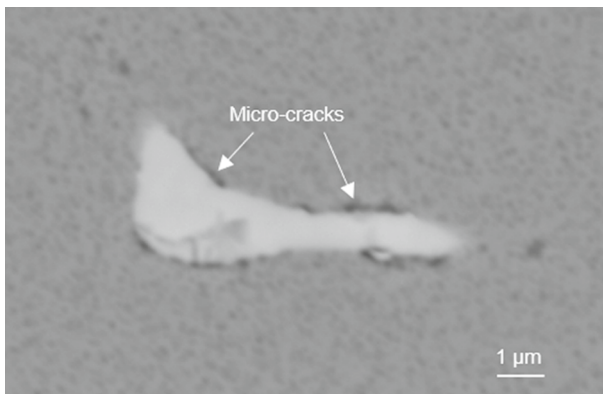
Fig. 7 Refractory metal carbide phase within IN6203DS superalloy showing micro-cracking at interface with the matrix

the surface causing surface roughening adjacent to the carbides. Based on this, it is highly plausible that the refractory metal carbides were responsible for IN6203DS showing the lowest resistance to the exposure conditions and experiencing greater levels and variance of surface roughening.
