## Erratum to: Wear Debris Mobility, Aligned Surface Roughness, and the Low Wear Behavior of Filled Polytetrafluoroethylene

**Erratum to: Tribol Lett (2015) 60:2**  
**DOI 10.1007/s11249-015-0581-7**

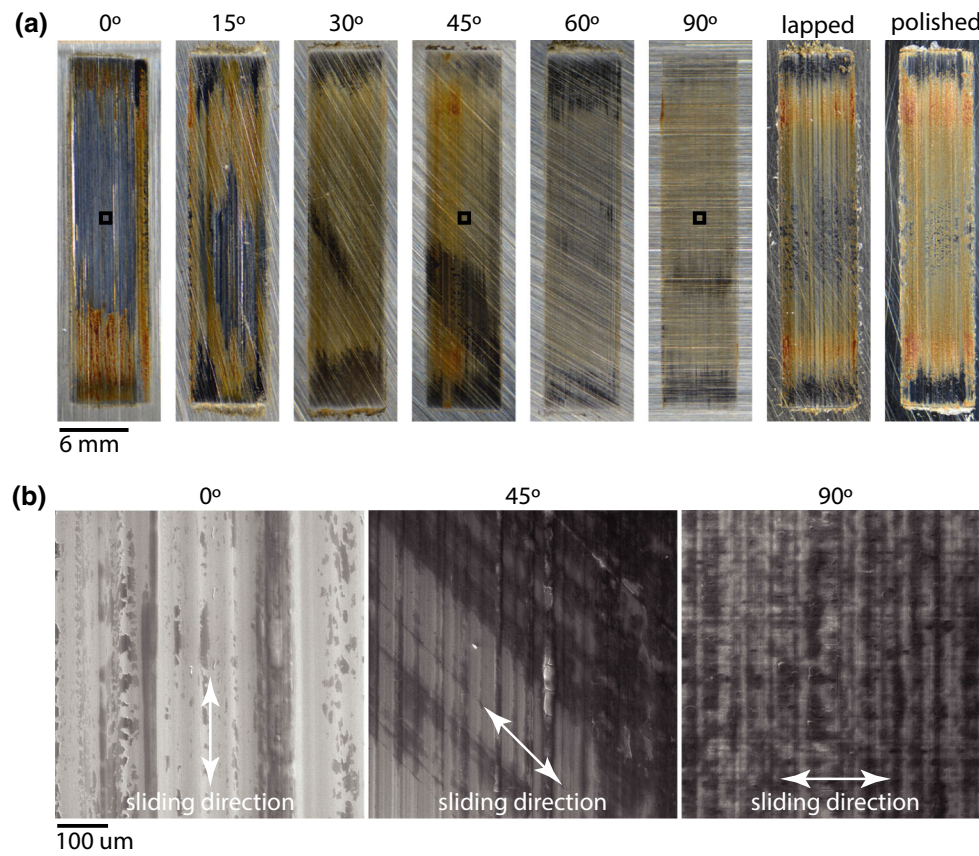
**Fig. 4** Transfer films. **a** Optical images of transfer films for each countersample. **b** Scanning electron micrographs of the 0°, 45° and 90° wear tracks. The transfer films are visibly more continuous and uniform as the roughness angle approaches 90°

Owing to an unfortunate error during the production process, the original article was published with an incorrect version of Fig. 4, which is corrected with this erratum. The original publication has also been updated.
