Sudden shortening of the paced AV delay: is this normal pacemaker function?

Arnold Pinter · Paul Dorian

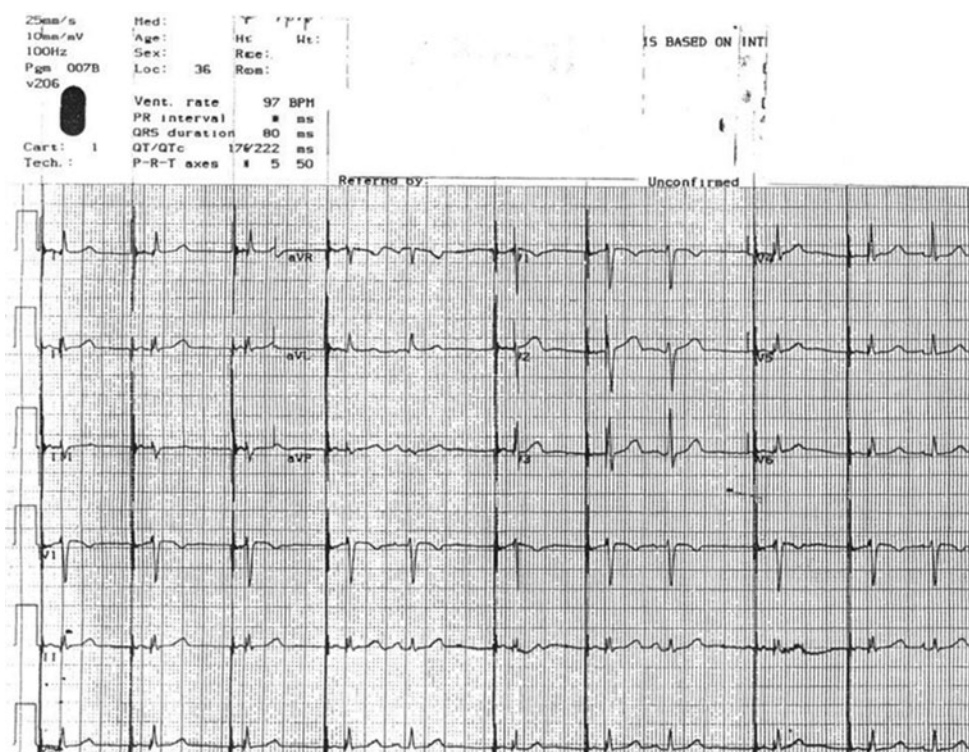
The postoperative 12-lead ECG showed mostly AV sequential pacing, with occasional spontaneous P waves

followed by native QRS (Fig. 1). The third complex of the tracing shows a shortened paced AV delay of 110 ms. Is this normal pacemaker function?

Fig. 1 Postoperative standard 12-lead ECG (1 mV/10 mm, 25 mm/s paper speed)

A 74-year-old female patient underwent a Medtronic KDR601 dual chamber pacemaker implantation for syncope due to sinus node disease. The ventricular and atrial passive fixation pacemaker leads were positioned in the right ventricular apex and right atrial appendage, respectively. The sensing and capture threshold values were satisfactory in both chambers. The device was programmed to DDDR mode 60–130 ppm with both the upper tracking rate and maximum sensor rate at 130 ppm, paced AV delay at 200 ms, and sensed AV delay at 180 ms. Postoperative chest X-ray showed normal pacemaker lead positions and no sign of complications.
