# Karst aquifers and water resource contamination in Haiti

Peter J. Wampler<sup>1</sup>

## Abstract

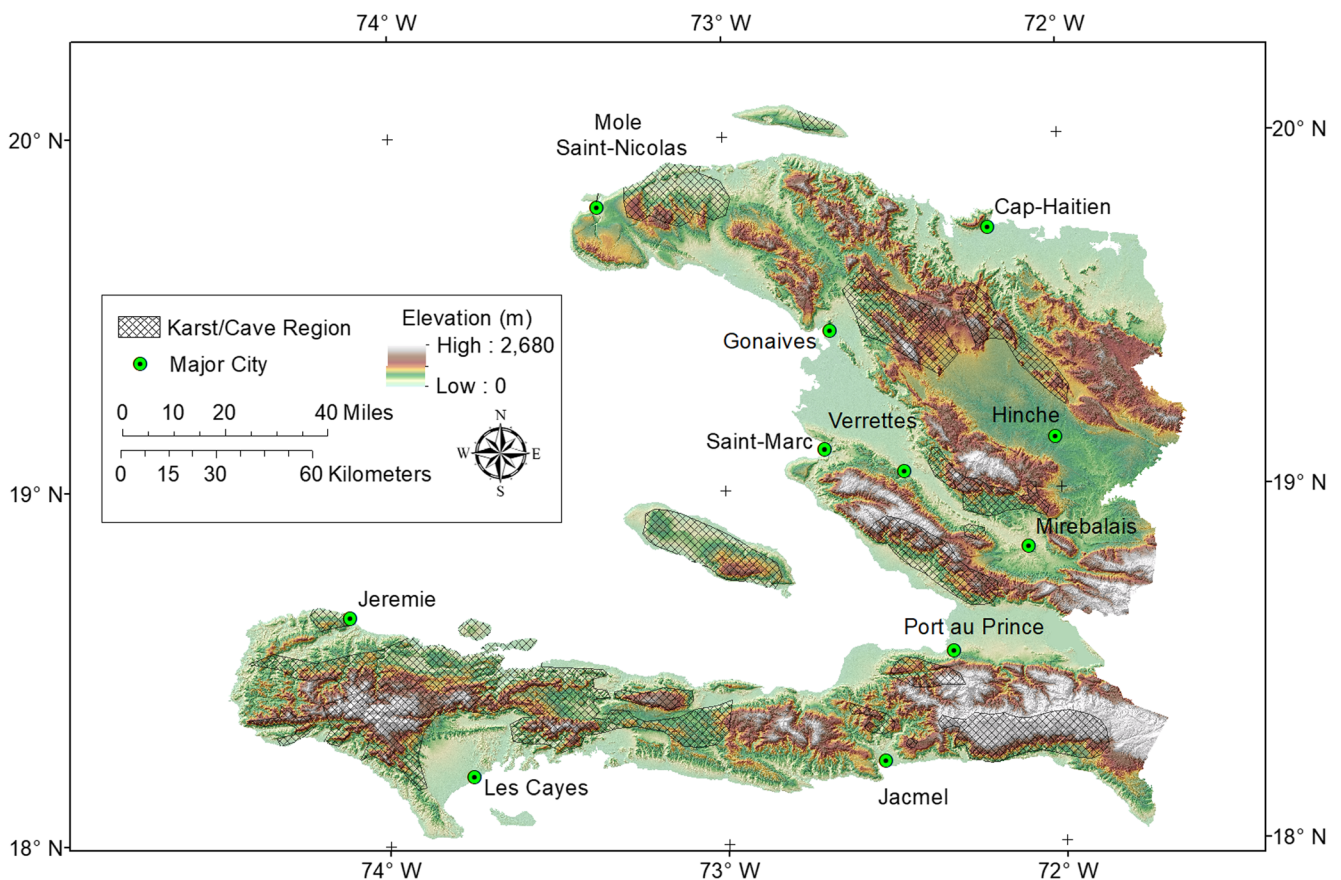
**Fig. 2** Haiti shaded relief map with approximate cave regions in the hachured areas (Cave regions modified from Olivier Testa, personal communication, 2021)

The development of karst dissolution cavities and caves varies considerably in different limestone units with some exhibiting extensive caves and karst conduits, while others have almost no karst or evidence of karst dissolution. No systematic mapping of the cave formations has been identified; however, available mapping suggests there are at least 150 caves located in several regions with greater cave and karst density (Figs. 2 and 4).

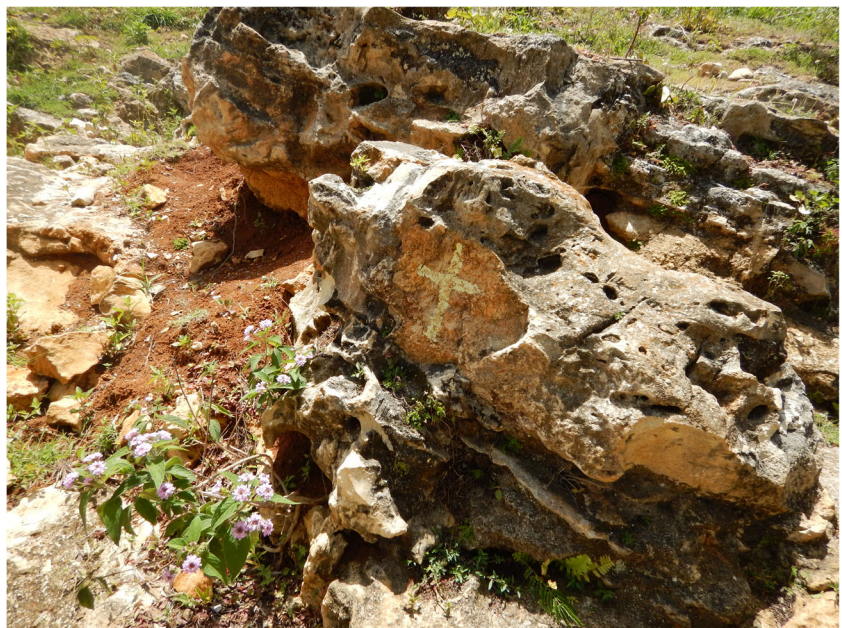
**Fig. 3** Dissolution of limestone along bedding planes and fractures

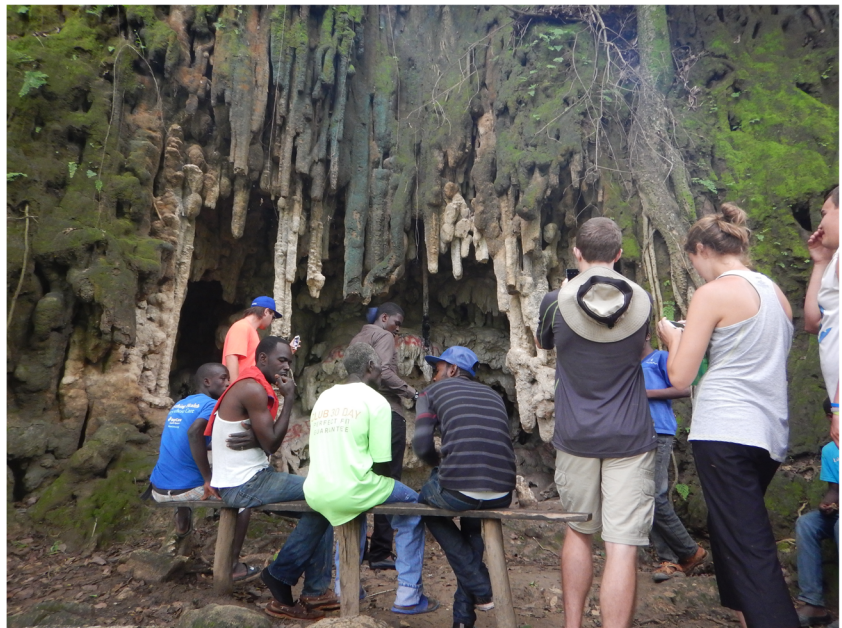
**Fig. 4** Karst cave at Bassim Zim on the central plateau near Hinche

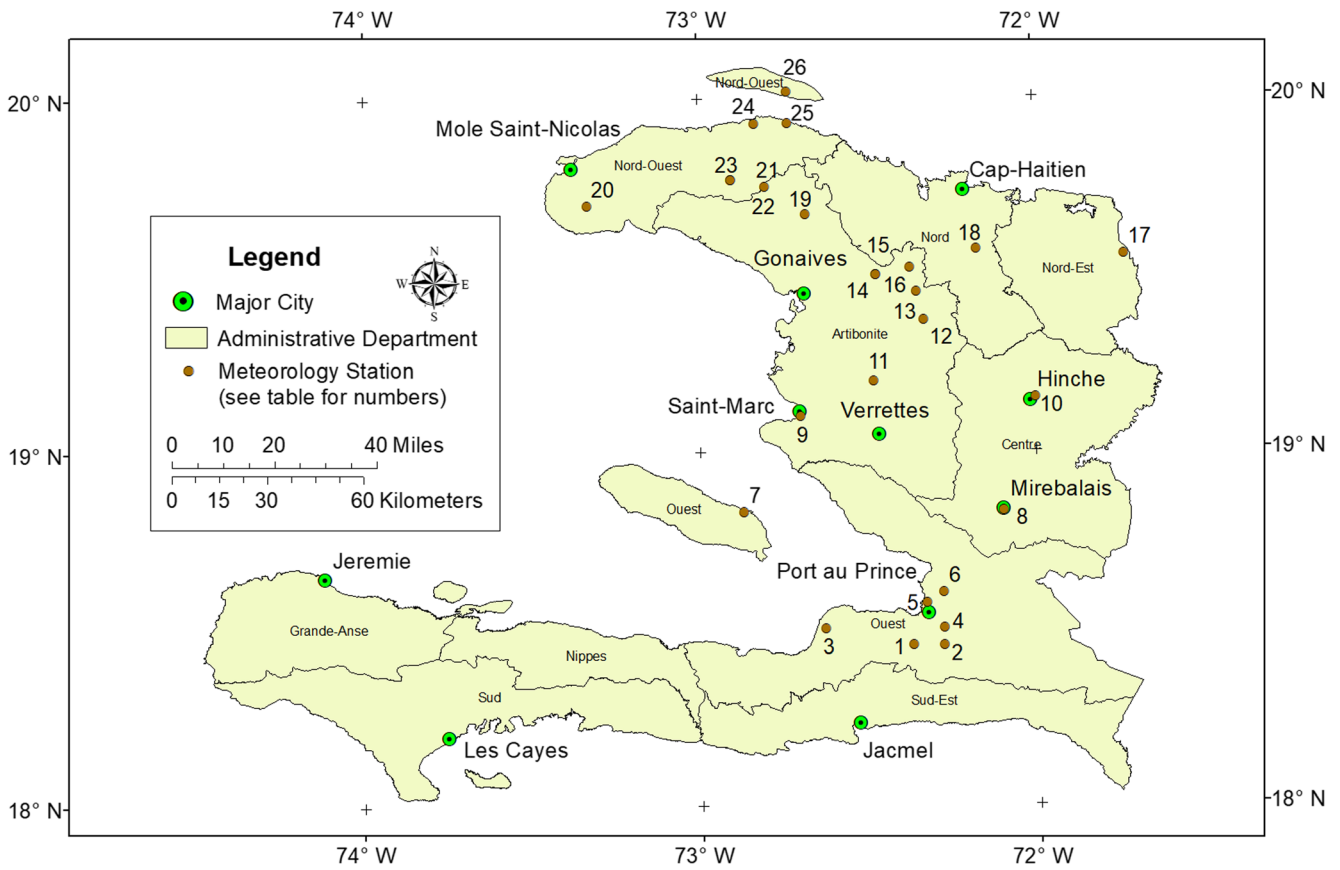
Fig. 5 Map of meteorological stations summarized in Table 3

Haiti receives a sufficient volume of water each year to support its growing population (Knowles et al. 1999); however, the precipitation that falls on Haiti is not evenly distributed geographically or temporally (Table 3; Fig. 5).

**Table 3** Average monthly and total annual precipitation, measured in millimeters, in major cities in Haiti (Centre National de l'Information Géo-Spatiale, 2017). See Fig. 5 for numbered site locations

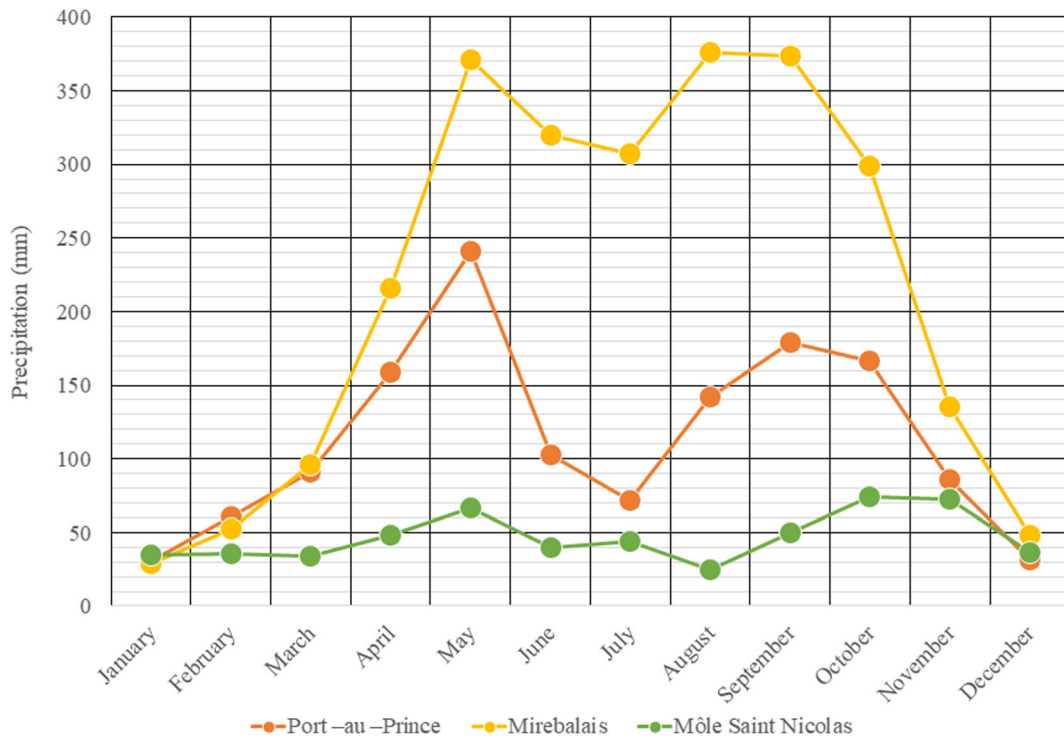
Fig. 6 Monthly precipitation in three Haiti cities showing variation in wet and dry seasons by zegion—Centre National de l’Information Géo-Spatiale (CNIGS 2008)

Haiti has two distinct rainy seasons, in May/June and in September/October (Fig. 6). Total precipitation also varies considerably by region with wet and dry seasons more pronounced in some regions than others—for example, in the northwest corner of Haiti near Môle St. Nicholas, the amount and timing of rainfall are significantly different than in Mirebalais, north of Port au Prince (Fig. 6). Observed differences are likely due to a combination of orographic effects and a prevailing wind direction from the east. Regional precipitation differences have important implications for selecting

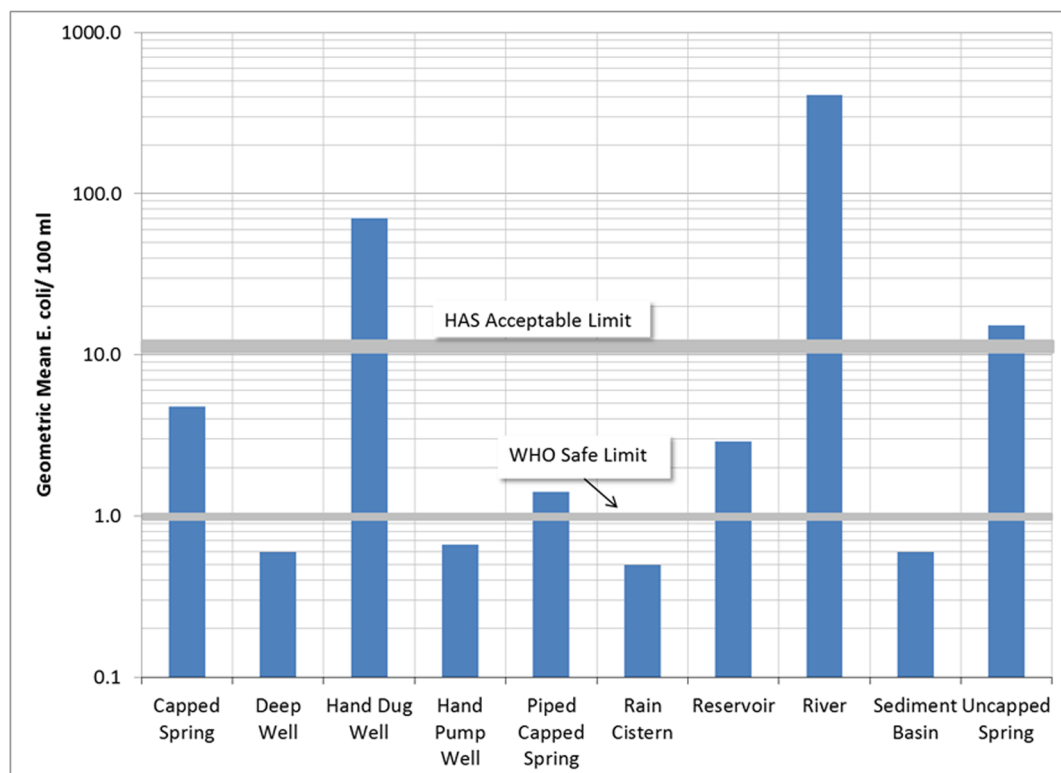
**Fig. 7** Summary of *E. coli* values for different water sources near Verrettes, Haiti. The Hôpital Albert Schweitzer (HAS) safe limit is a drinking water standard for a local hospital (10 MPN), and the WHO safe limit (1 MPN) is the World Health Organization drinking water standard

Since 2011, water samples from a range of different water sources have been collected and analyzed for *E. coli* in the Artibonite Department near Verrettes, Haiti (Figs. 1 and 7). Water sources sampled include rivers, undeveloped springs, developed springs, hand-dug wells, shallow hand-pump wells, deep wells, water reservoirs, and water treatment systems

(Figs. 8 and 9). The top three most contaminated water sources are rivers, hand-dug wells, and uncapped or unprotected springs. Twenty hand-dug wells were sampled for bacteria in 2016, with only two of these wells having acceptable *E. coli* levels for drinking water based on World Health Organization Standards (WHO) drinking water standards. The geometric mean of all the wells was 218.8 most probable number (MPN)/100 ml, which is greater than the United States Environmental Protection Agency (US EPA) acceptable body contact standard of 126 cfu/100 ml (Schram and Wampler 2018; US EPA 2012; Table 4).

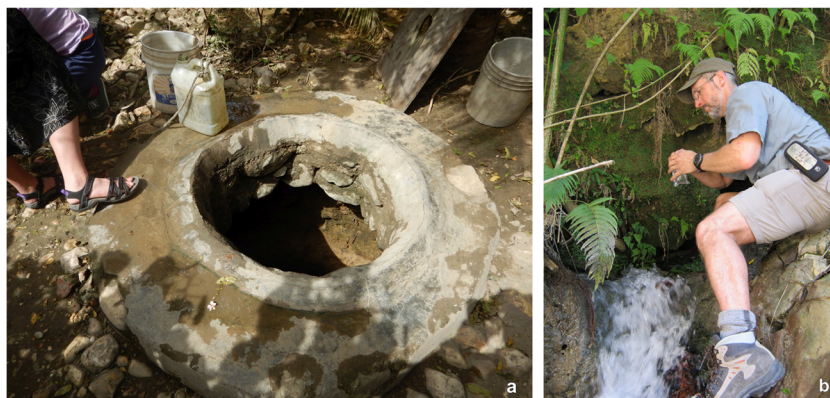
**Fig. 8** **a** Open hand-dug well common in many small villages. Note the plastic container and rope used to retrieve water. **b** Typical unprotected spring emerging from a shallow limestone aquifer

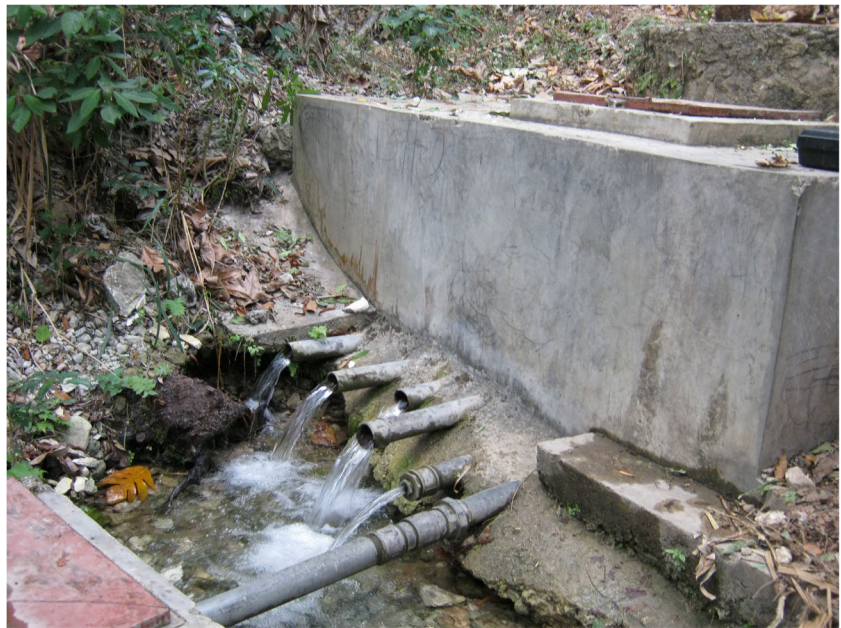
**Fig. 9** Typical concrete spring capping. The spring is covered and spring flow is directed into pipes or distribution systems. Access to the spring capping is typically restricted to a few local leaders

Spring protection through the installation of concrete capping provides some improvement in water quality, although the amount of protection provided does not usually justify the cost and maintenance required to install and maintain a capped spring (Fig. 9). The primary reason for this is that most springs

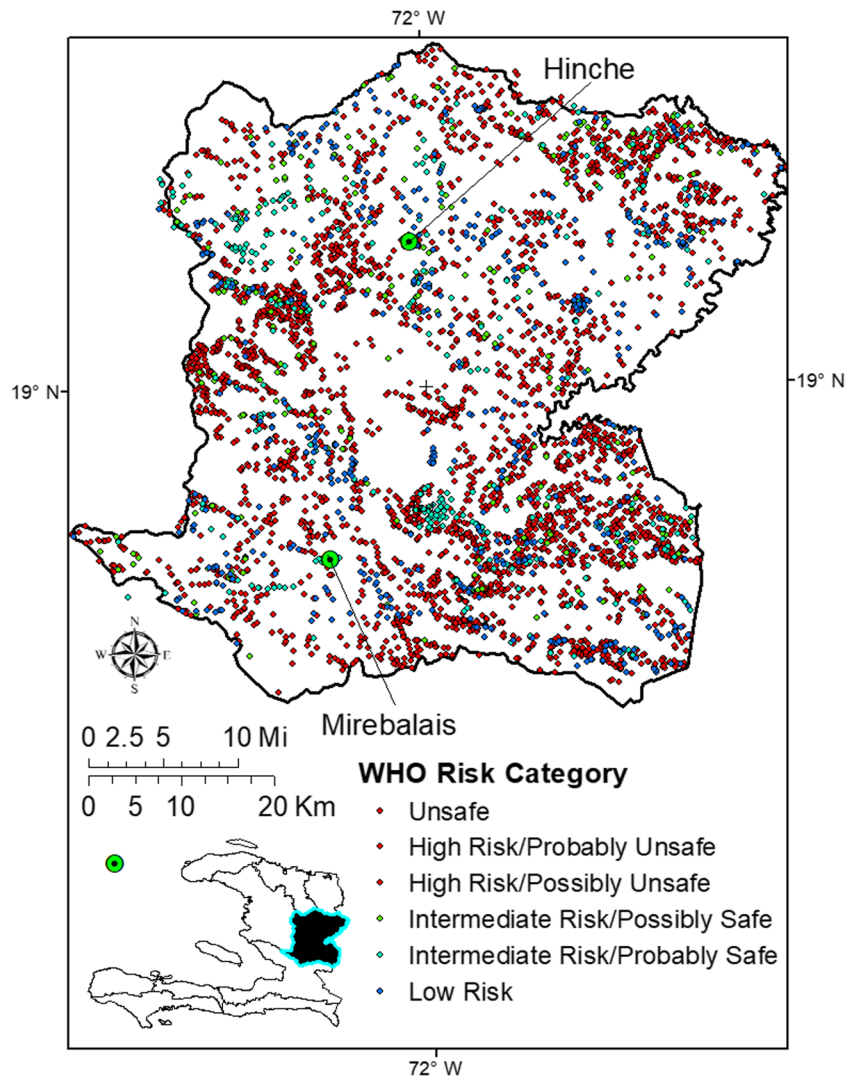
**Fig. 10** Aquagenx *E. coli* MPN data for 4,706 water points in the Centre Department. Colors represent different WHO risk levels for water sources as defined by Aquagenx. A total of 6,161 points were visited but 1,455 did not have *E. coli* data

4,706 water points in the Centre Department revealed clusters of high-risk water points. This is consistent with clusters of higher population density and inadequate sanitation (Fig. 10).

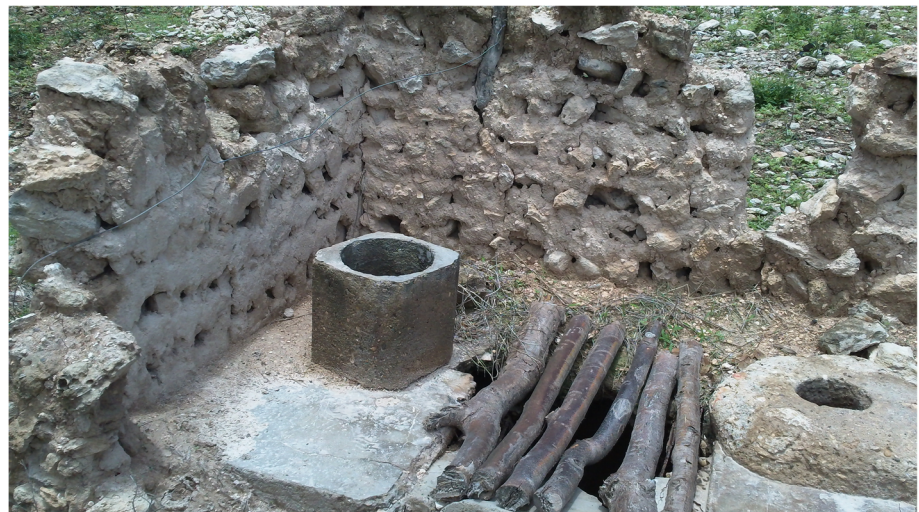
**Fig. 11** Unlined pit latrine located near a home in rural Haiti

contamination is the installation of unlined pit latrines which can result in leaching of contaminated water into unconfined aquifers and karst systems (Fig. 11). The combination of karst

development and fractures in limestone make site selection and lining of pit toilets critical to preventing shallow aquifer contamination.
