Tomasz A. Łabuz

20.1 Introduction

20.2 Characteristics of Coastal Types Around the Baltic Sea

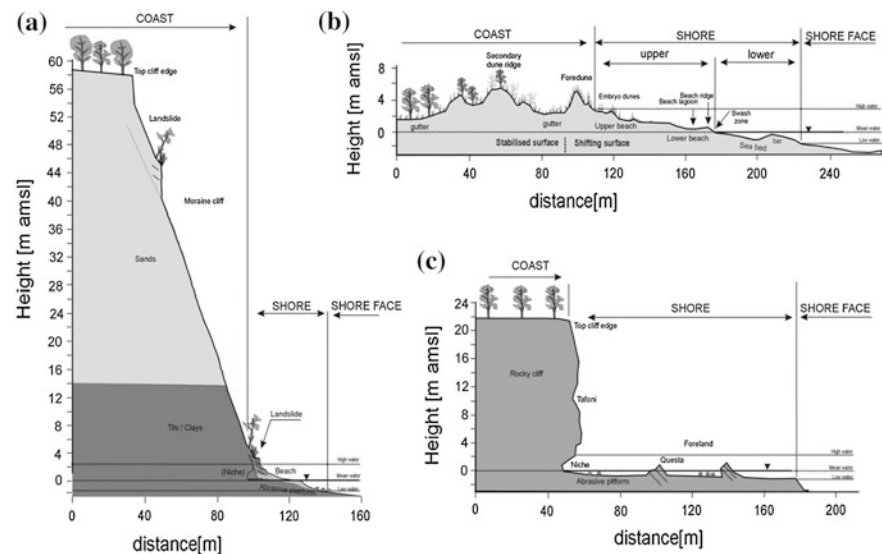
Fig. 20.1 Features and zones of the main Baltic Sea coast types. **a** Soft cliff coast, **b** Sandy coast with foredunes, **c** Rocky coast

The main coastal features in the Baltic Sea region are sand or gravel spits with diversified dunes, cliffs cut in a variety of sediments and low-lying areas such as lagoons, wetlands and salt marshes (Fig. 20.1). Accumulative features such as sand spits or beaches are formed by currents and waves. Dunes developed on sandy spits are higher origin forms accumulated in the past or now. They are developed as aeolian forms shaped by wind. Cliffs may be cut into hard rock or into soft clays, tills and sands and are usually higher-order relief forms shaped by erosion processes such as waves or landslides.

that slopes gently south-west (Schwartz et al. 1989). The following sections describe the coastal types by country. See Figs. 20.1 and 20.2 for the main the coastal types occurring in the Baltic Sea region.

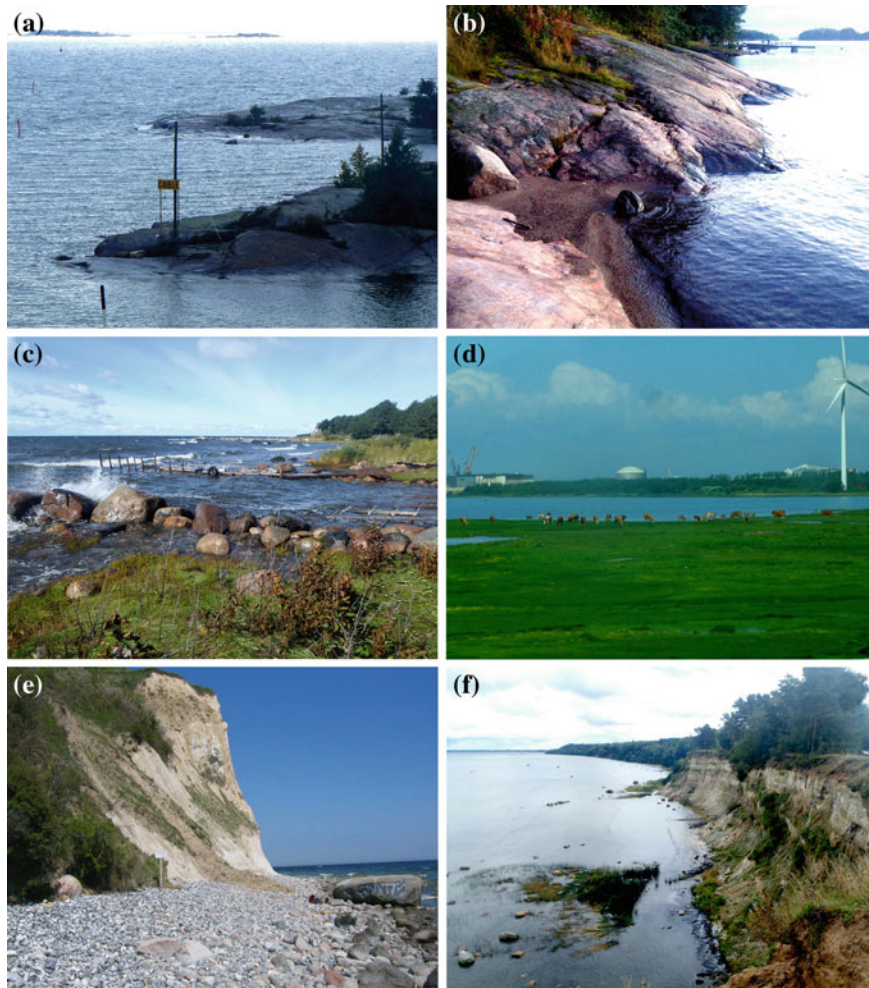
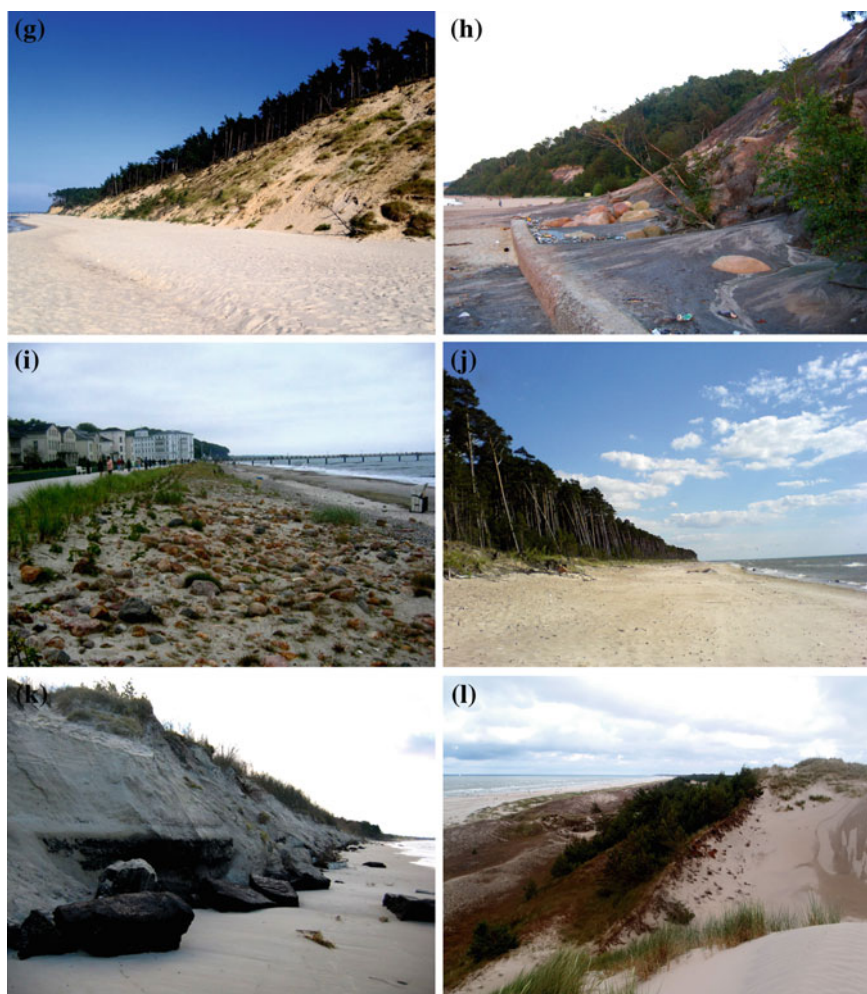
Fig. 20.2 (continued)

Fig. 20.2 Coastal types of the Baltic Sea. **a** Skerries in the Gulf of Finland, Finland; **b** Igneous rock, low coast shaped by glaciers, Helsinki, Finland; **c** Low coast of glacier boulders, northern Estonia; **d** Wetlands in southern Sweden near Malmö; **e** Rocky, chalk cliff covered by moraine sediments with an abrasive platform instead of beach, Rügen Island, Germany; **f** High-eroded cliff–klint coast in Estonia; **g** High soft moraine cliff coast of tills and fluvio-glacial sands, Wolin Island, Poland; **h** Typical cliff coast of tills and clays of moraine

deposits, landslides on the beach caused by ongoing storm surge, Sambian Peninsula, Kaliningrad region, Russia; **i** Low eroded coast without dune ridges in Heiligendamm, Germany; **j** Low coast of end moraine deposits covered by sands, Latvia; **k** Retreating dune coast entered and covered peatbog, Kolobrzeg, middle Polish coast; **l** Sandspit dunes: shifting inland with typical accumulative foredunes, Lebsko Lake Sandbar, Poland (Photos T.A. Łabuz)

The northern part of the Baltic Sea coast is mainly formed by isostatic uplift due to the loss of glacial cover in Scandinavia. In some places, accumulative forms occur in bays or river deltas. Finland and Sweden have emergent coasts where abundant skerries form archipelagos. Some U-shaped fjords were formed by glaciers in rocky, mainly igneous beds (Fig. 20.2b) with the presence of some sandy, accumulative barriers or beaches. Rocky limestone or chalk beds, found in Estonia and on the Baltic Sea islands, have formed cliff coasts (Fig. 20.2e, f).

Small patches of dune landscape are widespread on the Finnish coast, formed mainly from skerries (Fig. 20.2a) and post-glacial beaches on rapidly rising coastlines (Hellemaa and Doody 1991). The uplift rate is up to 9 mm year⁻¹, particularly in the Gulf of Bothnia. The dune landscape consists of parallel ridges separated by low, wet depressions arranged

The Swedish coastline is over 13,500 km long. Due to continuous uplift in the northern section, only the southern part of the Skåne coast is at risk of erosion (Fig. 20.2d). The present rate of land uplift by isostatic rebound varies from zero in southern Skåne to a maximum of 0.9 mm year^{-1} along the coast of the Bothnian Bay (Hanson 2002, see also Chap. 9 and references therein). Low coasts dominate in Sweden and active cliffs cut into tills and fluvio-glacial sediments are found in the south of the country. The rest of the coastline comprises low or average height cliffs made of hard rock, partly covered by glacier deposits such as till,

Two-thirds of the German Baltic Sea coastline is being eroded. The coastline is divided between the two German states of Schleswig-Holstein in the west and Mecklenburg-Vorpommern in the east. The Schleswig-Holstein coastline is 637 km long with 148-km-long soft cliffs and is generally in a retreat state due to sea-level rise (Hofstede 2008). The Mecklenburg-Vorpommern coastline is almost 1945 km long in total with an external coast of 376 km; of the latter, steep cliffs cover 128 km and flat sections 248 km. Approximately 70 % of this coast is in recession (Gurwell 2008). More than half of the coastline is ‘bodden’ coast—shallow bays and inlets cut-off from the sea by islands, peninsulas and spits (Sterr 2008). This coast was shaped during and after the last glaciation, with prevailing glacial and postglacial features and sediments, with low and soft cliffs. Natural coastal dunes are rare on the German Baltic Sea coast, and those that do occur are mostly found on the Darss Peninsula, Usedom Island and Rügen Island. The Darss Peninsula is a sandy spit covered by parallel ridges separated by wet, low depressions. Among these are sandy barriers that have developed as separate islands, like Hiddensee which is built from marine and aeolian deposits. These structures of marine origin have developed by long-shore transport of eroded soft moraine cliffs. Small dunes have developed on low parts of Rügen Island, mainly on the beaches, and are derived from fluvio-glacial deposits and chalk rocks. The chalk cliffs are unstable (Wahle and Obst 2009) and mainly covered by typical moraine deposits (Fig. 20.2e). The south of Rügen Island is formed by low, soft cliffs made from tills and clays, covered by sands. Some cliffs on Usedom Island reach heights of 50 m. In other places, low coastal cliffs are formed from bottom moraine deposits. The remainder of the German Baltic Sea coast is formed by moraine cliffs with an average height of 5–15 m and fronted by narrow beaches. Among them are lowland areas with wetlands—salt marshes or coastal meadows. This type of coast has vegetation typical of swampy saline areas. In coastal areas with low hydrodynamic stress (common in bodden areas), peatlands may develop and reed beds may replace the beach (Lampe and Janke 2002). In places where the coast is formed of low-lying valleys, as between Kiel and Heiligendamm on the western German Baltic Sea coast, many coastal sections are protected by artificial dykes (Fig. 20.2i).
