Enhanced high cycle fatigue resistance of Ti-17 titanium alloy after multiple laser peening without coating

Yang Jiao 1 • Weifeng He 2 • Xiaojun Shen 3

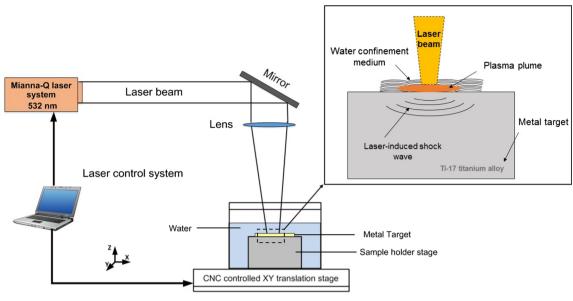
Fig. 3 Schematic diagram of the laser peening without coating process

The laser peening without coating experimental (LPwC) setup is schematically shown in Fig. 3, which is composed of three parts, namely laser control system, X-Y translation platform and Mianna-Q laser. The translation movements in x- and y-directions were controlled by two servomotors, operated through a self-developed software. The sample was fixed in a transparent sink and immersed in the water. This water served as a transparent overlap to create the plasma on the sample surface and confine the laser-induced shock wave. When the high-intensity laser directly irradiates the sample, the surface layer starts to ablate immediately. The laser-

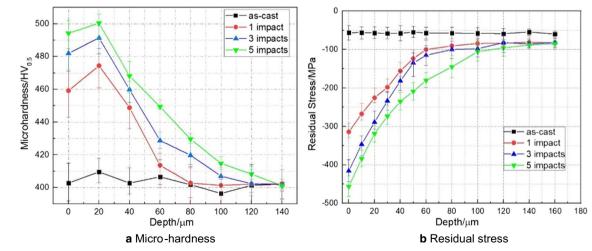
Fig. 5 Vickers micro-hardness and residual stress along the cross-sectional direction of titanium alloys under different LPwC impacts. a Micro-hardness. b Residual stress

As for the metallic components, the increase of microhardness can restrain cracks initiation from the surface, which plays an important role in enhancing the fatigue performance [33]. Figure 5a shows the profiles of the micro-hardness distribution along the cross-sectional direction of the specimens before and after LPwC with three different laser impacts. The surface micro-hardness of the AC specimen is $402.8~{\rm HV}_{0.5}$; the LPwC-treated specimens with 1 impact exhibit an average surface hardness of $459.2~{\rm HV}_{0.5}$ and was increased by 14%

from the AC specimen. With the increase of laser impacts, the surface micro-hardness is 482 HV_{0.5} and 494.2 HV_{0.5} for 3 impacts and 5 impacts, respectively. The surface microhardness of the target material increases with LPwC impacts, but the improvement magnitude is limited for more impacts. It shows that the hardness improvement of the titanium alloy tends to saturate with increasing the laser impacts. Similar results on TC6 titanium alloy were also found by Nie et al. [34]. They attributed this trend to the plastic deformation limit of material in the surface. In contrast to the present study, it was reported by A. Umapathi et al. [26] that the increase of the laser impacts did not induce the hardening but softening of the TC6 titanium alloy with multiple peening at 6 GW/cm². This apparent contrast can be explained by the repetition rate, as they used the repetition rate of 10 Hz in comparison with the present study (3 Hz), because lower repetition rate can provide the sample with enough time to cool down. As a result, the thermal softening effects will be weakened or even eliminated, and finally the mechanical effects dominate the LPwC process.

Along the cross-sectional direction, it can be seen that the highest hardness of the target material is not on the surface but on the subsurface. Without the protective coating, the direct laser irradiation on the surface of specimen may induce the softening of the material on the surface [24, 35]. For all LPwC-treated samples, the maximum micro-hardness appears at the depth of 20 μ m, which is a consequence of the softening due to the thermal effects on the sample surface and the similar results at the surface can be seen from the open literature [19, 26]. The hardness of all LPwCed titanium alloy samples decreases along the depth and finally reaches that of the AC specimen. The thermal effects are usually attributed to local melting and re-solidification on the sample surface. However, in the present study, no melting or re-solidification was observed, as evident from the microstructural cross-sectional

The affected depth of hardness increases from $80 \mu m$ for one LPwC impact to $140 \mu m$ for five impacts. For most crystalline alloys, the micro-hardness enhancement is attributed to the laser-induced high-density dislocations in the crystals [13, 37] and also the compressive residual stress [38, 39] after peening. The effect of laser peening without coating on the residual stress distribution and microstructure evolution will be discussed in Sections 3.2 and 3.3.

Some previous investigations [15, 17, 20] reported that the thermal effect of LPwC with less than 0.5 J is very small or even negligible, and then the effect of shock waves under this condition is prevailing. Under the effect of the laser-induced shock wave, compressive residual stress was introduced in the surface and subsurface of the metal material. The depth-wise residual stress profiles with different numbers of laser impacts are depicted in Fig. 5b. The residual stress of the AC specimen is about - 50 MPa compressive residual stress, which is so small that the effect of the initial residual stress on the high cycle fatigue strength can be neglected. It can be seen that compressive residual stress was generated on the surface of the Ti-17 titanium alloy, - 314.2, -415.5 and -456.1 MPa, after LPwC with one, three and five impacts, respectively. It can be demonstrated that the thermal effect of LPwC is negligible and LPwC can effectively induce the compressive residual stress. It is well known that the enhancement of the hardness is partially attributed to compressive residual stress. This is caused by the accumulated plastic strain induced by longer deformation time [40]. However, the increment of the surface residual compressive stress for each impact decreases with LPwC impact, which may be attributed to the plastic deformation limit of material on the surface. It consistents with the variation of the micro-hardness. This residual stress distribution observed in the present study can also be explained by that for the micro-hardness variation (Section 3.1).

The largest value of the compressive residual stress is on the surface of the specimen, and it goes on decreasing as it goes inward. This occurs due to the fact that the intensity of the laser-induced shock wave is the maximum on the surface and the kinetic energy of shock wave is absorbed by the plastic deformation. As a result, the compressive residual stress decreases along the in-depth direction. The affected depths of the specimen after LPwC were 100, 120 and 160 μm , after one, three and five impacts, respectively. Compared with the laser shock peening with large energy (> 1 J) [34], the affected depth is shallower, which can be attributed to the lower energy and shorter pulse duration time.

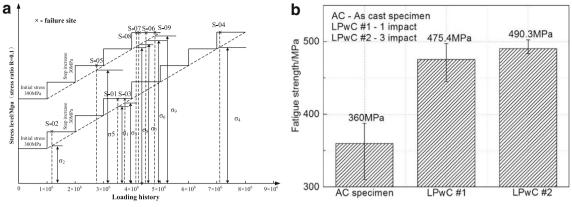
Fig. 9 Loading history (a) and fatigue strength (b) of the Ti-17 titanium alloy specimens with different laser parameters

treated with one impact and the other one is the LPwC treated with three impacts. The laser treated path of all the fatigue specimens are as shown in Fig. 1. The high cycle fatigue behaviours of the Ti-17 titanium alloy with different surface conditions are shown in Table 3 and the data was collected with the step-loading method. Taking the mechanical properties of Ti-17 titanium alloys into consideration, the initial stress of the as-cast specimen was set to be 300 MPa and the loading history of the specimens is shown in Fig. 9a. For the

sake of avoiding the failure of the specimens, 300 MPa was also set to be the initial stress of the LPwCed specimen but it came out that the fatigue strength is almost 480 MPa. Therefore, in order to save time, the initial stress of the LPwC specimens was then increased to 390 MPa. The average value of each group is taken as the fatigue strength of the specimens under the surface condition and the results are 360 MPa, 475.4 MPa and 490.3 MPa, respectively, as shown in Fig. 9b. It can be clearly seen that laser peening without

coating can improve the high cycle fatigue performance of Ti-17 titanium alloy significantly and the improvement of 3 laser impacts (36.16%) is higher than that of 1 laser impact (31.96%). However, compared with the fatigue strength improvement from as-cast to LPwC no. 1 specimen, the improvement from LPwC no. 1 specimen to LPwC no. 2 specimen is relatively small, which shows the similar trend with the compressive residual stress improvement and microhardness enhancement.

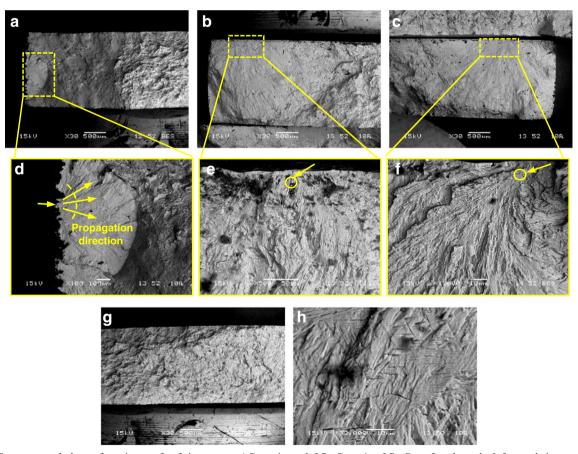
Fig. 10 Fracture morphology of specimens after fatigue test. a AC specimen, b LPwC no. 1, c LPwC no. 2 and panels d-f were their corresponding enlarged views. g The final region of the AC specimen. h The final region of the LPwC no. 1

In order to gain more insights into the effects of LPwC on the high cycle fatigue properties, the specimens with different surface conditions after fatigue test was observed by SEM as shown in Fig. 10. According to the fracture surface, the quasicleavage fracture with the typical features of river patterns was found on all the specimens. It can be seen that the fatigue crack initiation of the AC specimen appears on the surface

(Fig. 10a), but the fatigue crack initiation of the LPwCed specimen is located in the subsurface, about several micrometres away from the surface (Fig. 10b, c), which can be attributed to the LPwC-induced compressive residual stress. In addition, there are some secondary fatigue cracks on the LPwCed specimens. Maxwell et al. [32] indicated that the secondary fatigue cracks can retard the propagation of the fatigue cracks. As is shown in Fig. 10g, some dimples can be found in the final fracture morphologies of the AC specimen. In Fig. 10h, a plenty of fatigue stripes were generated after LPwC, which may result from the combined effect of residual stress and high-density dislocations [42].
