Mechanical and corrosion resistance properties of AA7075-T6 sub-zero formed sheets

Rachele Bertolini¹ · Enrico Simonetto¹ · Luca Pezzato² · Alberto Fabrizi³ · Andrea Ghiotti¹ · Stefania Bruschi¹

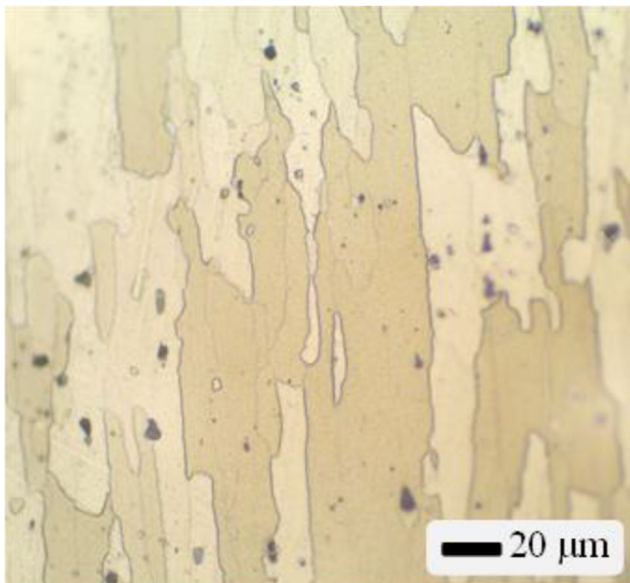
**Fig. 1** OM image of the as-received AA7075-T6 microstructure along the ST plane

short transverse (ST) direction as per the ASTM-E3 (95) standard. To this aim, specimens were cut from the sheet, cold mounted, polished and etched with the Keller's solution for 20 s. The microstructure was recorded with a Leica DMRE™ OM at a magnification of $\times 200$. Figure 1 shows the microstructure of the as-received alloy that reveals the presence of elongated pancake-shaped grains, typical of the rolling process, characterized by an average thickness, intended as orthogonal to the rolling direction, ranging between 12 and 17 μm . A very high density of precipitates is spread throughout the grains.

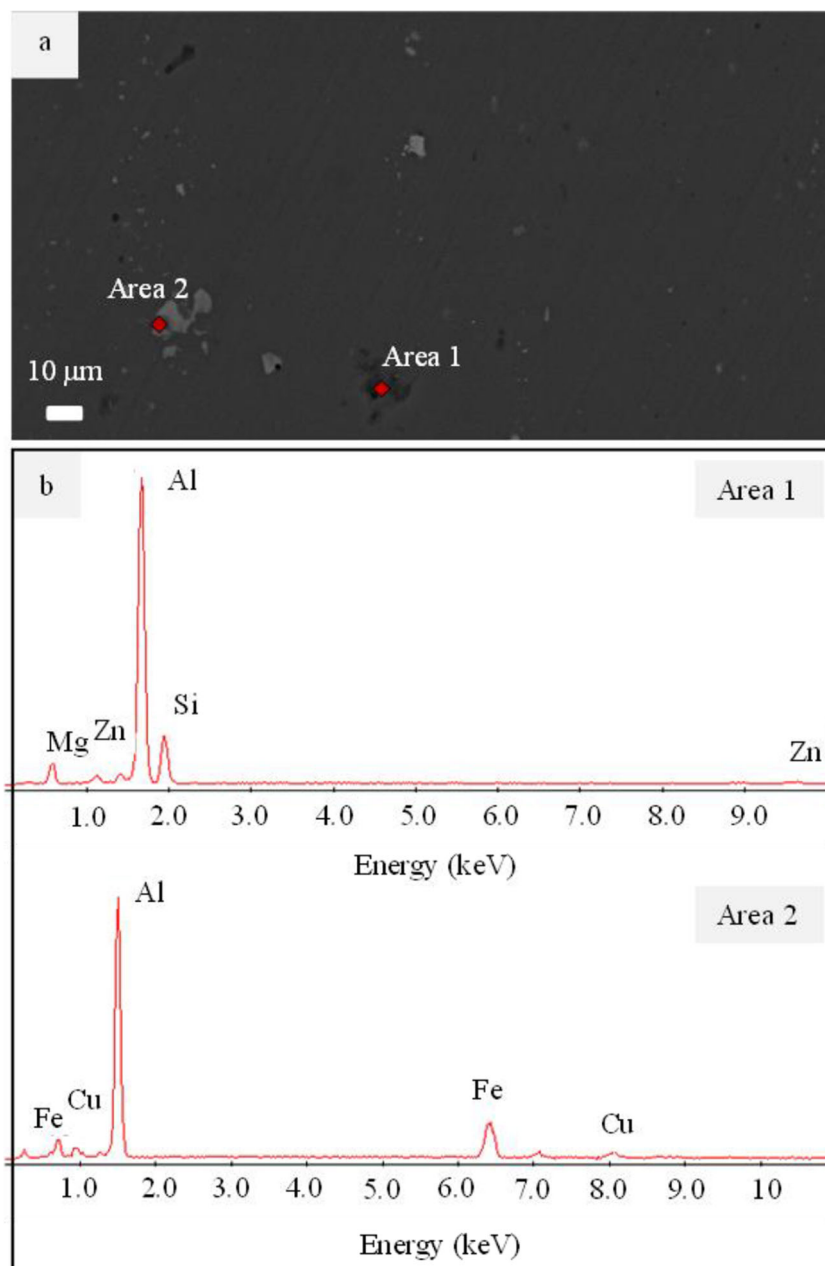
Fig. 2 **a** SEM image of the as-received AA7075-T6 alloy and **b** EDS spectra of the red areas highlighted in **a**

To identify the chemical composition of the intermetallic particles (IMPs), energy dispersive X-ray analysis (EDX) was carried out using the FEI™ QUANTA 450 Scanning Electron Microscope (SEM). Figure 2 a shows two main types of IMPs, one brighter and the other darker compared to the matrix. The former is characterized by very irregular shape and dimensions, whereas the latter assumes a polygonal aspect. The EDS spectra shown in Fig. 2b help in identifying the type of the particles, namely the bright ones correspond to $\text{Al}_7\text{Cu}_2\text{Fe}$, whereas the darker to Mg_2Si , in accordance to [16].

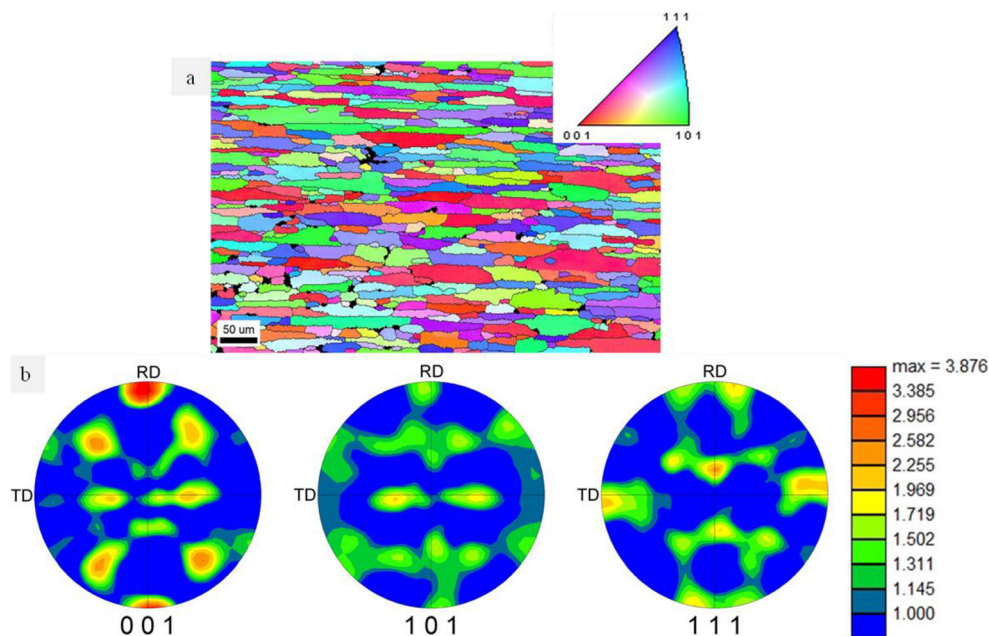
Fig. 3 **a** IPF map of the as-received AA7075-T6 alloy (RD, ND and TD stand for rolling, normal and transversal direction, respectively) and **b** 001, 101 and 111 PFs

The inverse pole figure (IPF) map in Fig. 3a confirms the microstructure of the AA7075-T6 alloy with elongated aluminium grains, whereas the pole figures (PFs) in Fig. 3b show a crystallographic texture dominated by the typical rolling texture, as indicated in [17]. According to the grain boundaries (GBs) map (Fig. 4a) and the related misorientation angle distribution (Fig. 4b), the as-received alloy exhibits a relative low fraction of LAGBs, while most of the grain boundaries present a misorientation angle ranging from 15 to 65° .

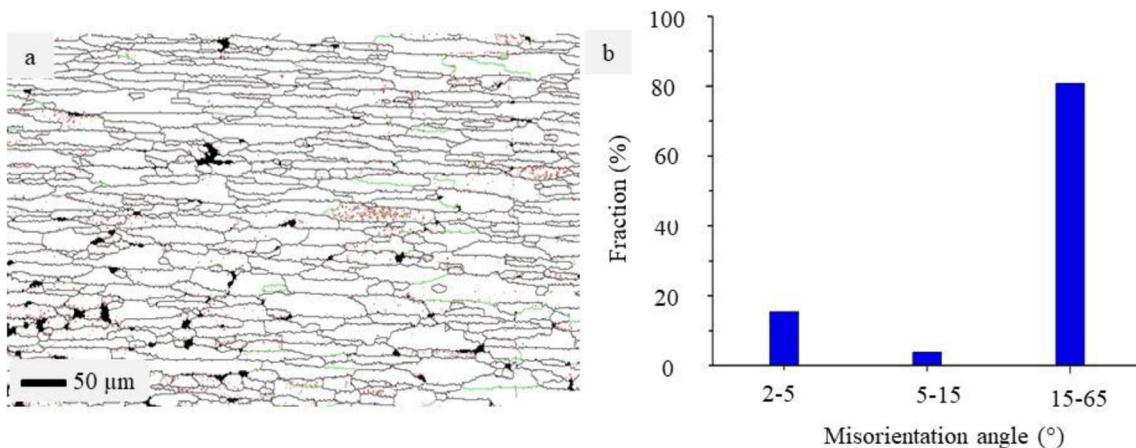
Fig. 4 **a** GBs map: LAGBs with misorientation angle between 2 and 5° in red lines, LAGBs between 5 and 15° in green lines and HAGBs in black lines. **b** Misorientation angle distribution

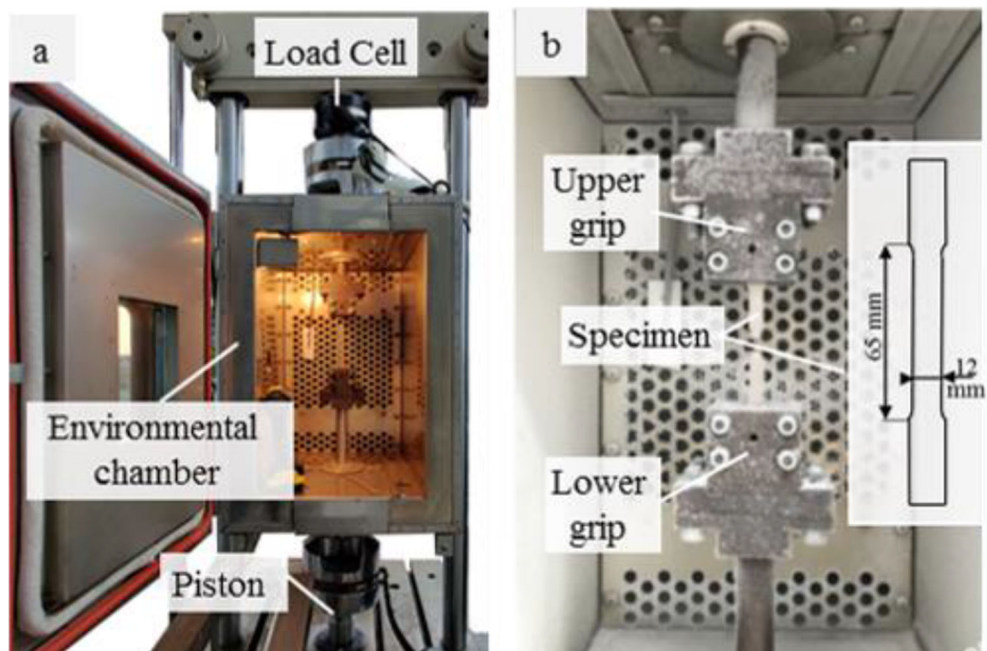
Fig. 5 **a** Dynamometer equipped with the environmental chamber and **b** magnified view in the case of a test carried out at -100°C

the environment are at the same temperature assuring a uniform distribution along the specimen gauge length. Figure 5 a shows the overall mechanical testing equipment, while Fig 5 b shows the inside of the environmental chamber after a test at -100°C . The specimen is gripped inside the environmental chamber between two grippers connected to the dynamometer load cell and the hydraulic piston, respectively. The use of liquid nitrogen allows reaching easily -100°C , which was therefore chosen as the minimum testing temperature. Each tensile test was repeated 3 times for sake of repeatability with a strain rate of 0.1 s^{-1} . The latter value was chosen in compliance of the strain rate values typical of sheet stamping processes carried out on aluminium alloys [19].

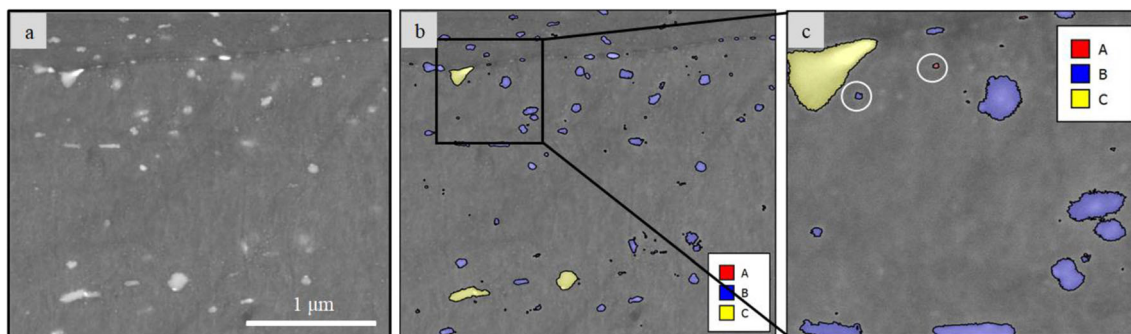
Fig. 6 Procedure for the calculation of the particle size: **a** original image acquired by FEG-SEM, **b** particles evidenced on the basis of their size, and **c** magnified image of **b** to show the difference between A and B particle classes

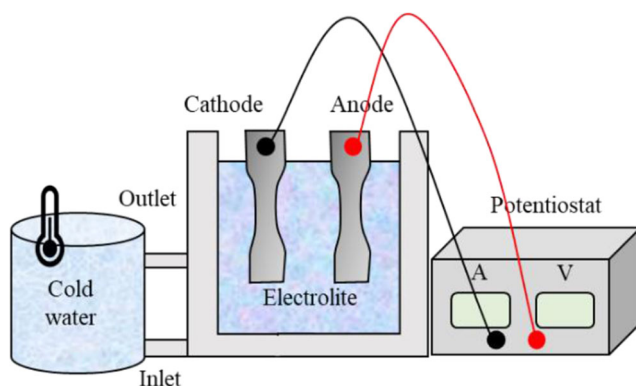
Fig. 7 Scheme of the setup used to carry out the anodization process

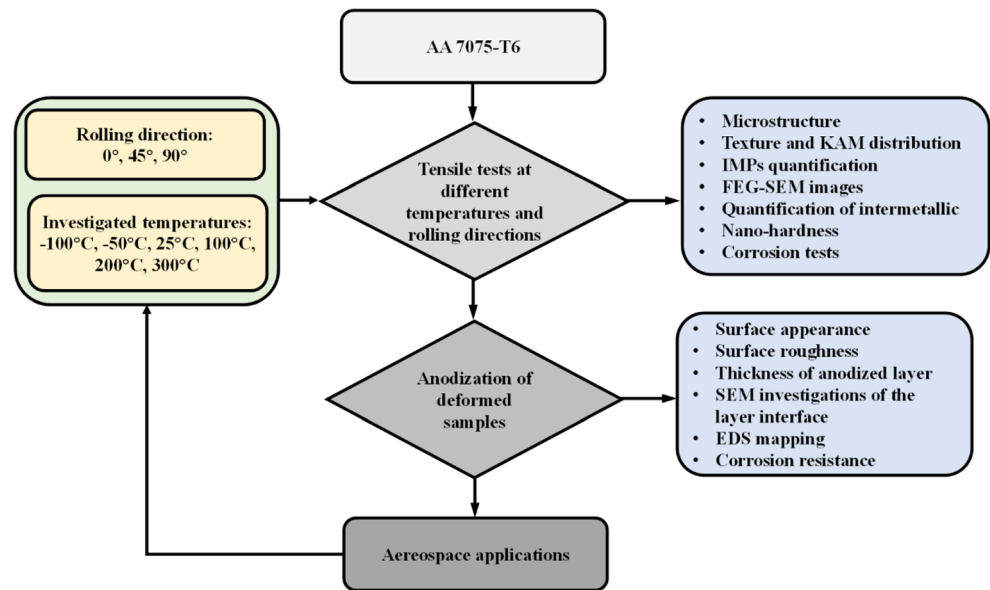
Fig. 8 Flow chart of the experimental methodology

The flow chart of the overall experimental methodology is presented in Fig. 8.

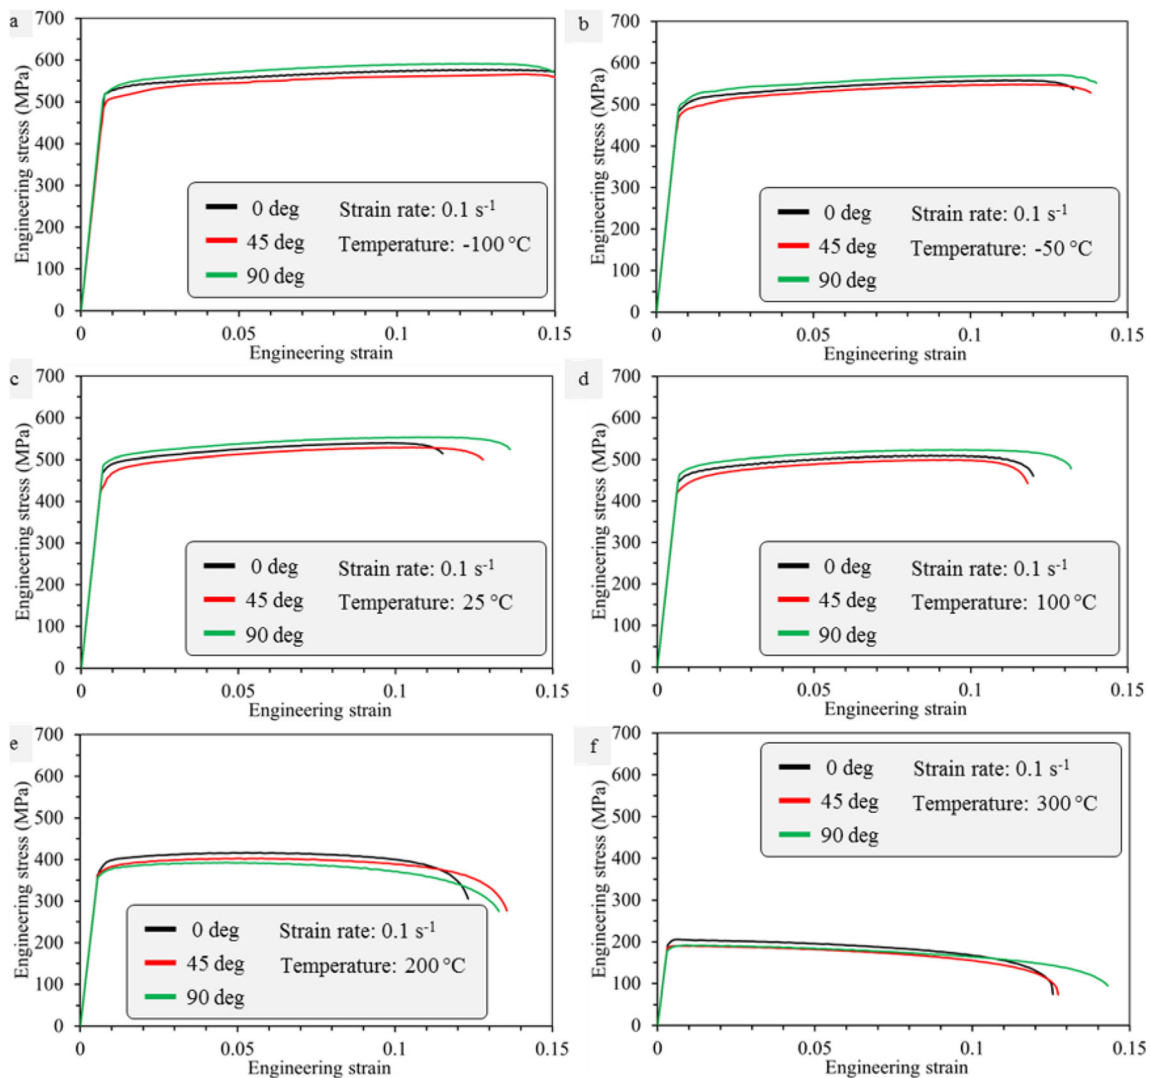
Fig. 9 AA7075-T6 engineering flow-stress at **a** -100°C , **b** -50°C , **c** 25°C , **d** 100°C , **e** 200°C , and **f** 300°C

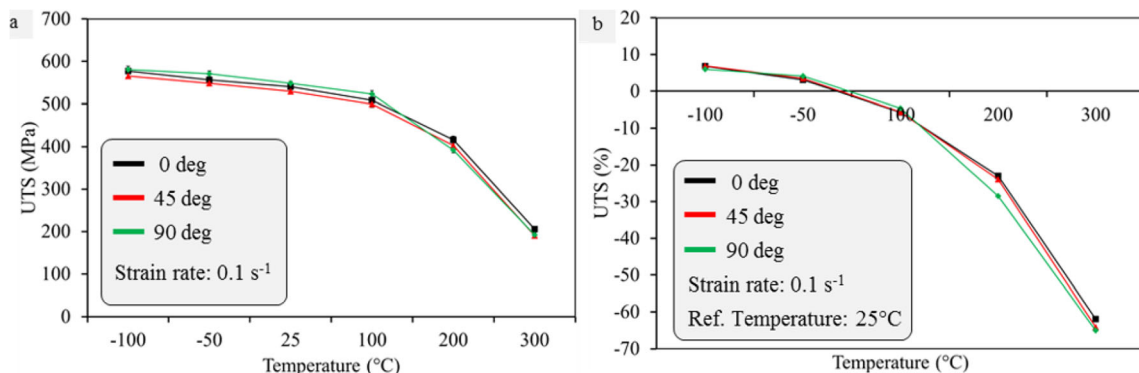
Fig. 10. AA7075-T6: **a** UTS (mean std. dev. is contained within ± 6.2 MPa) and **b** UTS percentage variation (baseline 25 °C)

The same trend can be seen in Fig. 10a where the UTS values are compared at varying testing temperatures and rolling direction. Furthermore, Fig. 10 b shows the UTS percentage variation taking as baseline condition the tests carried out at 25°C . It is worth noticing a mean increase of 6.6% of the UTS at -100°C and a mean decrease of 63.7% at 300°C . This means that the expected forming load for a sub-zero temperature forming process is close to the one of a conventional room temperature operation. On the other hand, forming at temperatures from 200 to 300°C implies a considerable forming loads reduction. However, at the same time, the application of a high temperature field can lower the component final mechanical characteristics. The influence of the rolling direction on the UTS percentage variation has proven to be negligible under 100°C , with relative difference between the specimens cut along three direction being under 1%. Only at higher temperature, the specimens cut along the orthogonal direction exhibit a greater drop in the UTS values, with a decrease of 28.5% compared to a mean decrease of 23.4% in the other cases at 200°C . The influence of the elevated testing temperature, $300\text{--}400^\circ\text{C}$, on the UTS values showed similar trends to those found in [23] for AA7075-T6. It was seen that the UTS values gradually dropped at increasing temperature, as is in the present study. Actually, the intensity of both the recovery and grain boundary migration processes is reduced when the deformation occurs at sub-zero temperatures, as well as the grain coarsening and precipitates dissolution. In [23] it was asserted that the enhancement of the workpiece mechanical properties was desirable also to limit the tool friction and avoid the wrinkle onset, which represents a critical formability limit in aluminium alloy hot stamping.

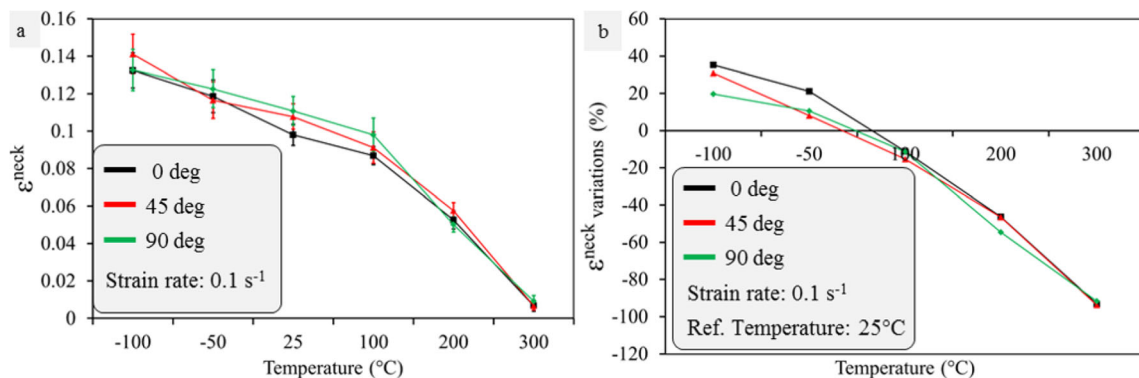
Fig. 11. AA7075-T6 **a** ϵ^{neck} (mean std. dev. is contained within ± 0.007) and **b** ϵ^{neck} percentage variation (baseline 25 °C)

The above-mentioned increase of the strain-hardening, as the temperature lessens, is connected with the strain at necking ϵ^{neck} increase. Figure 11 a shows the necking strain values as a function of temperature and rolling direction. Within the tested temperature range and along all the tested directions, a temperature decrease led to an increase of ϵ^{neck} . This means that deformation under uniaxial condition at sub-zero temperatures postpones the starting of necking accompanied with the localized sheet thickness reduction that represents a major disadvantage of the sheet stamping processes. Taking as reference the room temperature cases, the percentage variation of ϵ^{neck} is shown by Fig. 11b. For all the tested directions, the maximum mean increments are reached at -100 °C and are, respectively, of 35.2%, 31.0% and 19.6%, while the mean increments drop to 13% at -50 °C. However, as the testing temperature rises over the room one, the beginning of necking is reached for smaller strain values for all the tested conditions. Fig. 11b and Fig. 9 show that, as the temperature rises from -100 to 300 °C, most of the plastic strain occurs in post-necking conditions, with higher true strain at fracture, but coupled with a thickness decrease. On the other hand, as the temperature lessens, most of the plastic deformation takes place before the onset of localized necking, therefore in uniform elongation conditions, which is fundamental to manufacture sound components having a constant thickness distribution.

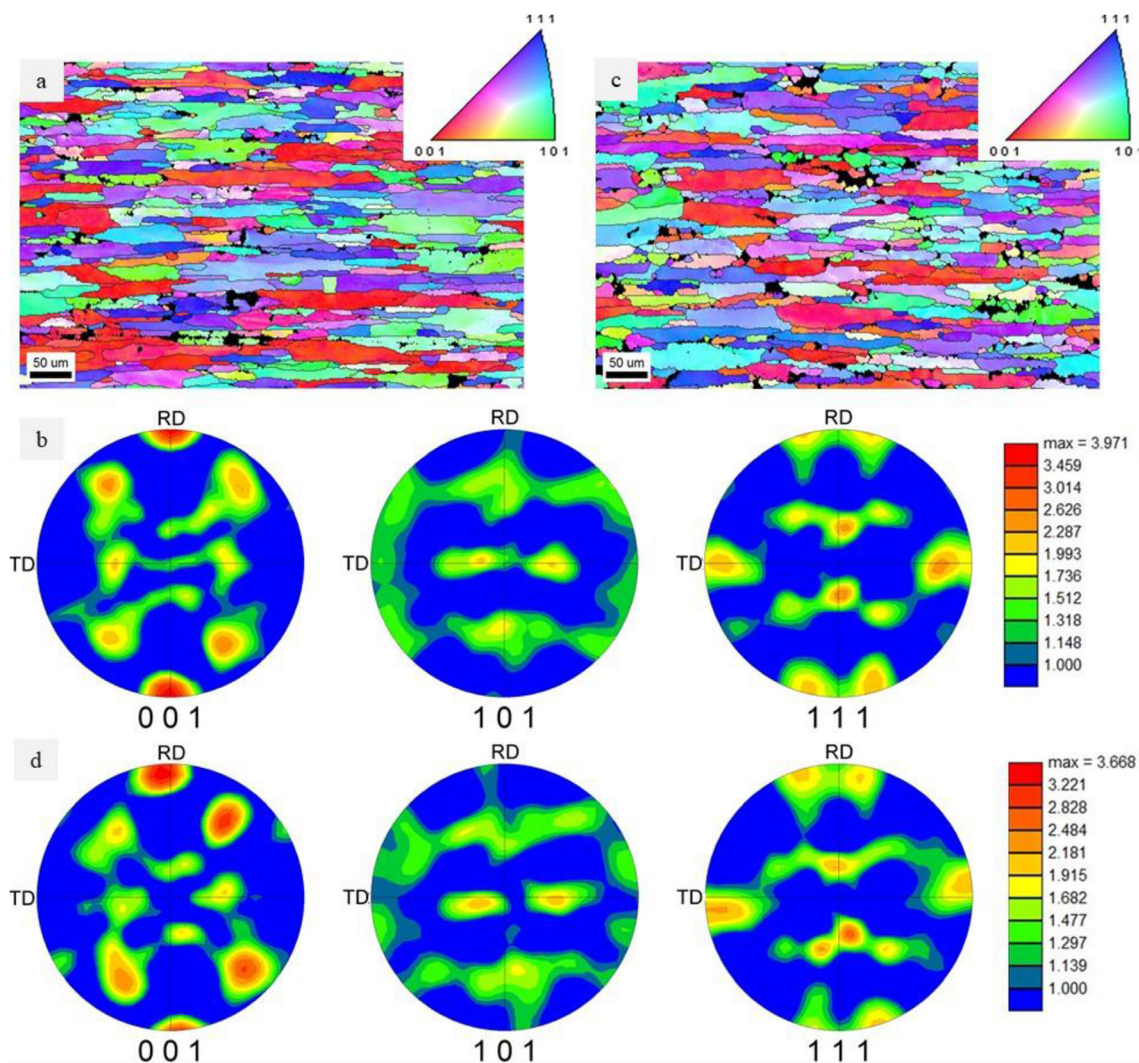
**Fig. 12** a IPF map and b 001, 101 and 111 PFs of the -100°C UTS-deformed specimen. c IPF map and d 001, 101 and 111 PFs of the 200°C UTS-deformed specimen

The IPF maps and the pole figures of the -100 °C and 200 °C UTS-deformed specimens are shown in Fig. 12. Such temperatures are here reported as representative of the cold and warm regimes, respectively. It can be observed that the crystallographic textures and related intensities are substantially equivalent; moreover, they appear similar to that of the alloy in the as-received condition (see Fig. 3 for comparison). This means that the crystallographic texture was not significantly affected by the deformation temperature and conditions adopted for the mechanical testing campaign.

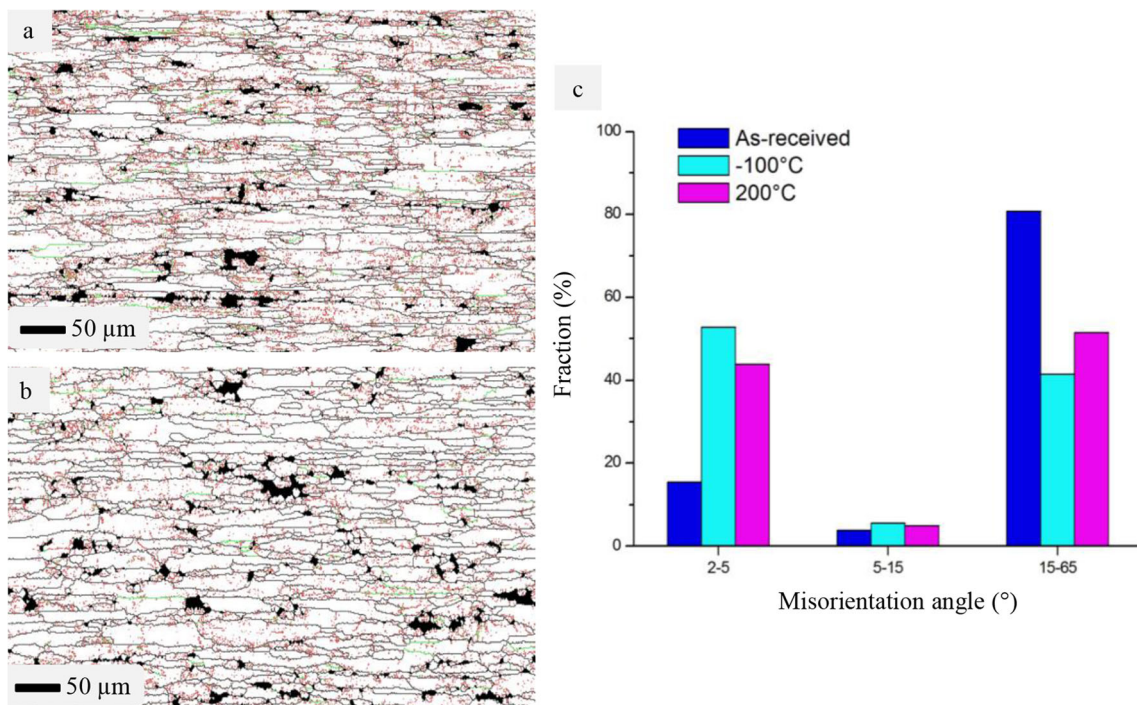
Fig. 13 GBs map along the ST plane of the **a** -100°C and **b** 200°C UTS-deformed specimens. **c** Misorientation angle distributions of the -100°C and 200°C UTS-deformed specimens (the distribution of as-received alloy is also reported)

The GBs maps of the -100°C and 200°C UTS-deformed specimens are shown in Fig. 13 a and b, respectively, whereas the related misorientation distributions are compared with the one of the as-received alloy in Fig. 13c. It can be observed that the deformed specimens show a higher density of LAGBs than the as-received alloy. In

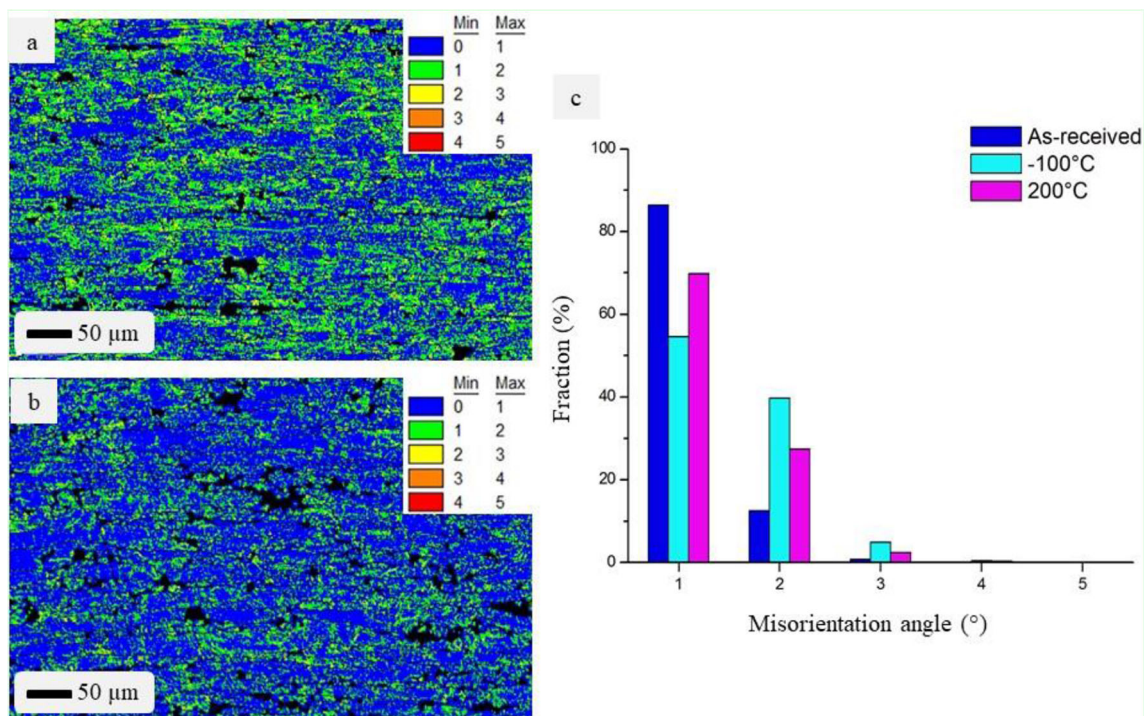
Fig. 14 KAM map along the ST plane of the **a** -100°C and **b** 200°C UTS-deformed specimens. **c** KAM distributions of the -100°C and 200°C UTS-deformed specimens (the distribution of as-received alloy is also reported)

The KAM maps and the corresponding KAM distributions of the -100°C and 200°C UTS-deformed specimens are displayed in Fig. 14 a and b, respectively, whereas the related data are summarized in Fig. 14c. It can be clearly seen that a larger fraction of green and yellow coloured regions, which correspond to the misorientation of 2° and 3° , was detected in the specimen deformed at low temperature. This can be attributed to a higher concentration of dislocations and, consequently, deformed aluminium grains.

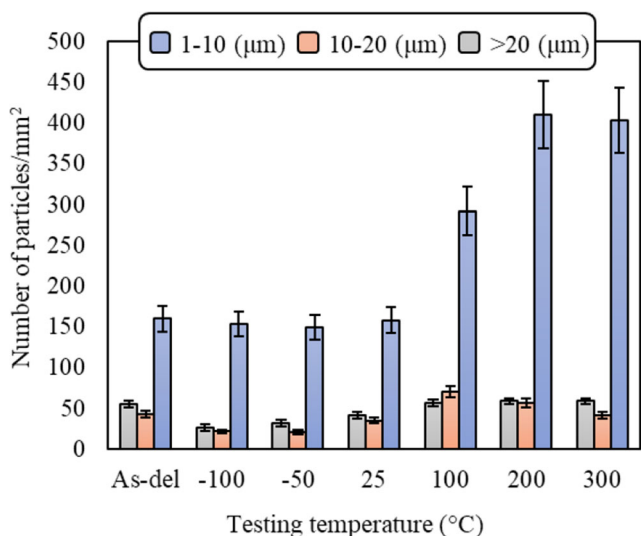
Fig. 15 IMPs of the UTS-deformed AA7075 specimens at varying testing temperature

Figure 15 graphs the amounts of IMPs per unit area for different sizes along the ST plane. A drastic increase in the number of larger particles with the respect of the as-received

sheet is visible for the specimens deformed at the higher temperatures. On the contrary, the specimens deformed at -100°C, -50°C and 25°C were characterized by a lower

number of large particles, even lower than the one of the as-received material. The same trend applies also for the other particle size.

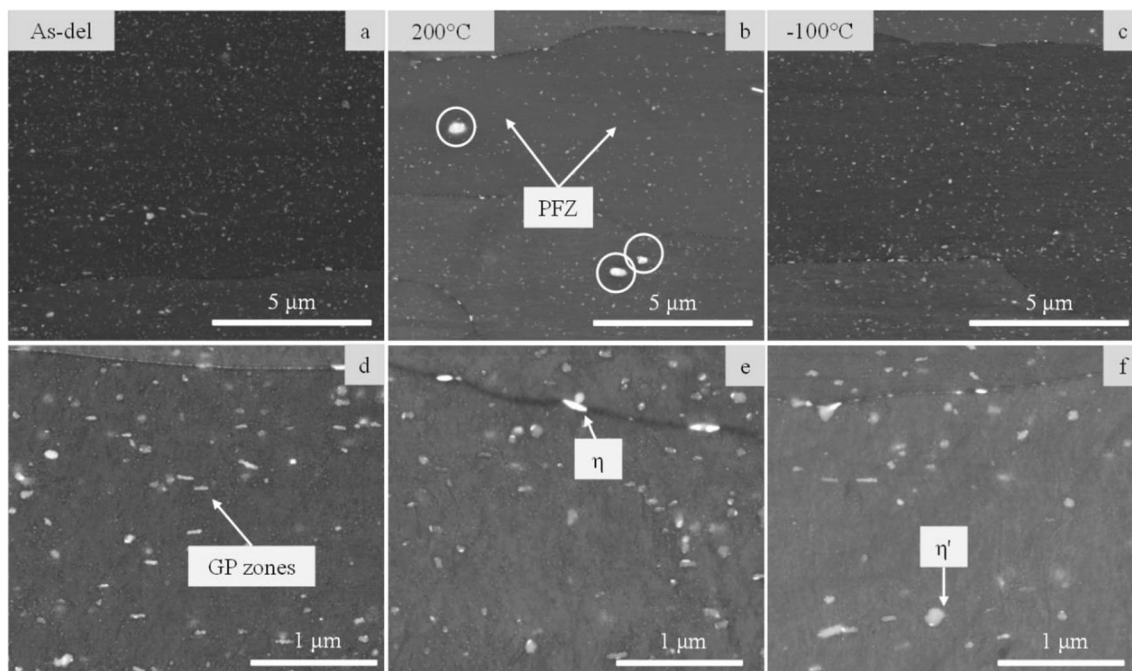
Fig. 16 FEG-SEM images of the as-delivered (a and d) and UTS-deformed AA7075 specimens at 200°C (b and e) and -100°C (c and f)

A close-up view of the microstructure was feasible by using the FEG-SEM and is reported in Fig. 16, whereas Fig. 17 shows the particle analysis results. By comparing Fig. 16 a,

In the present study, the same type of particles was present in the alloy as witnessed by the presence of similar particles morphology on FEG-SEM images of Fig. 16. Nevertheless, the size of particles was greatly affected by the temperature at which the mechanical testing took place. From Figs. 15 and 17, it can be seen that the particle size increased monotonically with the testing temperature. This means that the corrosion attacks may be more severe in the case of the specimen deformed at 300°C, as witnessed by its higher corrosion current density. On the contrary, the amount of dislocations is inversely proportional to the testing temperature, as demonstrated by the increase of strain hardening coefficient. This would have led to a corrosion resistance decrease. However, on the basis of the findings of the present study, the effect played by the particle size exceeded the one played by dislocation accumulation.

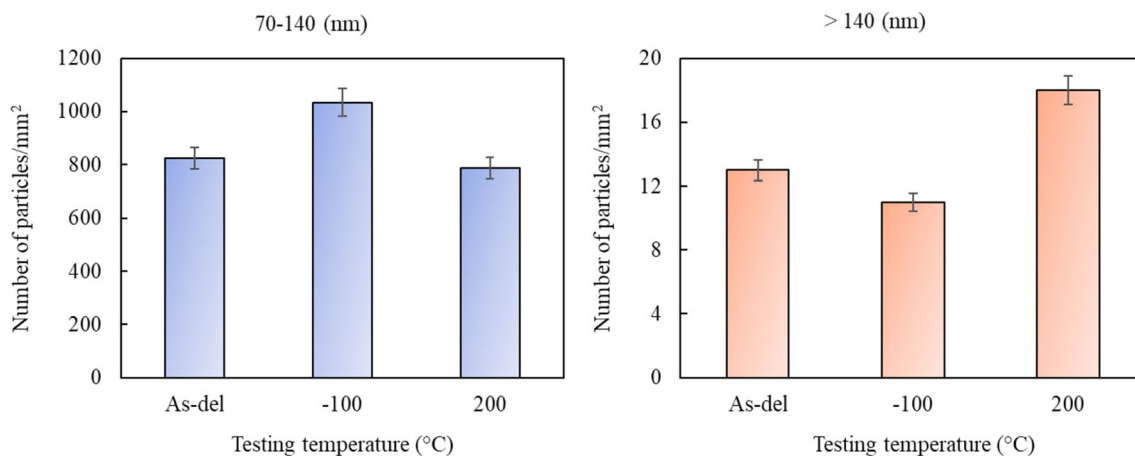
Fig. 17 Precipitates of the UTS-deformed AA7075 specimens at varying testing temperature

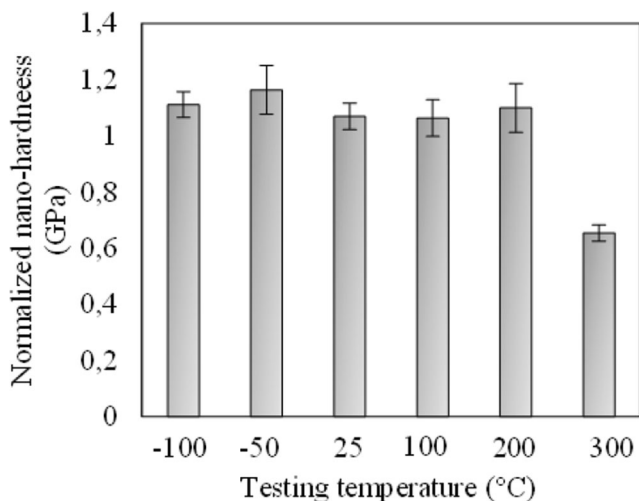
Fig. 18 Normalized nano-hardness of the UTS-deformed AA7075 specimens at varying testing temperature

Results of nano-hardness measurements carried out on the ST plane are reported in Fig. 18. Harder surfaces compared to the as-received material were obtained solely in the case of

deformation at -50°C and -100°C . Specifically, considering the specimen deformed at 25°C , a 11% and 16% nano-hardness increase was registered for the specimens tested at -100°C and -50°C , respectively. On the contrary, a 35% decrease was found for the specimen tested at 300°C .

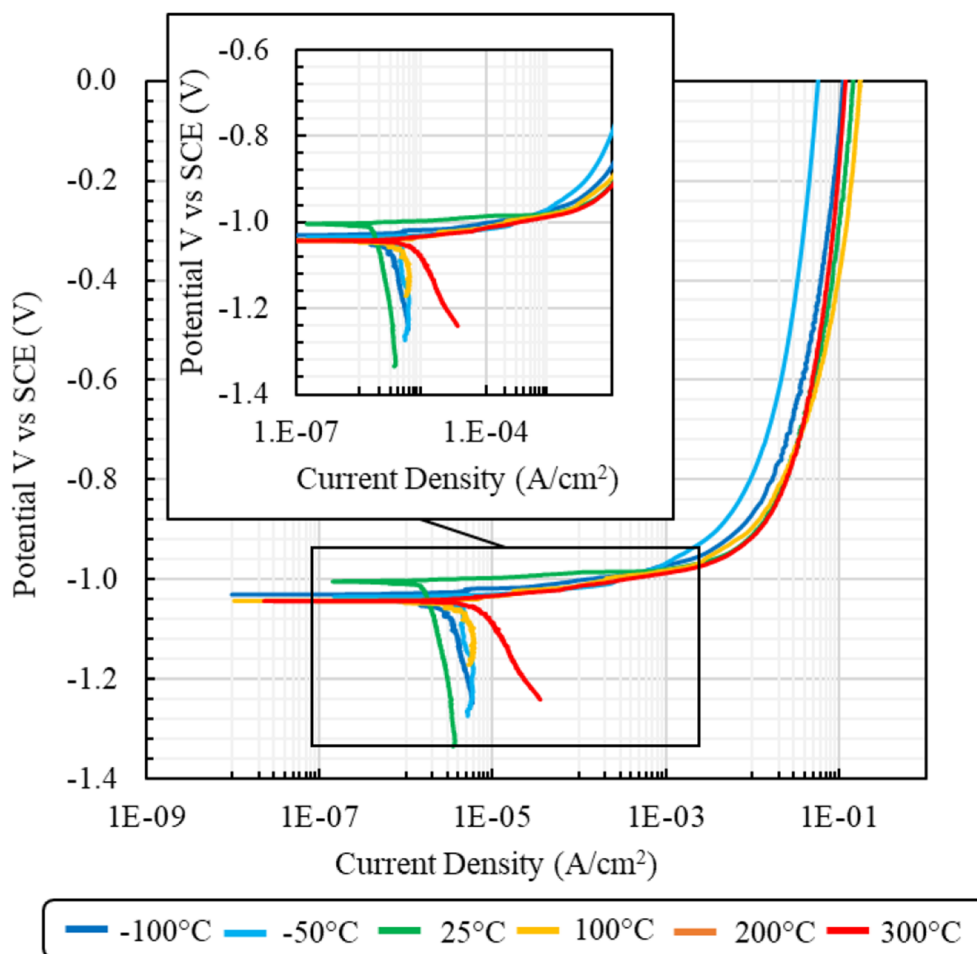
Fig. 19 Potentiodynamic polarization curves obtained in 3.5% NaCl solution at room temperature at varying testing temperature

Figure 19 reports the potentiodynamic polarization curves for the specimens tested at different temperatures, whereas Table 3 summarizes the corrosion data derived from the figure. Both the E_{corr} and I_{corr} can be used as indicators of a material resistance to corrosion. In particular, the higher the value of the former and the lower the value of the latter, the better the metal resistance to corrosion. From Table 3, no significant differences of E_{corr} between the investigated specimens were observed. However, a significant decrease in I_{corr} , namely 85%, was observed for the specimen deformed at −100°C compared to the one of the specimen deformed at 300°C. Overall, the specimens deformed at temperatures ranging from −50 to 100°C show similar behaviour, whereas a slight worsening is found for the specimen deformed at 200°C. These observations imply that deformation at 200°C and 300°C induces a corrosion resistance reduction.

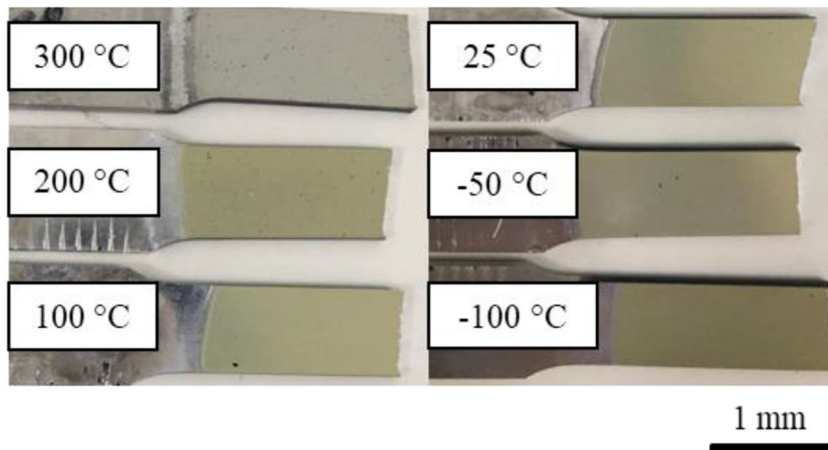
Fig. 20 Appearance of the AAO film at varying testing temperature

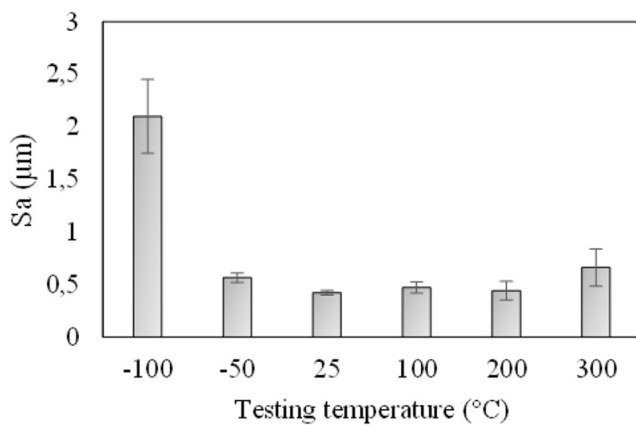
Fig. 21 Surface roughness at varying testing temperature

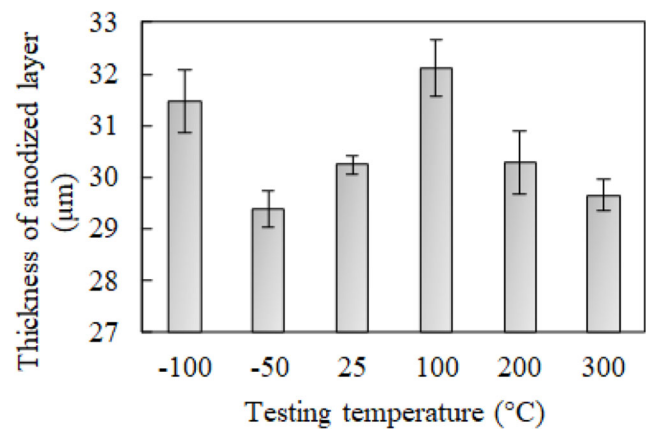
Fig. 23 Anodization coating thickness at varying testing temperature

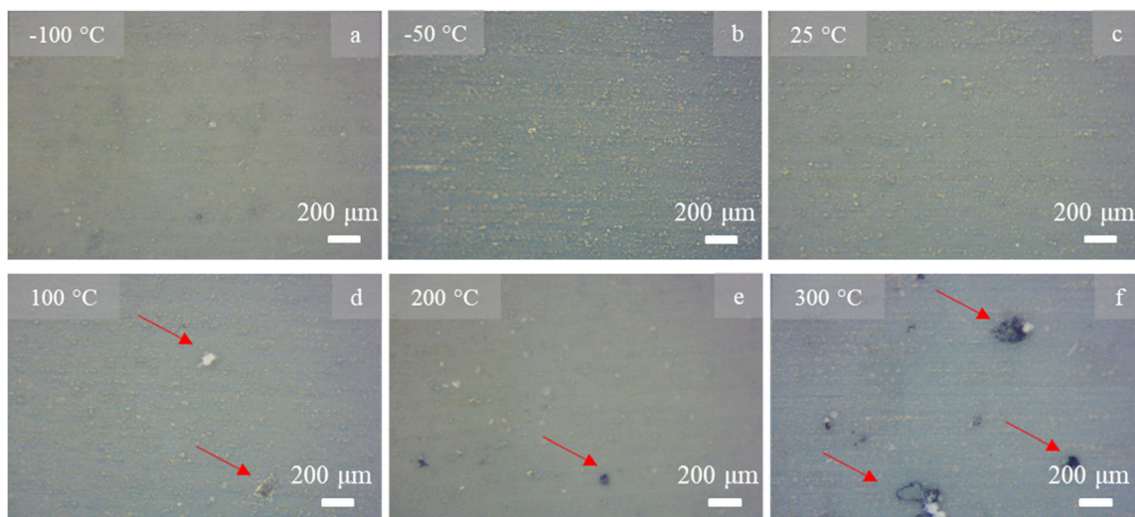
Fig. 22 Surface appearance of the AAO film at varying testing temperature: a) -100°C , b) -50°C , c) 25°C , d) 100°C , e) 200°C , f) 300°C

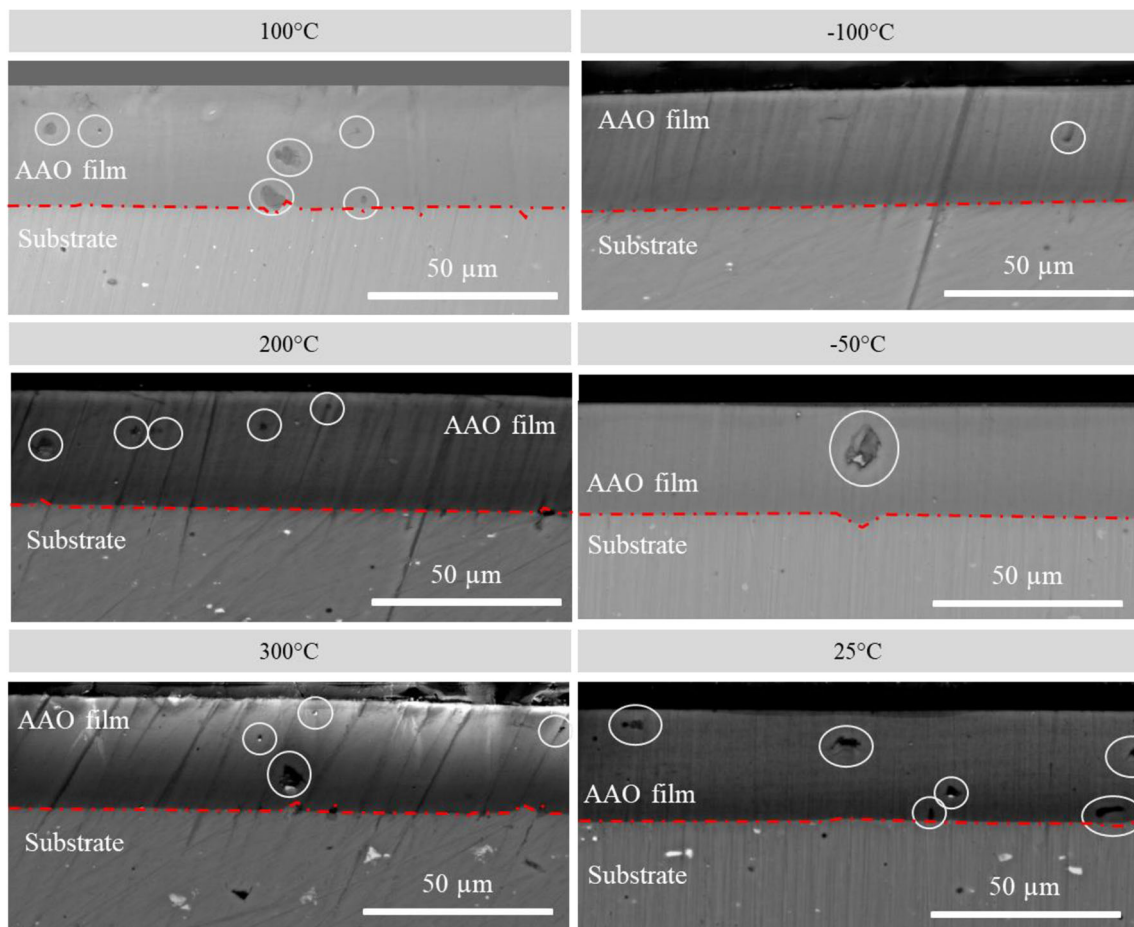
Fig. 24 SEM images of the cross-section of the AAO specimens at varying testing temperature

On the contrary, a closer observation of the images reported in Fig. 24 reveals the presence of defects whose size and

dimension depend upon the testing temperature. At increasing testing temperature, more defects characterized the AAO coating. In addition, in correspondence of the IMPs, irregularities or flaws appeared in the coating (see the dotted red lines that represent the interface between the substrate and the AAO film). The best coating quality pertains to the specimen deformed at -100°C , since an almost defects-free layer was formed.

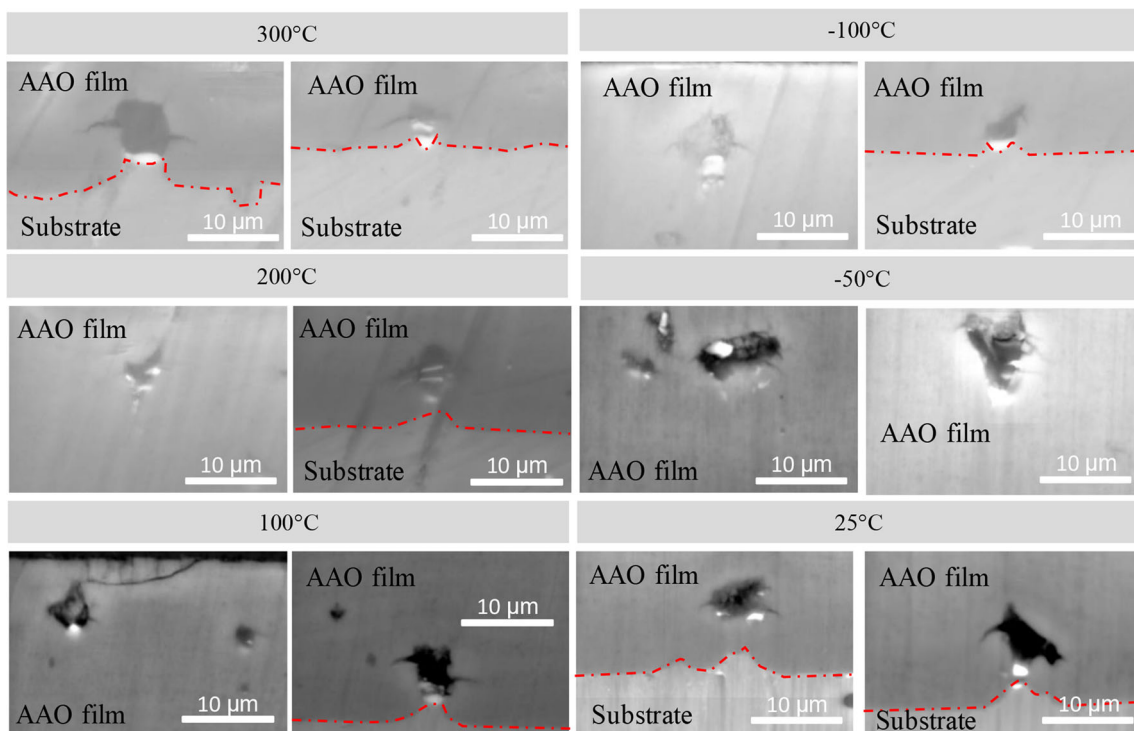
Fig. 25 Magnified SEM images of the defects present on the cross-section of the AAO specimens at varying testing temperature

Detailed investigation of the coating quality is reported in Fig. 25, which shows $\times 10,000$ magnified SEM images of the cross-section of the specimens at varying testing temperature. These images witness that the presence of IMPs played an

important role on the AAO film formation. In fact, to a particle entrapped within the film corresponds the formation of a concavity of the film interface when the particle is near the substrate, or the formation of cracks that can extend up to the surface when the particles are located far from the substrate.

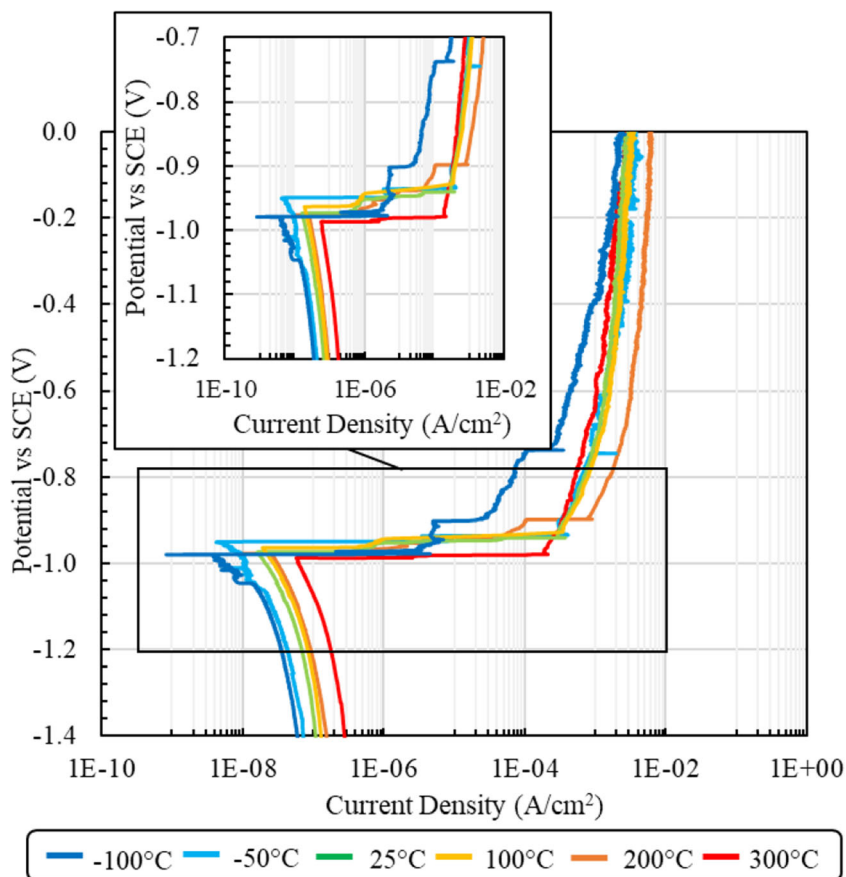
Fig. 27 Potentiodynamic polarization curves of the specimens after anodization at varying testing temperature

The corrosion resistance after anodization results strictly dependent upon the mechanical testing temperature as demonstrated in Fig. 27 and Table 5. As a matter of fact, different surface roughness, AAO layer thickness and density of defects within the AAO layer were noticed after mechanical deformation. In the following, the contribution of each of these factors in affecting the corrosion resistance is discussed in detail.

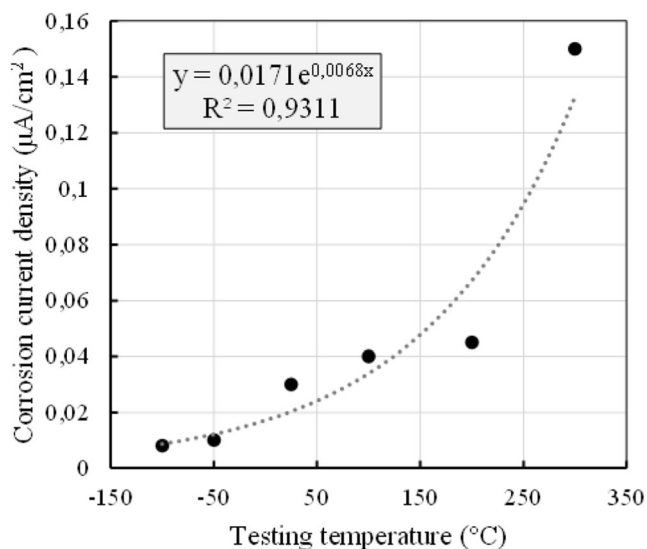
Fig. 28 Correlation between I_{corr} and mechanical testing temperature

Specifically, an exponential relationship was found to correlate I_{corr} and the mechanical testing temperature ($R^2=0.93$) and is shown in Fig. 28.

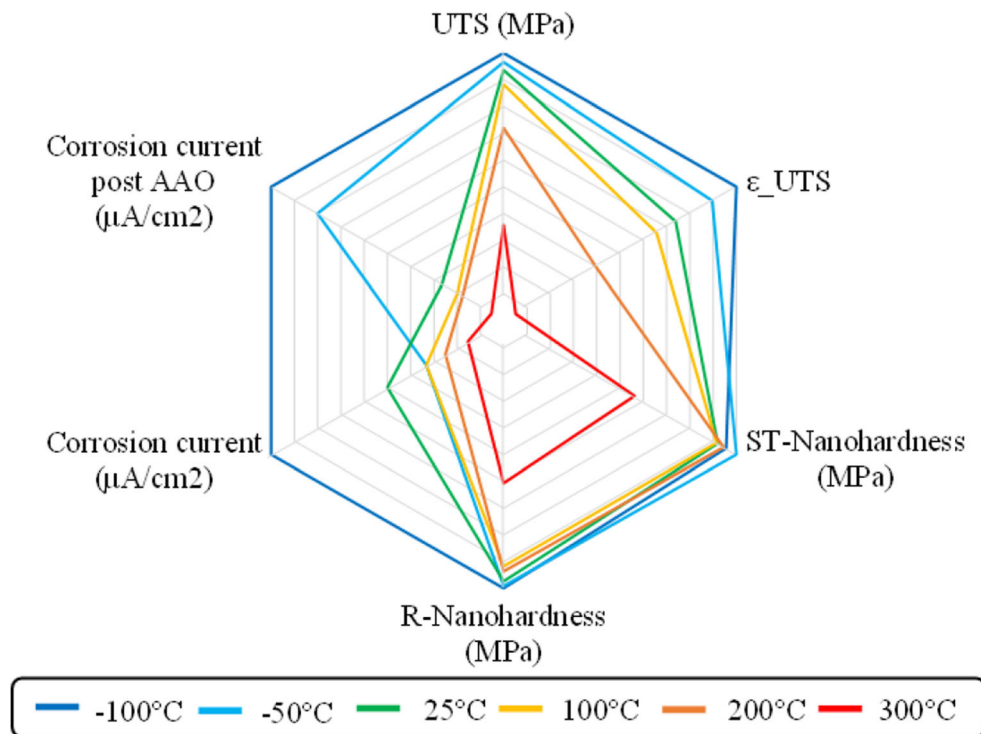
Fig. 29 Radar plots for the AA7075-T6 alloy characteristics at varying testing temperature

On the basis of these considerations, -100°C is the forming temperature that allows achieving the best performances, since its curves maximize all the considered variables. The worst performances pertain to the case of 300°C testing temperature, while the other temperatures lie in between.
