## **Erratum to: Stress examination of flexor tendon pulley rupture in the crimp grip position: a 1.5-Tesla MRI cadaver study**

## Erratum to: Skeletal Radiol DOI 10.1007/s00256-014-2002-7

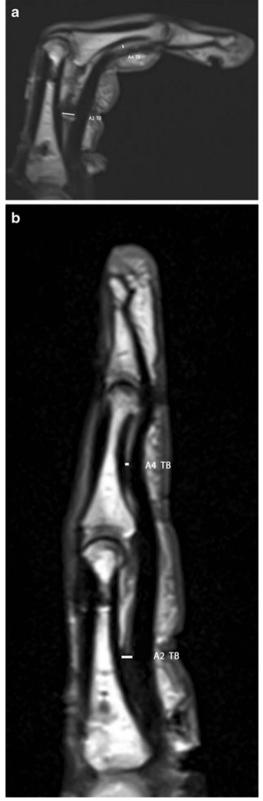
**Fig. 3** Single A2 pulley rupture **a** in the crimp grip position and **b** in the neutral position. A2 tendon bone distance (A2 TB) is augmented to 3.6 mm in the crimp grip position in comparison to 2.1 mm in the neutral position. A4 tendon bone distance (A4 TB) is not augmented

The original version of this article unfortunately contained error. Figure 3 was incorrectly captured, the correct Fig. 3 is shown below:
