Prospective study on magnetic resonance imaging in cochlear implant patients

Purpose Monocentric, prospective study to investigate whether concomitant support of cochlear implant (CI) patients by CI-trained otolaryngologists and application of a standardized head bandage can minimize potential complications during magnetic resonance imaging (MRI).

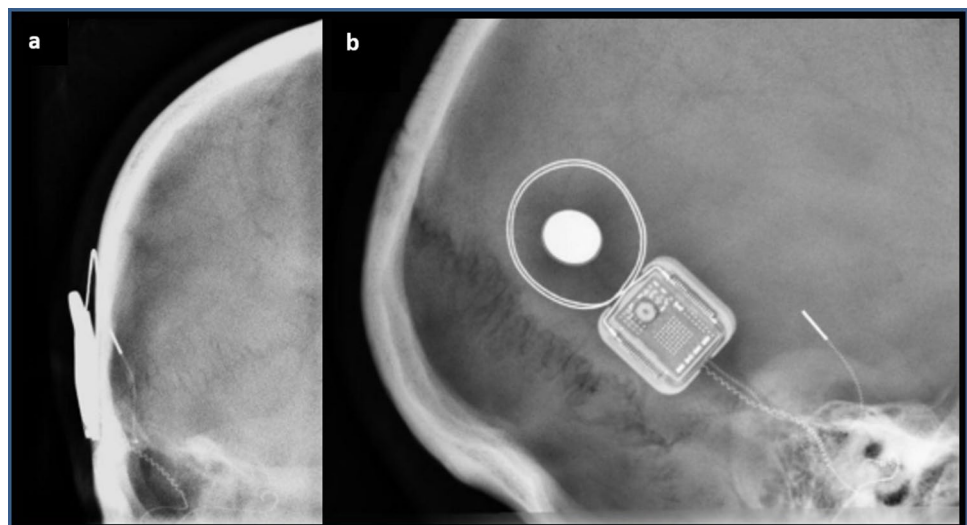
Fig. 3 Radiographs of suspected and later confirmed magnet dislocation. **a** Radiograph of the skull anterior–posterior to show the case tangentially. The tilt of the magnet can be seen in the image. **b** Skull X-ray laterally, looking at the case from above. An off-center position of the magnet in the coil area can be seen

Since the risk of dislocation of the internal magnet is twice as high in bilaterally implanted patients, the following evaluation refers to implanted ear by MRI. Within the scope of 37 MRIs with applied head bandages, 46 implants could be included in the evaluation. The overall rate of magnet dislocation in this study was 2.17% (1/46). If new generations of implants with self-aligning magnets (Synchrony and CI612) are excluded, as there is a high probability that no dislocation will occur, the rate increases to 3% (1/33). Displacement of the internal magnet occurred in one patient with a unilateral CI512. The head MR scan was scheduled at 1.5 T but had to be stopped after five minutes due to severe pain with a visual analog scale (VAS) score of 10 out of 10. A direct medical examination followed: a dislocated magnet could be felt under the skin above the coil. However, the patient initially refused imaging to confirm the diagnosis. Manual pressure was applied to the magnet and the swelling reduced. Five months later, the patient presented for a scheduled routine check-up, and again painful swelling around the coil was confirmed, which had already caused the patient's use of the CI to be severely restricted. This time the patient consented to imaging, which revealed a dislocation of the internal magnet (Fig. 3). Despite the offer of immediate revision, she agreed to revision one month later. The implant was preserved and wound healing was uneventful.

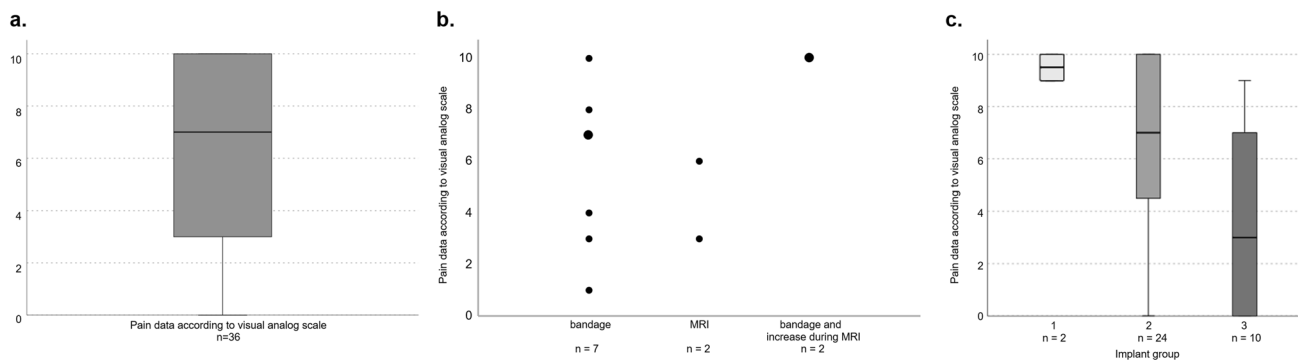
Fig. 4 **a** Boxplot for the results of reported pain in the total study group ($n=36$). **b** Scatter plot showing causes of pain during examination and individual pain data (mean 7, interquartile 5) in the 'amendment' group ($n=11$). Tightness of the dressing was reported as the main cause of pain. **c** Boxplot for the results of reported pain in the three categorized implant housing groups. 1 implants with ceramic

housings and magnets that do not align their poles in the MRI; 2 implants with silicone-titanium housings and magnets that do not align their poles in the MRI; 3 patients with silicone-titanium housings that align in the magnetic field during the MRI. Pain was significantly less in the third group

The mean VAS score for reported pain during the MR examination was seven, with a minimum of 0 and a maximum of 10. The interquartile range was seven (Fig. 4a). In five out of 36 cases (14%) the MRI was painless. In all other cases (86%), patients reported pain during the scan. In two cases, patients were even given oral painkillers during the preliminary interview because of the painful wrapping bandage. When it was realized that the bandage itself was causing significant pain, the questionnaire was extended. In an amendment dated 15/07/20, the question was added as to whether the pain could be explained by the head bandage, whether it occurred during the MRI, or whether both the head bandage and the MRI procedure caused pain. Eleven patients responded, and the following graph gives an overview of the causes of pain. In the majority of cases (7/11) the pain was caused by the tight bandage. The mean score for reported pain within this "amendment" group was also seven, with a minimum of one and a maximum of 10. The interquartile range was 5.0 (Fig. 4b).

Three groups were created to investigate the occurrence of pain according to the type of implant. The first two groups consisted of patients with non-rotating magnets, with implant group 1 consisting of a ceramic housing and group 2 consisting of a silicone-titanium housing. The third group was implanted with the newer generation of magnets (Synchrony, CI612). The Kruskal–Wallis test showed a significant difference in pain perception between the implant groups ($p=0.019$). The subsequent Bonferroni-corrected post hoc test showed a significant difference between group 2 and group 3 ($p=0.043$). The results for these three groups are shown in Fig. 4c. Patients with newer implant types and freely rotating magnets had significantly less pain during the study.
