Seismic performance of buried electrical cables: evidence-based repair rates and fragility functions

I. Kongar¹ · S. Giovinazzi² · T. Rossetto¹

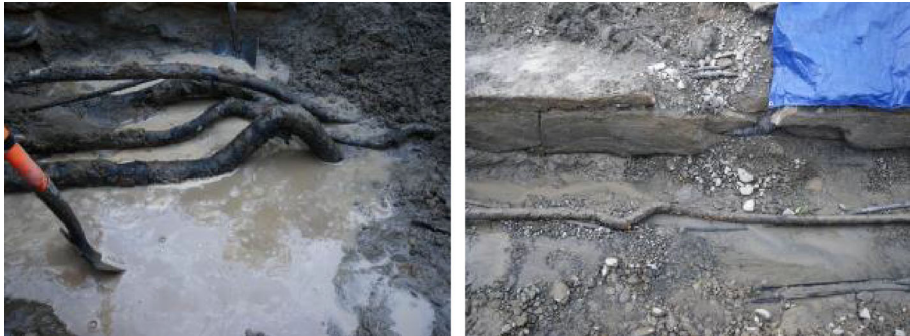
Fig. 2 Examples of typical curvature damage observed amongst buried cables due to the Canterbury earthquakes. Photos courtesy of Andrew Massie at the Christchurch Polytechnic Institute of Technology
