# A comprehensive review on structural tsunami countermeasures

**Keywords** Tsunami countermeasure · Hard countermeasure · Structural countermeasure · Tsunami mitigation · Extreme-wave events

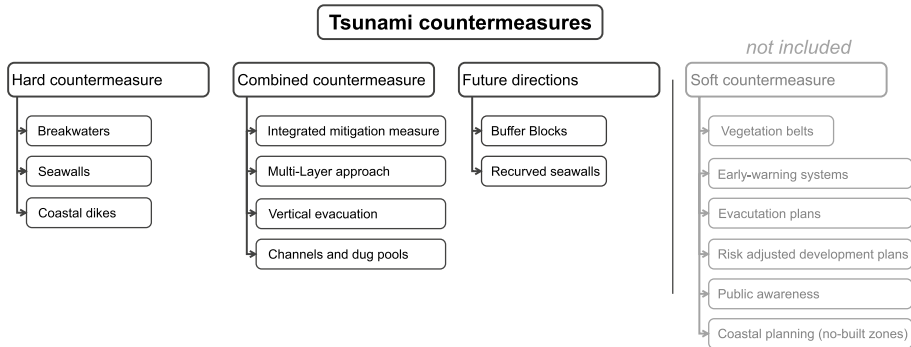
**Fig. 1** Broad classification of structural tsunami countermeasures

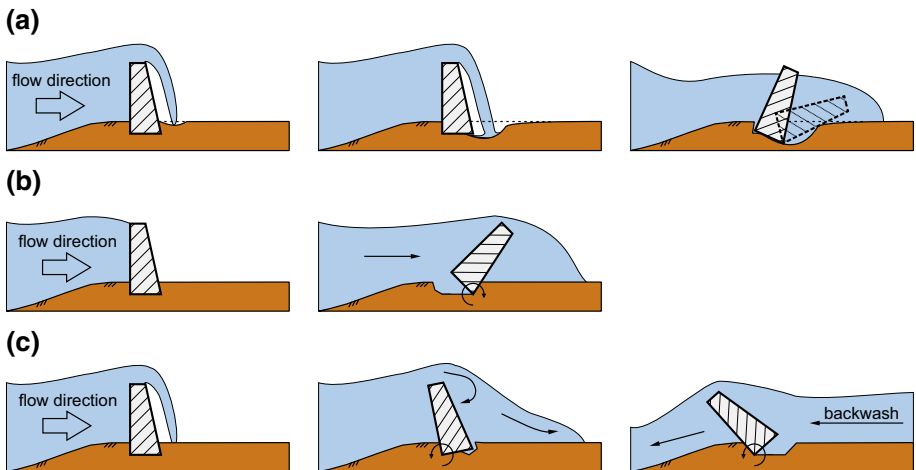
**Fig. 5** Typical tsunami-induced seawall failure. **a** Landward scour leads to seawall instability. **b** Tsunami impact forces lead to overturning. **c** The backwash current after overtopping leads to seaward overturning (modified and redrawn from Jayaratne et al. 2015)

Japanese seawalls were not designed considering wave overtopping as potential design criteria. Therefore, the leeward toe of the seawalls was not designed to resist destabilising erosional processes, which subsequently lead to overturning or sliding. However, even a failing seawall can possibly reduce the tsunami impact (Guler et al. 2018). In summary, Jayaratne et al. (2015) identified six main failure types of seawalls and sea dikes during field surveys in the aftermath of the 2011 Tohoku Tsunami, which are described in Figs. 4 and 5. It is stated that seaward toe scour was not often observed during the 2011 Tohoku Tsunami. However, this failure mechanism may occur during the backwash of a tsunami, destabilising the seaward dike armour (Fig. 5b; Jayaratne et al. 2015) as observed by Sundar et al. (2014) elsewhere. Whilst the tsunami impact on vertical walls/seawalls is broadly investigated (e.g. Asakura et al. 2003; Kato et al. 2012; Mizutani and Imamura 2000), the effect of preceding breakwaters is understudied as pointed out by Hanzawa and Matsumoto (2015).

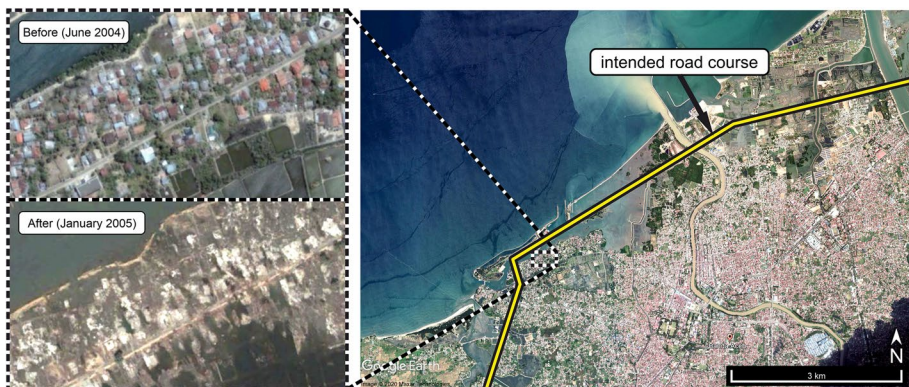
**Fig. 6** Intended course of the elevated road in Banda Aceh. Left: Consequences of the 2004 IOT in Banda Aceh (Satellite data composite from Maxar Technologies accessed through Google Earth Pro, vers. 7.3.4.8248)

Beside structures designed solely as mitigation measure against coastal erosion or tsunamis, they can also be integrated as part of infrastructure constructions. At the coast of Banda Aceh (Indonesia), it is proposed to construct a circuit road (Banda Aceh Outer Ring Road; BORR) intended to also act as tsunami mitigation measure (Syamsidik et al. 2019). During the 2004 IOT, the maximum tsunami height in Banda Aceh is estimated to be 15 m (Lavigne et al. 2009) and its impact resulted in a death toll of about 26,000 (Doocy et al. 2007). The BORR is planned to be constructed as an elevated road (3 m) as shown in Fig. 6 to act as a mitigation measure and shall be located behind the shoreline in Banda Aceh. Syamsidik et al. (2019) showed that the construction of the BORR may reduce the area of inundation by 8–22%, depending on the tsunami intensity, but also point to the possibility of damage (e.g. due to breaching) which needs to be examined further.

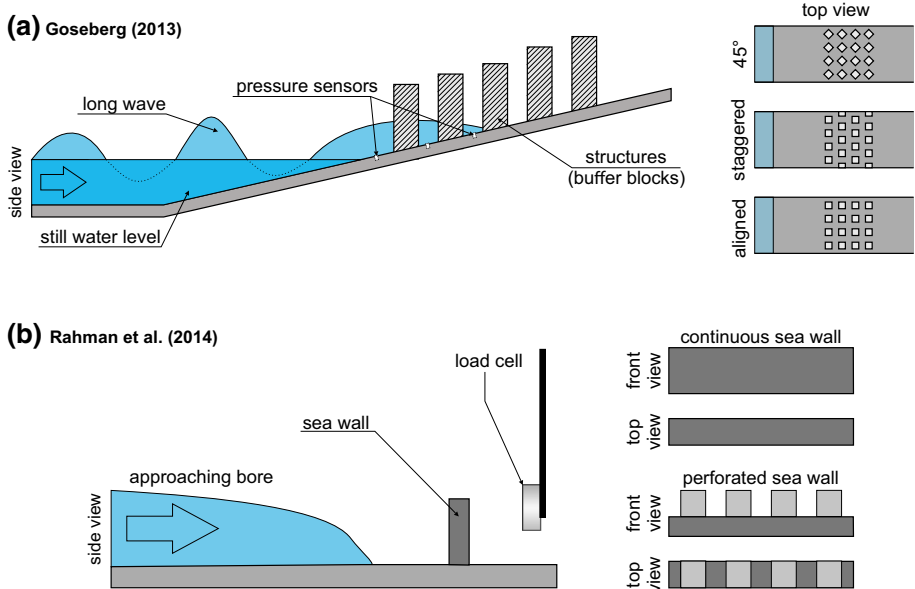
**Fig. 9** Simplified sketch of the laboratory experiments of Goseberg (2011, 2013; redrawn) and Rahman et al. (2014; redrawn). Goseberg (2013) shows that buffer elements can reduce the run-up significantly. In Rahman et al. (2014) the continuous seawall leads to a force reduction of 41% in the experiments, while the perforated seawall reduces the impact force by 35% of the case without any protection of the load cell

long waves mainly depending on element configuration (aligned, staggered) and wave direction. Goseberg (2011, 2013) focussed on the run-up reduction due to the presence of macro-roughness elements as buildings (referred to as coastal urban settlements), which are not fully submerged during the run-up, but did not consider the force reduction behind the macro-roughness elements (Fig. 9). The run-up reduction was mainly addressed towards momentum exchanges within the wave during the overflow of the macro-roughness elements, leading to the generation of higher turbulences. These preliminary findings support the use of buffer blocks for tsunami mitigation (Goseberg 2011, 2013). Similarly, Giridhar and Muni Reddy (2015) investigated the effect of different shapes of buffer blocks (rectangular, semi-circular, trapezoidal) installed over sloped structures to assess their effectiveness in the reduction of wave run-up and reflection. Rahman et al. (2014, 2017) investigated the performance of continuous seawalls of two different heights and one perforated seawall regarding wave impact attenuation. A dam-break setup and a load cell for investigating the bore impact were used. The load cell was installed behind the seawall to gain insights into the mitigation characteristics of these structures (Fig. 9). For continuous seawalls, the performance of higher seawalls built closer to a structure of interest led to the highest impact-force reduction on the structure of interest. Nevertheless, the perforated seawall exhibited a reduction in wave height and force of about 35% compared to no protection. Furthermore, the perforated seawall allows overtopping and backflow into the sea, resulting in decreased forces acting on nearby structures. The perforated seawall had the same total height as the continuous sea wall (8 cm) but is divided into a lower continuous section (3.8 cm height) and an upper discontinuous section (elements of 4.2 cm height). This results in material savings to an extent of about 25% with good attenuation characteristics.
