Wear Mechanisms of Hydrogenated DLC in Oils Containing MoDTC

Abstract Diamond-Like Carbon (DLC) coatings are well known for offering excellent tribological properties. They have been shown to offer low friction and outstanding wear performance in both dry and lubricated conditions. Application of these coatings for automotive components is considered as a promising strategy to cope with the emerging requirements regarding fuel economy and durability. Commercially available oils are generally optimised to work on conventional ferrous surfaces and are not necessarily effective in lubricating non-ferrous surfaces. Recently, the adverse effect of the Molybdenum DialkyldithioCarbamate (MoDTC) friction modifier additive on the wear performance of the hydrogenated DLC has been reported. However, the mechanisms by which MoDTC imposes this high wear to DLC are not yet well understood. A better understanding of DLC wear may potentially lead to better compatibility between DLC surfaces and current additive technology being achieved. In this work, the wear properties of DLC coatings in the DLC/cast iron (CI) system under boundary lubrication conditions have been investigated to try to underst

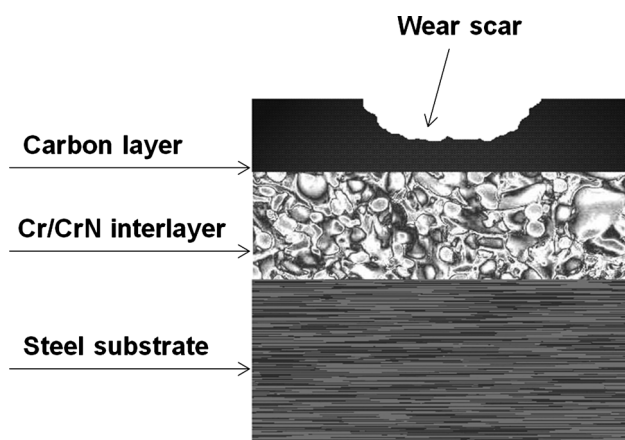
Fig. 1 Schematic diagram showing the cross section of the DLC-coated plate. The concentration of Cr, detected by EDX, is higher inside the wear track compared to outside

mapping obtained within the wear tracks showed the presence of carbon (C) and chromium (Cr). Chromium comes from the underlying CrN/CrC intermediate layer of the DLC coating. This could be used as a qualitative analysis of the extent of the coating wear. The higher the chromium intensity in the EDX maps, the greater the removal of coating thickness due to wear (Fig. 1).

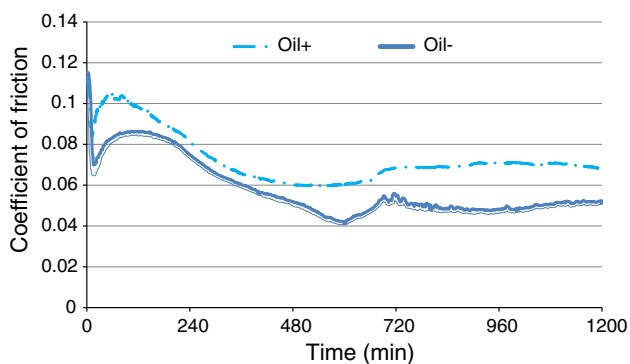
Fig. 2 Representative friction traces for Oil+ and Oil- oils over 20 h tribo-tests

A drop in friction was observed (Fig. 2) using both oils, but the addition of ZDDP to the oil (Oil+) resulted in higher friction values. Higher friction is consistent with what is seen in the literature for ZDDP-containing oils on steel surfaces [21]. Following long (20 h) tests, the friction response of the oils (see Fig. 2) was seen to vary with time. The friction coefficients, which initially dropped, started to rise again in the region of 10–12 h after the start of the tests. This increase of friction could be due to coating failure or/and its continuous wear. The changes in the interface due to wear could lead to the formation/depletion of the tribofilm on the interface. Thus, 12 h tests were conducted to provide a better understanding of friction behaviour and wear mechanisms of the oils on the DLC coating as a function of time. Also, 6 h tests were also conducted in the region where friction was still decreasing, and the coating was not suffering from severe wear which will be discussed later in this paper.

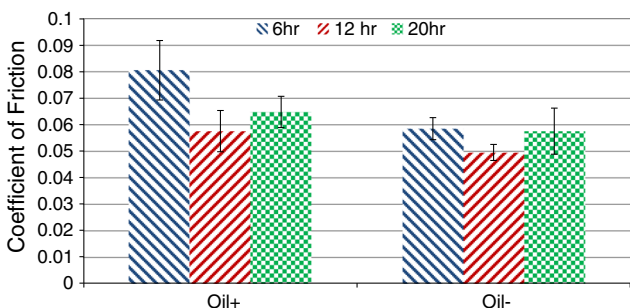
Fig. 3 Average coefficient of friction for the last hour of the tests as a function of oils at different time intervals for the DLC/CI system

Figure 3 shows the average coefficient of friction for the last hour of the tests for different time intervals using both Oil+ and Oil-. Overall, friction values were higher for Oil+ for all the time intervals, as expected [21]. Based on

the friction results, it is evident that friction values were generally lower for 12 h tests than 20 and 6 h tribo-tests.

Nevertheless, ZDDP in Oil+ raised the friction values compared to Oil- (see Fig. 3). This could be due to the

high wear of the DLC is shown to lead to a new interface (CrN/CI), and as a result increased friction at longer rubbing times (Fig. 3). This observation is in agreement with the friction results obtained by testing another type of DLC with CrN as an interlayer [23]. It appears that the rubbing process results in significant intensity change of Mo detected on the wear scar on both pin and coating (Table 3), resulting in carbon layer wear and friction increase. In addition, the formation and depletion of the tribofilm could be responsible for the changes observed in the friction response. It appears that reduction in friction in the DLC/CI system came at the cost of significant wear of the hydrogenated DLC. Furthermore, high wear of the DLC coating resulted in the transfer of the DLC's worn material to the CI pin. The presence of sp^2 carbon bonds in the DLC coating matrix provides them with inherently low-friction properties. Therefore, the transfer layer of the DLC coating, as evidenced by the XPS analysis, may consist of the low shear strength sp^2 -dominated graphitic carbon. Therefore, it appears that a combination of MoDTC-derived MoS_2 species along with DLC wear debris facilitated friction reduction for the DLC/CI tribocouple. This is in agreement with a recent study [24] where a mixture of additive- and DLC-derived products was found to be responsible for the tribological behaviour of the DLC/steel system. In Fig. 17, the mechanism of low-friction film formation on the DLC coating is schematically compared with that of the uncoated steel surface. Figure 17, shows that the friction reduction on the DLC surface is influenced by both the low-friction MoS_2 and the low-friction DLC wear debris whereas on the steel surfaces, low-friction MoS_2 species were the dominating factor for the friction performance [10].

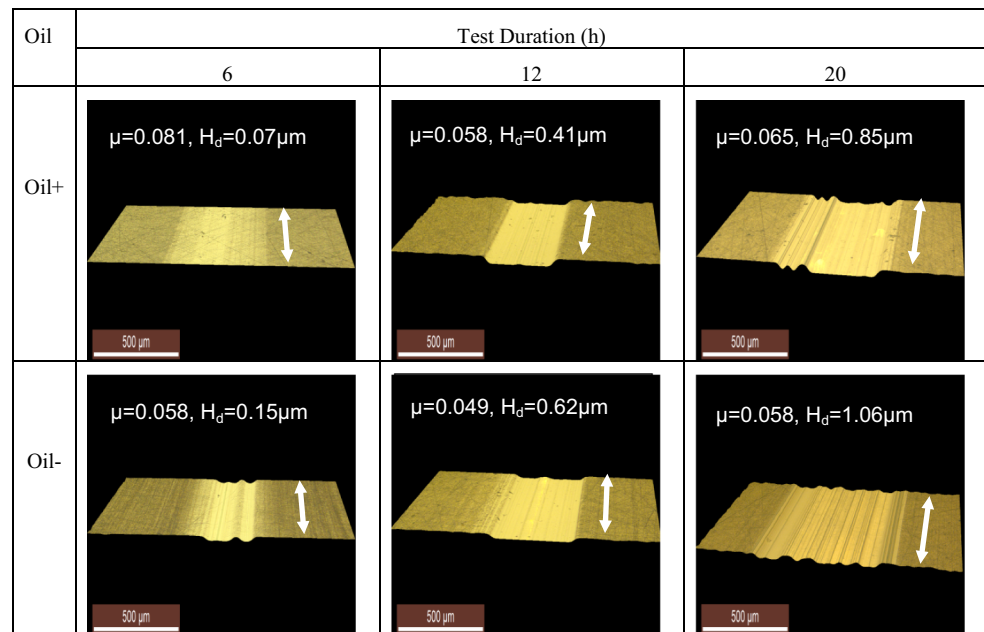
Fig. 4 Optical images of the wear scars formed on the DLC-coated plates using Oil+ and Oil-. The arrows on the images show sliding directions and μ and H_d are the coefficient of friction and the average depth of the wear track, respectively

Figure 4 shows representative images of wear tracks on the DLC coating after 6, 12 and 20 h, respectively. Based on the optical images, the colour of the coatings was brighter inside the wear tracks than outside. This suggests that the underlying Cr/CrN layers were exposed due to high wear. The average depth of the wear track (h_d) of the DLC coating for the highest obtained wear, provided by Oil-, was approximately 0.15 μm over 6 h test (see Fig. 4) while it increased to 1.06 μm when the duration of the test was 20 h.

Figure 13 shows a representative optical microscopic 3D image of the wear scar on the DLC coating when rubbed against ceramic when tested with Oil−. It is clear that using the ceramic counterpart, there was barely any measurable wear on the plate while high wear was seen using the same oil with CI pins (see Fig. 4).

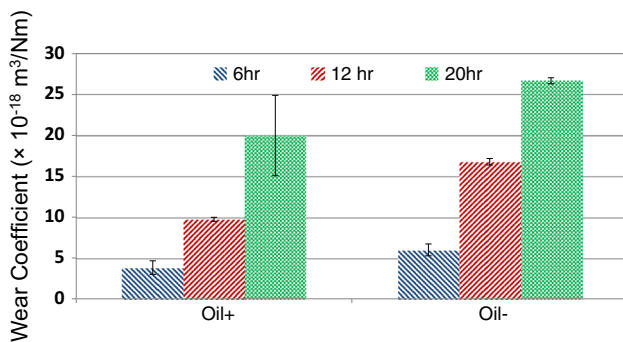
Fig. 5 Wear coefficient of DLC-coated plates as a function of oils at different time intervals for the DLC/CI system

The wear coefficients as a function of the test duration for the DLC/CI combination using the two oils are given in Fig. 5. For 6 h tests, the wear values for both oils were found to be relatively low. By increasing the test duration to 12 and 20 h, the wear rates given by both oils rose. However, Oil- promotes a faster wear increase than Oil+. This could be due to the positive effect of ZDDP in the Oil+ formulation.

formation of pad-like ZDDP tribofilms in Oil+ [21]. In addition, irrespective of the test duration, wear was always lower in Oil+ than in Oil−, as shown in Fig. 5.

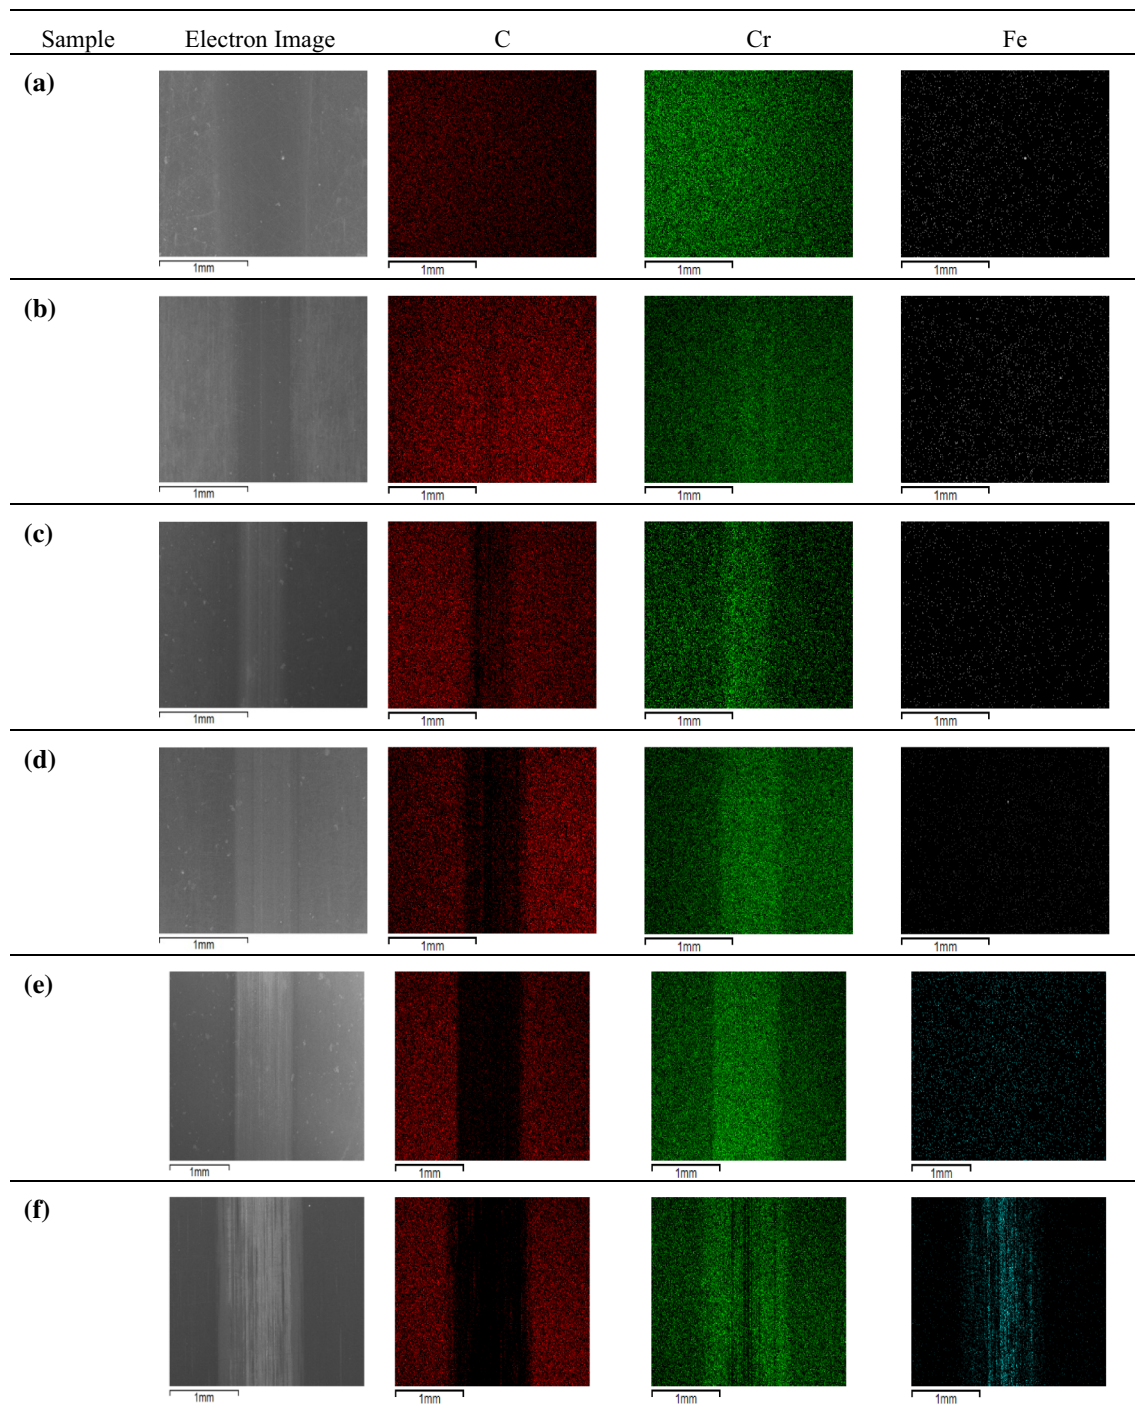
Fig. 6 SEM image of the DLC coating along with EDX mapping of the C, Cr and Fe atoms for: **a** Oil+ after 6 h, **b** Oil- after 6 h, **c** Oil+ after 12 h, **d** Oil- after 12 h, **e** Oil+ after 20 h and **f** Oil- after 20 h tribo-tests

To verify the observations from the wear results and the optical microscope images, EDX was carried out inside the wear scar. The representative Secondary Electron (SE) images of a section of the DLC coating wear scar along with EDX mapping of carbon (C), chromium (Cr) and iron (Fe) after 6, 12 and 20 h tribo-tests are shown in Fig. 6. In the case of Oil-, the chromium intensity increased inside the wear track (Fig. 6a, b), showing higher removal of the C layer of the coating after 6 h tests. This observation is in agreement with our obtained wear data and optical microscope observation where Oil- gave relatively higher wear to the DLC coating for 6 h tests. Fe was not detected using any of the oils confirming no delamination of the DLC coating after 6 h tribo-tests.

By increasing the test duration to 12 h, the intensity of carbon peak detected with EDX decreased, and chromium increased inside the wear scar as compared to outside, indicating wear of the C layer. Chemical element mapping shown in Fig. 6 confirms the presented wear data in Fig. 4, in which Oil- gave higher wear to the DLC coating after 12 h tribo-tests. Fe was absent from all regions inside the wear scar indicating that no delamination of the coatings or/and iron transfer from the CI pin to the DLC coating has occurred after 12 h of the tests using both oils.

Increasing the test duration to 20 h resulted in a higher intensity of chromium inside the wear track than outside, implying wear of the coatings for both oils after 20 h tests. In contrast to the analysis of 6 and 12 h samples, iron was detected in the EDX map of the DLC plate after 20 h tribo-test, when using the Oil- lubricant. This could be either due

For 6 and 12 h tests, using both oils, the absence of a Fe 2p peak in the tribofilm formed on the DLC coating indicates that no delamination of the coating occurred or/and that no iron coming from the pin wear particles participated in the tribofilm formation on the DLC surface. For 20 h tests, however, a Fe 2p peak was detected in the Oil- DLC wear scar, in agreement with the EDX analysis of the same sample shown in Fig. 6.

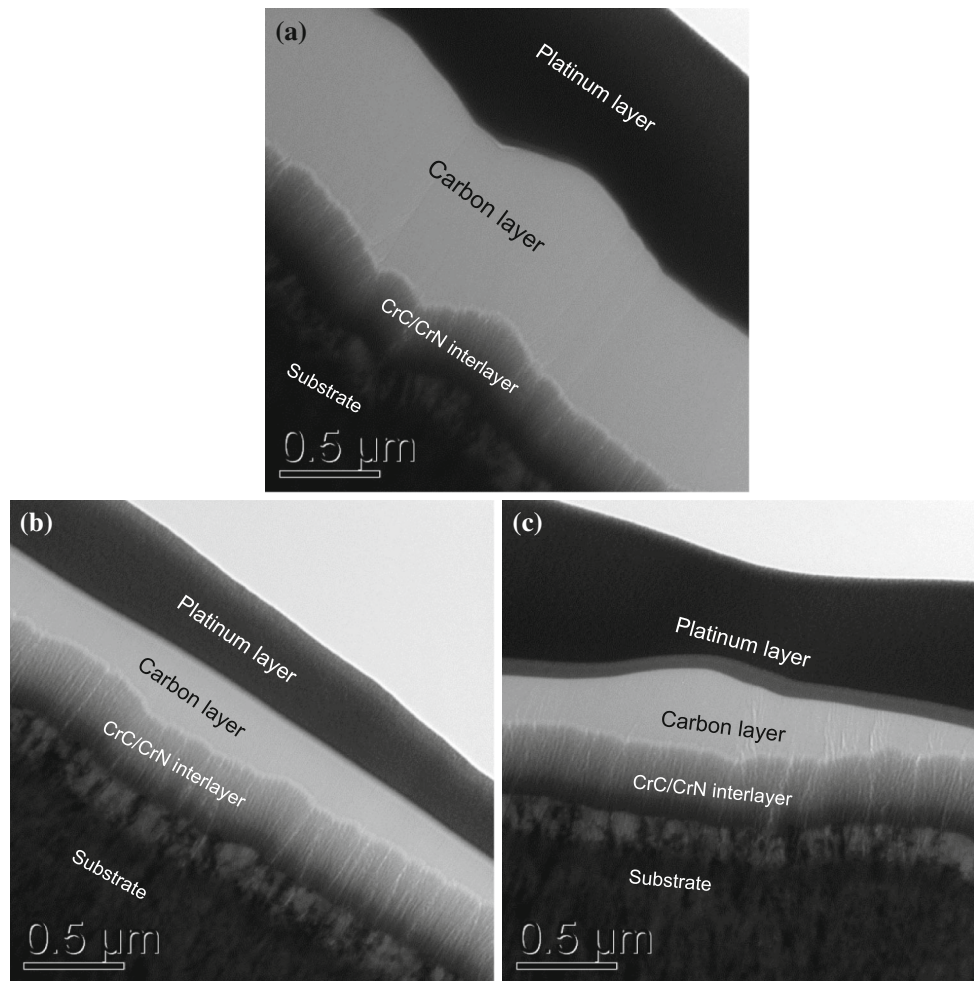
Fig. 7 TEM image of the: **a** as-deposited DLC coating, **b** worn DLC coating by Oil+ after 20 h DLC/CI tribo-tests and **c** worn DLC coating by Oil- after 20 h DLC/CI tribo-tests

For the DLC/CI contacts after 20 h tribo-tests, cross sections of a small area inside the DLC wear scar as well as the as-deposited DLC were exposed by FIB. Cross-sectional TEM images of the as-deposited DLC coating, worn DLC coating by Oil+ and worn DLC coating by Oil- are shown in Fig. 7.

Based on the TEM high-resolution images, the thickness of the as-deposited coating, including CrC/CrN interlayer, was seen to be around $2 \mu\text{m}$. It is also evident that using either Oil+ or Oil-, more than half of the top DLC layer (carbon layer) has been worn out after the 20 h tribological test (Fig. 7b, c). This is in agreement with the observations obtained from optical microscope, interferometer and EDX

mapping which showed that the DLC coatings have undergone severe wear after 20 h tribo-tests. Apart from sputtered platinum films on top of the carbon layer (DLC layer), which was thicker on the DLC sample for Oil-, no sign of any other film was observed on the DLC coating using either oils (see Fig. 7), showing that cleaning the samples in an ultrasonic bath before the analysis led to the removal of any potential tribofilm formed on the DLC coating surface.

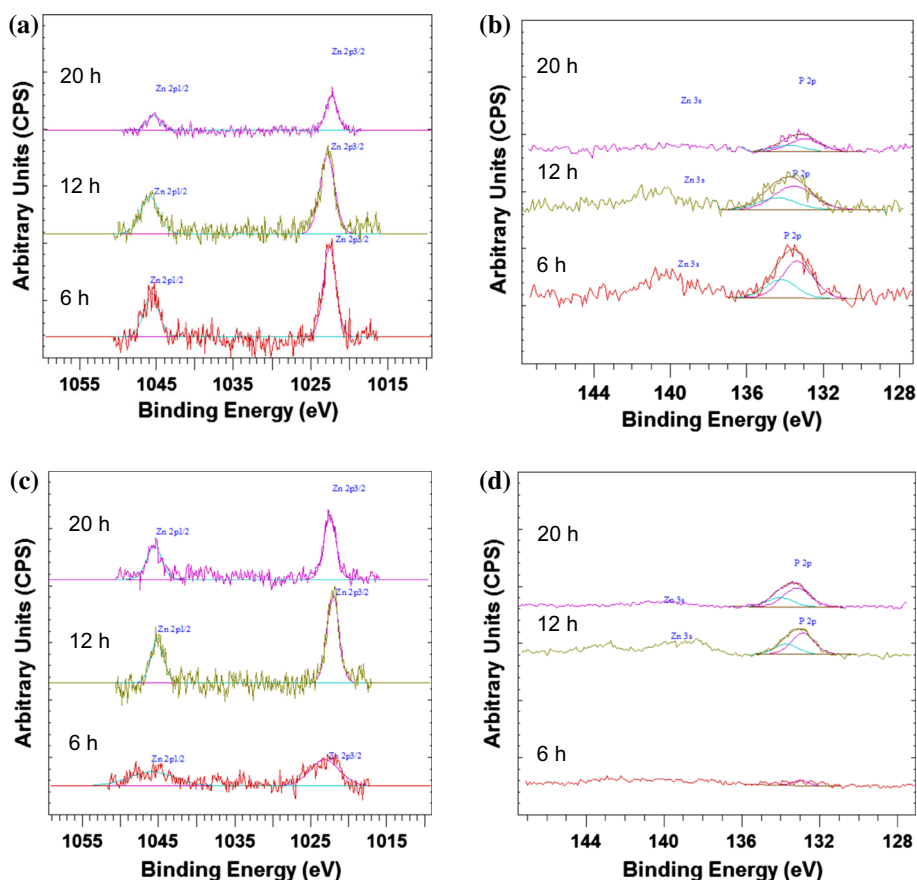
Fig. 8 XPS spectra of ZDDP-derived species **a** Zn 2p, **b** P 2p formed on the DLC-coated plate and **c** Zn 2p and **d** P 2p formed on the CI pin using Oil+ as a function of test duration

3.1.3.2 Anti-Wear Film Formation Figure 8 shows XPS spectra of ZDDP-derived species (Zn 2p and P 2p) formed on the DLC plate (a and b) and the CI pin (c and d) using Oil+ as a function of test duration. It is clear that using Oil+, irrespective of the duration of the tests, Zn phosphate and ZnS/ZnO species were formed on both the DLC surface and CI pins. The only exception was the tribofilm which

was formed on the CI pin after 6 h test using Oil+, which was mainly Zn-S-O compounds (BE = 1023.15 eV). It is, therefore, evident that despite the high level of Mo-FM which was blended in the Oil+, formation of phosphate films on the surface was not deterred.

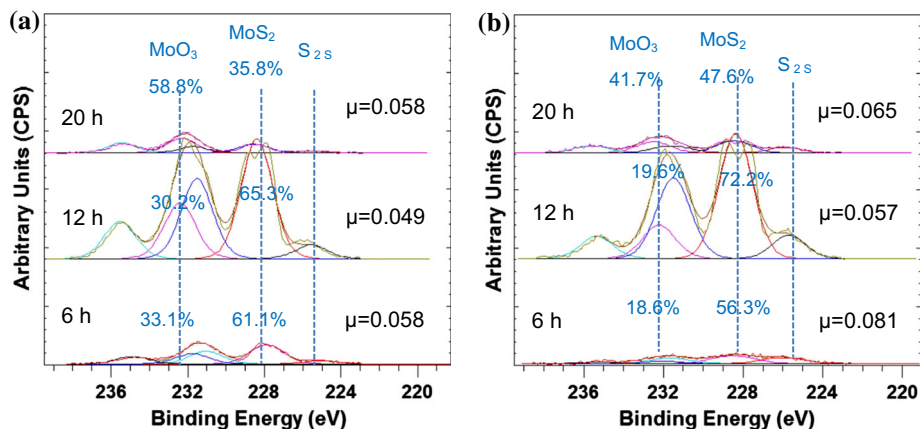
Fig. 9 Fitted Mo 3d peaks formed on the CI pins from **a** Oil− and **b** Oil+ as a function of test duration. The corresponding average steady state friction for each oil for all time intervals is also shown

Higher intensity of the Mo detected is an indication of a more MoDTC-derived tribofilm on the wear scar. Therefore, it appears that the tribofilm formed from these oils were richer in Mo (mainly consisting of MoS₂) after 12 h, but that MoDTC-derived species were depleted in the tribofilm after 20 h test. Qualitative and quantitative features of the Mo XPS peaks seem to correlate with the friction results (see Fig. 3), where lower friction values corresponded to large MoS₂ peak on the wear scar.

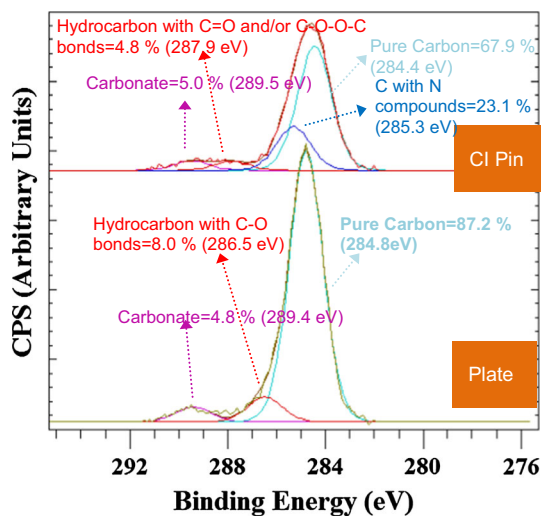
Fig. 10 Carbon species on the wear scar of the DLC coating and CI pins for the highest wear giving lubricants (Oil−)

The fitted carbon peaks for the higher wearing oil (Oil−) in the tribofilm formed on both the CI pin and the DLC plate after 12-h test are shown in Fig. 10. It can be seen that only a minor portion of carbon on the DLC coating was oil-derived oxygen-containing hydrocarbon species while a major part was detected to be pure carbon (graphitic) [20]. This could be due to the modification/graphitization of the DLC coating. High wear provided by the high Mo-FM concentration fully formulated oil resulted in transferring the DLC wear debris to the pin counterface. This is confirmed by the presence of graphitic carbon in the tribofilms formed on the CI pin. Furthermore, the higher detected oil-derived hydrocarbon species on the CI pin could be due to the higher reactivity of the ferrous counterbody with the

lubricant components as compared to the DLC coating. Therefore, it appears that DLC wear debris could also contribute to the friction reduction along with the additive-derived low-friction MoS₂ sheets [10].

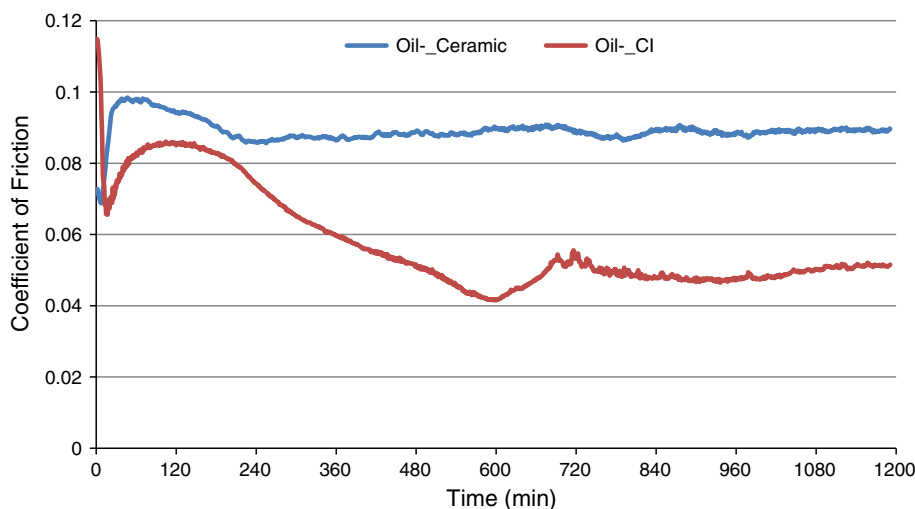
Fig. 11 Friction traces as a function of time using different counterpart on the DLC-coated plate lubricated in Oil–

Figure 11 displays the friction traces produced by the lower friction/higher wearing oil (i.e. Oil−) using two different counterparts when rubbed against the DLC coating. The friction trace for the DLC/CI system using Oil− is redrawn here for comparison purposes. Interestingly, using the same test parameters, no drop in friction was observed when the counterpart was ceramic while a significant friction reduction was evident using the CI pin.

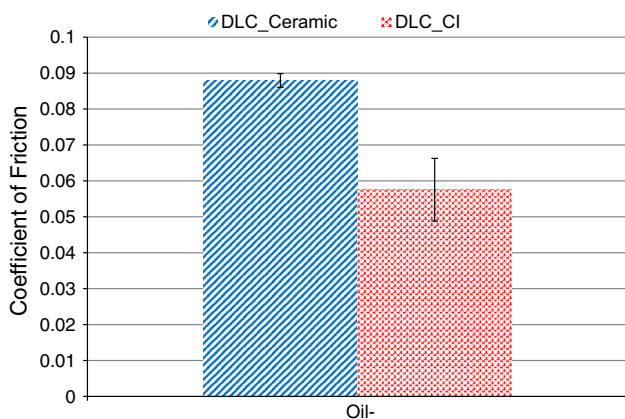
Fig. 12 Average coefficient of friction for the last hour of the tests as a function of Oil– using different counterpart materials on the DLC-coated plate. Standard deviation is obtained from three repeated tests

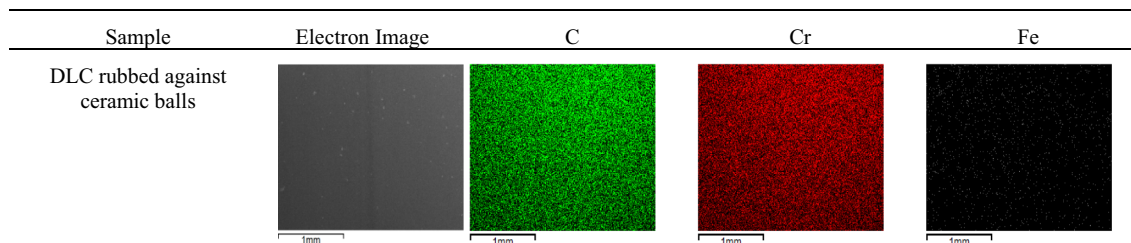
Fig. 14 SEM image of the DLC coating along with EDX mapping of the C, Cr and Fe atoms lubricated with Oil– using ceramic balls

EDX mapping of the DLC coating when rubbed against the ceramic counterpart is shown in Fig. 14. Based on the EDX mapping results, it is clear that using the ceramic ball, no difference in carbon or chromium intensity are seen comparing inside and outside the wear scar, confirming the

lack of noticeable wear on the coated plates when rubbed against ceramic balls.

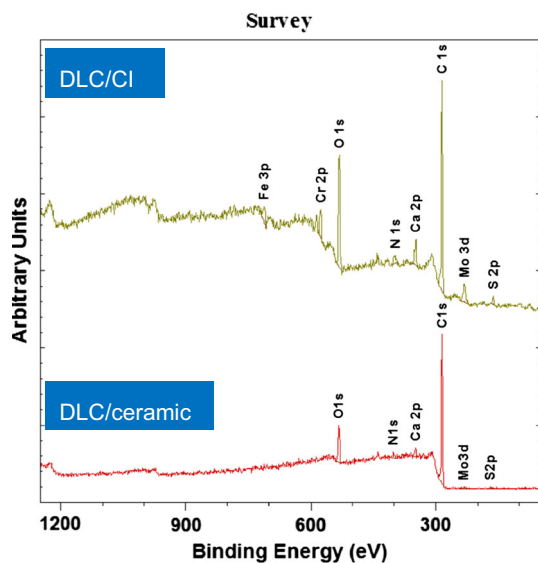
Fig. 15 Survey scan obtained from inside the DLC coating wear scar when rubbed against CI (*top*) and ceramic (*bottom*) using Oil–

XPS analysis was also performed on the DLC coating when rubbed against ceramic balls using the highest wear giving oil (Oil–). Figure 15 shows the survey scans of the DLC wear scar when rubbed against CI pins and ceramic balls. The XPS elemental quantification of the tribofilms formed on DLC wear scars (Table 4) shows that additive-derived elements were present in the tribofilm irrespective of the counterpart type. However, Fe 2p and Cr 2p peaks were only detected in the DLC tribofilm for the DLC/CI system suggesting severe wear/delamination of the DLC coating (20 h test using Oil–) only using cast iron counterpart.

It is clear that tribofilms formed on the coating were rich in carbon for both the DLC/ceramic and the DLC/CI system (see Table 3f), whereas a minor portion of the tribofilm is formed from the additives in the oil. More additive-derived elements were detected on the DLC in the DLC/CI system compared to the DLC/ceramic system. For instance, MoDTC decomposed and took part in the film formation on the DLC coating using both CI and ceramic ball. However, Mo 3d peak was more dominant in the tribofilm formed on the DLC coating when rubbed against CI (see Fig. 15).

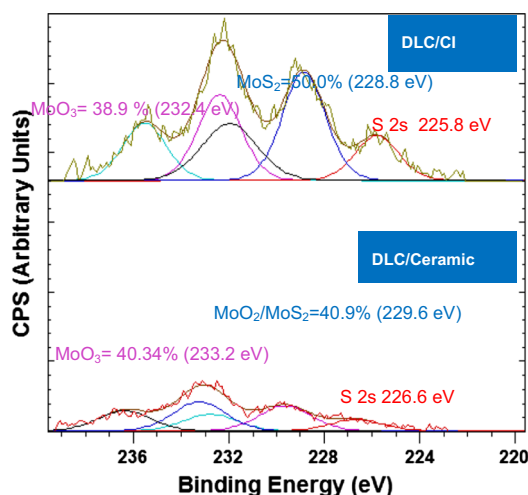
Fig. 16 Curve fitting of Mo 3d peaks obtained from tribofilm formed from Oil– on the DLC coating using CI pin (*top*) and ceramic ball (*bottom*)

Figure 16 shows the deconvoluted Mo 3d peaks obtained from the tribofilm formed on the DLC surface. It is evident that, for the DLC/CI, MoDTC-derived MoS₂ and MoO₃ formed on the DLC coating. In the case of the DLC/ceramic system, binding energy of 229.6 eV corresponds to formation of Mo⁴⁺ compounds such as MoO₂ or MoS₂ and binding energy of 233.2 eV corresponds to Mo⁶⁺ compounds such as MoO₃. Nevertheless, the amount of molybdenum compounds detected in the tribofilm of the DLC in the DLC/CI formed from Oil– is higher compared to the DLC/ceramic system.

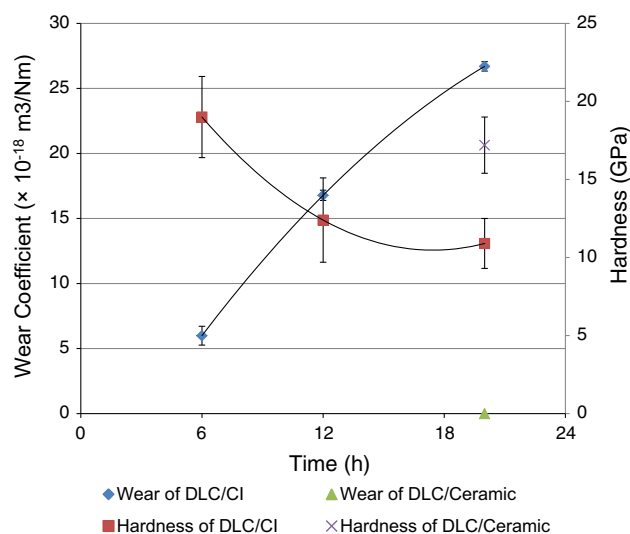
Fig. 18 Wear and hardness variation with time using DLC/CI and DLC/ceramic systems using Oil-

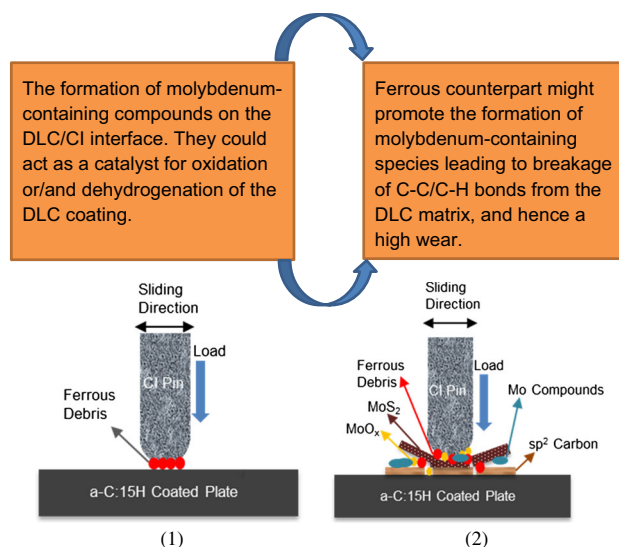
Fig. 19 Schematic diagram showing the MoDTC-induced wear mechanisms. (1) and (2) represent the first and the second stage of the proposed wear mechanisms

The mechanisms leading to low friction and high wear, induced by MoDTC in the DLC/CI system, are then proposed (schematically shown in Fig. 19) as follows:

1. Molybdenum-containing species (molybdates) formed under tribological conditions could act as a catalyst for oxidation or/and dehydrogenation of the DLC coating. This will eventually lead to high wear of the DLC coating.
2. Wear debris formed from ferrous counterparts (cast iron pins) can promote formation of molybdenum-containing species (i.e. iron molybdates) leading to a continuous process as described in point 1. The addition of ZDDP will potentially limit the formation

of these wear debris (and a reduced catalytic effect from the iron surface) or promote the formation of iron sulphides rather than iron molybdates leading to reduction of these molybdates and hence reduced coating wear.
