# Influence of Feedstock and Thermal Spray Process on the Phase Composition of Alumina Coatings and Their Sliding Wear

**Abstract** Suspension thermal spraying is an emerging coating technology that enables the deposition of dense-structured ceramic coatings. As wear resistance is a main application field of alumina ( $\text{Al}_2\text{O}_3$ ) coatings, this study aimed to evaluate the dry reciprocating sliding wear resistance of suspension sprayed high velocity oxy-fuel (S-HVOF) alumina coatings and to compare it with atmospheric plasma sprayed (APS) and HVOF coatings. Coatings were analyzed in the as-sprayed state and post-treated at 910 °C (hot isostatically pressed, HIPed) conditions. Wear tests were conducted using a tribometer, following the ASTM G133-02 standard and a sintered WC-6 wt.% Co ball as the counterbody. Coating characterization was done using scanning electron microscopy, x-ray diffraction and nanoindentation technique. Results indicate that the HVOF, HVOF-HIP and S-HVOF coatings had a high  $\alpha$ - $\text{Al}_2\text{O}_3$  content, whereas the APS and APS-HIP coatings had a high  $\gamma$ -phase content together with high porosity. Sliding wear resistance was

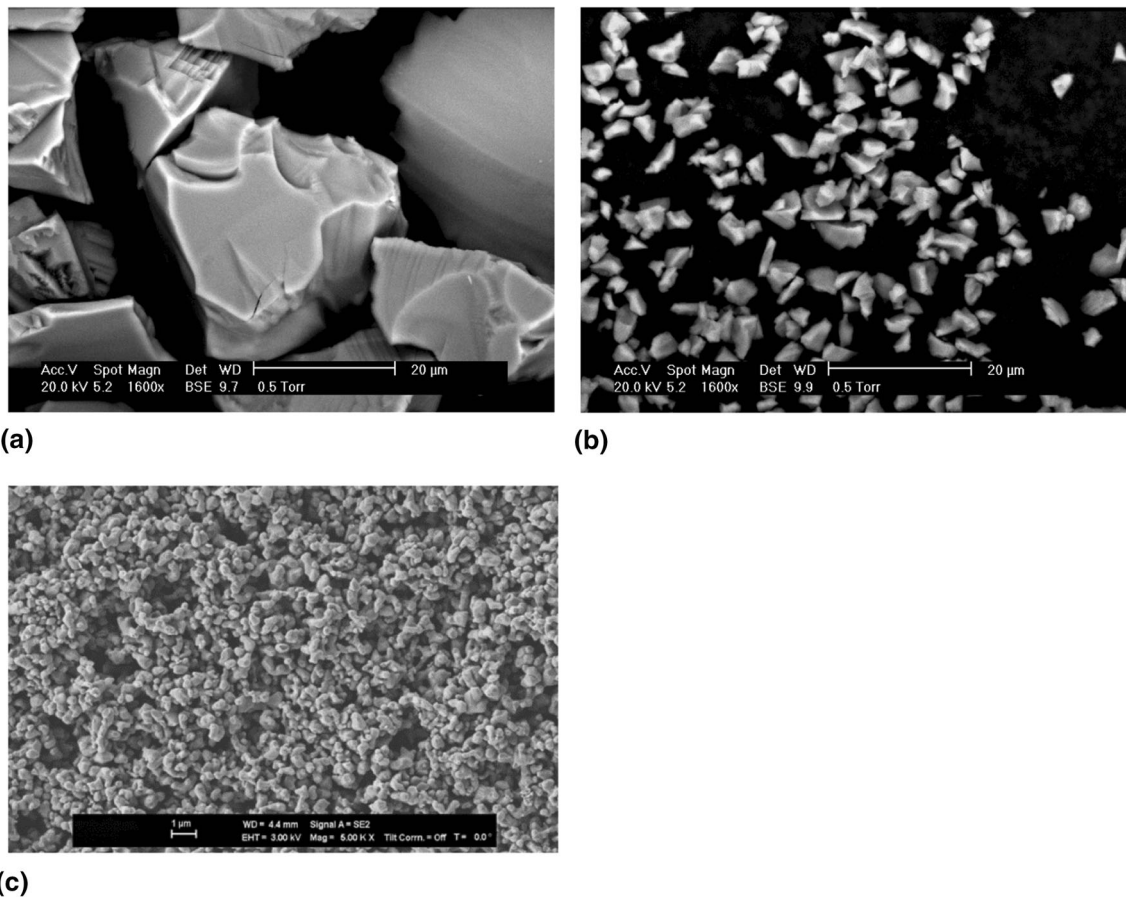
**Fig. 1** Al<sub>2</sub>O<sub>3</sub> feedstock powders and their particle size range (a) APS: 10-45 μm (b) HVOF: 1-5 μm (c) S-HVOF: 0.4-3.5 μm

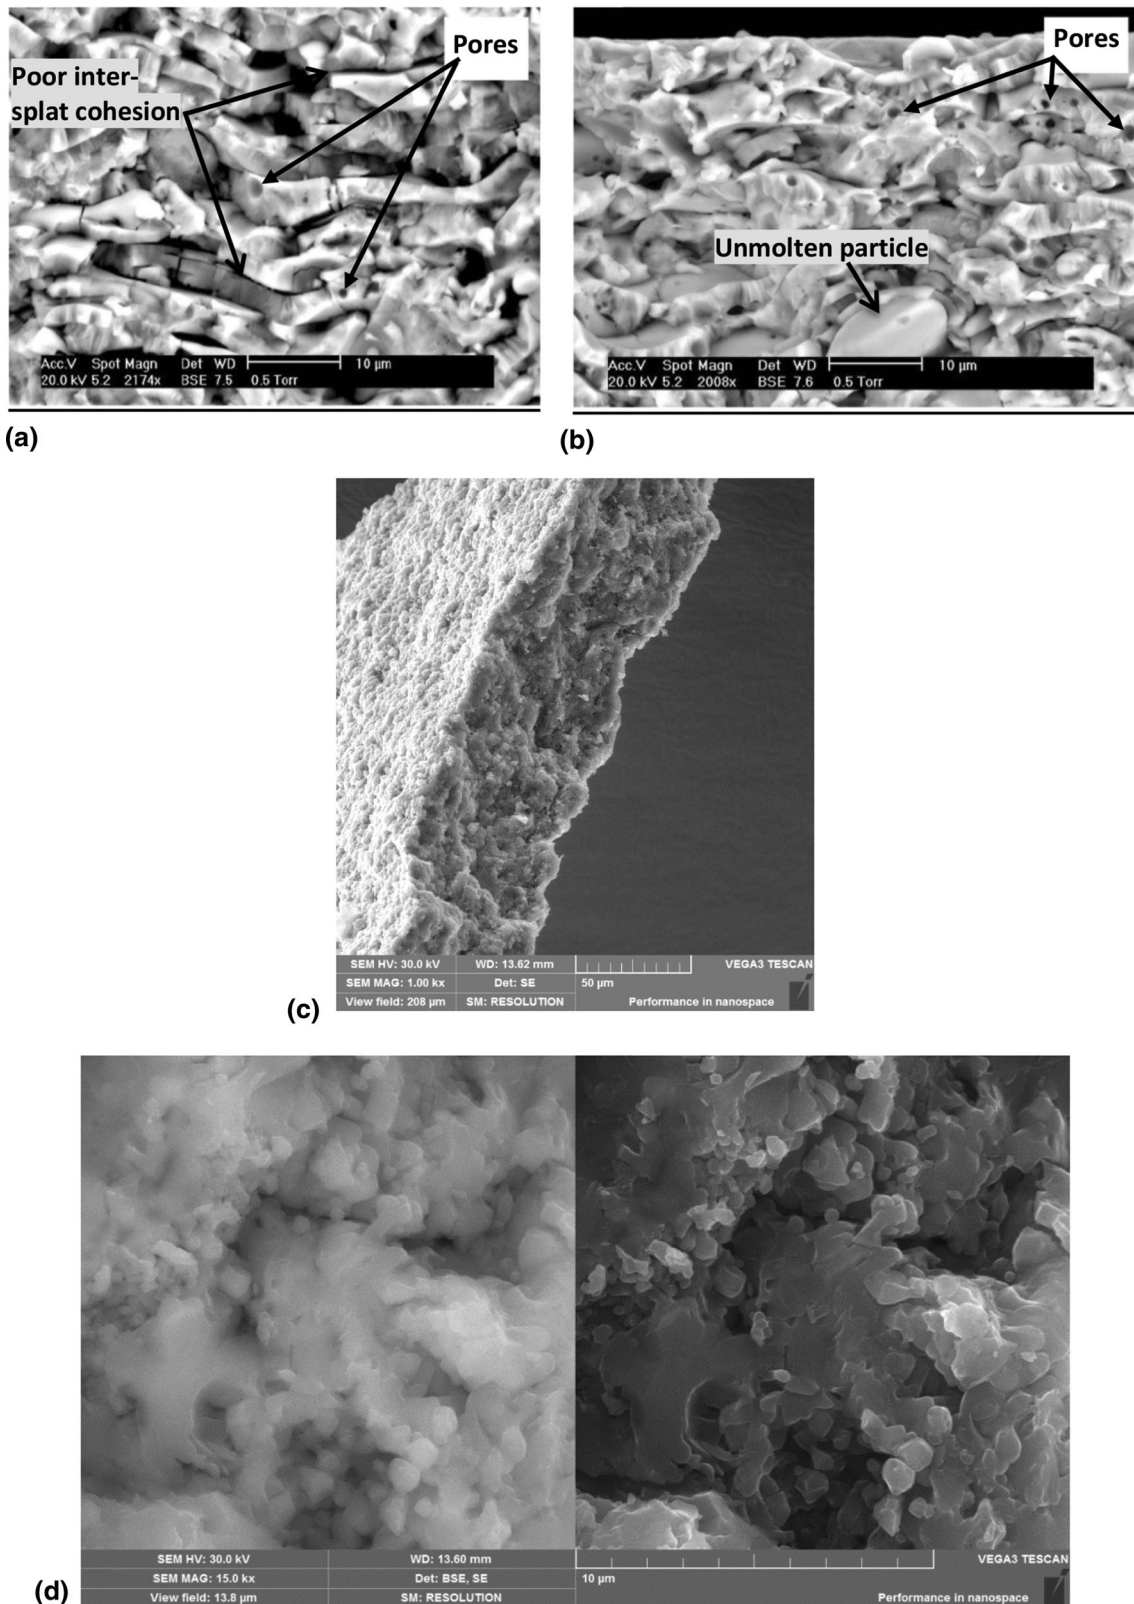
**Fig. 2** Fractured cross-sectional SEM micrographs of (a) APS (Ref 52), (b) HVOF (Ref 52), (c) S-HVOF low magnification, and (d) S-HVOF high magnification (BSE and SE mode, respectively). (a) and (b) reprinted from R. Ahmed, N. H. Faisal, A. M. Paradowska,

To reveal the lamella microstructure of the coatings, they were cooled in liquid nitrogen and fractured to visualize the intersplat morphology. Figure 2 provides the cross sections of the fractured APS, HVOF and S-HVOF coatings. The APS and HVOF coatings show distinct intersplat boundaries, whereas the S-HVOF coating shows a much finer nodular structure (Fig. 2d). Figure 3 shows the polished cross-sectional micrographs of the as-sprayed and HIPed coatings. There was evidence of crack formation within the coating microstructure due to thermal stresses and particle sintering after HIPing. Surface cracks were observed in all HIPed coatings, and subsequent grinding and polishing of samples was conducted, which resulted in their lower thickness than their as-sprayed counterparts. The extent of grinding and polishing required for the APS-HIP coating was extensive, resulting in a significant reduction in coating thickness. Some vertical cracks were visible in the HVOF coating after HIPing, as shown in Fig. 3(d). The S-HVOF coating showed intensive microcracking after HIPing, as shown in Fig. 3(f), leading to partial delamination of coating segments between cracks. Higher magnification SEM observations of coatings are shown in Fig. 4.

The APS coating’s microstructure has relatively high porosity (Fig. 5) and poor inter-splat bonding compared to the other as-sprayed coatings (Fig. 2a, 4a). The HVOF coating, as observed in Fig. 2(b) and 4(c) has relatively higher inter-lamellar cohesion than the APS coating, which is observable by the distinctness of the horizontal cracks present in both coatings (Fig. 2), and attributed to the high impact velocities and lower temperature of the HVOF spray process. Occasionally, unmolten particles can also occur, as shown in Fig. 2(b). The S-HVOF coating, on the other hand, has a very different microstructure. The powder particles have fused together to form a dense structure with no evidence of intersplat cracking (Fig. 2d), which agrees with the results from Toma et al. (Ref 16, 70, 71). The APS and HVOF coatings’ splat thickness is similar in size despite the feedstock powders having large differences in size. This is due to a combination of factors such as the in-flight temperatures and impact velocities, where particle temperature is generally higher and velocity lower in APS compared to HVOF spraying (Ref 76).

above 80 wt.%, confirming the results reported in earlier studies (Ref 72–74). However, the microstructure in Fig. 2(b) does not show an unusual amount of unmelted particles, which might be expected from the XRD result (Fig. 6 and Table 4). The  $\alpha$ -Al<sub>2</sub>O<sub>3</sub> content in the S-HVOF coating is consistent with previous studies in suspension spraying of alumina coatings (Ref 46, 71).

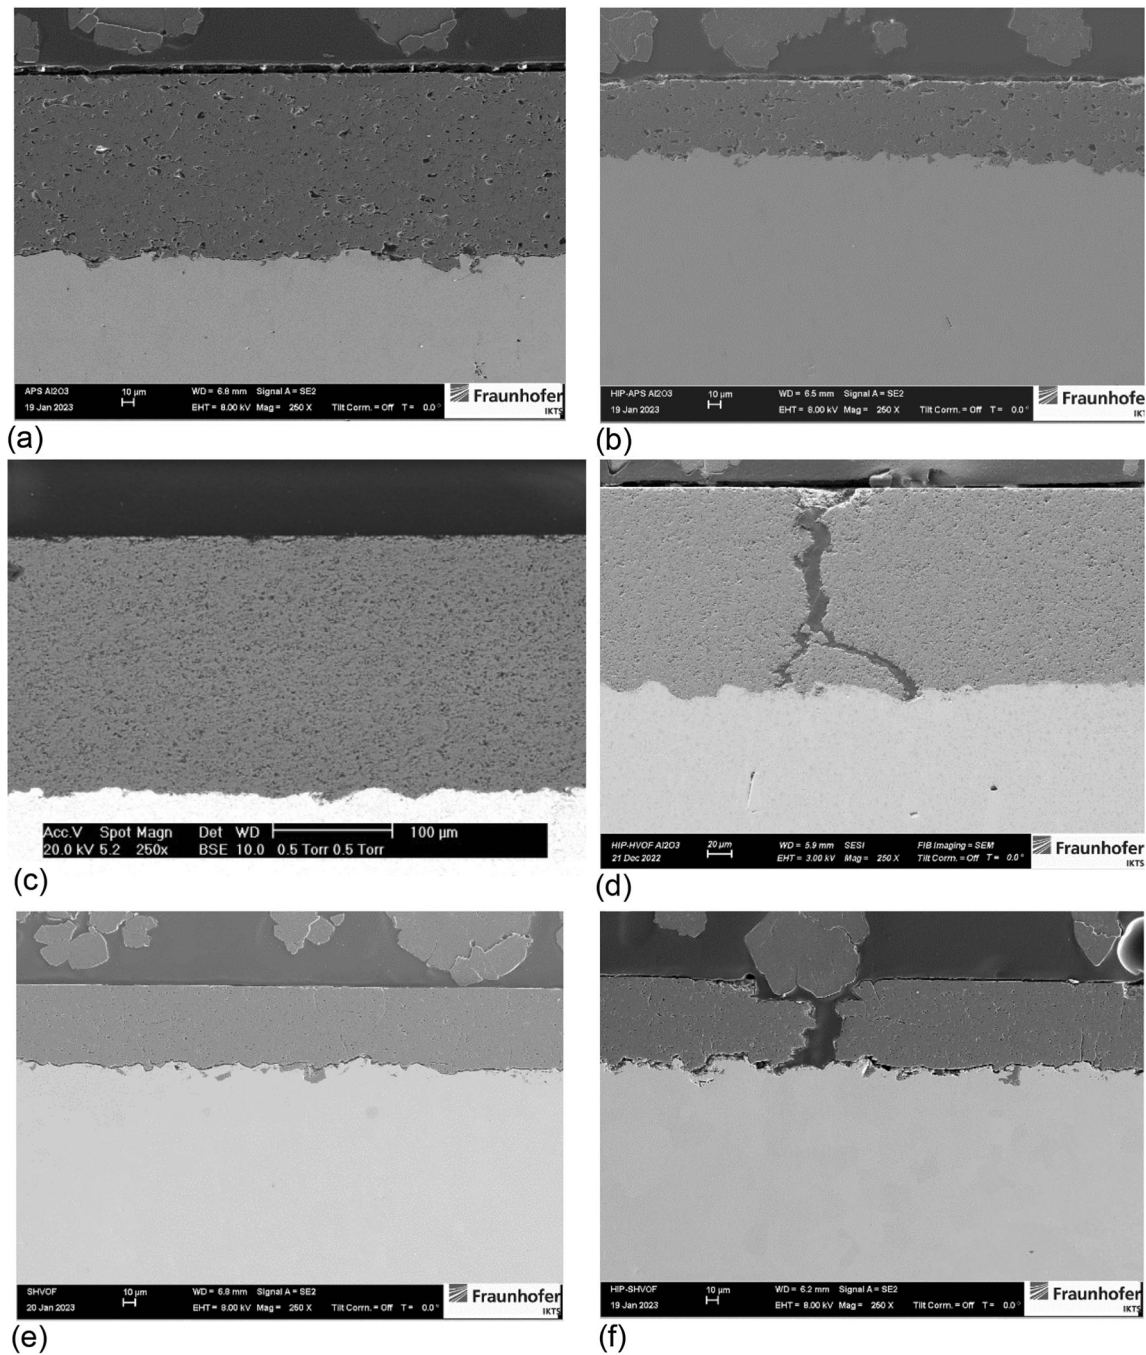
**Fig. 3** Polished low magnification cross-sectional SEM micrographs of coatings, as-sprayed and after HIPing post treatment (a) APS, (b) APS-HIP, (c) HVOF, (d) HVOF-HIP, (e) S-HVOF and (f) S-HVOF-HIP

The cross-sectional images shown in Fig. 3 indicate that HIPing post-treatment caused a varying degree of microcracking in the coating microstructure. During the HIPing post-treatment, microcracking led to the delamination of parts of the coating for the S-HVOF-HIP coating (Fig. 3f). Vertical cracking was also observed in the case of HVOF-HIP coating (Fig. 3d, 9e(1)); however, no coating delamination was observed in this case. In the case of APS-HIP coatings, despite significant surface cracking which was removed by grinding leading to a significantly lower coating thickness (Fig. 3b), no coating delamination was observed after HIPing. As the HIPing conditions of heating/cooling rate and the hold time were the same for all coatings, the residual stresses caused by the mismatch of thermal expansion of the coating and substrate material could induce relatively more significant cracking in the case of the relatively dense structure of HVOF-HIP and S-HVOF-HIP coatings (Fig. 2). The relatively poor intersplat bonding (Fig. 2a, 4a, b) and higher porosity (Fig. 5) in the case of APS coatings, provided a stress relaxation mechanism to avoid coating delamination during the

As discussed above, after HIPing, all coatings cracked (Fig. 3), and hence any build-up of residual stress during this post-treatment was released by the onset of cracks. The APS-HIP coating cracks were near-surface and removed by grinding and polishing before sliding wear tests. Hence these cracks are not observed in Fig. 3(b). Although the severity of cracking after HIPing varied between the three coatings, it would not be possible to experimentally measure the *in-situ* evolution and build-up of residual stress during high temperature HIPing treatment, prior to cracking, using existing destructive and non-destructive measurement techniques (Ref 79). Experimental residual stress measurement of cracked HIPed coatings would be misleading, as delamination and cracking of coatings would release stress. However, it is possible to approximate the build-up of residual stress prior to cracking using mathematical models based on the difference in the coefficient of thermal expansion, as initially proposed by Gill (Ref 80). The in-plane thermal residual stresses produced in a thin coating attached to a thick substrate can be approximated using the difference in the coefficient of thermal expansion (CTE) of the coating substrate system (Ref 78).

of the extent of cracking after HIPing, as indicated in Fig. 3, 4.

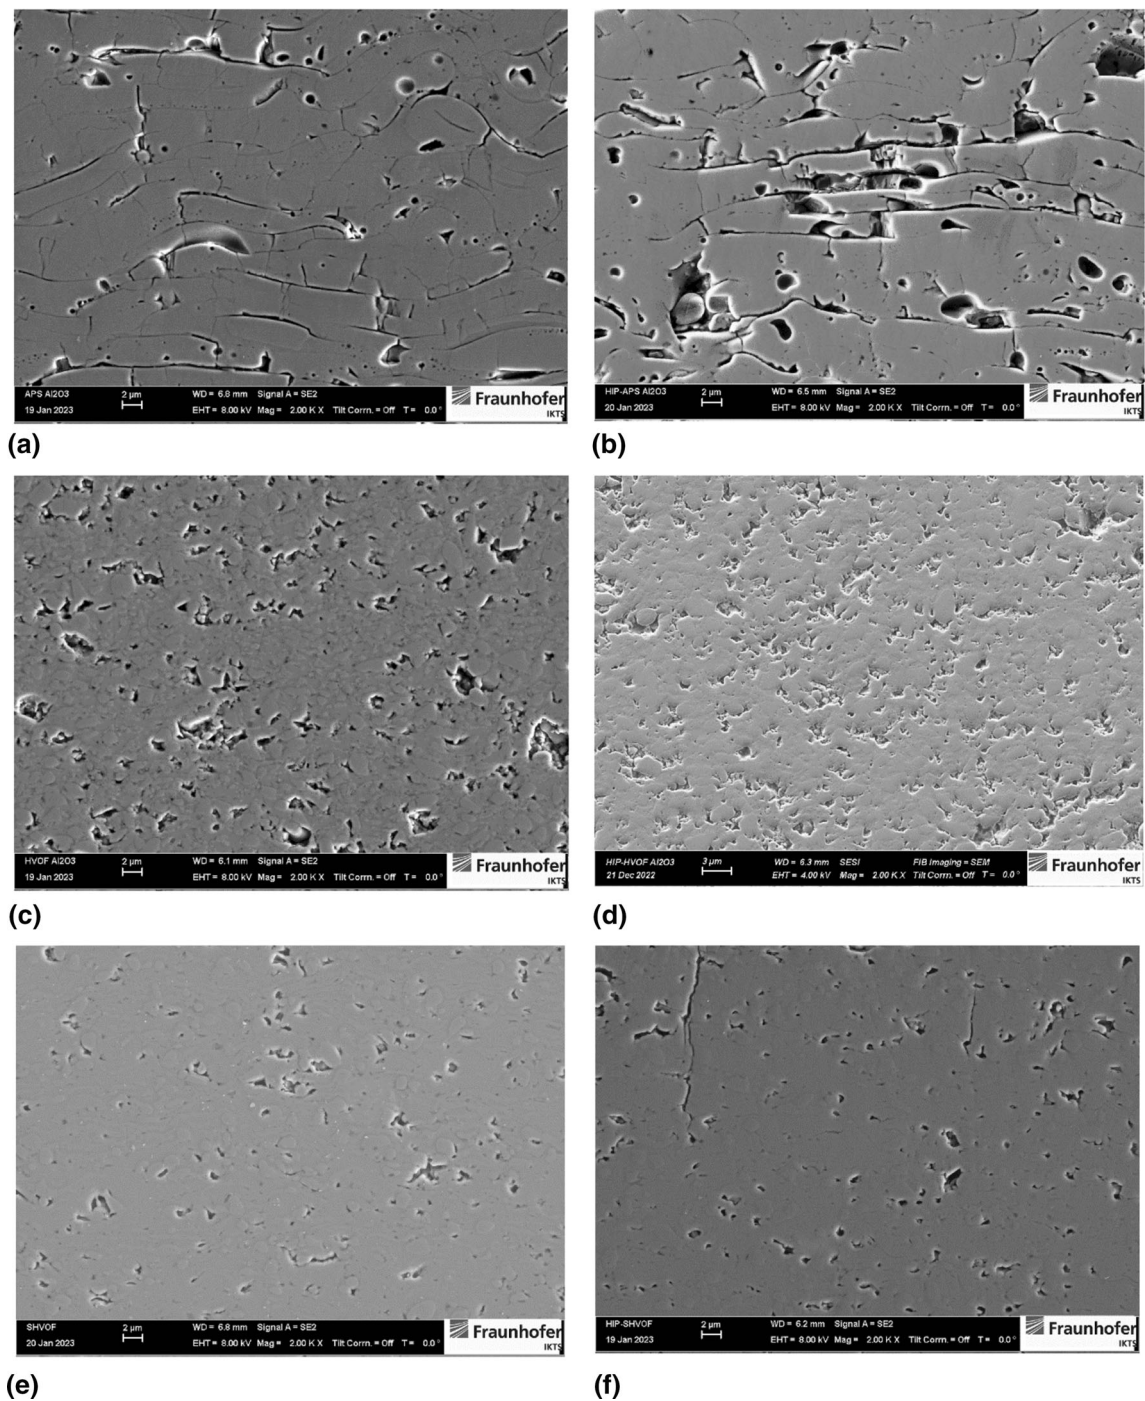
**Fig. 4** Polished cross-sectional SEM micrographs of coatings (a) APS, (b) APS-HIP, (c) HVOF, (d) HVOF-HIP, (e) S-HVOF and (f) S-HVOF-HIP

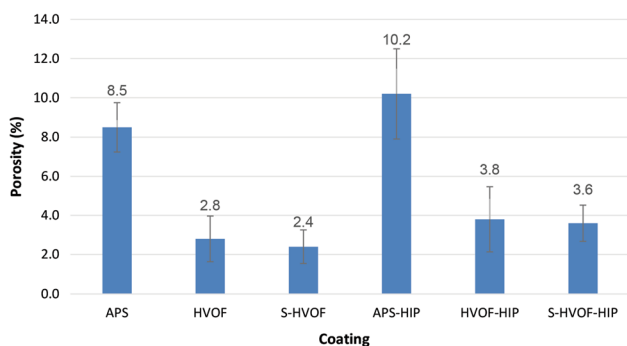
**Fig. 5** Porosity analysis of as-sprayed and HIPed coatings—the porosity in HIPed coatings was determined in areas without any cracks

Averaged porosity values of the as-sprayed and HIPed coatings are summarized in Fig. 5. The average porosity

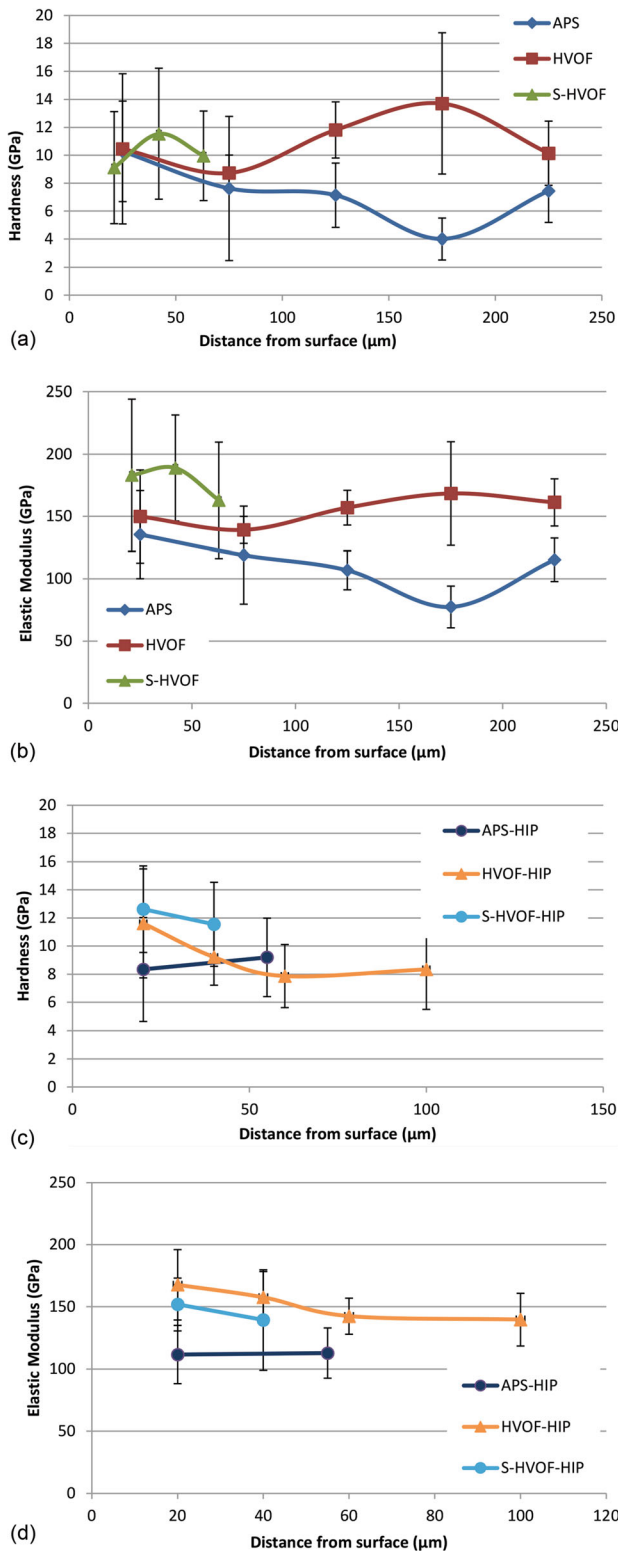
**Fig. 7** Nanoindentation analysis of (a) hardness in as-sprayed coatings, (b) hardness in HIPed coatings, (c) elastic modulus in as-sprayed coatings and (d) elastic modulus in HIPed coatings

**Coating fracture** The hardness of the sintered WC-Co ball is Rockwell 'A' 90.5–91.5 (Table 3), which was significantly higher than the average hardness of all coatings in this study (Fig. 7 and Sect. 4.3). The fracture toughness of alumina thermal spray coatings was also limited, typically in the range of 2.3–3.5 MPa m<sup>1/2</sup>, respectively, for the APS and HVOF coatings (Ref 51), which is significantly lower than for the sintered WC-Co (Ref 76). Fracture toughness values in Ref 51 were similar to the published literature values for alumina coatings (Table 1), with a range of 0.8–2.8 MPa m<sup>1/2</sup>. Low fracture toughness of alumina coatings triggers micro- and macro-fracturing under the contact stress and asperity interaction during the sliding wear process.

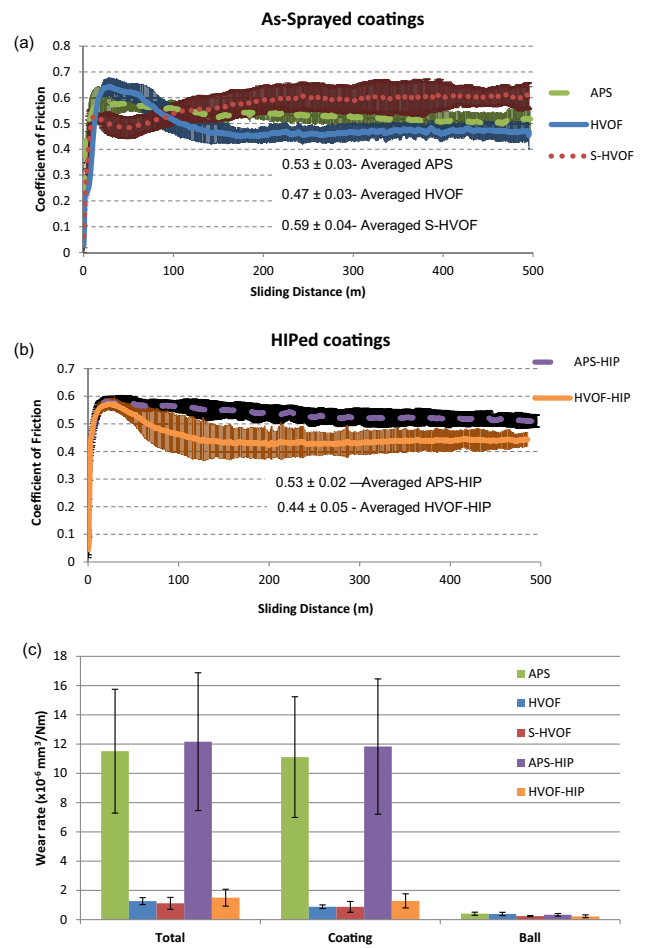
**Fig. 8** (a) Coefficient of friction (CoF) of the as-sprayed coatings, (b) HIP coatings, (c) Wear performance of the coating showing total, coating and counter-body (ball) wear rates. The averaged steady state CoF values for the last 300 m of sliding distance are also given in Figures (a) and (b)

The averaged coefficient of friction (CoF) values derived from the five tests for each couple are plotted against sliding distance along with their respective standard deviation in Fig. 8(a, b). The wear rate of the as-sprayed and HIPed coatings in terms of coating wear, ball wear and total wear of the test couples is shown in Fig. 8(c). A summary of the ball, coating and total wear losses of the test couples is shown in Table 5. The average CoF for the steady-state, calculated from the last 300 m of the wear tests is also shown in the same Figure (Fig. 8a, b).

Sliding wear rates shown in Fig. 8(c) indicate that the APS coating has the highest wear rate, which was an order of magnitude higher than for the HVOF and S-HVOF coatings. The S-HVOF coating had the highest wear resistance among the test couples considered in this investigation. The total wear rate was dominated by the coating wear rate, as the ball wear rate was relatively low (Table 5). After the HIPing post-treatment, there was an increase in the average total wear rate of 5.6% and 18% for the APS-HIP and HVOF-HIP coatings, respectively. This increase in the average value was within the standard deviation of the results shown in Fig. 8(c). In the study reported in Ref 18, although the feedstock was not  $\alpha$ -alumina, it was reported that at a low heat-treatment temperature of 600 °C, there was a decrease in the wear rate of about 47%; however, the wear rate increased by orders of magnitude when the coating was heat-treated at 750 °C. Hence, the wear performance is dependent on the heat-treatment temperature. After the running-in stage, the steady-state CoF was the highest for the S-HVOF coating, followed by APS and then HVOF in the as-sprayed test couples. There was no significant relative difference in the steady-state CoF values after the HIPing post-treatment.

Except for S-HVOF coating, the CoF initially increases during sliding wear tests, which is attributed to the absence of the W-rich tribofilm during the initial stages of the test (Fig. 8a). S-HVOF coating initially shows the lowest friction coefficient, probably due to the finer microstructure. During the steady-state period, HVOF coatings, having the highest concentration of W-rich tribofilm (Fig. 9), showed the lowest CoF. Therefore, a stable and thick tribofilm helped reduce the CoF for the HVOF and HVOF-HIP coatings. Although there was evidence of tribofilm formation in APS and APS-HIP coatings, the film was not as stable because of the coating material's fracture and delamination. The three-body wear mechanism due to entrapped debris in the APS coating wear track was also not conducive to tribofilm regeneration. The averaged steady-state CoF values shown in Fig. 8 also indicate that HIPing post-treatment had no significant effect on the steady-state friction measurement. In the case of S-HVOF coatings, the steady-state CoF value was higher than the APS and HVOF coatings. This is attributed to the relatively thin tribofilm formation in the case of S-HVOF coatings, as shown in the EDS plot and SEM observations in Fig. 9c. The wear resistance of the S-HVOF coating was the highest, which indicates that the tribofilm protected the coating; however, its thickness and stability did not facilitate a reduction in the CoF. Values of CoF are dependent upon the energy dissipation mechanism within the contact region, which relies on the tribomechanical properties of both the coating and counterbody material. The CoF values

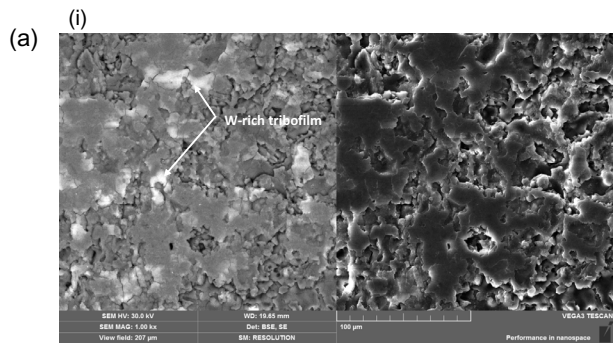
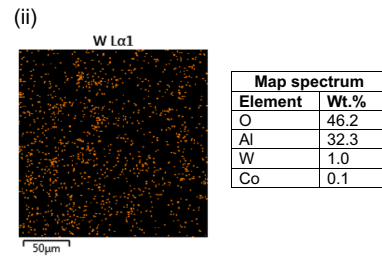
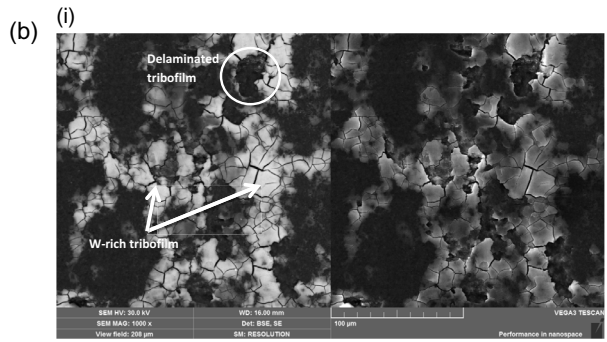
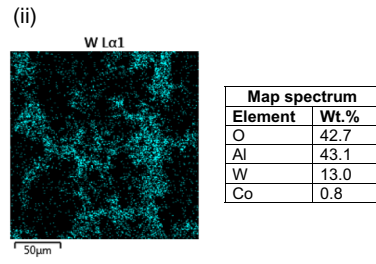
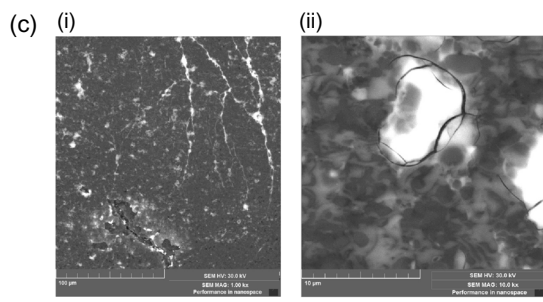
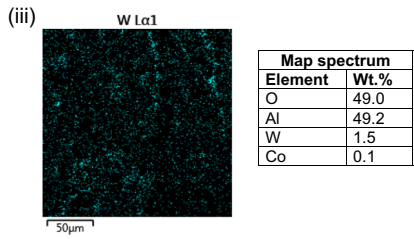
**Fig. 9** BSE images of wear track with EDS map of W of (a) APS (i) BSE and SE mode, respectively, (ii) EDS map of (i); (b) HVOF (i) BSE and SE mode, respectively, (ii) EDS map of (i); (c) S-HVOF (i) BSE, (ii) BSE (higher magnification), (iii) EDS map of (i); (d) APS-HIP (i) SE, (ii) EDS map of (i); (e) HVOF-HIP coatings (ii) BSE, (ii) BSE (higher magnification), (iii) EDS map of (ii)

SEM images of the wear scars for the as-sprayed and HIPed coatings are presented in Fig. 9. The EDS map and the spectrum data are also given for the wear scars. Because of significant coating segment delamination due to crack formation, the wear volume loss analysis on the S-HVOF-HIPed coatings could not be accurately performed after the sliding wear tests. These results are

therefore not included in Fig. 8. Macrocracking in the HIPed HVOF coating could be observed (Fig. 9e(i)). However, the coating did not delaminate, and the wear data are presented in Fig. 8. The macrocracking observed in Fig. 9e(i) was similar to a previously reported study of heat-treated alumina coatings (Ref 18). Figure 10 shows the typical wear debris morphology for the APS and HVOF

Figure 9 shows the SEM observations of the worn wear tracks in both SE and BSE modes. Two features are evident from these observations. The first is W-rich transfer film presence on coatings' surface, as seen in the BSE images and associated tungsten maps. In some cases, e.g., Figure 9(b), the W-rich transfer film covered a significant portion of the observed wear track, whereas in Fig. 9(a), small islands of the W-rich transfer film can be observed. The EDS map spectrum indicated that tungsten ranges from 1 to 13 wt.%. The second feature was the presence of microcracks in the coating leading to the removal of material. The SEM observations at various magnifications did not indicate any plasticity or abrasive marks on the wear tracks' surface. The microfractured surfaces look rough, whereas the W-rich film presented a smooth surface (Fig. 9).

**W-rich tribofilm** Tribofilms form due to the exchange of materials between the coupled bodies due to flash temperature during asperity contact. The tribofilm can reduce both the CoF and wear rate by acting as a solid lubricant and providing a low-shear strength layer. SEM and EDS analysis of the wear tracks of the coatings showed the presence of tungsten, indicating that the tribofilms formed on the coatings were the cause of asperity interactions and flash temperatures in the presence of oxygen during the sliding wear tests (Fig. 9). Engqvist et al. (Ref 89) have discussed the reactions forming tribofilm consisting of WO<sub>3</sub> for self-mated WC-Co during dry sliding in air and nitrogen environments. In previous studies, authors have also indicated the presence of oxygen-rich tungsten tribofilm for test couples involving WC-based hardmetals (Ref 76, 90). This tribofilm occurs regardless of the microstructural phase of W in the tribo-system (Ref 76). For the case of Al<sub>2</sub>O<sub>3</sub>-TiO<sub>2</sub> coatings sliding against WC-Co counterbody (Ref 83–85), WO<sub>3</sub> tribofilm was reported by Fervel et al. (Ref 83), whereas Guessasma et al. (Ref 84) also reported the formation of a tribofilm. In the current investigation, the extent of this protective W-rich tribofilm varied for different test couples (Fig. 9). There is a

The amount of tribofilm formation was relatively higher for the HVOF and HVOF-HIP tests (Fig. 9b, e) compared to the APS and APS-HIP coatings (Fig. 9a, d). There was also tribofilm formation in the case of S-HVOF coating, as observed in the tungsten map and high-resolution image (Fig. 9c); however, this film's intensity in the wear track was lower than the HVOF coatings. Therefore, it is postulated that the relatively higher content of the  $\alpha$ -Al<sub>2</sub>O<sub>3</sub> in the HVOF and S-HVOF coatings (Table 4) promotes a more stable W-rich tribofilm formulation. This was consistent with the findings of Deng et al. (Ref 82), which indicated  $\alpha$ -Al<sub>2</sub>O<sub>3</sub> as a stable phase during sliding wear, and the authors concluded the transformation of  $\gamma$ -Al<sub>2</sub>O<sub>3</sub> to  $\alpha$ -Al<sub>2</sub>O<sub>3</sub> due to frictional contact in the sliding wear process. However, this needs to be considered in combination with the high wear rate for the APS and APS-HIP coatings, which can destabilize the tribofilm due to fracture of underlying coating material and wear debris entrapment in the wear track, as discussed in the next sections.

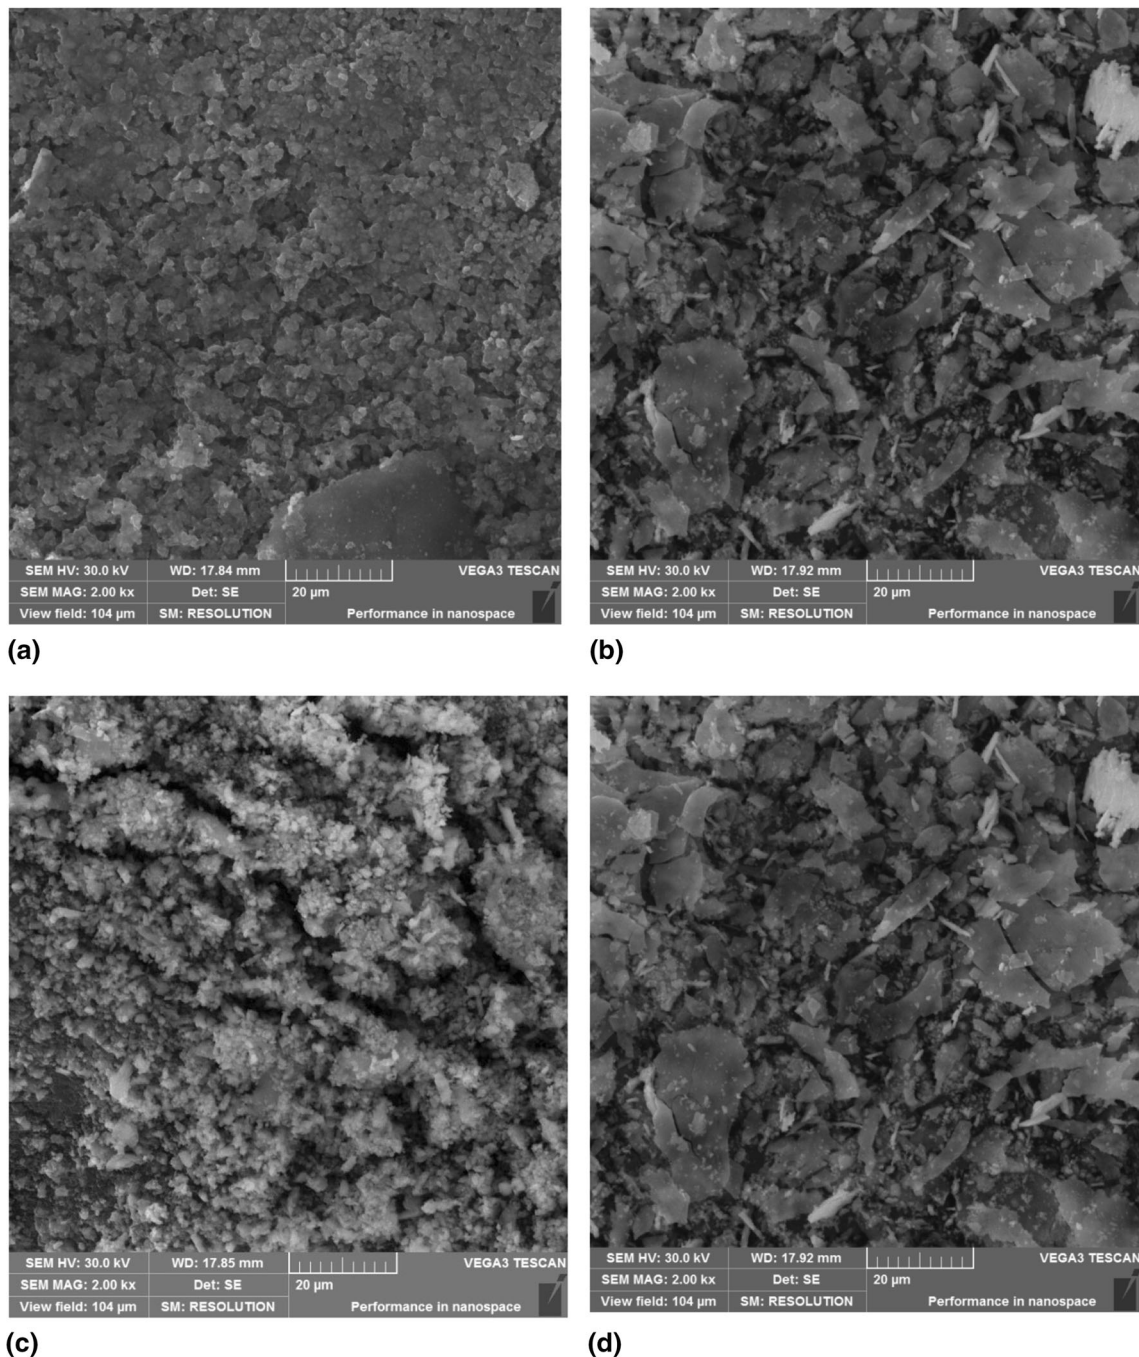
**Fig. 10** SEM images of sliding wear debris from (a) APS, (b) HVOF, (c) APS-HIP and (d) HVOF-HIP coatings

The observations of the wear debris in Fig. 10 indicate delaminated fragments of coatings. In the case of APS and APS-HIP coating, the debris fragments were finer (Fig. 10a, c), indicating that they were trapped within the wear track and ground to finer particles during the sliding wear process. This was consistent with the depth and width analysis of the wear track profile shown in Fig. 12(a), where the wear scar was significantly deeper and wider compared to other test couples. Once the debris was trapped, it influences both the friction and wear behavior in the form of three-body wear. In the case of HVOF and S-HVOF coatings, the depth of the wear scar, as well as the morphology of the delaminated debris shown in Fig. 10(b and d) indicate that the delaminated debris was pushed from the wear track because of its relatively lower depth (Fig. 12); the friction and wear mechanism was two-body and three-body wear. SEM observations of the wear track on the WC-Co ball counterpart did not reveal any abrasive marks or transfer material (Fig. 11).

**Debris interaction** The wear debris' entrapment in the APS and APS-HIP coating test couples' deeper wear groove led to finer debris (Fig. 10). This also changed the wear process to predominantly three-body wear. The rolling and sliding of trapped wear debris in the APS coatings' deep wear groove further increased the coating wear due to local stress concentration originating from the asperity contact on the coating and debris surface (Fig. 12). As the entrapped debris in the case of APS and APS-HIP coating was predominantly alumina coating particles since the WC-Co ball wear was very low in all cases (Fig. 8c), the contact became predominantly alumina coating—alumina coating debris. As the entrapped debris is crushed within the contact zone, its fracture toughness increases due to finer size and hardness vary depending upon the phase composition of its constituents. The shape of the debris increases the contact stress as debris protrusions decrease the real area of contact, accelerating coating wear. As the contact becomes predominantly alumina coating—alumina coating debris, the WO<sub>x</sub> tribofilm formation on the coating surface caused by the WC-Co counterbody becomes unstable, as indicated by the relatively lower concentration and isolated locations of W-rich tribofilm (Fig. 9), which further accelerates APS and APS-HIP coating wear rate.

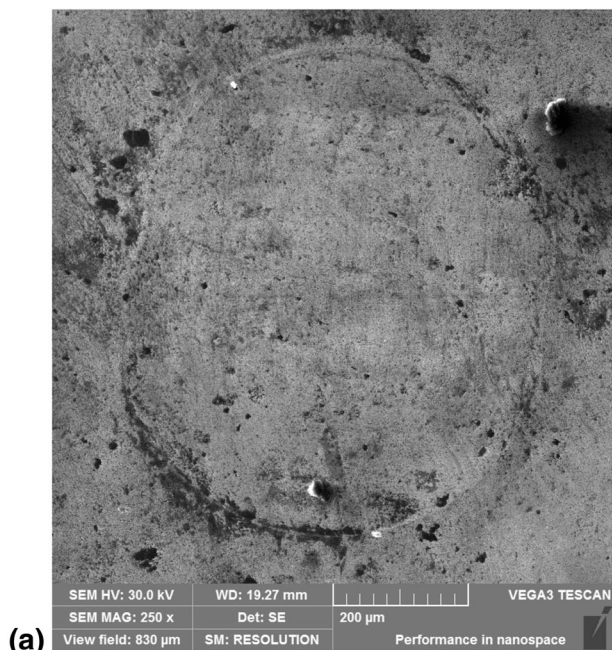
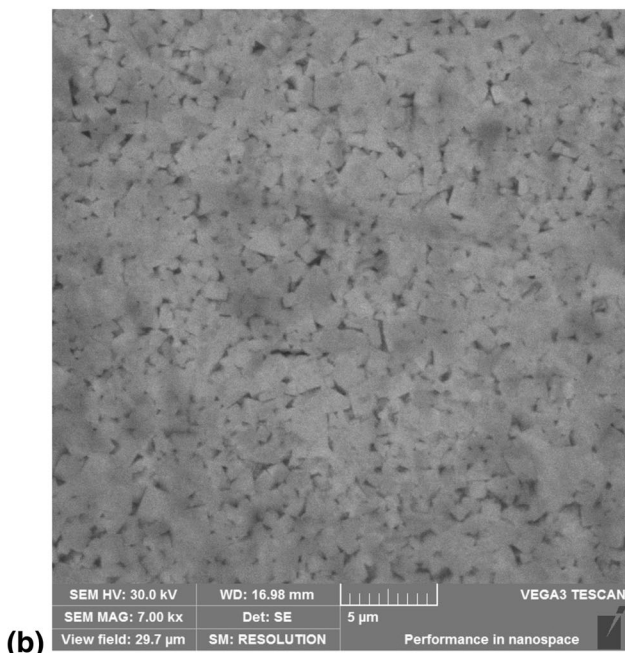
**Fig. 11** SEM images of WC-6Co ball wear scar for the APS coating test couple (a) low magnification, (b) high magnification

The entrapment of debris also influenced the wear rate and mechanism of the WC-Co ball (Fig. 11). There was no evidence of abrasion marks on the WC-Co ball's worn surface, which is attributed to its high hardness. Even the sintered alumina's hardness ranges from 1250 to 1500 HV, which is lower than the WC-Co ball (Ref 76). Similarly, the fracture toughness of sintered alumina is lower than the WC-Co ball (Ref 76). Hence, even if the alumina debris from the coating shows higher toughness due to finer particles and a hardness dominated by the  $\alpha$ -alumina wear particles, its mechanical strength is still lower than the sintered WC-Co ball. As discussed earlier, the WC-Co ball's wear was predominantly caused by the formation of the WO<sub>x</sub> tribofilm. Some contribution of wear from the asperities of alumina coating and debris also resulted in ball wear (Fig. 8e). This can be understood from the wear rate results of APS and APS-HIP coatings, where the extent of WO<sub>x</sub> film is lower compared to the HVOF coatings; however, the ball wear is relatively higher (Table 5).

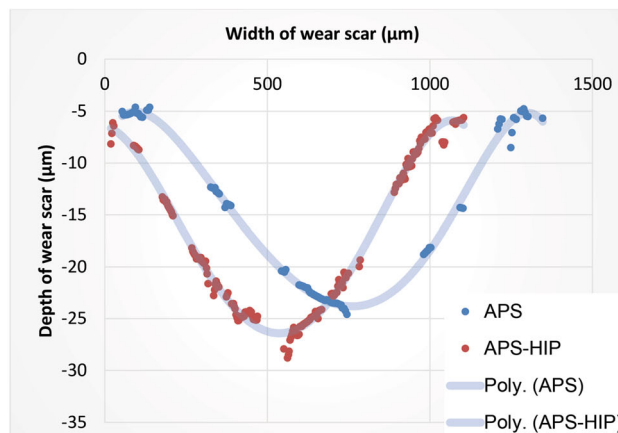
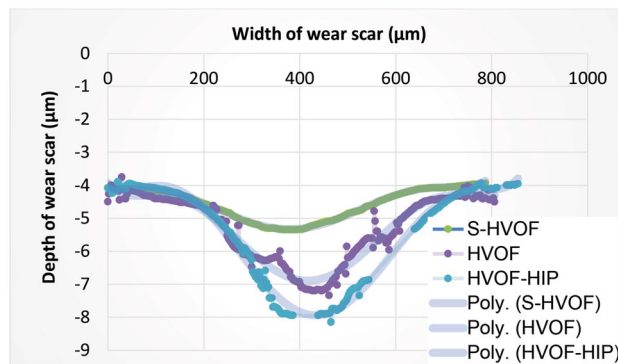
**Fig. 12** A comparison of wear track depth and width profiles of (a) APS and APS-HIP, and (b) HVOF, S-HVOF, HVOF-HIP coatings

wear at two different magnifications. Figure 12 provides a comparison of the wear track profiles in terms of their width and depth for the as-sprayed and HIPed coatings.

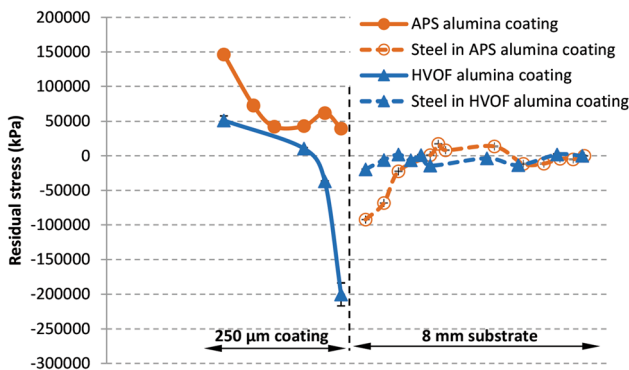
**Fig. 13** Through thickness neutron diffraction residual stress results for APS and HVOF alumina coatings (Ref 52). Reprinted from R. Ahmed, N. H. Faisal, A. M. Paradowska, and M. E. Fitzpatrick, Residual strain and fracture response of Al<sub>2</sub>O<sub>3</sub> coatings deposited via APS and HVOF techniques, Journal of Thermal Spray Technology, Vol. 21, pg. 23-40, 2012, Springer Nature

Equation 1 can also be applied to approximate residual stress build-up between the coating and substrate material during coating deposition. As shown in Fig. 13, the compressive residual stress in the as-sprayed HVOF coating shows a value of 200 MPa, whereas the APS coating has a tensile stress of 50 MPa near the interface (Fig. 13). For a

As depicted in the current work, residual stress is another factor influencing the wear mechanism. The residual stress profiles (Fig. 13) indicate that the alumina APS coating had high tensile stress, whereas the HVOF coating had compressive residual stress. A compressive residual stress is advantageous in combatting fracture and fatigue failure by reducing the tensile stress field responsible for crack initiation and propagation. Tensile residual stress in the APS coating does not resist crack initiation and propagation. Relatively lower hardness, fracture toughness, and poor intersplat bonding (Fig. 2a, 4a) of the APS coatings thus indicate its lower resistance to fracture and delamination during the sliding wear process. As discussed above, this lower coating quality is linked to the higher  $\gamma$ -Al<sub>2</sub>O<sub>3</sub> content of the APS coating and tensile residual stress. Similarly, the relative lower velocity of the impacting lamella in APS coatings led to poor intersplat strength (Fig. 2a, 4a). Higher mechanical strength of the HVOF and S-HVOF coatings (nanohardness and elastic modulus) and a finer and dense microstructure resulted in the highest wear resistance. This is consistent with the relatively smooth wear track surface of the S-HVOF coatings with no significant fracture.

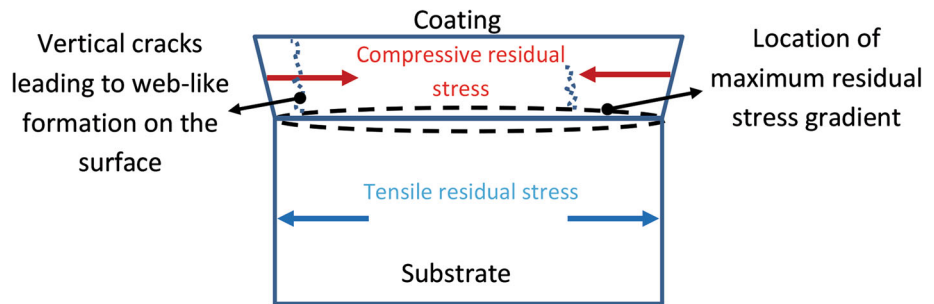
**Fig. 14** Schematic of interfacial stress gradient for alumina coating where  $CTE_s > CTE_c$ , leading to delamination at the coating substrate interface and cracking within the coating
