Polyurea Coating Protects Sewage Tunnels in Mexico City

Two-Component Mixing System Successfully Used on Large-Scale Project

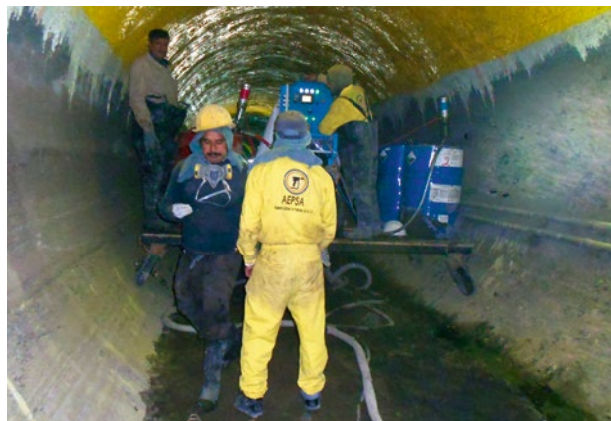
Around 110 tonnes of polyurea had been applied by the end of the project.

In the Tula project in Mexico, the tunnels are being coated using an efficient two-component mixing and dosing system (Duomix PU 460) supplied by machinery manufacturer Wiwa. The system allows coatings and linings to be applied seamlessly and efficiently to large areas. In the case of the two- and three-kilometre-long tunnels, around 110 tonnes of polyurea had been applied to an area of 40,000 m² by the summer of 2014.
