Repairing Rotor Blade Edges Six Times Faster

Thanks to a single-layer structure and extremely fast curing, rotor blade edges of wind turbines can be repaired six times faster compared to conventional repair systems using an advanced elastomer coating.

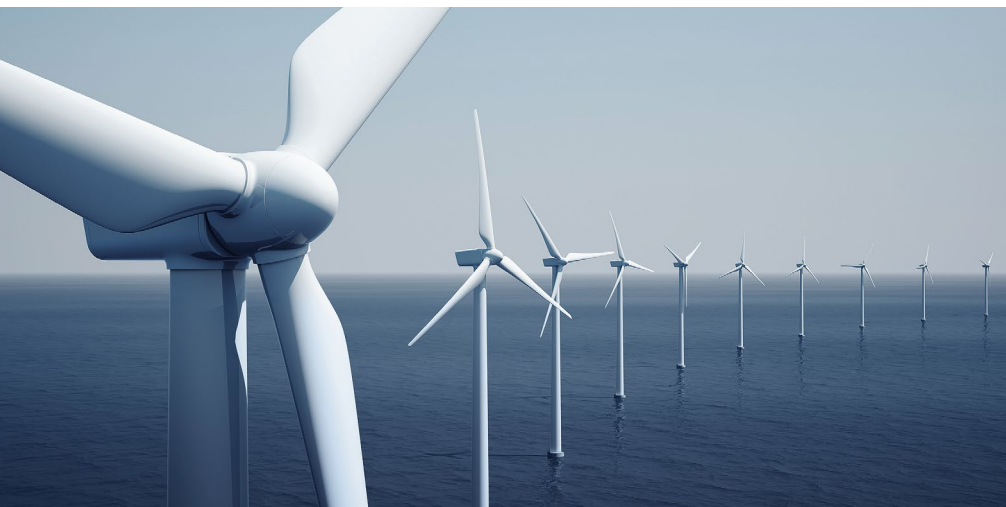
With the new coating, rotor blade edges can be repaired without additional priming and filling in just one work step.

Teknoblade Repair 9000-20 is an elastomeric-based high-build coating with 100 % solids content. In a single coat it forms a protective, elastic layer with a thickness of up to 2500µm, and it cures in a few minutes. The leading edge can be repaired in just one step without additional priming or filling, which delivers a considerable impact on time-savings.

Application has been improved, too. The coating can be applied both manually or by using a battery powered caulking gun and a unique spatula that has been further optimised. The new design ensures the uniformity of the layer thickness and serves as a wind shield during application. With a view to the near future, the simplicity of the application process makes elastomer coating an ideal solution when robotic applications are being considered.
