Advanced microstructural characterisation of cast ATI 718Plus®—effect of homogenisation heat treatments on secondary phases and repair welding behaviour

Abstract

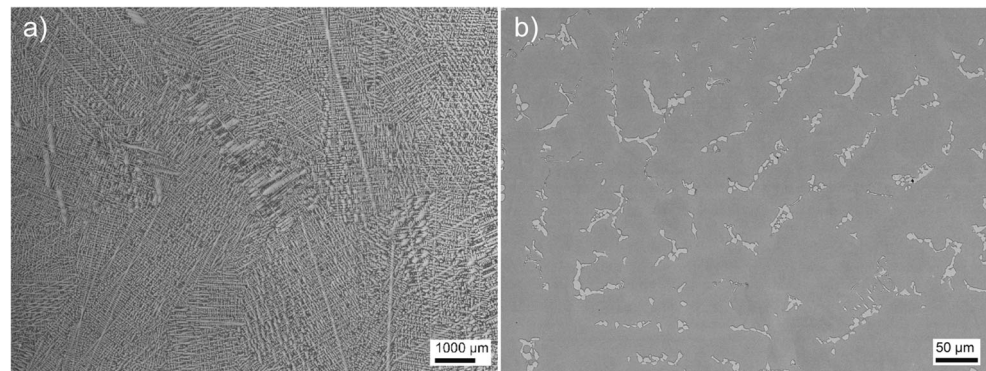
Fig. 1 **a** Microstructure of as cast ATI 718Plus[®] showing grain structure. **b** Bright Nb-rich precipitates in SEM BSD contrast

The ATI 718Plus® used in this study was in the form of investment cast plates with dimensions of 150 × 60 × 13 mm. The chemical composition is shown in Table 1. In the as-cast condition, the material shows a dendritic microstructure with an average grain size of 1300 ± 200 µm as shown in Fig. 1a. In interdendritic areas, blocky Nb-rich precipitates can be observed as bright areas in SEM backscattered electron (BSE) contrast Fig. 1b. The hardness has been measured to 415 ± 5 HV0.5.

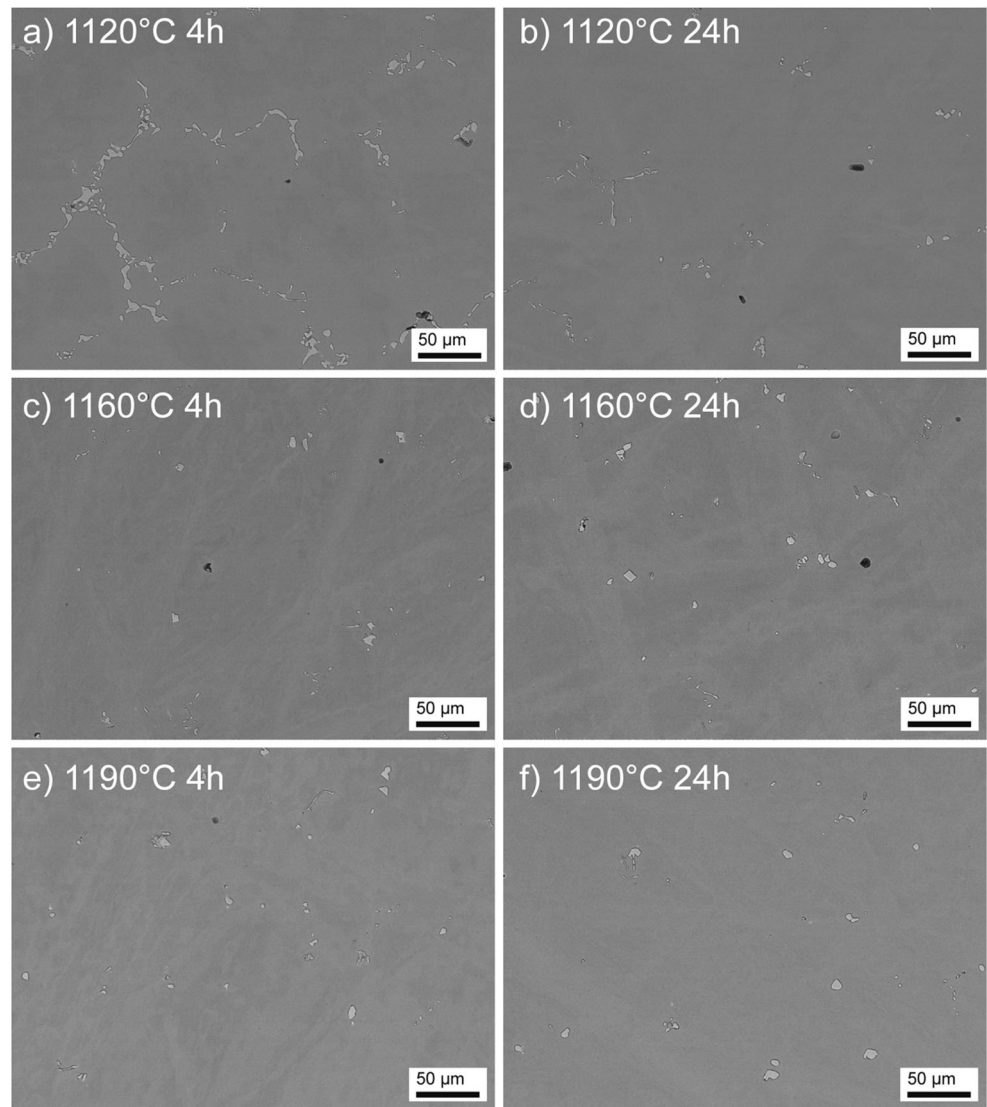
Fig. 2 Base material microstructure after homogenisation heat treatments. **a** 1120 °C 4 h. **b** 1120 °C 24 h. **c** 1160 °C 4 h. **d** 1160 °C 24 h. **e** 1190 °C 4 h. **f** 1190 °C 24 h

The homogenisation heat treatments were most discernible by the amount of the Laves phase they could dissolve (cf. Fig. 2 and 3). With the absence of high-Nb, low melting phases in the

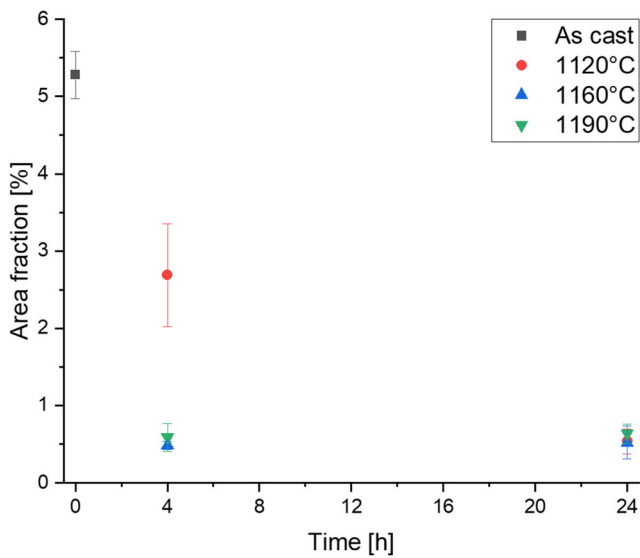
Fig. 3 Area fraction of Nb-rich precipitates after different homogenisation heat treatments, indicating incomplete dissolution for the 1120 °C 4 h heat treatment

The grain size was found to be constant over all investigated material conditions, while a significant drop in hardness could be observed for all solution heat-treated samples as compared with the as-cast condition. Grain size and hardness results are shown in Table 2. The change in microstructure after solution heat treatments is shown in Fig. 2, where a reduction in interdendritic secondary phases is clearly visible for all heat-treated samples, albeit the 1120 $^{\circ}\text{C}$ 4 h treatment being less effective than the other conditions. The area fraction of Nb-rich phases as obtained by automatic image analysis is shown in Fig. 3. With an initial amount of 5.2 ± 0.3 area% in the as-

cast material, a baseline amount of ~ 0.5 area% is reached for all but the 1120 $^{\circ}\text{C}$ 4 h heat treatment. JMatPro predicts the equilibrium phase fraction of primary MC-type carbides as 0.47–0.49 wt% for the investigated homogenisation heat treatment temperature range. For a true comparison, the volume fraction would need to be computed from the image analysis results by taking the particle shape into account. This is however not attempted here, and the close apparent agreement of the results with the simulation is rather seen as an indication of what phases are expected to be present in the material.

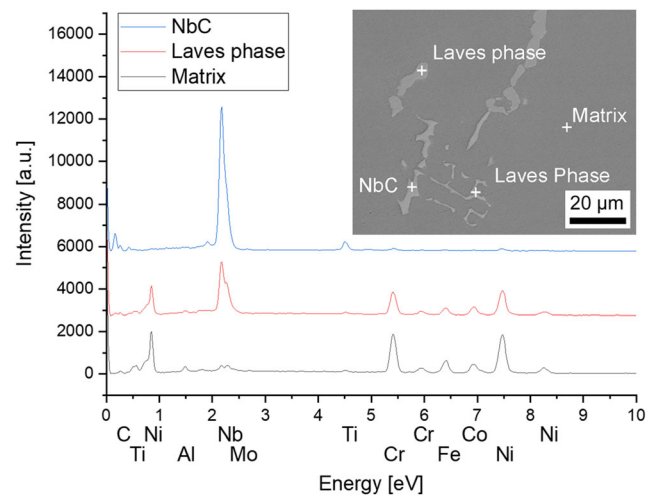
Fig. 4 EDS spot measurements in an interdendritic area of the as-cast material. Distinct differences in Nb L- α indicate the presence of both NbC carbides and Laves phase

With further microstructural investigation of precipitates using SEM EDS on as cast material, two distinct precipitate types could be identified in the microstructure. Figure 4 shows EDS spot measurements in an interdendritic area of the as-cast material, together with a BSE image indicating the measurement positions. The bright appearance of the phases in BSE mode indicates high content of heavy elements such as Nb, which is supported by the high measured intensities at the Nb-L α position. A distinct difference in intensity between measurement points further suggests the presence of two separate phases in the interdendritic areas. Nb-rich MC-type carbides are stable phase in ATI 718Plus[®], while the Laves phase is commonly formed in Nb-bearing superalloy castings due to elemental segregation [10].

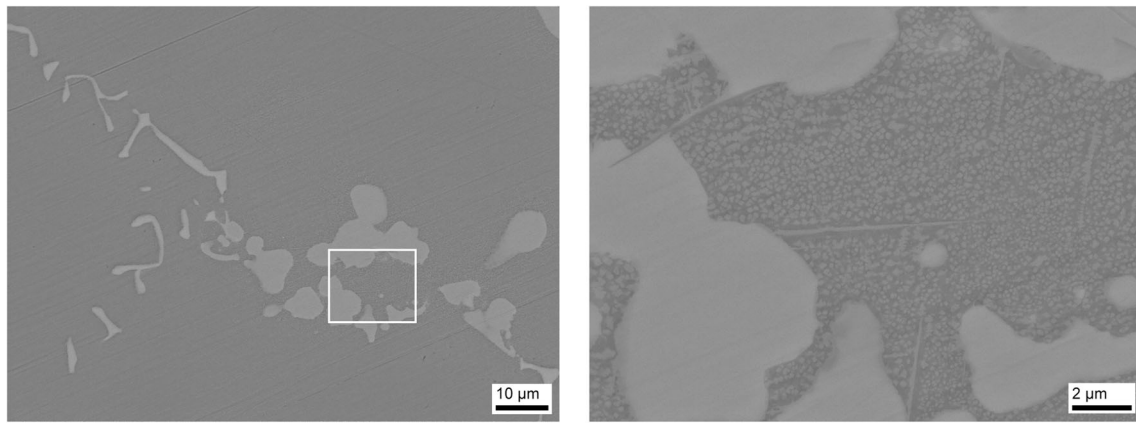
Fig. 5 Interdentritic area precipitates in the as-cast material. γ' precipitates were found in close vicinity of MC carbides. Plate-shaped particles growing out of MC particles are presumed to be η phase

High resolution FE-SEM imaging shows the presence of small cuboidal precipitates around the presumed Laves phase and MC carbides, Fig. 5. The phase appears to be γ' , which can

explain the high hardness of the alloy in the as-cast condition. It has to be noted, however, that the γ' precipitation is not uniform but rather concentrated close to interdendritic areas around larger Nb-rich precipitates, where their particle size increased as well. Small plate-like precipitates can also be observed in close vicinity to the Laves phase/MC carbides. The morphology suggests η phase, which has been reported in ATI 718Plus® [11]. While qualitative distinction was possible from SEM images, the phases were too small for EDS analysis.

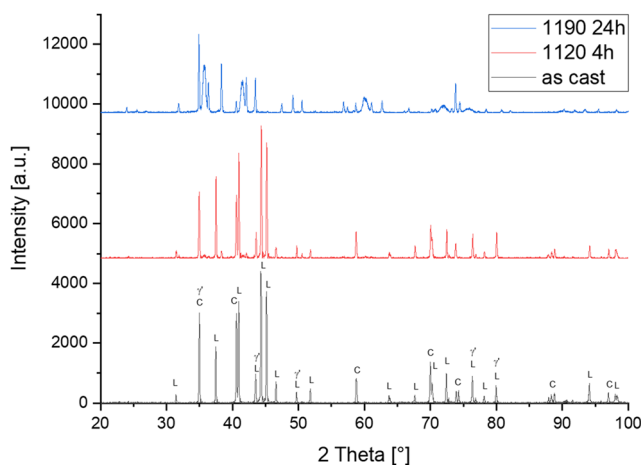
Fig. 6 XRD spectra on extracted powder of ATI 718Plus® in the as-cast condition (bottom) and after homogenisation heat treatments at 1120 °C 4 h (middle) and 1190 °C 24 h (top). The Laves phase peaks are absent in the latter condition

With the preliminary assumption that both Laves phase and MC carbides are present in the as-cast microstructure, XRD scans were conducted on electrolytic phase extracts of different heat treatment conditions to confirm the dissolution of interdendritic precipitates. Figure 6 shows the results from XRD analysis with indexed peaks for the C14 Laves phase (P63/mmc, 194), NbC (Fm3m, 225) and γ' (Pm3m, 221). While the spectra for the as-cast condition and the 1120 °C 4 h solution heat treatment show identical peak positions for NbC and Laves, the Laves phase peaks disappear for the

1190 °C 24-h heat treatment. Additionally, significant peak shift and peak broadening can be observed. The η phase could not be identified with powder XRD, presumably owing to its relatively small phase fraction and the difficulty to distinguish phases with similar crystal structures with only small differences in lattice parameter. The η phase has a hexagonal P63/mmc, 194 crystal structure [11], which is similar to the more abundant Laves phase. Furthermore, the used filter size of 0.8 μm together with the small phase fraction and size of the presumed η precipitates shown in Fig. 5 makes it possible that they were not filtered out from the extraction solution.

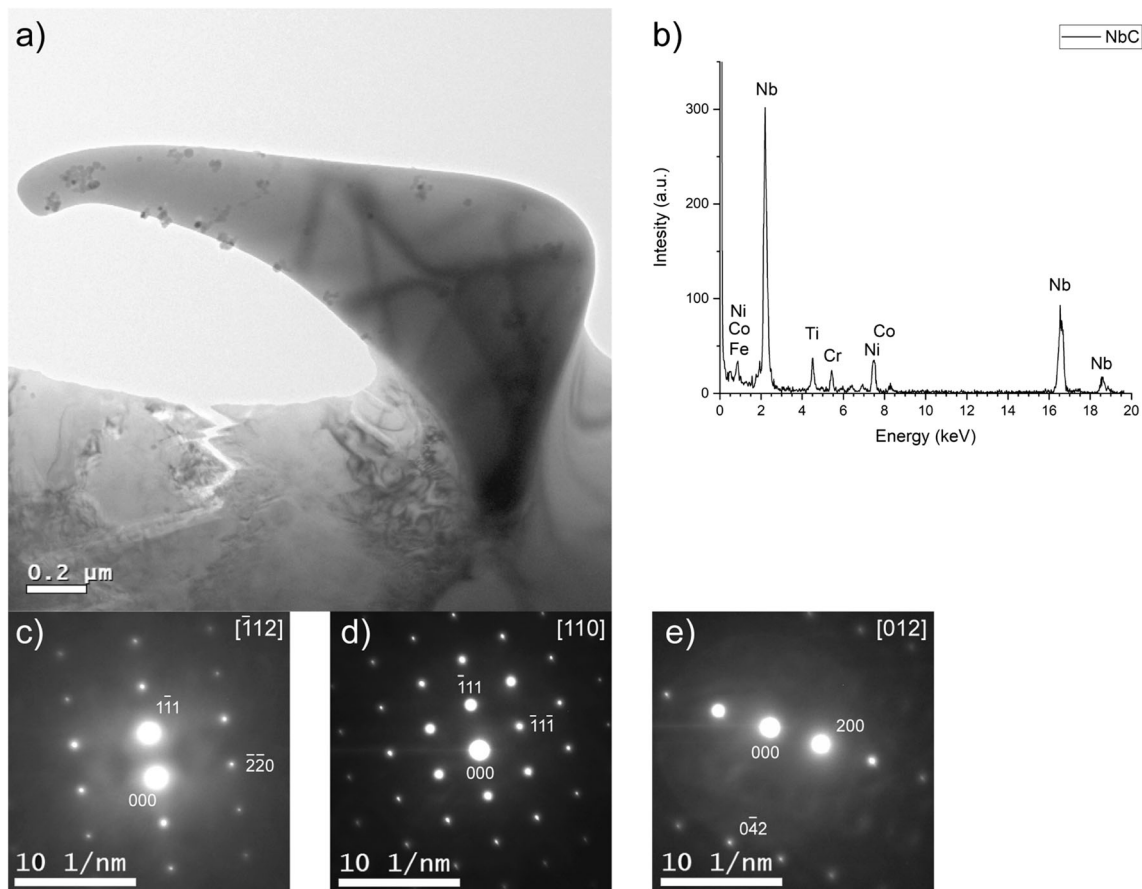
Fig. 7 TEM bright field image of a Nb(Ti) MC-type carbide (a), with TEM EDS showing high intensity at the Nb-Lx position (b). SA diffraction patterns are shown indexed as cubic Fm3m structure with $[112]$ (c), $[110]$ (d) and $[012]$ (e)

For the phase shown in Fig. 7, it can be observed that, apart from having a relatively large size, a clear peak on the Nb L- α position is present in the EDS spectrum. The diffraction patterns shown in Fig. 7c–e were indexed as a cubic Fm3m (225) crystal structure. This confirms the particle as Nb(Ti) MC-type carbide.

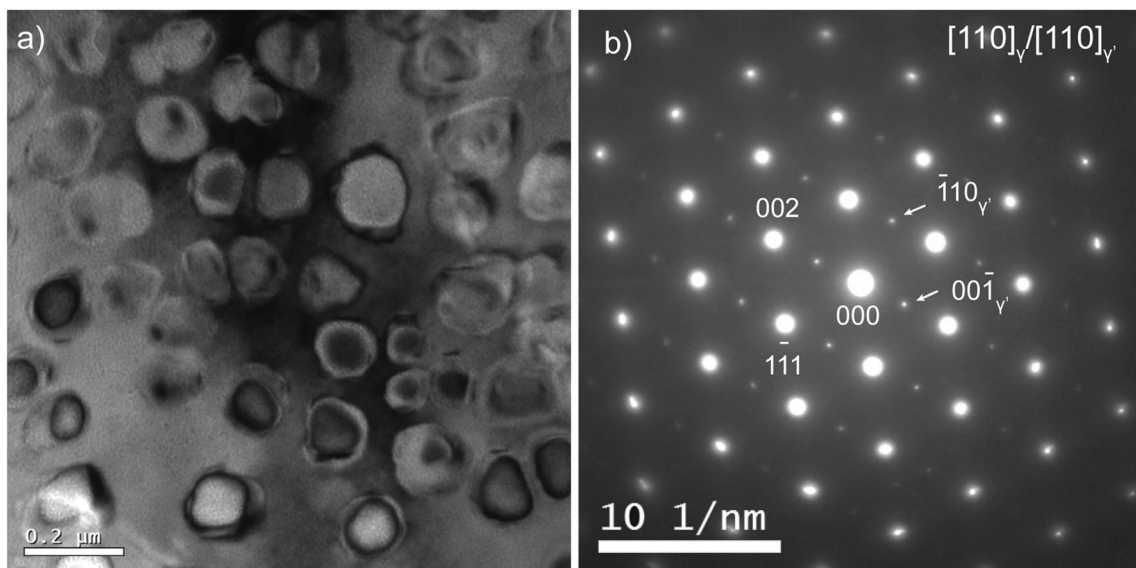
Fig. 9 a TEM $\langle 110 \rangle$ dark field image of cuboidal γ' particles surrounding laves phase. b The SA diffraction pattern clearly reveals the γ' sublattice reflections

In the surroundings of the Laves phase, cuboidal γ' precipitates were found as well, which are shown as $\langle 110 \rangle$ dark field image in Fig. 9a together with the respective SA diffraction pattern in Fig. 9b, where the γ' sublattice reflections are clearly visible. The particles were found to have a maximum particle size of about 120 nm. As observed in the SEM investigation (cf. Fig. 5), the phase is however not uniformly present in the material and instead is only found surrounding in interdendritic precipitates. The presented maximum particle radius does not represent the total population of γ' particles. Nevertheless, their presence explains the high hardness of the as-cast condition as compared with the homogenisation heat-treated material.

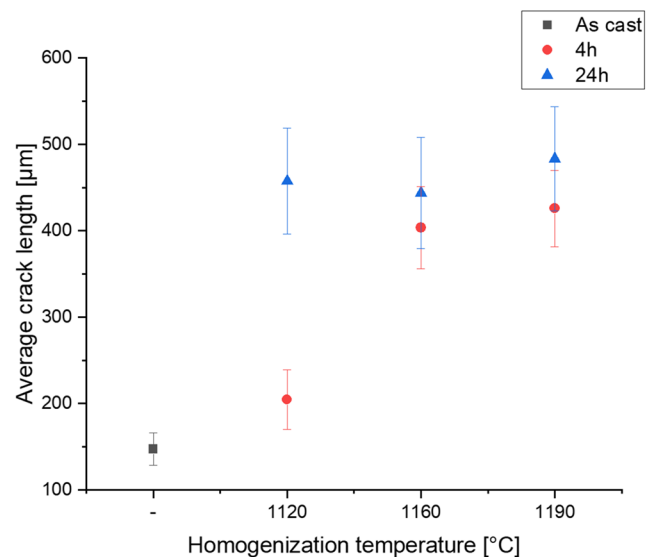
Fig. 11 Average crack length in the base metal HAZ of as cast and homogenised ATI 718Plus[®], showing significantly lower values for material in the as-cast condition and after 1120 °C 4 h homogenisation heat treatment

Microstructural characterisation revealed a difference in crack appearance, with short cracks for as-cast and 1120 °C 4 h, while long cracks running along former solidification grain boundaries were found for the other homogenisation heat treatments. Using average crack length values instead of the TCL confirms the results of visual microstructural inspection as indicated in Fig. 11.

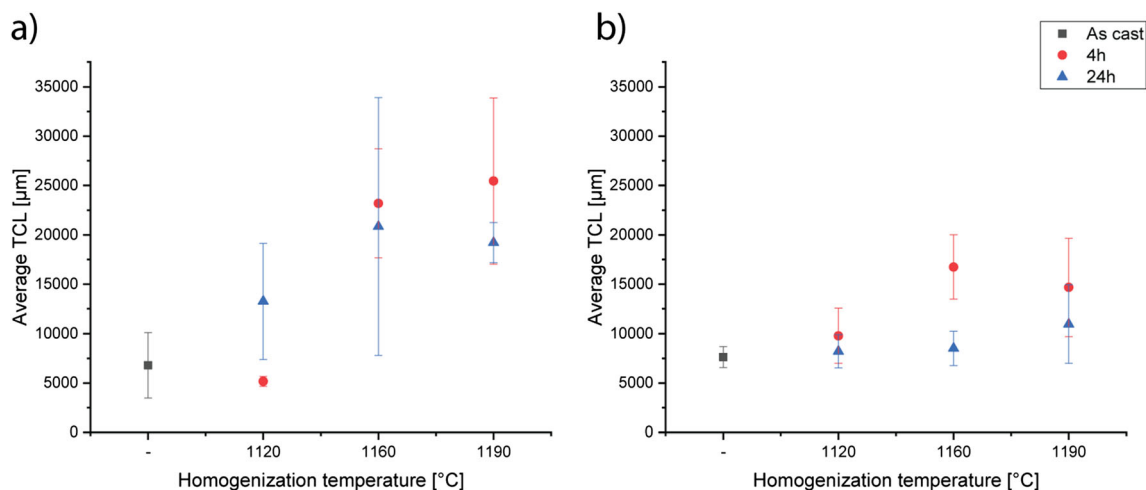
Fig. 10 Total crack length in (a) HAZ and (b) FZ after welding as a function of pre-weld homogenisation heat treatment condition

The difficult-to-weld groove geometry with a small bottom radius, together with a relatively high heat input as compared with typical repair welding operations produced weld cracks in all tested conditions. Cracks were found in both fusion zone (FZ) and HAZ as presented in Fig. 10a, b. Fusion zone cracking did not show a clear trend with changing base material microstructure, and the total crack length in the fusion zone was found to be generally lower than those observed in the HAZ. It can be

reasonably assumed that cracking in the FZ was mostly affected by the heat input and thermal stresses generated during the welding operation. The presented results have not been normalised with respect to investigated cross-section area, which was larger for the FZ with a factor of approximately 3:1. Higher total crack length in the HAZ, combined with the smaller investigated cross-section area indicates that HAZ cracking is the more severe cracking phenomenon in this material. Furthermore, with cracking occurring in the base material, an effect of pre-weld thermal history can be observed. Both the as-cast condition and homogenisation heat treatment at 1120 °C for 4 h produced a comparable TCL. All other heat treatments resulted in an increased TCL in the HAZ.

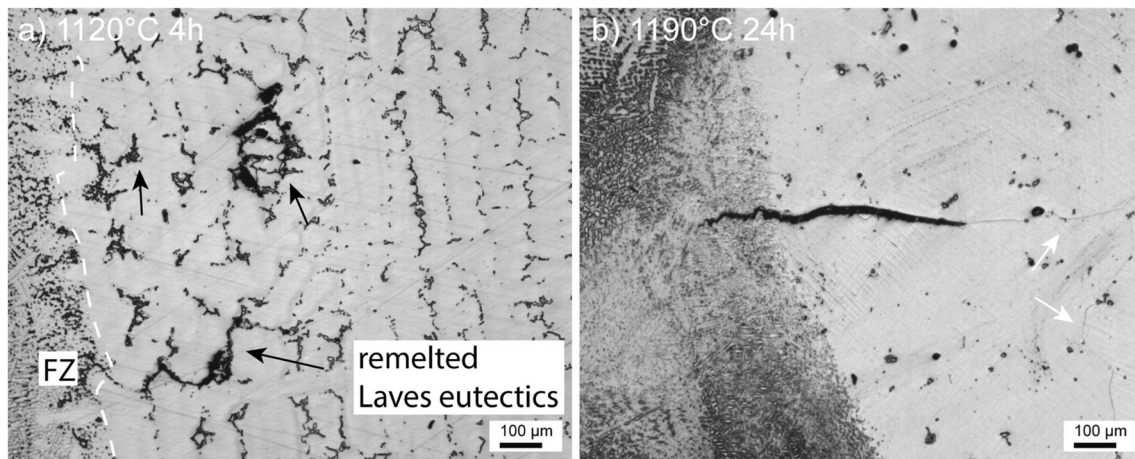
Fig. 12 Crack appearance in the base metal HAZ. **a** Short, not connected cracks in interdendritic regions of material homogenised at 1120 °C for 4 h. The fusion zone boundary is indicated by dashed line, while arrows

indicate fine eutectic structure of the remelted Laves phase. **b** 1190 °C 24 h homogenisation heat treatment showing a long crack running along a former solidification grain boundary (indicated by arrows)

microstructure, long cracks were formed on former solidification grain boundaries, while the Laves phase containing samples produced shorter cracks. The typical crack appearance is shown in

Fig. 12, exemplarily for samples homogenised at 1120 °C for 4 h and 1190 °C for 24 h, respectively. The former also shows significant Laves liquation in the HAZ in the form of fine gamma-

Laves eutectics in interdendritic areas and around the formed cracks. Cracks formed in interdendritic areas are furthermore forced to propagate following the shape of the dendrites, which causes a tortuous appearance. Cracks in the Laves-free material on the other hand propagate on relatively straight solidification grain boundaries. Grain boundary tortuosity has been found to reduce ductility-dip cracking in high-Cr filler metals due to hindering crack propagation [12], which can be assumed to also contribute to the shorter observed crack lengths in the Laves-containing material.

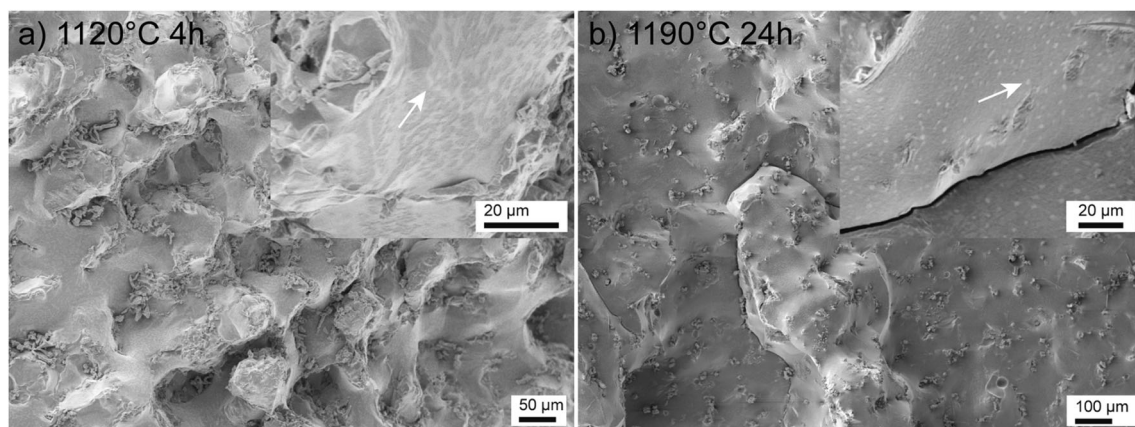
Fig. 13 Fracture surfaces after thermomechanical Gleeble simulation at 1150 °C on microstructures with (a) 1120 °C 4 h and (b) 1190 °C 24 h homogenisation heat treatment. Signs of liquation are indicated by arrows

1190 °C for 24 h when tested in the hot ductility test at 1150 °C. The fracture and associated ductility, Fig. 13, is zero for both material conditions at this test temperature, indicating significant liquation. The fracture surfaces resemble the general microstructural appearance after homogenisation heat treatment. Lower homogenisation temperature and exposure time retained a more dendritic structure, while at 1190 °C, those cast features are much less visible. This led to a more dendritic fracture surface appearance with smaller features for the lower homogenisation temperature, however both samples show similar signs of liquation in the form of small freckles on the surface of grain and dendrite facets.

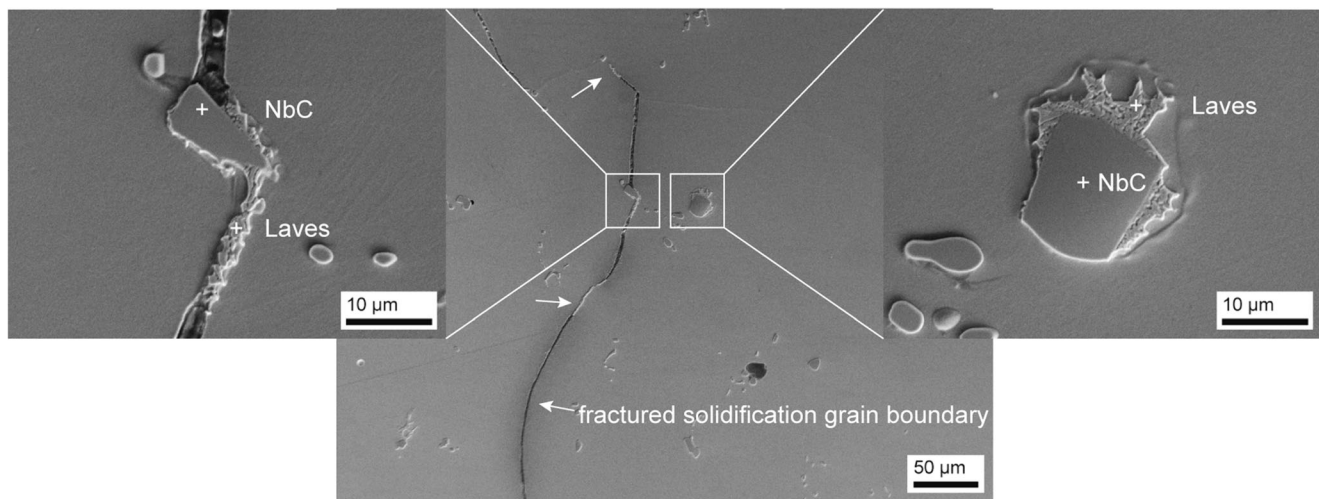
Fig. 14 Cracked grain boundary in Gleeble-simulated HAZ microstructure with Nb(Ti) MC-type carbides lying on and in close vicinity to the grain boundary. Presence of the γ -Laves eutectic surrounding the

particles indicates the formation of liquid. Presence of further gamma-Laves eutectic is indicated by right facing arrows

load. However, even under this test condition, the material homogenised at 1190 °C for 24 h fractured upon thermal exposure at 1150 °C. Figure 14 shows one of the formed cracks propagating along a former solidification grain boundary. Indicated are also two NbC carbide particles showing signs of constitutional liquation in the form of gamma-Laves eutectic around the carbide particles. One of them is located on the fractured grain boundary, and it is evident that the gamma-Laves eutectic liquid spread onto the surrounding grain boundary area. Spot EDS analysis revealed a similar chemical composition as those determined with TEM measurements, cf. Table 3.
