RESEARCH PAPER

In situ detection of product age and argon concentration as measure of the re-use potential of insulating glass units in buildings

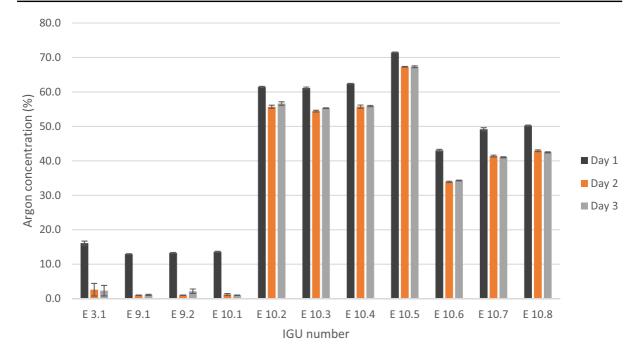
Fig. 4 The average of the argon concentration readings of the tested IGU's of building E at different measurement days

All IGU's showed an average argon concentration based on the readings for each measuring day below 72% (Fig. 4). The selected IGU on the third floor was leak (E 3.1). It had several centimeters of liquid water inside at the bottom of the IGU panel. Above this liquid water condensation was visible. Only this IGU showed corresponding SD's of more than 0.6%.

Remarkably, on the first measuring day, the average of the argon concentration readings of this leak IGU was 16.1% (SD 0.6%). On the other two measuring days the average was around 13,5% lower, dropping to 2.6% and 2.3%.

The difference in argon concentration in the IGU's of building E between day 1 and the other two measuring days varies from 4 up to 14%. The measurements on day 2 and 3 are considered to be correct. This can be explained by the results of the leak window. This window has visual water in the cavity, showing that the IGU is not properly sealed anymore. Therefore, the window is expected to have no argon left, which should be reflected in a measurable argon concentration of around 1%. The measurements on day 2 and 3, showing an average argon concentration for the leak window of around 2.5%, which is closer to the expected value than the average argon concentration of day 1 (16%).

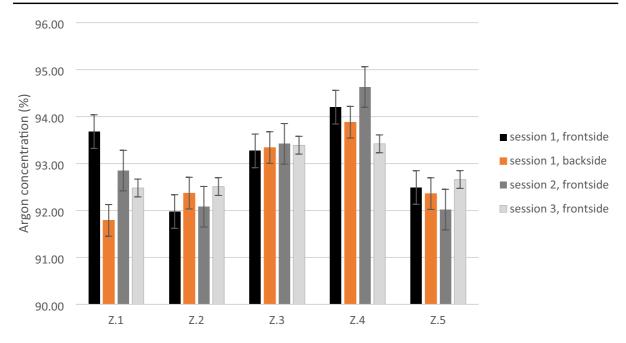
Fig. 5 The argon concentration of the defined sample test IGU's at different measurement sessions on the same day

Combining the thickness of the same IGU measured in multiple sessions may cause a higher spread than of each measuring session separately. This can be seen in the results of the defined sample test. Comparison of the deviations of the different windows is omitted, because it is considered less informative due to different sample sizes. The larger the sample set, the smaller the standard deviation of the sampling distribution gets. Based on the current data an absolute difference in cavity width measurements per window per session of up to 0.3 mm is considered reliable.
