Leakage current characteristics in estimating insulator reliability: experimental investigation and analysis

Ali Ahmed Salem^{1✉}, Kwan Yiew Lau^{1✉}, Wan Rahiman^{2✉}, Zulkurnain Abdul-Malek¹, Samir A. Al-Gailani², R. Abd Rahman³ & Salem Al-Ameri¹

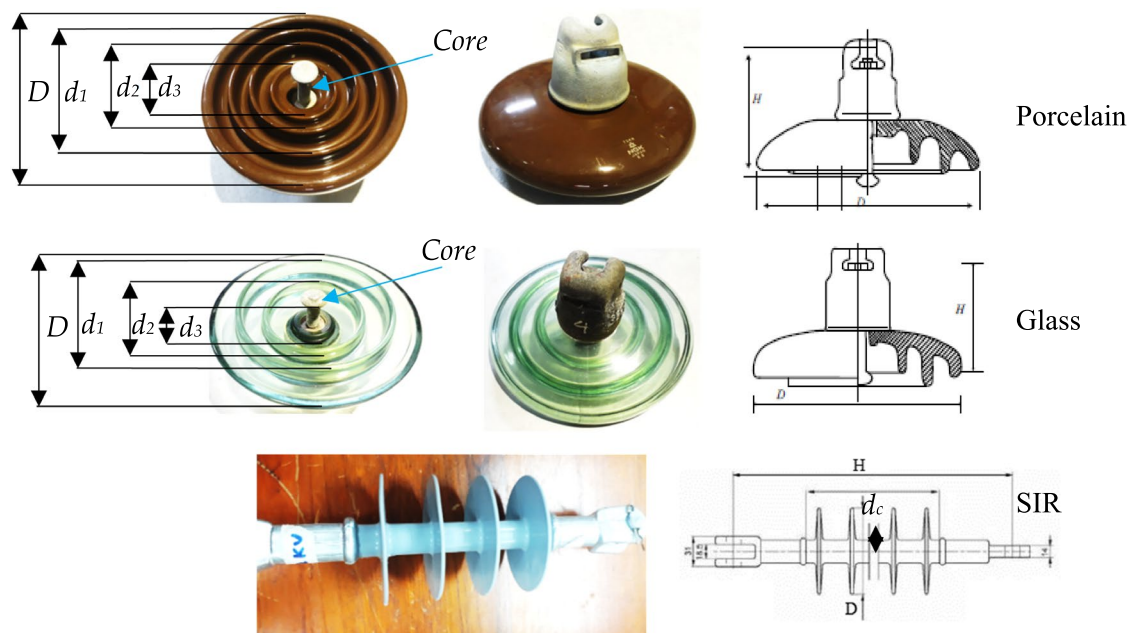
Figure 1. Insulators samples.

Test sample. Three types of insulators specimens (porcelain, glass, and SIR) were collected from the transmission lines in Malaysia. The insulators were all naturally field-aged samples with similar aging and service histories. Figure 1 depicts the primary form of the chosen insulators. Table 1 lists the specifications of the insulators.

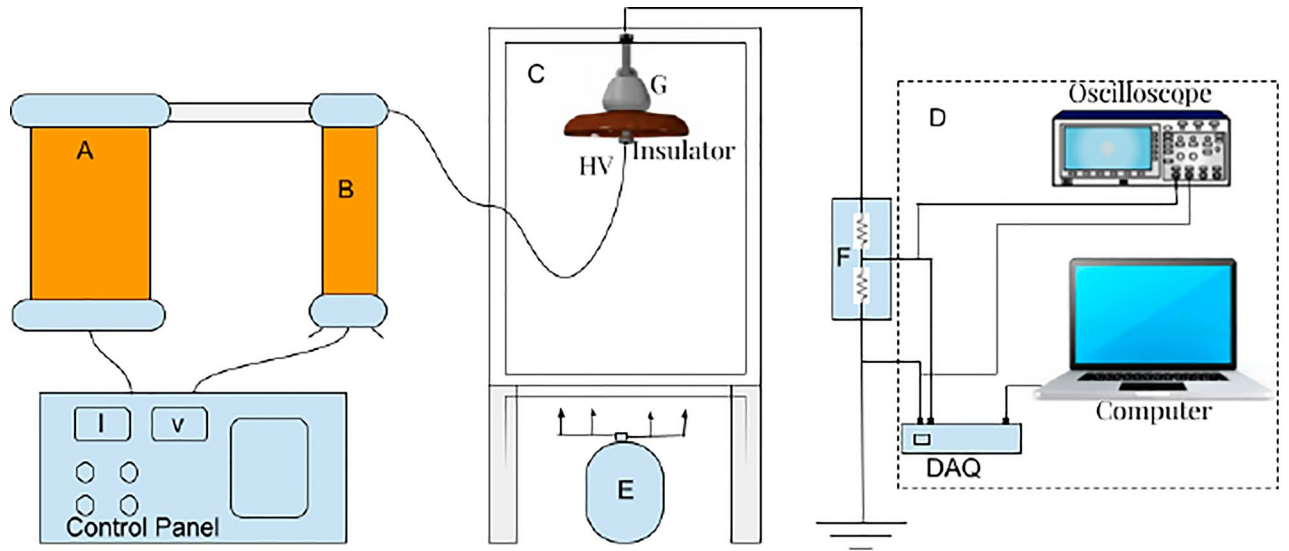
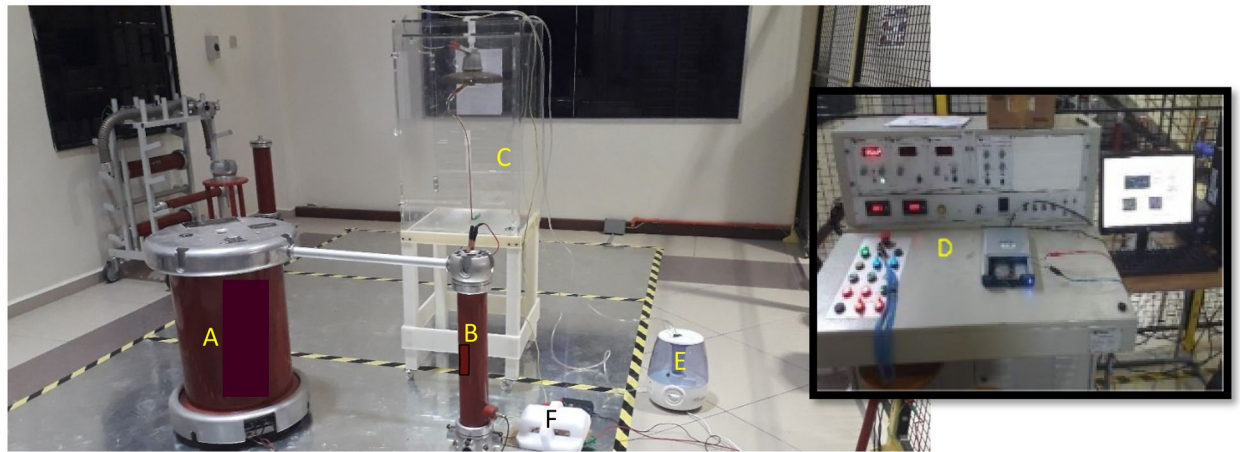
Figure 2. Insulator test: (a) Schematic diagram for experimental setup; (b) Test pictorial view.

Experimental setup. The experimental setup was carried out according to the IEC 60,507 standard³⁵ "Artificial pollution tests on high-voltage ceramic and glass insulators to be used in AC systems". All of the trials were conducted in a 50 × 50 × 75 cm test room with polycarbonate sheet walls. Four inlet valves were put in the chamber that was used to moisten the test insulators. Figure 2a shows the schematic diagram for the high voltage insulator experimental setup. Figure 2b depicts a visual representation of the high voltage laboratory's test setup and equipment. The following components made up the experimental circuit setup: A is an energized transformer (230 V/100 kV, 5 kVA, 50 Hz), B is a capacitive voltage divider, C is a test sample, D is a LC monitoring system, E is a steam fog generator and controller, and F is a resistive voltage divider (10,000:1) that is employed to capture the LC data. During the test, the energizing voltage was steadily increased by 2 kV step voltage until it reached 11 kV, and LC was measured at 11 kV. With 11 kV, LC was monitored without interruption under clean,

Monitoring of data. The applied voltage was measured using a capacitive voltage divider via the control panel in the experimental setup as shown in Fig. 2. Meanwhile, the LC monitoring system for LC includes a data acquisition (DAQ) card NI6024E, a computer, and an oscilloscope. A voltage downscaling divider (10,000:1) was employed since the DAQ's input voltage range was just 10 V. The data was sent from the DAQ to the computer, where it was stored as a CSV file and shown in Laboratory Virtual Instrument Engineering Workbench (LabVIEW). The oscilloscope was used to calibrate the DAQ data reading for testing the accuracy of the data reading. Matrix Laboratory (MATLAB) software was used to convert the LC signal in the time domain into the frequency domain. Figure 3 shows the technique used for monitoring and assessing LC.

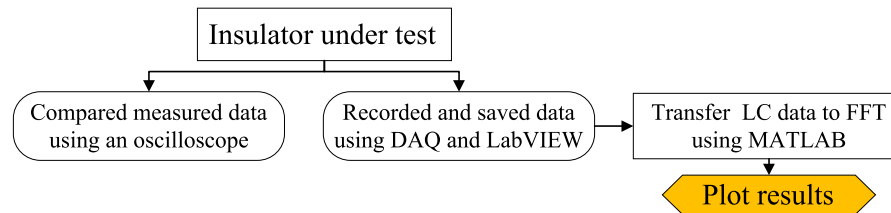
Figure 3. Leakage current monitoring process.

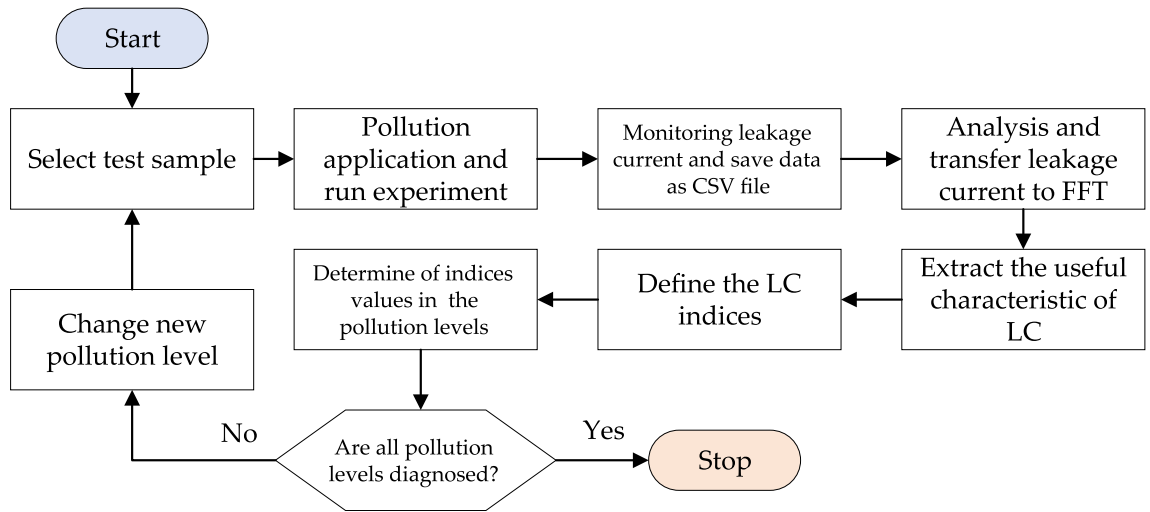
Figure 4. Flowchart process of insulator condition diagnosis.

Characteristic parameter of leakage current. One of the effective ways for developing new techniques for detecting insulators' health is to extract features from LC waveform. These properties may be derived from the frequency and time domains of the LC signal. Six LC characteristics/indicators were extracted in both the time and frequency domains in this work. Figure 4 shows the insulator condition diagnostic diagram utilizing LC characteristics.

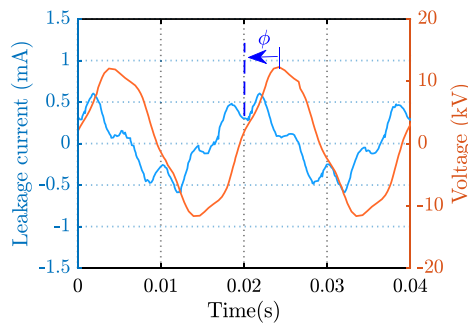
Figure 5. The phase difference between leakage current and applied voltage.

The phase difference between the applied voltage and LC (ϕ), as shown in Fig. 5, was determined using MATLAB software.

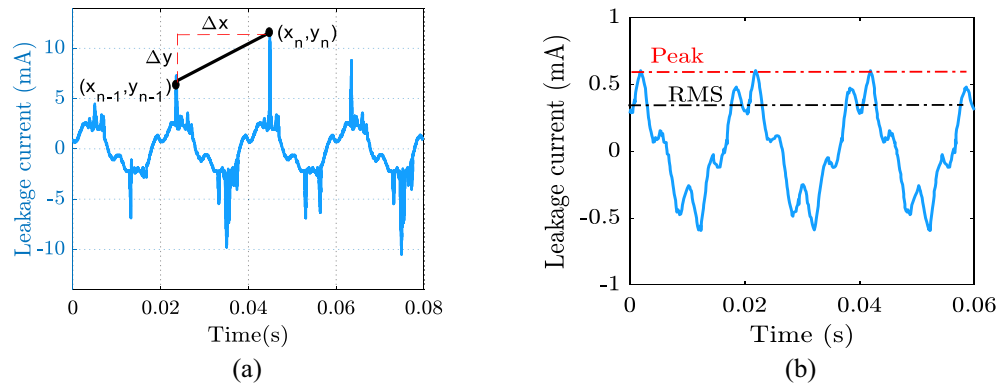
Figure 6. Extracting leakage current characteristics: (a) slope curve, (b) crest factor.

where Δy_n is the difference in leakage current between neighboring peaks at n , and Δx_n is the time period between these peaks. Figure 6a shows how the LC signal slope was determined. The fourth index was the crest factor (C_4), which was calculated by dividing the peak value by the RMS value of the leakage current (as illustrated in Fig. 6b). As a result, Eq. (11) was used to represent C_4 :

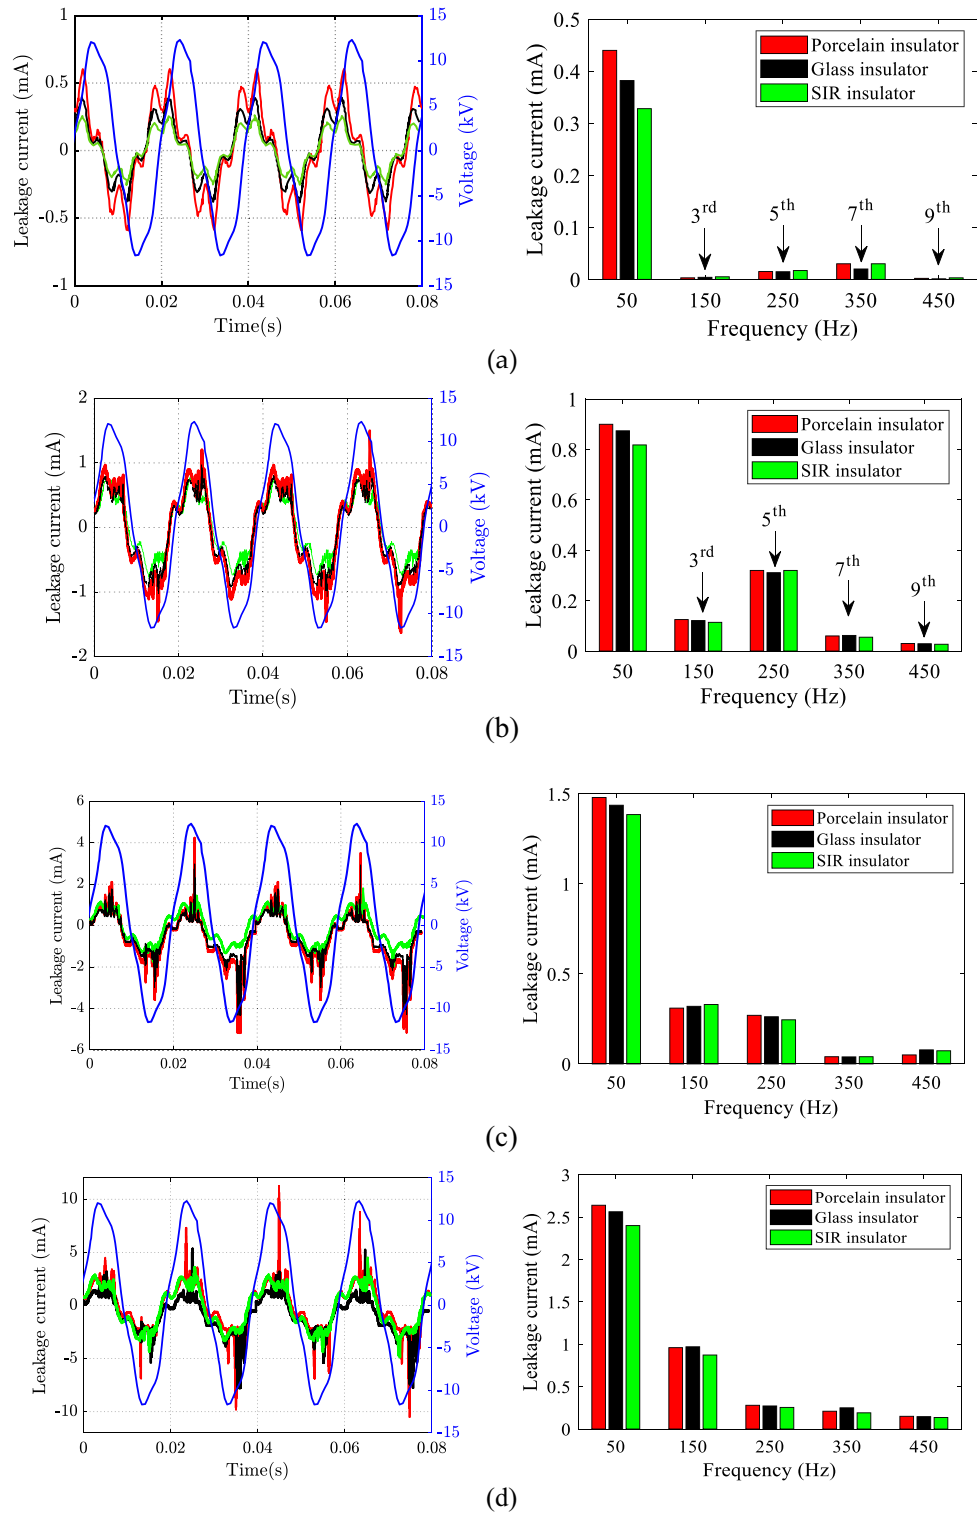
Figure 7. LC waveform and its FFT under different SDD pollution degree, 0.15 of NSDD, and 3 l/h of wetting rate: **(a)** SDD = 0.00 mg/cm²; **(b)** SDD = 0.05 mg/cm², **(c)** SDD = 0.12 mg/cm², **(d)** SDD = 0.2 mg/cm².

Leakage current results. Figure 7 depicts the sample of LC results in the time and frequency domains for porcelain, glass, and SIR insulators under different SDD pollution levels, 0.15 mg/cm² of NSDD and 3 l/h of Wt and uniform pollution distribution. Figure 7 illustrates that increasing pollution severity SDD under specific NSDD, Wt, and P_u/P_L causes a large rise in LC. The current spike could be explained by the creation of a layer because of pollution and moisture, which enhanced conductivity along the insulator's surface. Consequently, a path was created to flow LC in the form of ions between insulator poles. Spot-arcing was found on occasion under high pollution conditions, particularly in the presence of moisture. The signal of LC looked to be substantially warped during the arcing activities, as illustrated in Fig. 7d. When LC increased, THD and harmonics levels also increased, but the phase shift angle between LC and voltage decreased. Because the resistive current increased with the constant capacitive current, the phase angle between LC and voltage decreased. Furthermore, a great variance in the odd harmonics 3rd to 9th could be observed when the contamination severity on the surfaces of the insulator was increased gradually, where the third harmonic would increase to overtake other odd harmonics (5th, 7th, and 9th), with a considerable rise in both of the 7th and 9th harmonics, as shown in Fig. 8. It can be noted that when the insulator had an arcing activity on its surface, the 3rd harmonic increased sharply.

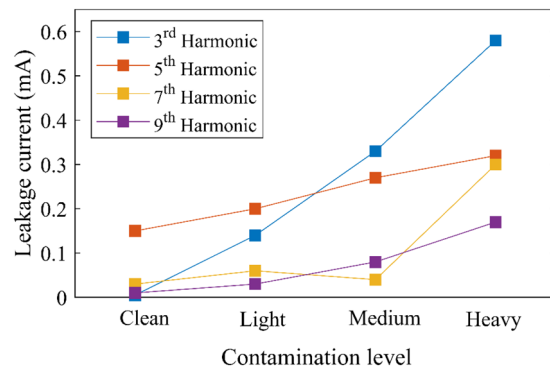
Figure 8. Odd harmonics of leakage current under pollution grading.

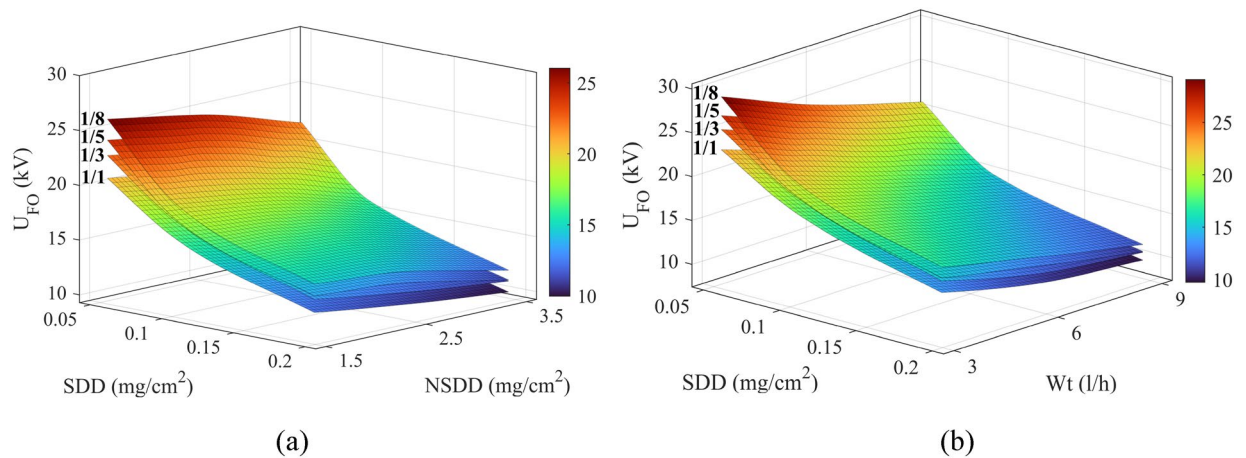
Figure 9. Flashover voltage of glass insulator vs. (a) SDD and NSDD (b) SDD and Wt under different non-uniformity degrees P_u/P_L .

Flashover voltage results. The flashover voltage experimental result under different conditions for the tested insulators are listed in Table 4. The flashover voltage as a function of SDD and NSDD under different P_u/P_L for the glass specimen as an example is displayed in Fig. 9a. Meanwhile, Fig. 9b depicts the influence of SDD and wetting rate on the flashover voltage. The findings indicate that the flashover voltage drops significantly

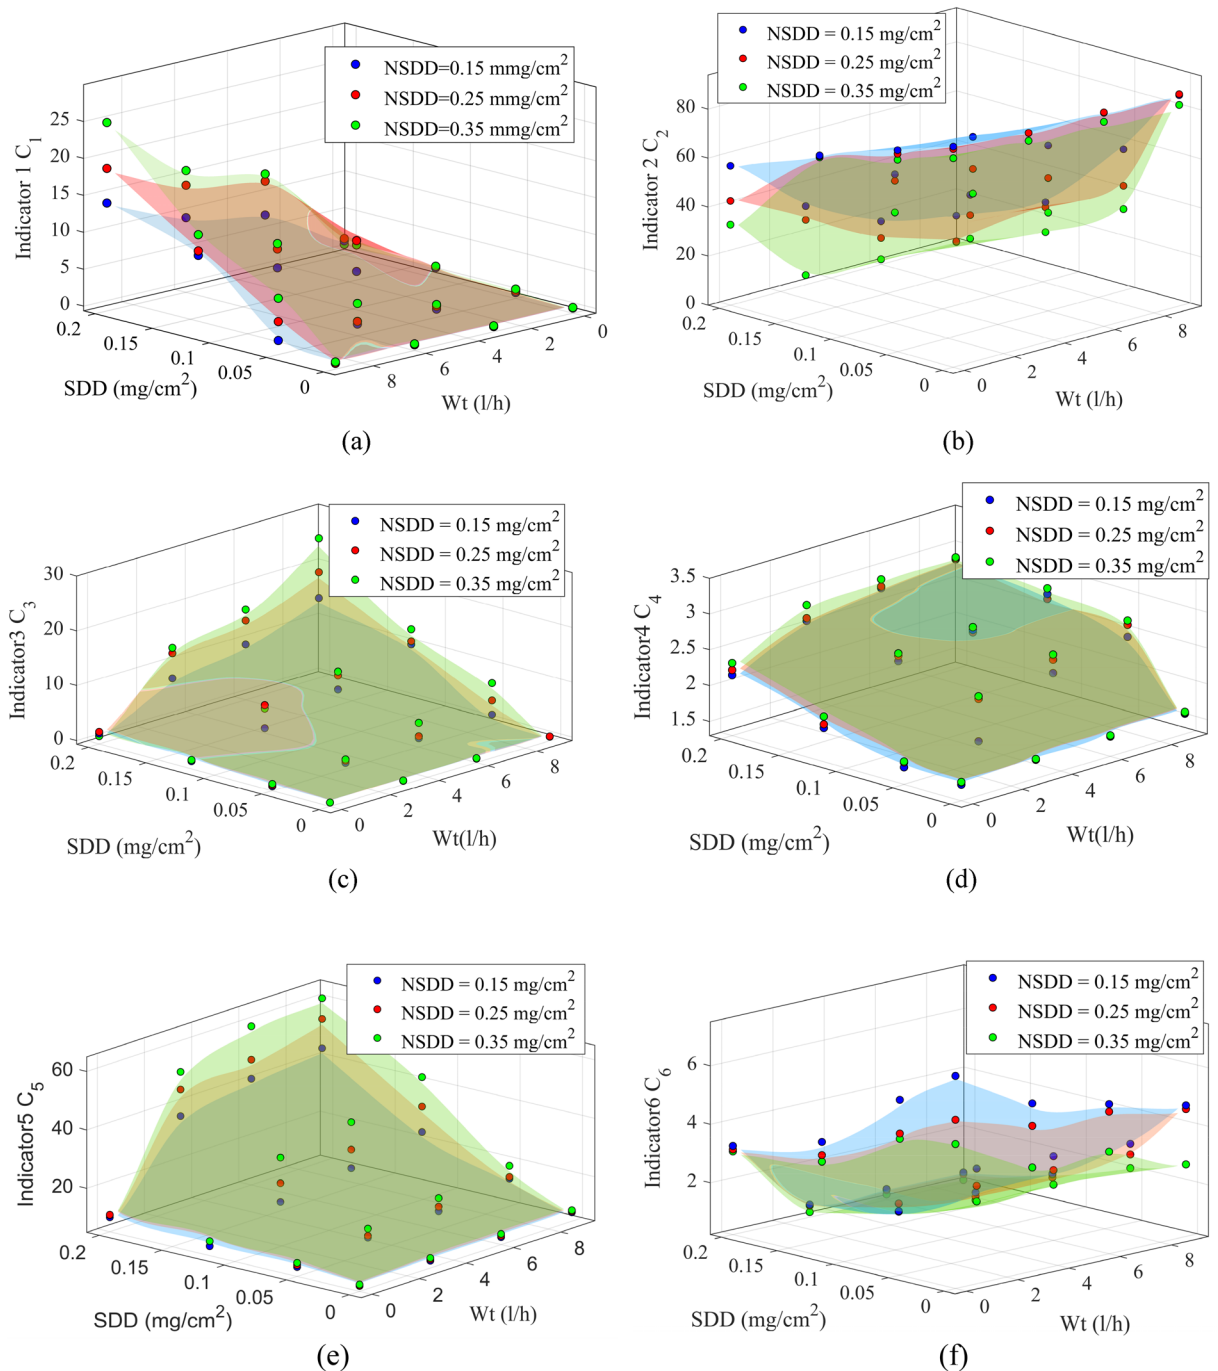
Figure 10. Leakage current indicators of uniform polluted insulators under various Wt and NSDD: (a) C₁; (b) C₂; (c) C₃; (d) C₄; (e) C₅; (f) C₆.

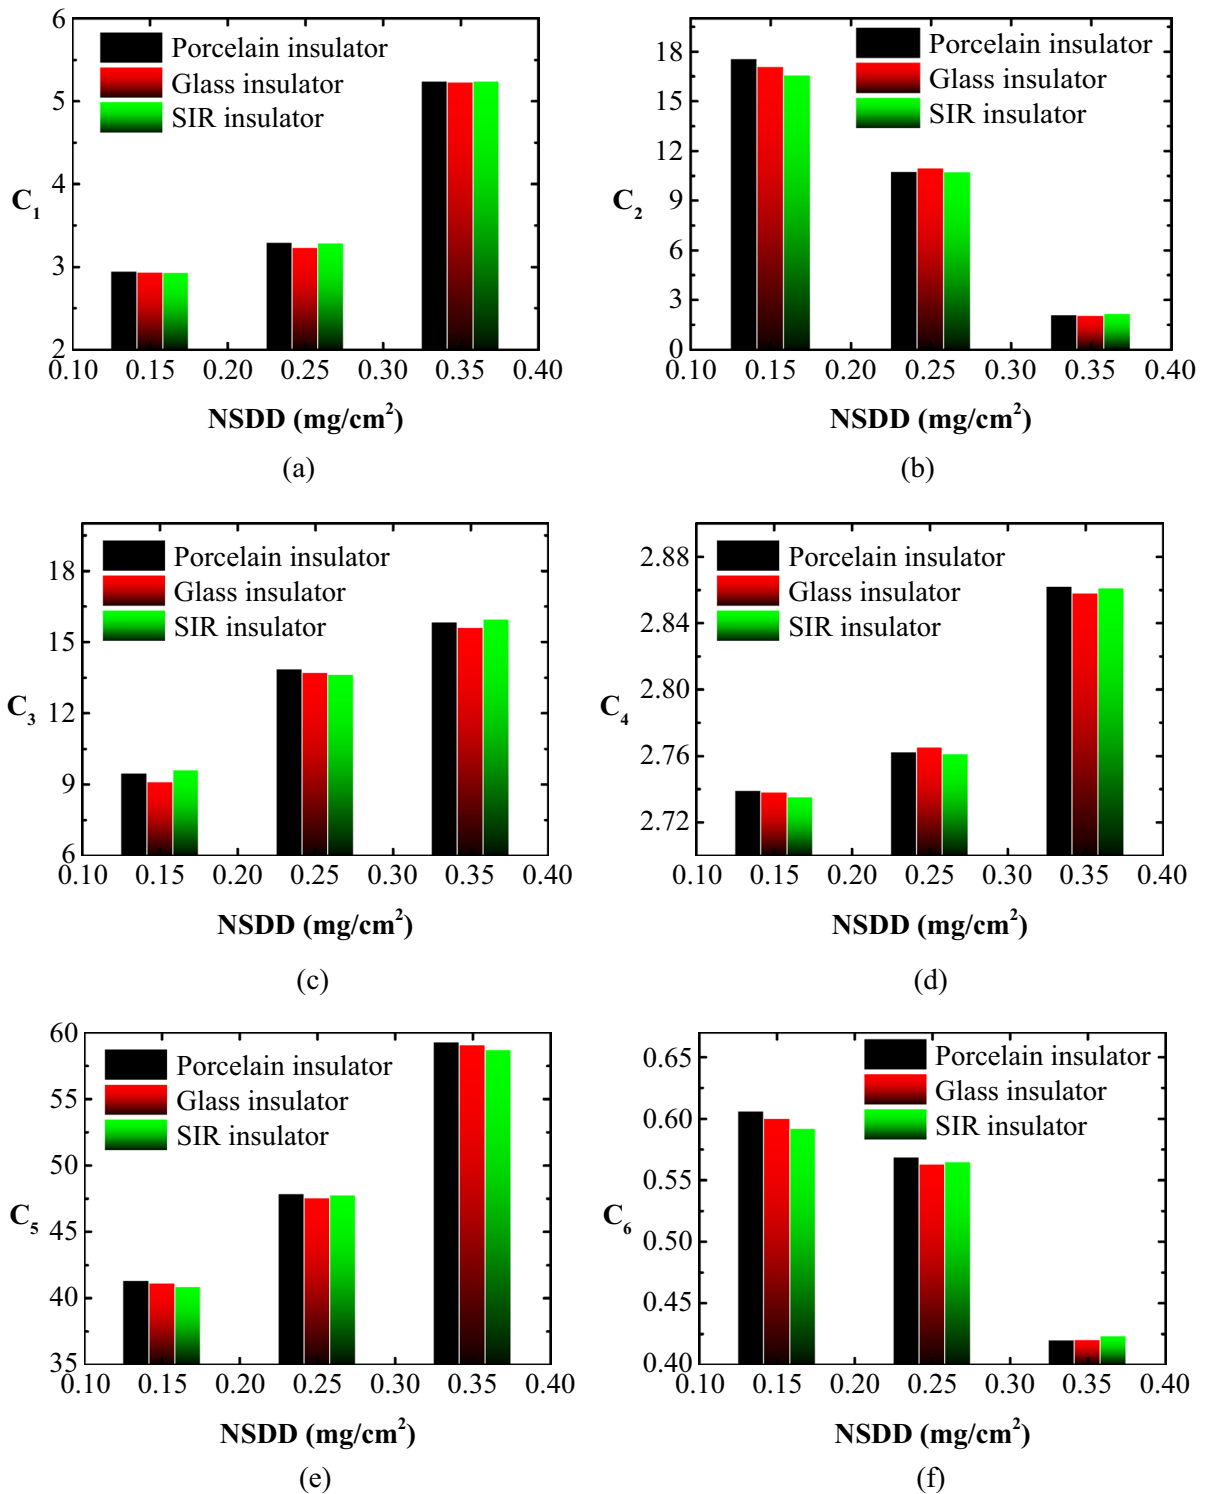
Figure 11. LC indicators versus NSDD for tested insulators under SDD=0.2 mg/cm², Wt=9 l/h and P_u/P_L=1/1: (a) C₁; (b) C₂; (c) C₃; (d) C₄; (e) C₅; (f) C₆.

Leakage current indicators trend under different NSDD. The performance of the indices is similar to the previous case with changing NSDD. However, there are discrepancies in the magnitude of increase or decrement. The test results indicated that for constant SDD, W_t , and P_u/P_L , if the NSDD increased, the C_1 , C_3 , C_4 , and C_5 would increase while the C_2 and C_6 would decrease. Figure 11 depicts the C_1 , C_3 , C_4 , C_5 , and C_6 versus NSDD curves for porcelain, glass, and SIR insulators with SDD = 0.2 mg/cm², W_t = 6 l/h, and P_u/P_L = 1/1 to help demonstrate the relationship between NSDD and the suggested indicators.

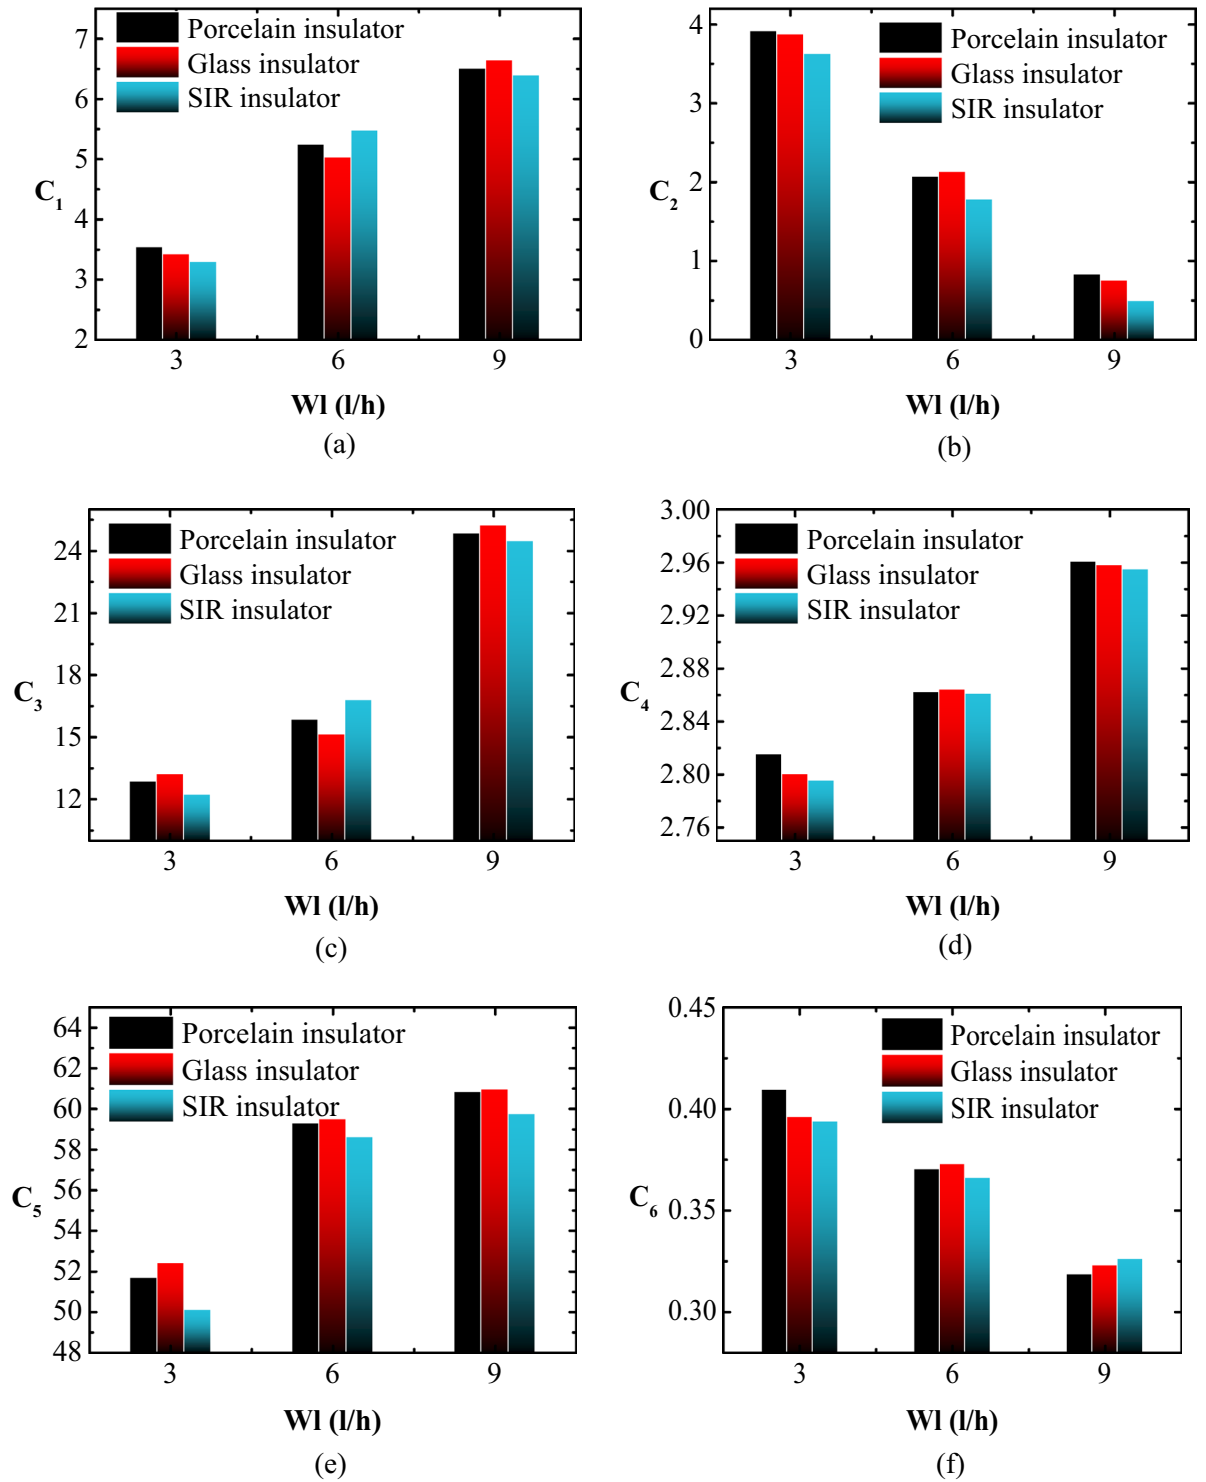
Figure 12. LC indicators versus Wt for tested insulators under SDD=0.2 mg/cm², NSDD=0.35 mg/cm² and P_u/P_L=1/1: (a) C₁; (b) C₂; (c) C₃; (d) C₄; (e) C₅; (f) C₆.

Leakage current indicators trend under different W_t . Figure 12 shows the connection between the suggested C_1 - C_6 indices and W_t for porcelain, glass, and SIR insulators under SDD = 0.2 mg/cm², NSDD = 0.35 mg/cm², and P_u/P_L = 1/1. It can be seen that when W_t increases, C_2 , and C_6 decreases while the C_1 , C_3 , C_4 , and C_5 increases. For example, when W_t increased from 3 to 6 and 9 l/h with SDD = 0.2 mg/cm², NSDD = 0.35 mg/cm², and P_u/P_L = 1/1, C_1 for porcelain insulator rose by 13.4% and 15.4%, respectively. Meanwhile, C_2 fell by 72.1% and 57.2%, respectively, under identical conditions.

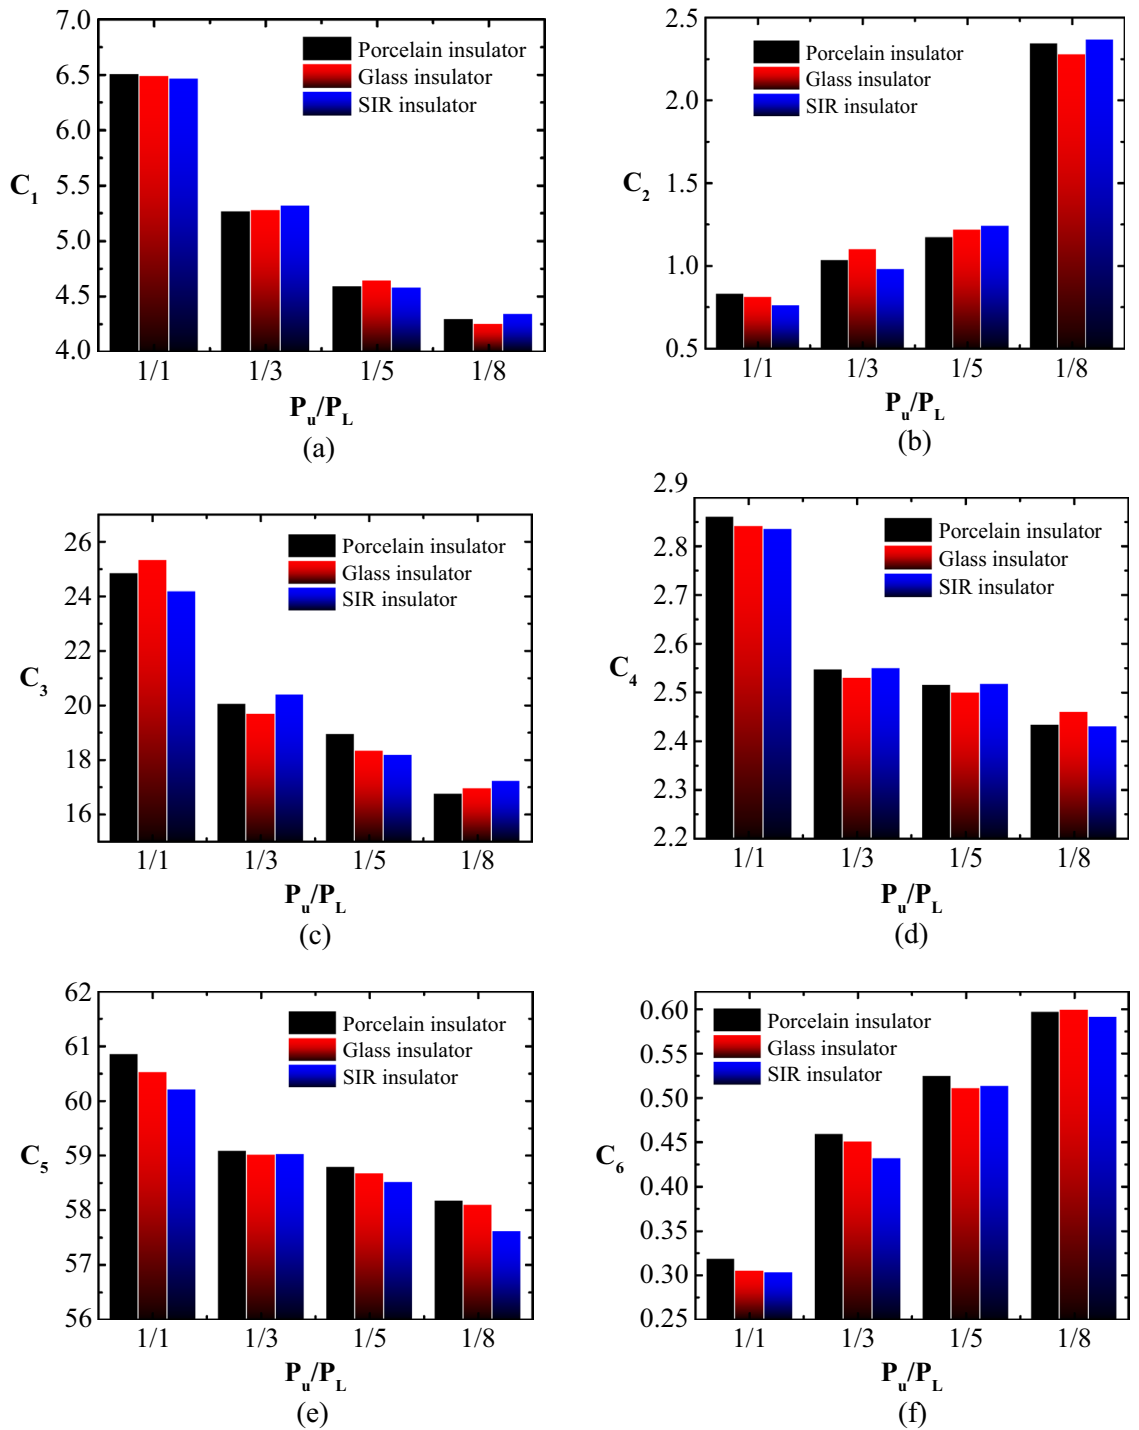
Figure 13. LC indicators versus P_u/P_L for tested insulators under $SDD=0.2 \text{ mg/cm}^2$, $NSDD=0.35 \text{ mg/cm}^2$ and $Wt=9 \text{ l/h}$: (a) C_1 ; (b) C_2 ; (c) C_3 ; (d) C_4 ; (e) C_5 ; (f) C_6 .

Leakage current indicators trend under different P_u/P_L . Figure 13 shows an example of the relationship between the suggested C_1 - C_6 indices and P_u/P_L for a dirty porcelain insulator with SDD of 0.2 mg/cm², NSDD of 0.35 mg/cm², and W_t of 9 l/h. It can be noted that rising P_u/P_L leads to increased C_2 and C_6 but decreased C_1 , C_3 , C_4 , and C_5 . This suggests that insulators under uniform pollution conditions have a higher probability of flashover occurrence than insulators under non-uniform pollution conditions.

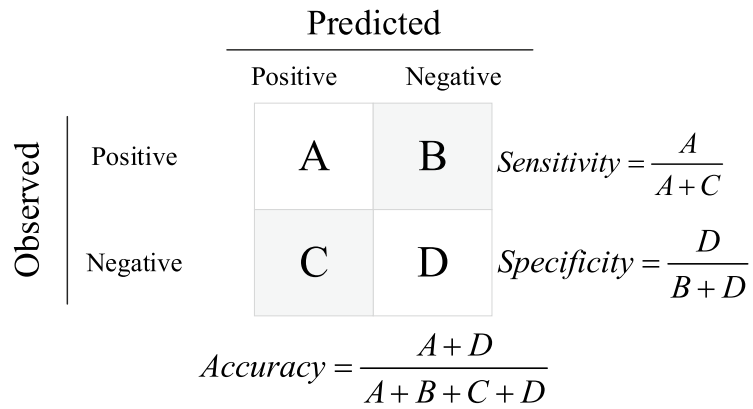
Figure 15. Confusion matrix for determining indices' sensitivity, specificity, and accuracy.

Determination of indices performance. To determine the performance of the proposed indicators precisely, the ability of the indicators to accurately estimate the insulators' state based on 912 tests for three insulators under different conditions was examined. The sensitivity, precision, and accuracy of these indices were calculated using the confusion matrix shown in Fig. 15 during the assessment. The parameters of the confusion matrix were specified based on the insulator condition preparation. The decision of test results and proposed indices are defined as:

- A. The tested insulator condition and the indicator prediction for the insulator condition are positive.
- B. The tested insulator condition is positive, but the indicator prediction for the insulator condition is negative.
- C. The tested insulator condition is negative, but the indicator prediction for the insulator condition is positive.
- D. The tested insulator condition and the indicator prediction for the insulator condition are negative.

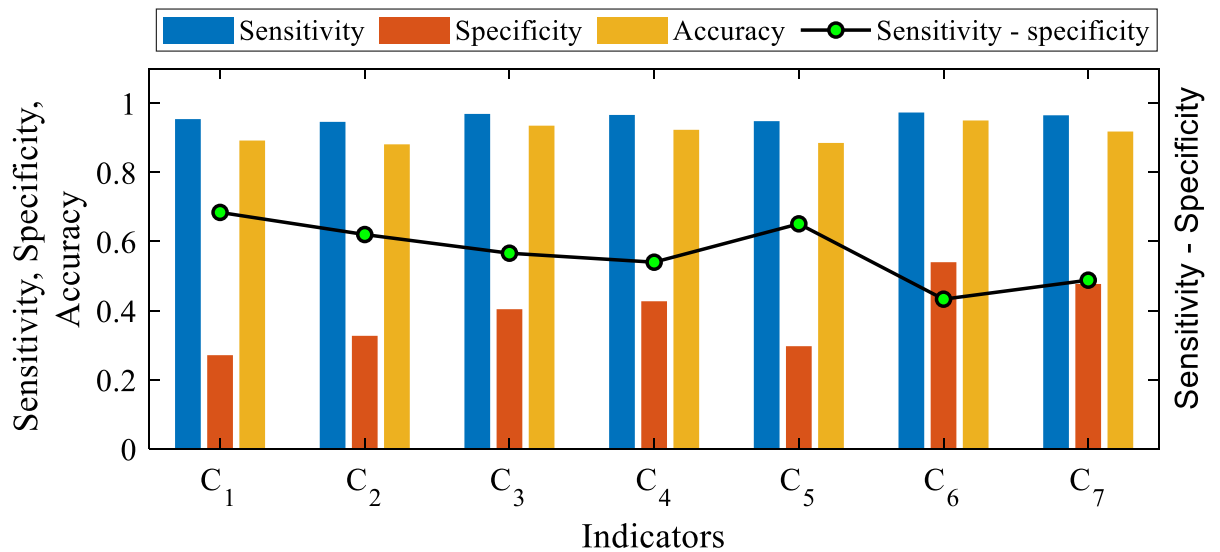
Figure 16. The indicators sensitivity, specificity, accuracy, and the difference between sensitivity and specificity.

According to the indices prediction results, C_6 (862) had the highest number of right projected outcomes, followed by C_3 (852), C_7 (851), C_4 (832), C_1 (812), C_5 (801) and C_2 (793). Consequently, C_6 has the best indication accuracy, followed by C_3 , C_4 , C_1 , C_5 , and C_2 (see Table 7). Meanwhile, C_6 has also the highest sensitivity, followed by C_7 , C_4 , C_3 , C_2 , C_1 , and C_5 (see Table 7). Furthermore, the "best" performance is defined as having the smallest fluctuation between sensitivity and specificity⁴². According to Fig. 16, C_6 has the least difference between sensitivity and specificity, followed by C_7 , C_4 , C_3 , C_2 , C_5 , and C_1 .

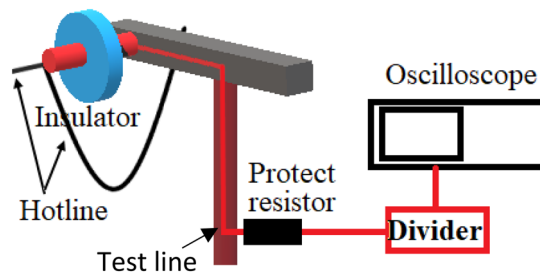
Figure 17. Illustration of on-site insulator testing.
