# Experimental Study on Seismic Capacity of Reinforced Concrete Composite Columns Based on a High-ductile Fiber Cementitious Composite

**Keywords:** concrete column, high-ductile fiber cementitious composite (HDFC), precast box, seismic improvement

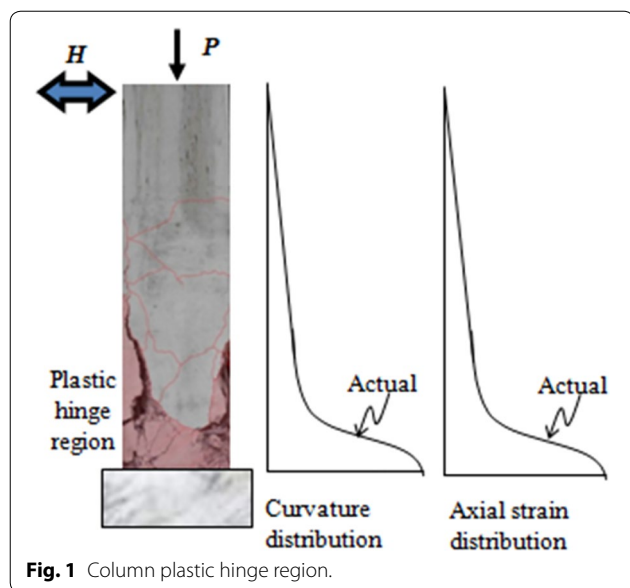
In the earthquake-resistant design of buildings, columns, as main structural members, are required to have not only high load-carrying capacities but also ductile deformation capacities for overall structural safety. In conventional reinforced-concrete columns depicted in Fig. 1, however, damage to the concrete and deformation of steel bars in the column plastic hinge region lead

to failure caused by flexural cracks in the concrete, yielding and buckling of the longitudinal bars, and crushing of the concrete in the flexural critical zone (Chai et al. 1994; Cho et al. 2005; Paulay and Priestley 1992; Priestley et al. 1996).

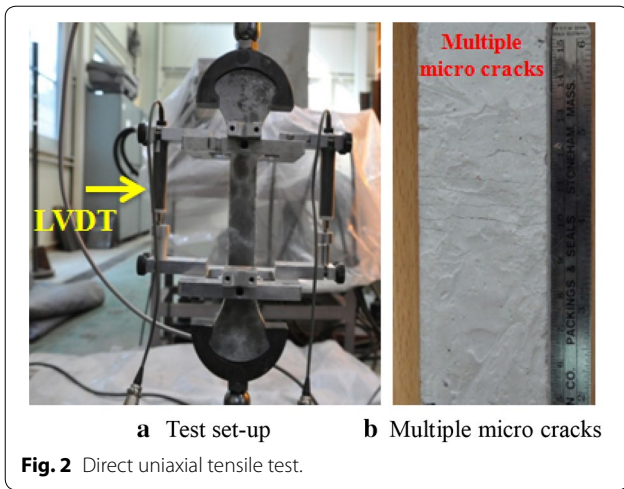
A direct uniaxial tensile test was conducted to investigate the tensile strain of the hardened HDFC, as shown in Fig. 2. The tensile test used a 10-kN capacity universal testing machine (UTM) with control of the displacement at 0.2 m/min. Two linear vertical displacement transducers (LVDTs) were attached to the sides of the specimens to obtain the tensile strains from the measured displacements. The specimens for tensile tests were made with a dog-bone shape (Lee et al. 2012). The hardened HDFC specimens were removed from the mold after 1 day and were cured in water for 28 days. The specimen had a cross-sectional dimension of 36 mm × 20 mm and a length of 350 mm.

From the tensile test, the direct tensile behavior of the HDFC was measured. As depicted in Fig. 3, the HDFC showed a high-ductile performance after reaching tensile cracking, with a measured tensile strain of ~3.0%. The high-ductile tensile characteristics were due to multiple micro cracks (see Fig. 2).

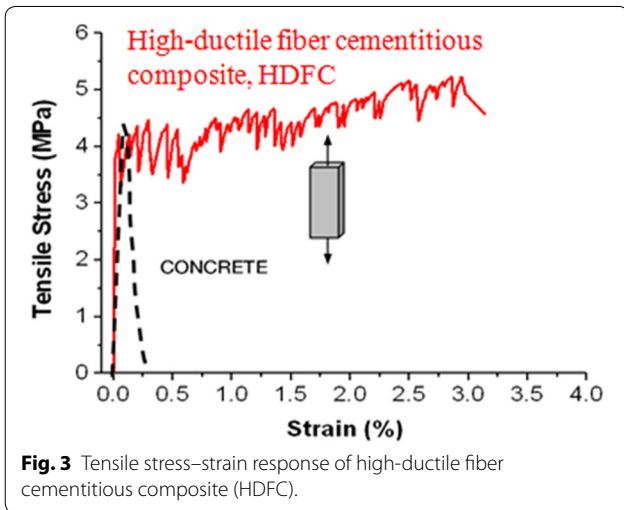
After cracking, the specimen showed strain-hardening behavior and clear ductility with multiple cracking. The premature cracking strength was ~4 MPa, while the maximum tensile strength measured in the interval of the curing behavior was 5.0 MPa. The experimental results explained why the HDFC showed high-ductile tensile strain with multiple micro cracks, avoiding crack localization, thus enhancing the brittleness of the concrete.

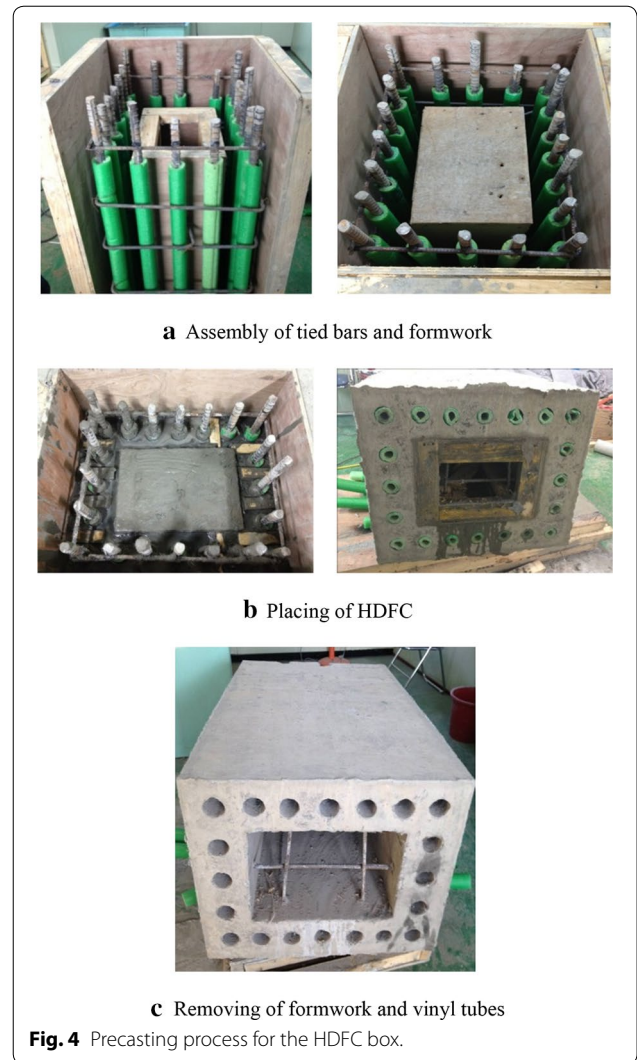
The manufacturing process and descriptions of the precast HDFC box are presented in Fig. 4. The HDFC box was designed to have transverse reinforcements and lead holes. The lead holes, to be transpierced by the main reinforcing bars, were made using vinyl tubes in the process of formwork. After 7 days of curing of the HDFC box, the formwork and vinyl tube were removed. At the placing stage of topping concrete, the lead holes would be filled with non-shrink mortar after the main reinforcing bars transpierced it, and the inside of the HDFC box filled with concrete.

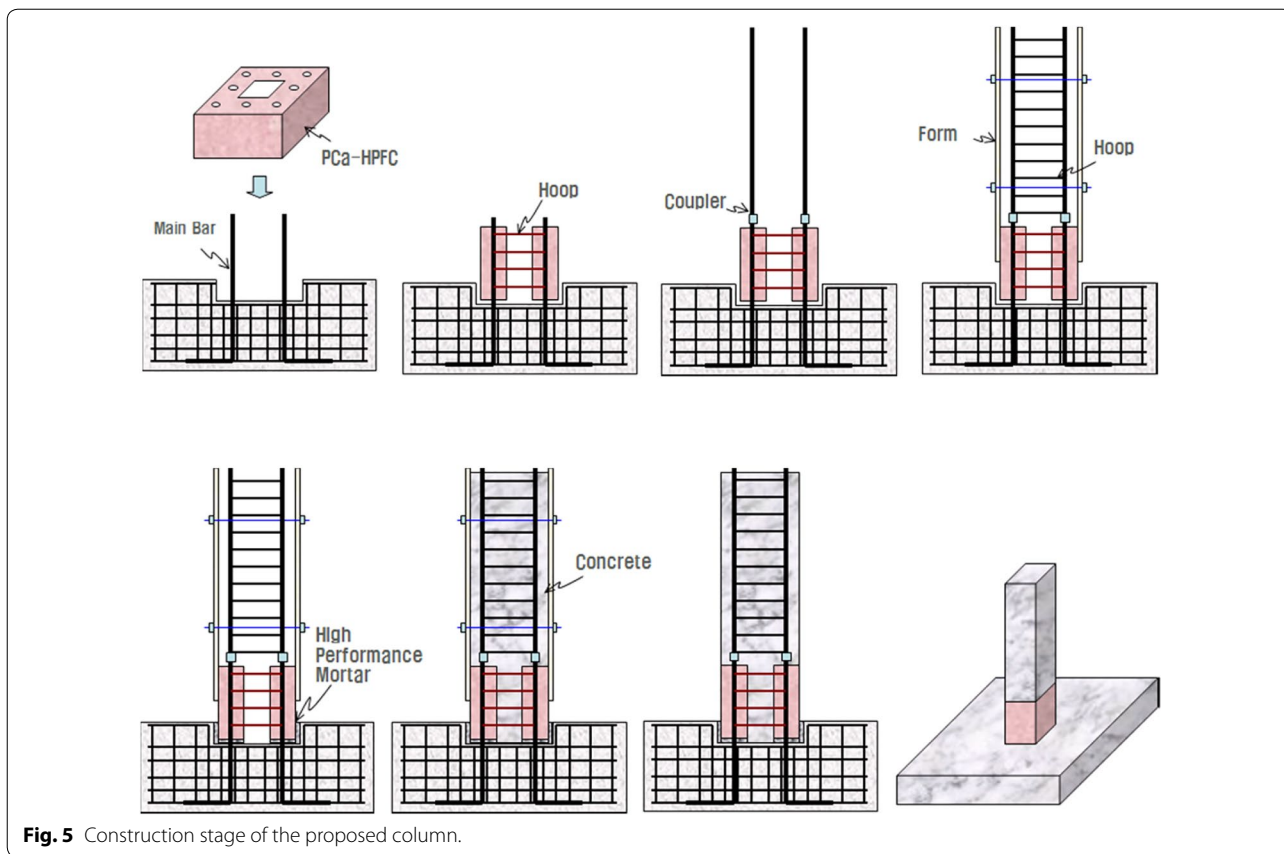
**Fig. 5** Construction stage of the proposed column.

**3.2 Method using Half Precast HDFC and Concrete Column**  
Using a precast HDFC box, a half precast composite column method is proposed, as shown in Fig. 5. It is considered that this column method can be applied in the

There are three main processes in manufacturing the proposed column at the structural construction stage. First, the reinforced concrete footing is cast with assembly of the reinforcing bars and placing of concrete. The footing surface at the location of the column is cast as a rectangular column seat, with a lower height of 120 mm, to inset the precast HDFC box. The main reinforcing bars are lengthened from inside the footing. Second, a precast HDFC box is put down along the main reinforcing bars, which will transpierce the lead holes in the HDFC box. The HDFC box is inset ~120 mm into the column seat on the footing surface. After locating the HDFC box on the footing, the gaps between the footing surface and the HDFC box, as well as the gaps of the lead holes and the main reinforcing bars, are injected with non-shrink

mortar to gain sufficient integrity between the HDFC box and the footing. Third, to place topping concrete, the main reinforcing bars are extended with bar couplers. Hoop reinforcing bars are assembled, the formworks for topping concrete are installed, and the concrete is poured. Finally, the half precast HDFC and reinforced concrete composite column construction is complete after curing of the topping concrete and removing the formwork.

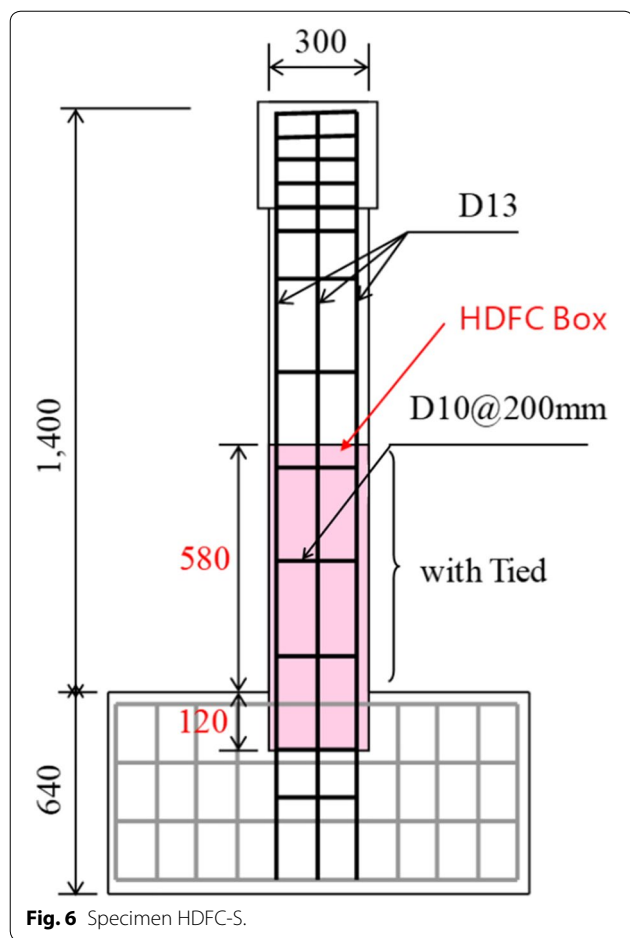
Fig. 6 illustrates the geometry and reinforcement details of a specimen, HDFC-S.

The main variables in the experiments were the number of hoop reinforcing bars with strengthening by the precast HDFC box. Each column had a  $300 \times 300 \text{ mm}^2$  cross-section, a height of 1400 mm from the base to the top of the column, a  $400 \times 400 \text{ mm}^2$  cross-section of the head part of the column and the column base, which was connected to a reinforced concrete footing, measuring  $900 \times 900 \times 700 \text{ mm}^3$ . All specimens had main longitudinal reinforcements of eight units of D13 bars. For specimen HDFC-N, the transverse reinforcements were not placed at the precast HDFC box to evaluate the control of shear cracks by HDFC, while for the other cases, the transverse reinforcements were assembled with D10 bars with a spacing of 100 mm or 200 mm.

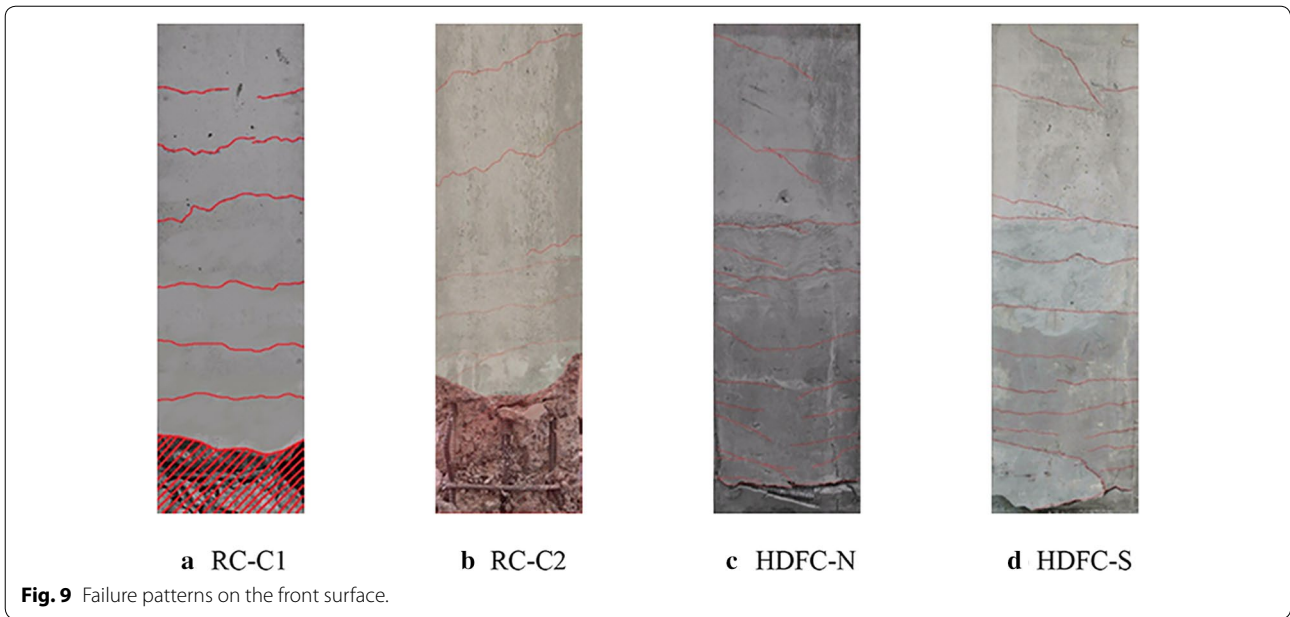
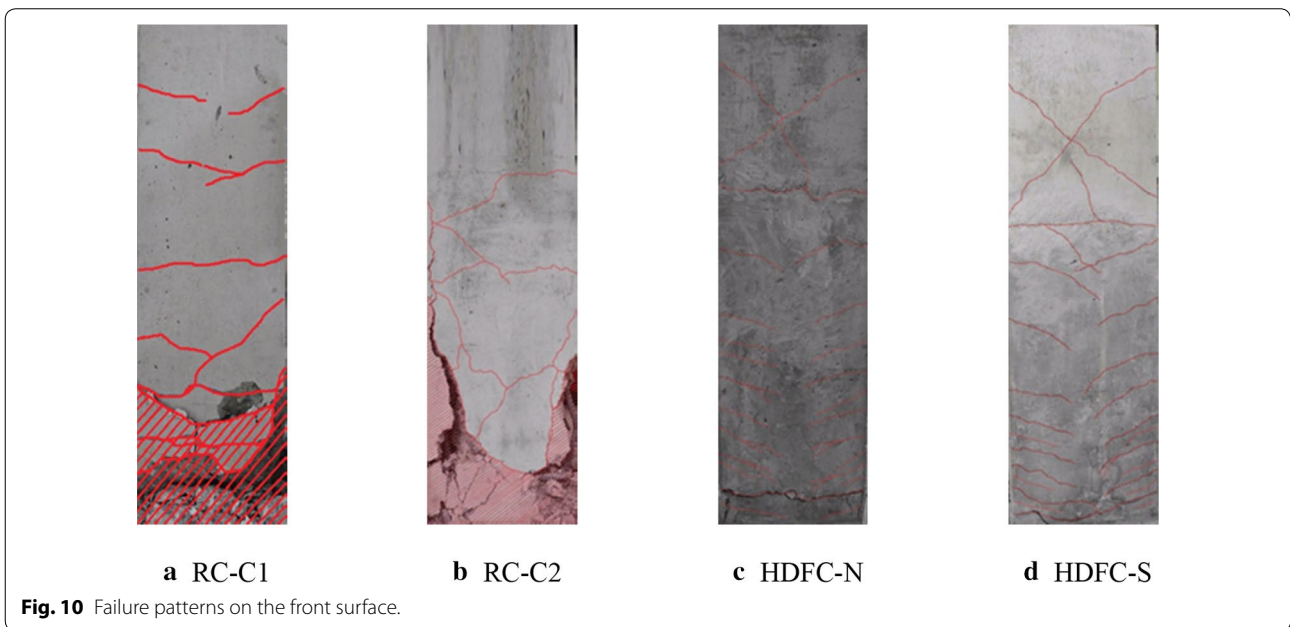
Each specimen of the column was tested in the loading frame under a laterally reversed cyclic load combined with a constant axial load. Final failure patterns at ultimate load on the front and side surfaces are shown in Figs. 9 and 10, respectively. Cyclic lateral load and top-displacement responses of specimens are shown in Fig. 11.

Unlike the specimens RC-C1 and RC-C2, shear cracks were not observed during the loading sequence, spalling and damage in the precast HDFC surface were not as serious, and finally the specimen reached failure with bending cracks near the column base.

reinforcement at a maximum displacement of 72.4 mm (see Figs. 9 and 10). In the final cycle of loading, the load carrying capacity was so terribly dropped below 60% of the maximum load the specimen was unable to resist the axial compressive load of the column.

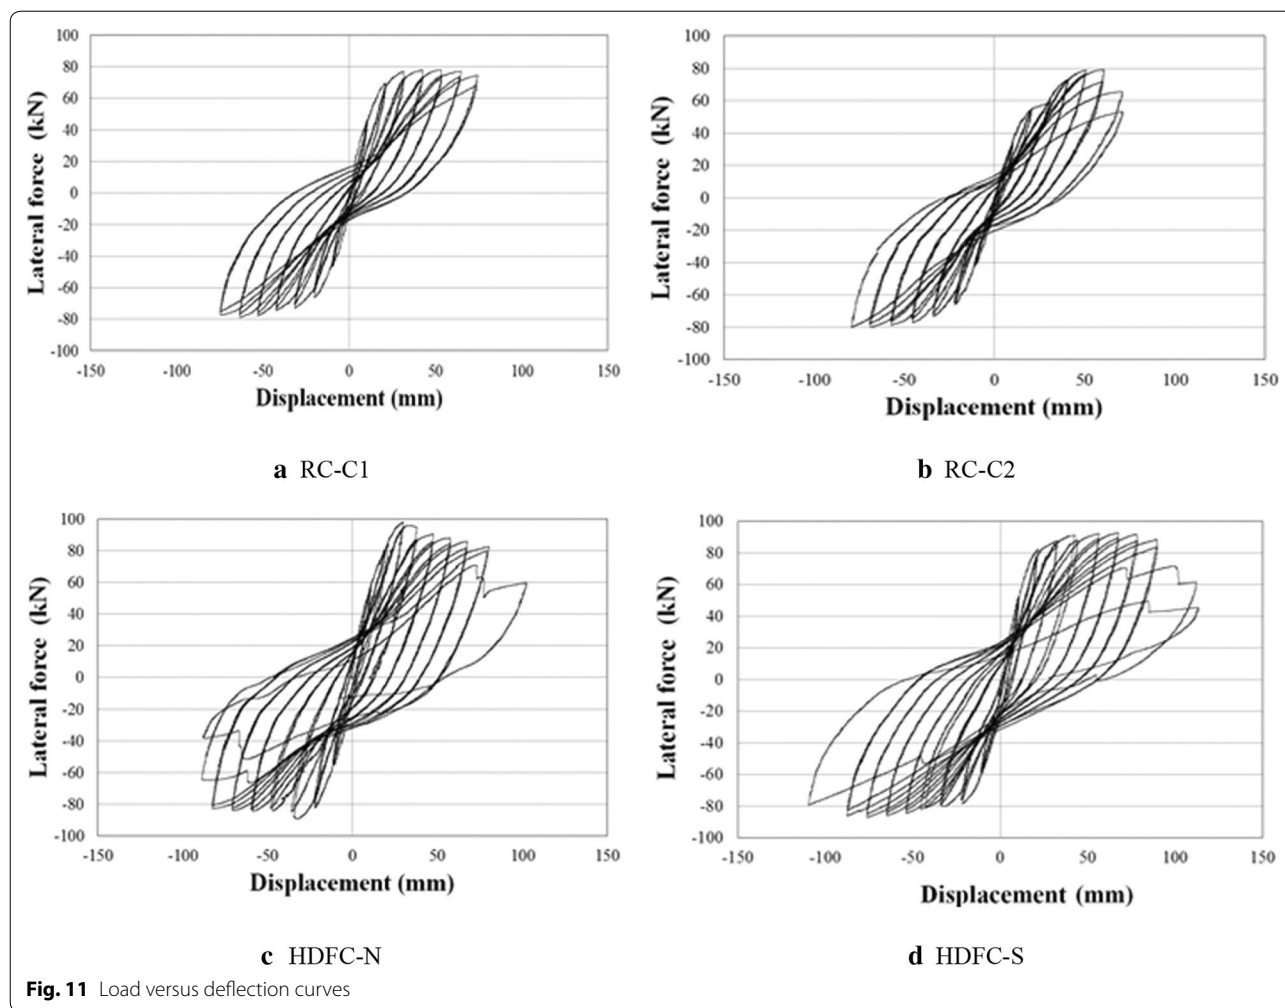
For specimen HDFC-S, strengthened with the precast HDFC box with transverse reinforcements in the plastic hinge region, an initial flexural crack occurred at a displacement of 5.2 mm. Yielding of the main reinforcement occurred for the first time at a horizontal displacement of 15.4 mm after showing an increase in load-carrying capacity according to the increase in displacement with definitive stiffness. The maximum load carrying capacity of 97.7 kN was reached at a horizontal displacement of 31.5 mm. The horizontal displacement was up to 77.9 mm with increasing horizontal displacement and decreasing strength. The results of the tests showed that no more load carrying capacity could be maintained due to internal degradation in the plastic hinge region caused by yielding of the main reinforcement at a maximum displacement of 101.9 mm. Shear cracks on the surface of HDFC box were not observed until the column reached failure by bending, and in the column plastic hinge zone, spalling and damage to the HDFC surface as well as buckling of the main bars were not observed, in comparison with the specimens of reinforced concrete columns. The overall responses of each specimen are summarized in Table 3.
