RESEARCH ARTICLE

# Effective cleaning of rust stained marble

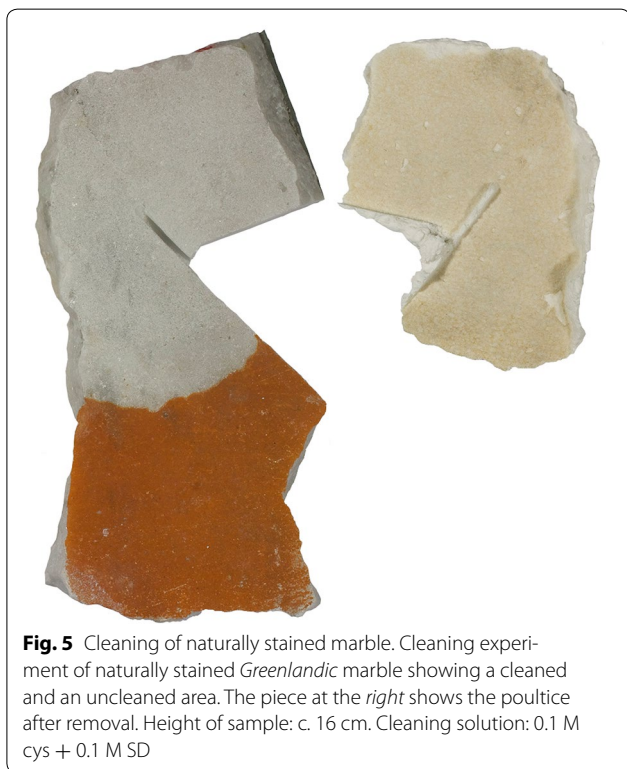
**Fig. 5** Cleaning of naturally stained marble. Cleaning experiment of naturally stained *Greenlandic* marble showing a cleaned and an uncleaned area. The piece at the *right* shows the poultice after removal. Height of sample: c. 16 cm. Cleaning solution: 0.1 M cys + 0.1 M SD

Figure 5 shows the cleaning experiment of a sample of naturally stained Greenlandic marble with the poultice containing cys and SD only. After one treatment, the surface was cleaned satisfactorily. The right part of the photograph shows the poultice material after cleaning and the yellowing of the poultice material reflects the absorbed iron.
