LETTER TO THE EDITOR

# Transient oxygen-rich air from air outlets promptly detected by failure of end-tidal control anesthesia

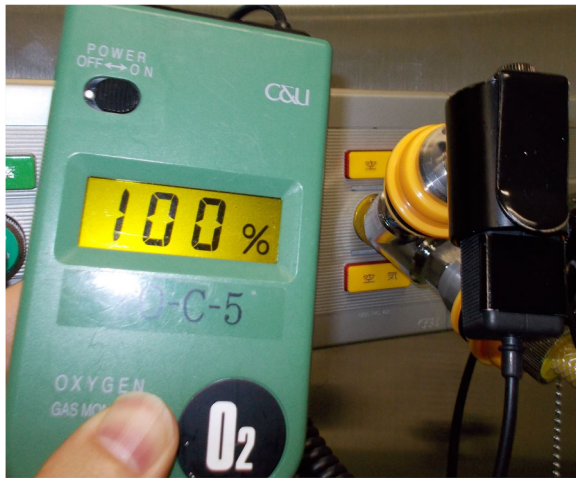
With frequent checks on the oxygen concentration at our air outlets, increases of up to 100% oxygen lasting a few minutes were occasionally detected in those rooms using a handheld oxygen analyzer (XO326-BC, New Cosmos Electric Co., Ltd., Osaka, Japan) (Fig. 1). To exclude the possibility of oxygen reflux toward the air pipeline within the Aisys, the air source for the Aisys was changed from the pipeline to stand-alone air compressors. No EtC failure occurred during this investigation period, although oxygen-rich air from air outlets in the three rooms was still observed.

**Fig. 1** Oxygen-rich air of up to 100% oxygen was occasionally detected by a handheld oximeter (XO326-BC, New Cosmos Electric, Osaka, Japan) connected to medical air outlets in certain operating rooms

promptly detected by EtC failure. The cause was a faulty air/oxygen blender built into an infant warmer installed in one of our operating rooms. Our experience suggests that air/oxygen blenders should not be left connected to pipelines when not in use. If they are left connected, the bleed switch on the warmer should be turned on, allowing partial release of the air/oxygen from the blender into the atmosphere, preventing cross-contamination.
